**Dower House,
Harlington**

Bat Activity Survey

August 2023

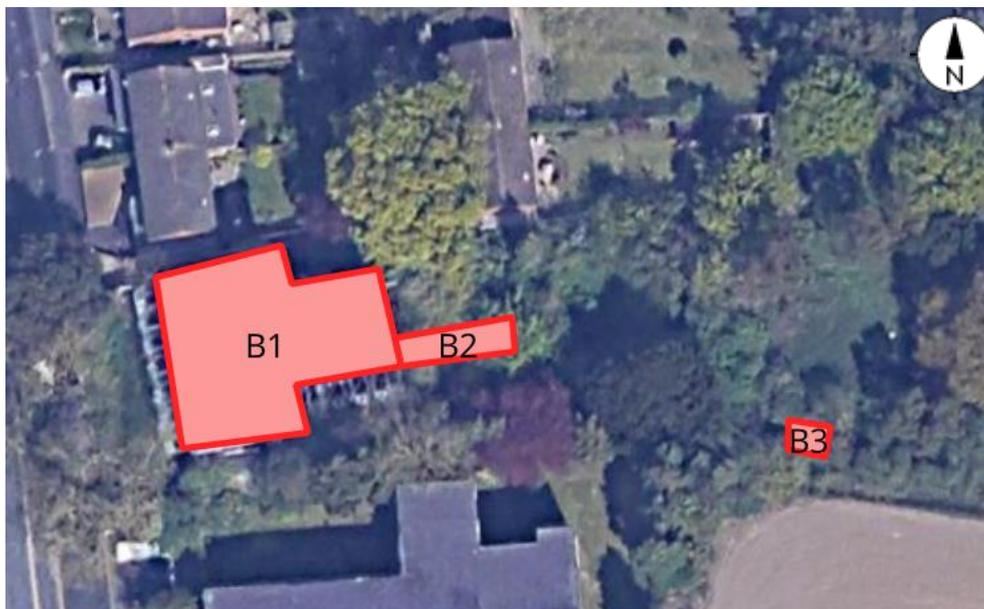
Figure 1: An aerial photograph of the surveyed site at Dower House, Harlington (as shown by the red outline). The arbitrary building numbers referred to throughout this report are also illustrated.

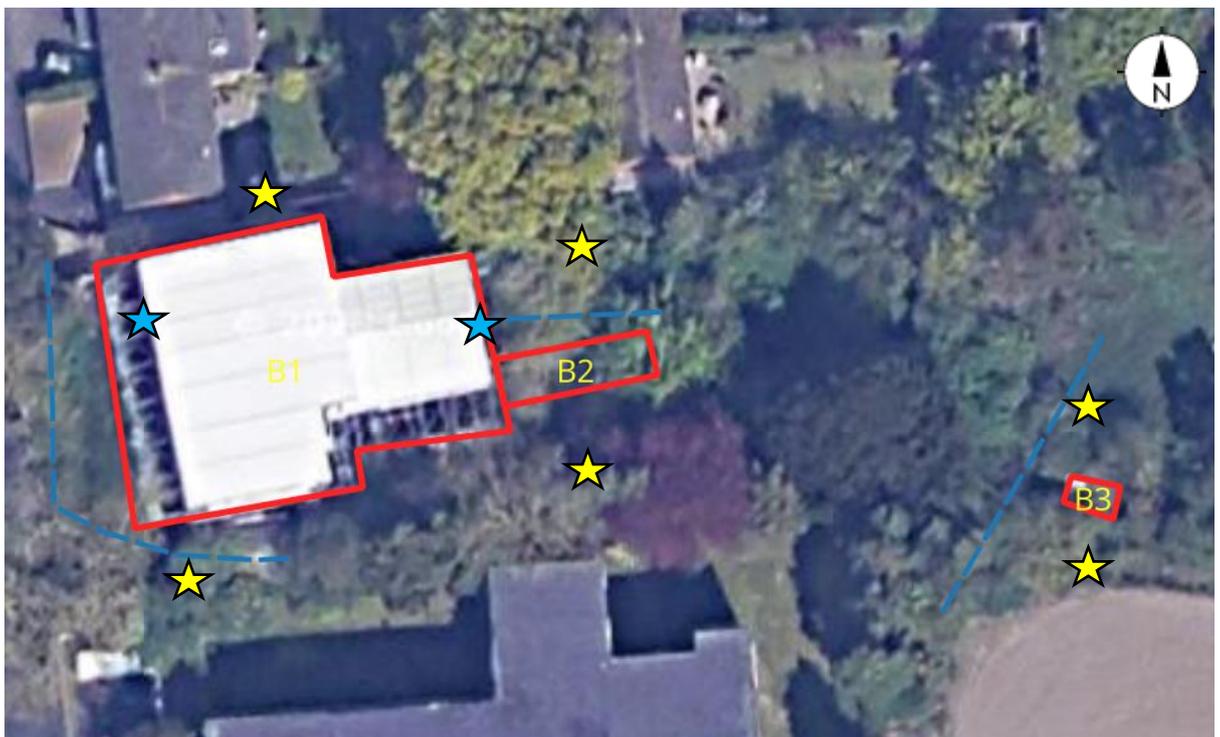
In addition, common pipistrelle bats were identified to be using the site for passing and foraging.

Figure 3: An aerial photograph of the surveyed buildings (red outline), the surveyor locations (yellow stars) and the common bat flight paths (dotted blue lines). Bat emergences are noted by the blue stars.

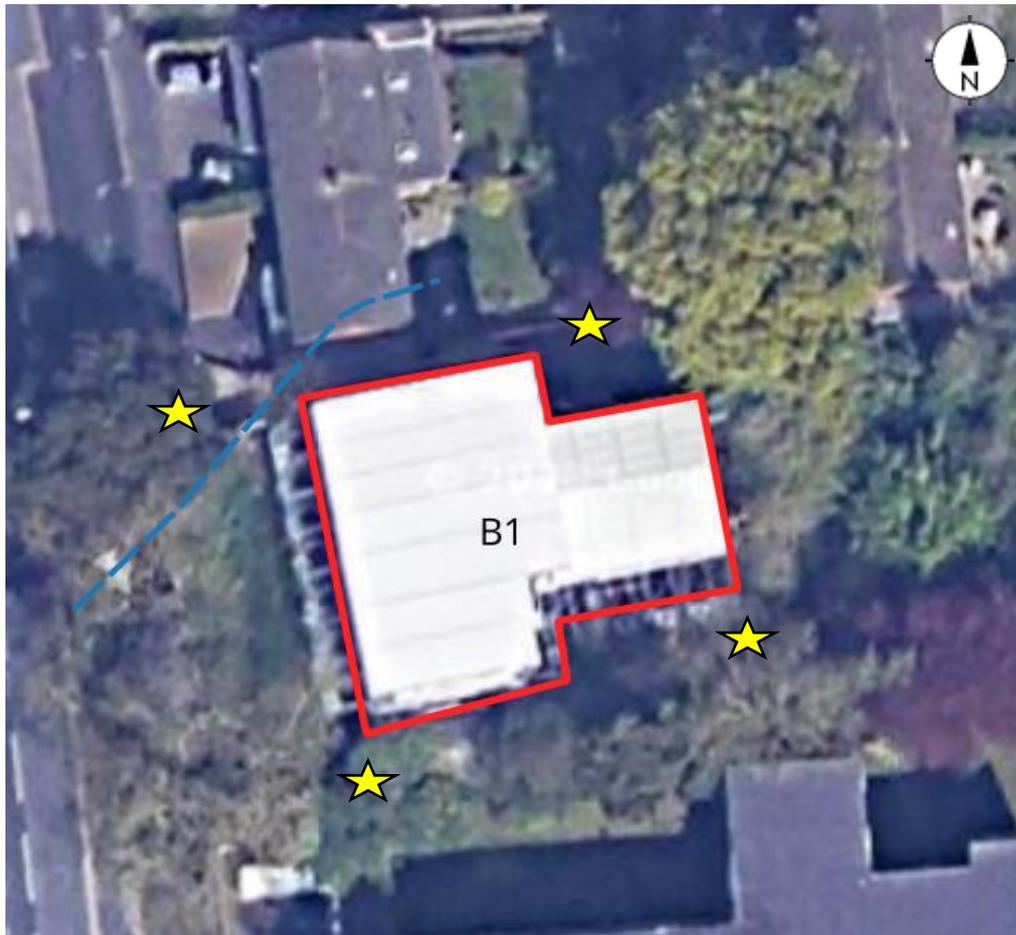
However, common pipistrelle bats were identified foraging and commuting in the area.

Figure 4: An aerial photograph of the surveyed buildings (red outline) and the surveyor locations (yellow stars).

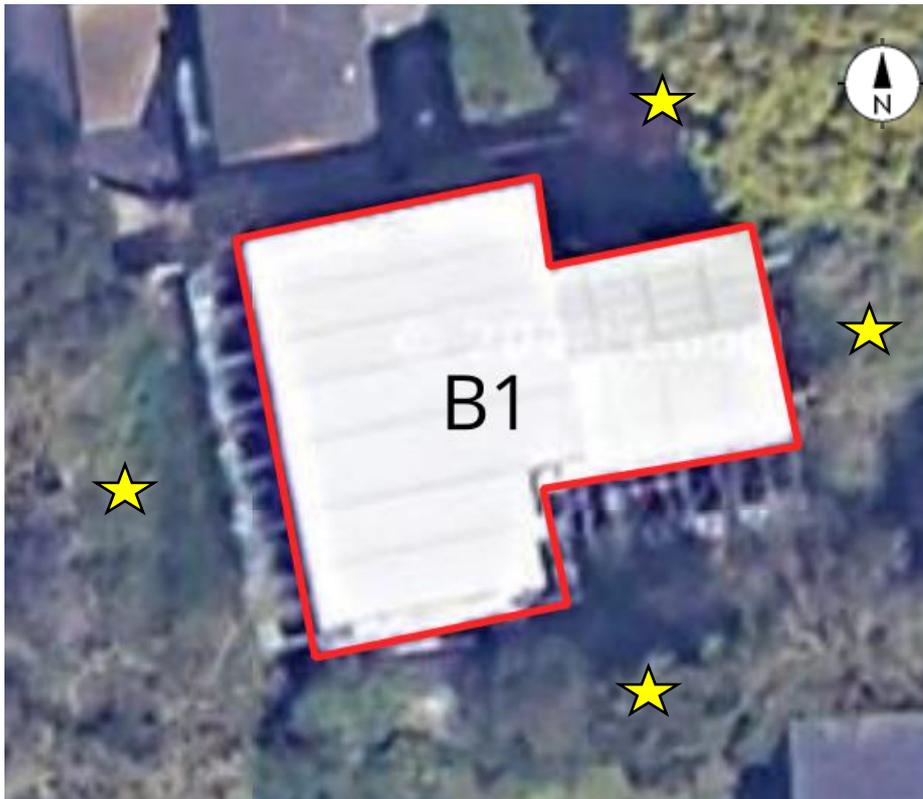
In addition, common pipistrelle and noctule (*Nyctalus noctula*) bats were identified using the site for commuting, foraging, and socialising.

Figure 5: An aerial photograph of the surveyed buildings (red outline) and the surveyor locations (yellow stars).

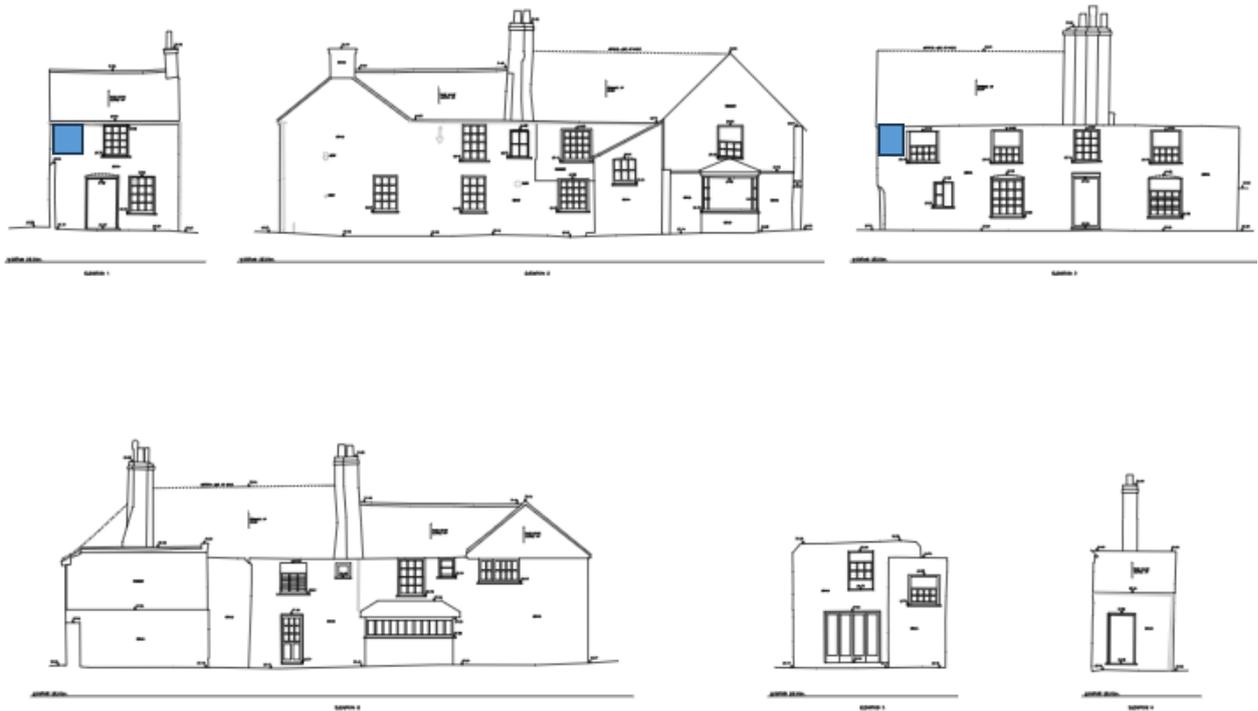
Figure 6: Proposed elevation plans of the rebuild at Dower House, Harlington with the locations of Integrated Eco Bat Boxes shown (blue shape). Please note these shapes are not to scale.

It is recommended that the existing access points are retained. If this is not possible, then two [Integrated Eco Bat Boxes](#) (one for each emergence point on **B1**) must be implemented into the new development. Placements of these can be seen in **Figure 6**. These can be purchased by contacting admin@eliteecology.co.uk, and should be placed as close to the existing bat access points as possible.

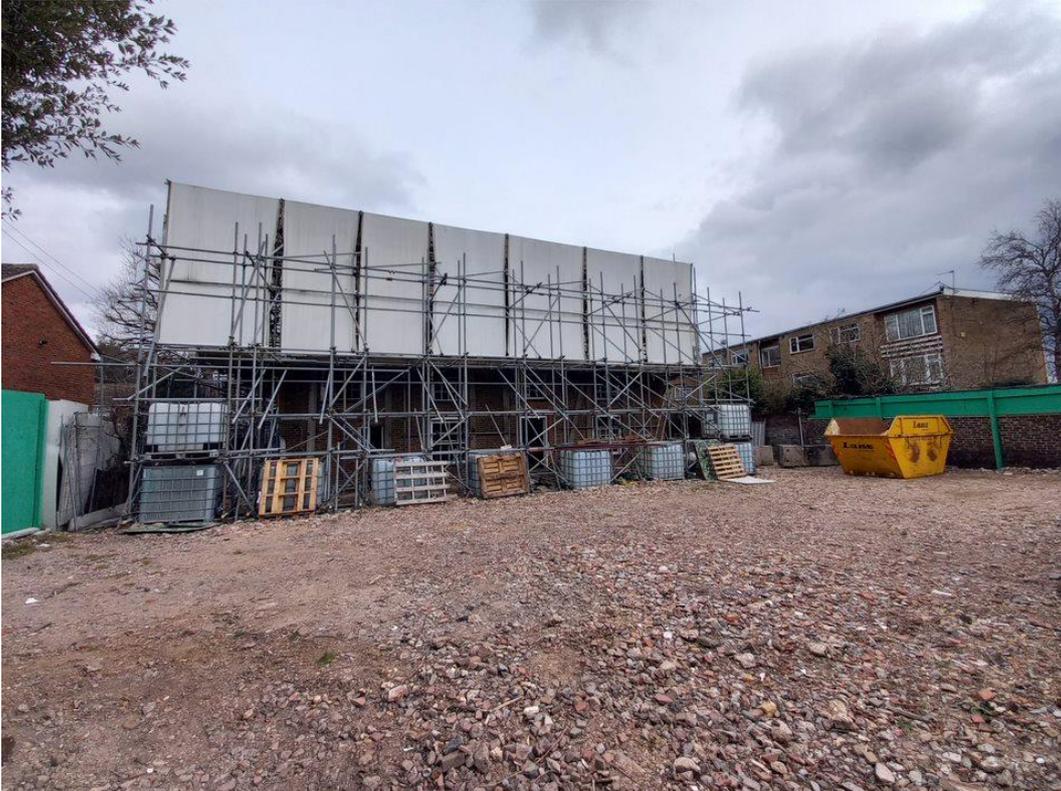
Plate 1: Image showing the hard standing ground at the west of the site and the western elevation of **B1**.

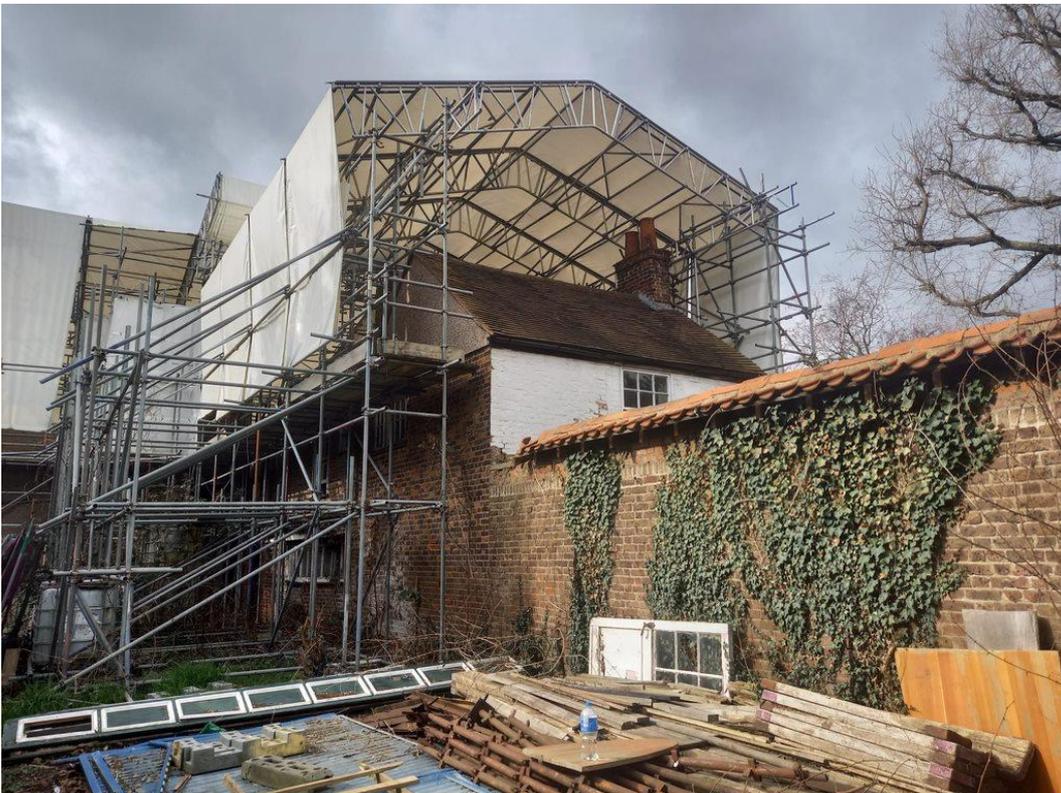
Plate 2: Photograph showing the eastern elevation of **B1**.

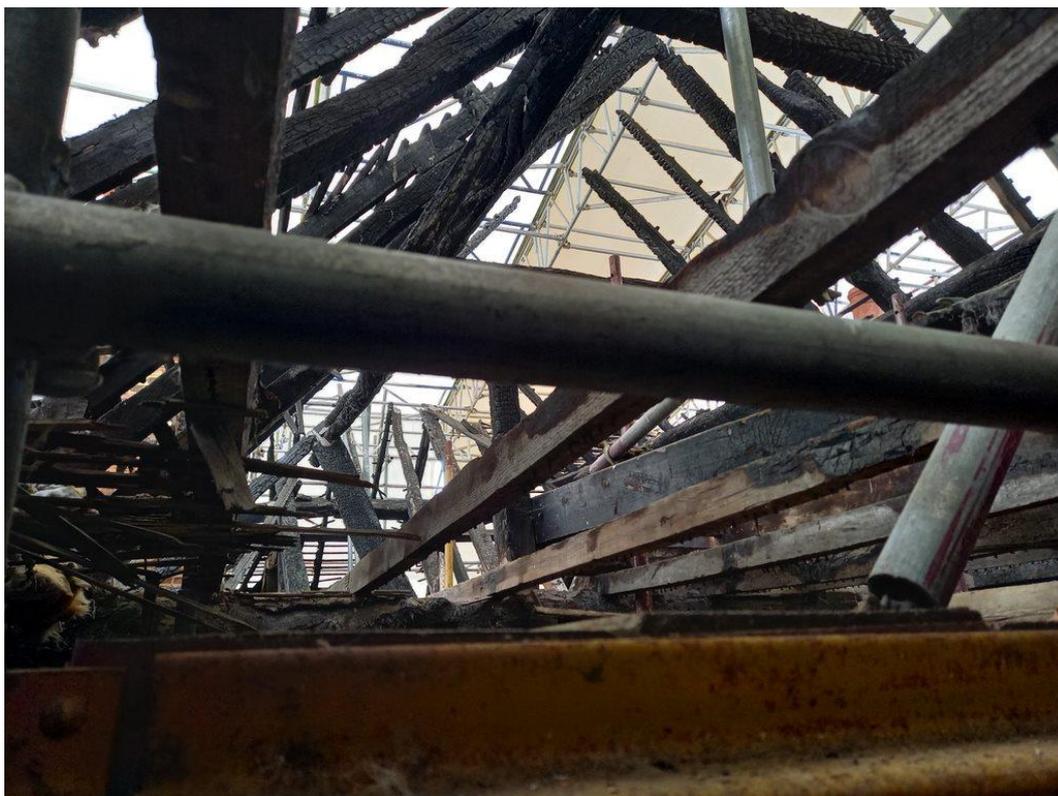
B1 is a detached residential building. Its walls are constructed of solid brick, with some parts of the southern and eastern elevations being rendered. There is currently no roof on the majority of this building, as it was damaged by fire. However, there is a small section of clay tile roof remaining in the eastern section of the building. The building is covered by temporary roof scaffolding to protect the interior of the building from further deterioration from the weather. The doors of the building are wooden, and the windows are also wooden framed, although at the time of the survey visit the doors were smashed. A brick chimney is present on the northern elevation on the eastern wing of the building. A large crack running up the brickwork can be found on the southern elevation of the building. Several gaps under the tiles on the eastern side of the roof of the eastern wing were identified. No external bird nests were identified during the survey visit.

Plate 3: Image showing the state of the roof of B1.

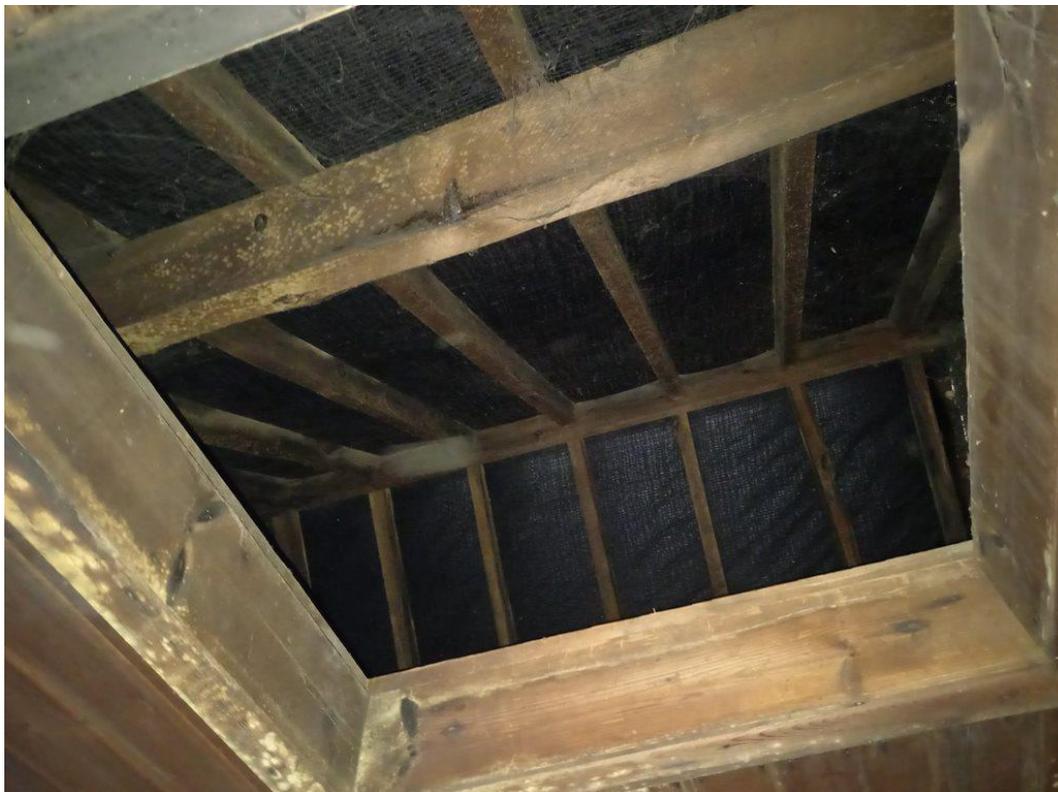
Plate 4: Image showing the loft area of the eastern wing.

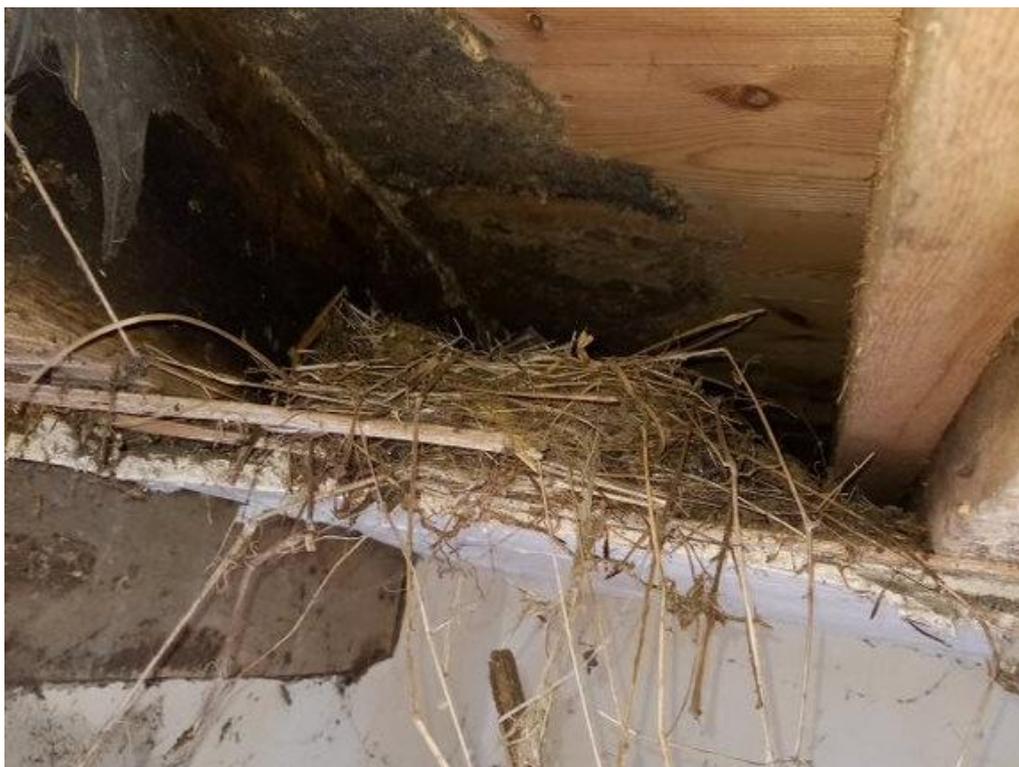
The ecological value of the buildings to birds has been deemed **high** due to **B1** supporting nests of blackbird (*Turdus merula*).

Plate 5: Image of the bird nest found within B1.

- Incorporate Bird Boxes, such as an [FSC Blackbird Nest Box](#) into the proposed scheme of works to compensate for the loss of blackbird (*Turdus merula*) nests.

All works on the structures must be undertaken outside of the bird breeding season (March to August, inclusive). If these features are required to be altered during the bird breeding season, then a further inspection by a suitably qualified ecologist is required no more than twenty-four hours before this process commences. This is to ensure that no active nest site is illegally destroyed, due to the protection afforded to **all** active bird nests under the Wildlife and Countryside Act 1981. If an active nest is found by a site inspection, an exclusion zone around the nest will be necessary to preserve this feature until the chicks have fledged the nest.

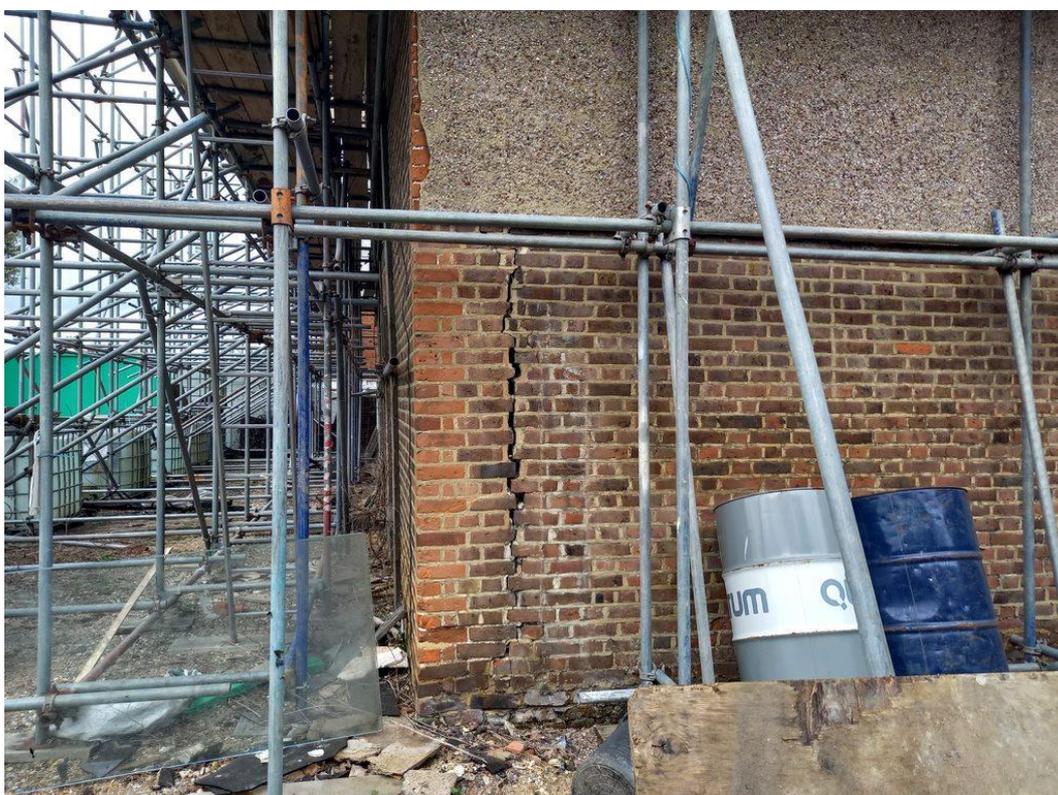
Plate 6: Image showing a crack in the wall of the southern elevation of B1.

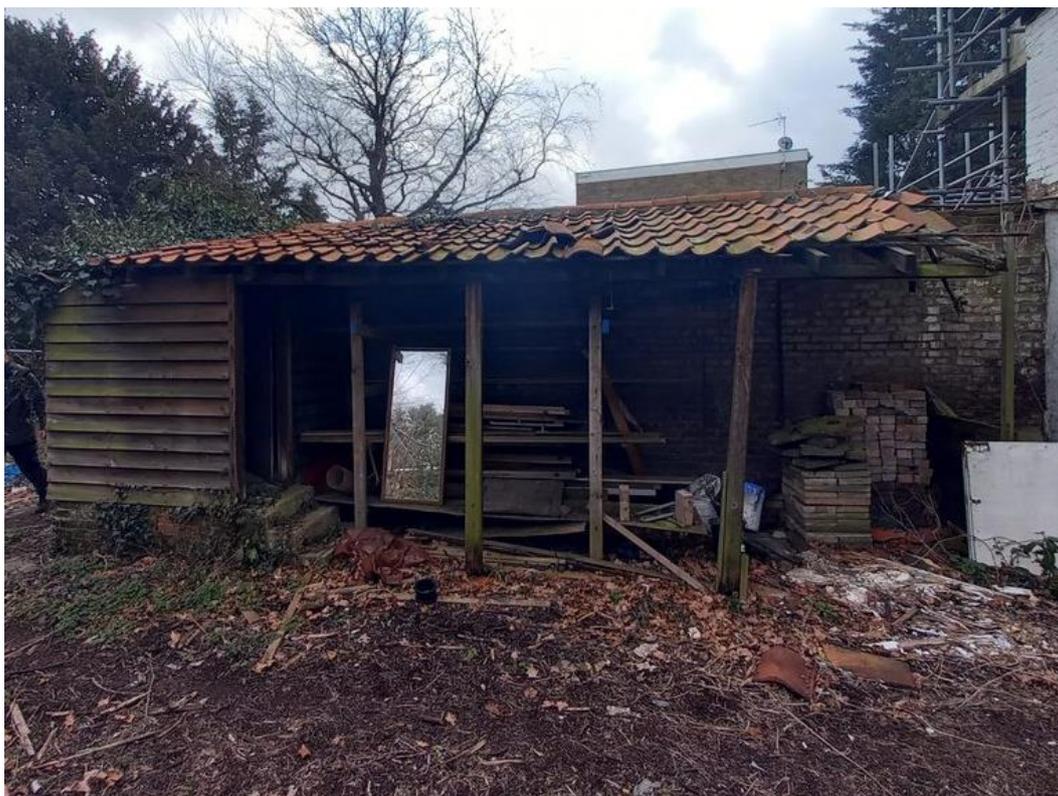
Plate 7: Image showing **B2**.

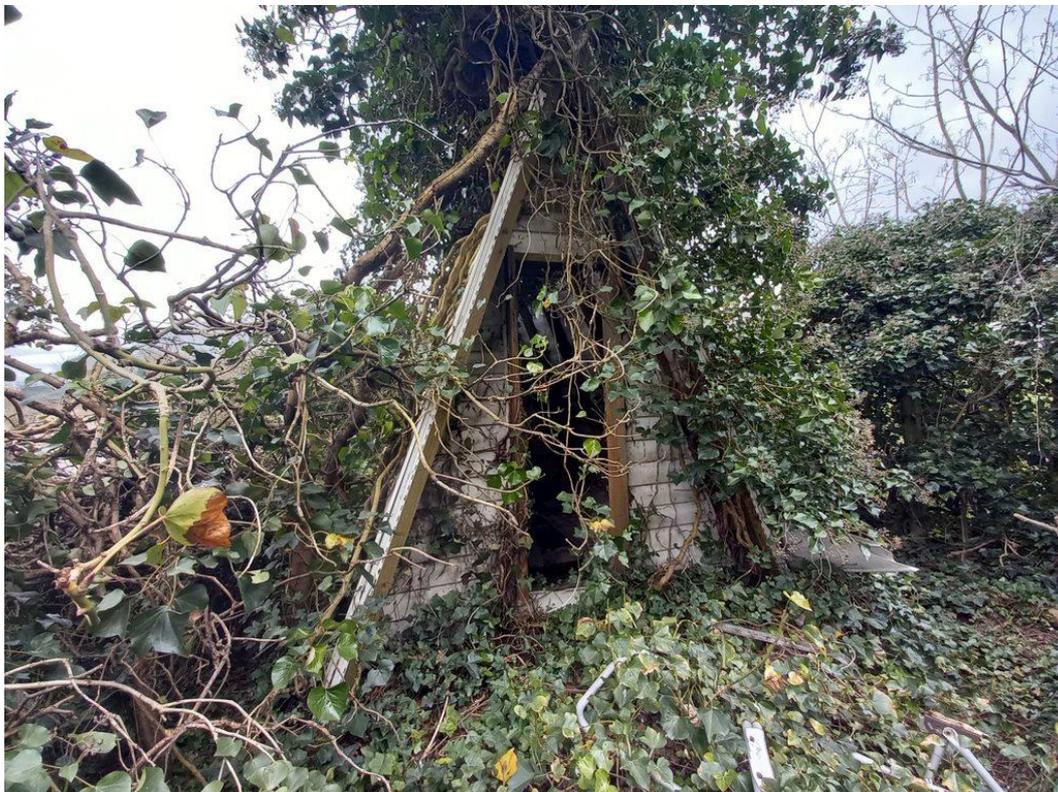
Plate 8: Image showing the exterior of **B3**.

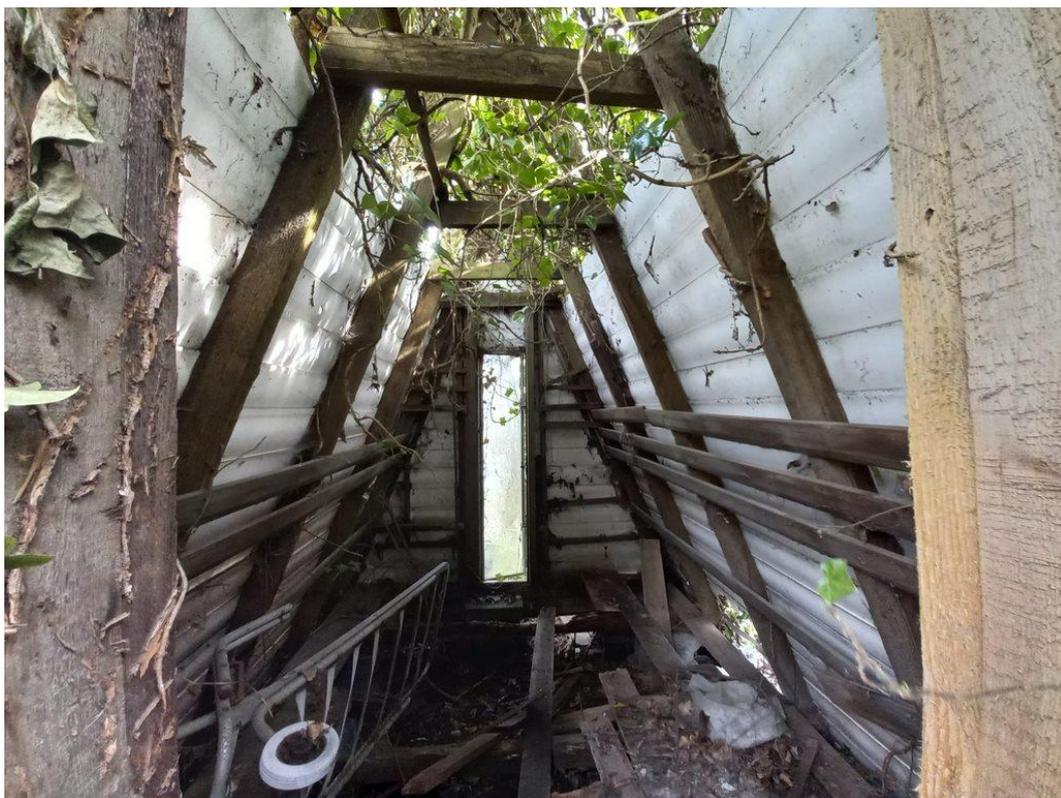
Plate 9: Image showing the interior of **B3**.
