**PHASE II COMBINED GEO-
ENVIRONMENTAL &
GEOTECHNICAL SITE
INVESTIGATION**

LAND AT DOWER HOUSE

REPORT REF: R0653/23

April 2023

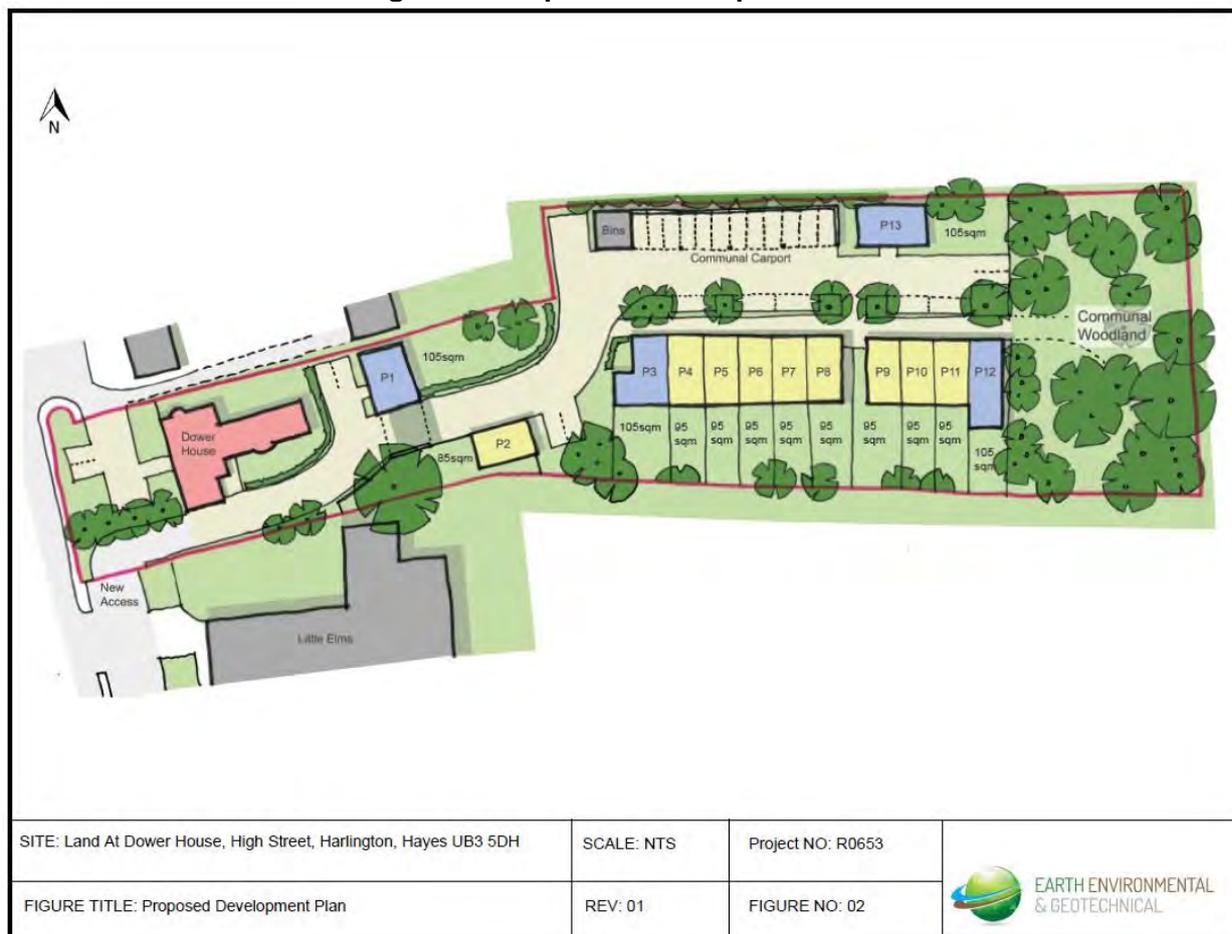
Figure 2: Proposed Development Plan

It is understood that the proposed development involves the clearance of vegetation within the central parts of the assessment site, the renovation of Dower House and construction of up to 5 No. 3 bed dwellings and 12 No. 2 bed dwellings with associated access road, refuse area, parking and communal woodland area (in the eastern end of the assessment site). See figure 2 for the current proposed development plans

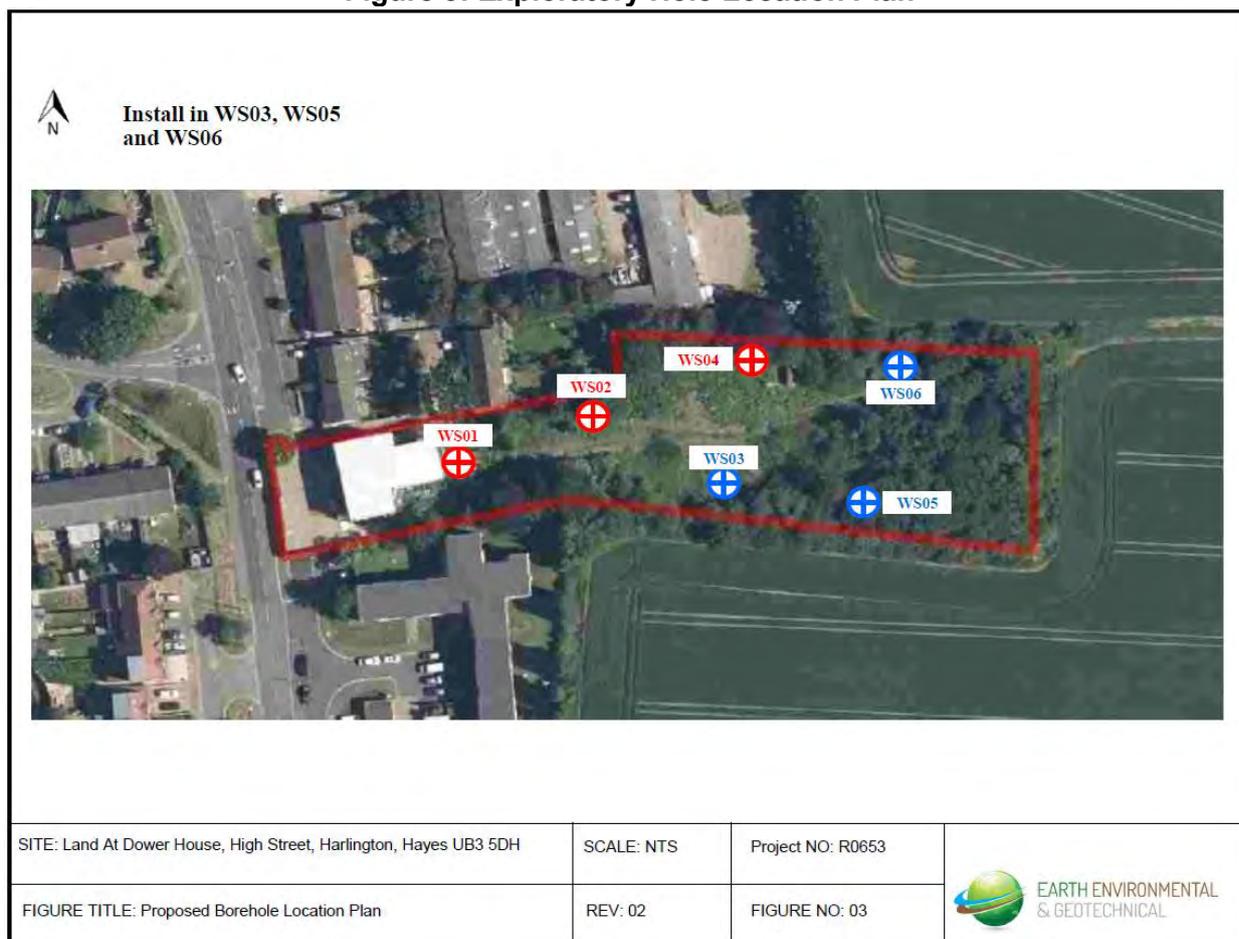
Figure 3: Exploratory Hole Location Plan

The fieldwork was carried out generally in accordance with BS 5930:2015+A1:2020 Code of Practice for Site Investigations unless otherwise stated. The exploratory hole locations were determined on site by EEGSL and considered site restrictions present at the time. The investigation locations completed are shown approximately on the Exploratory Hole Location Plan (Figure 3).

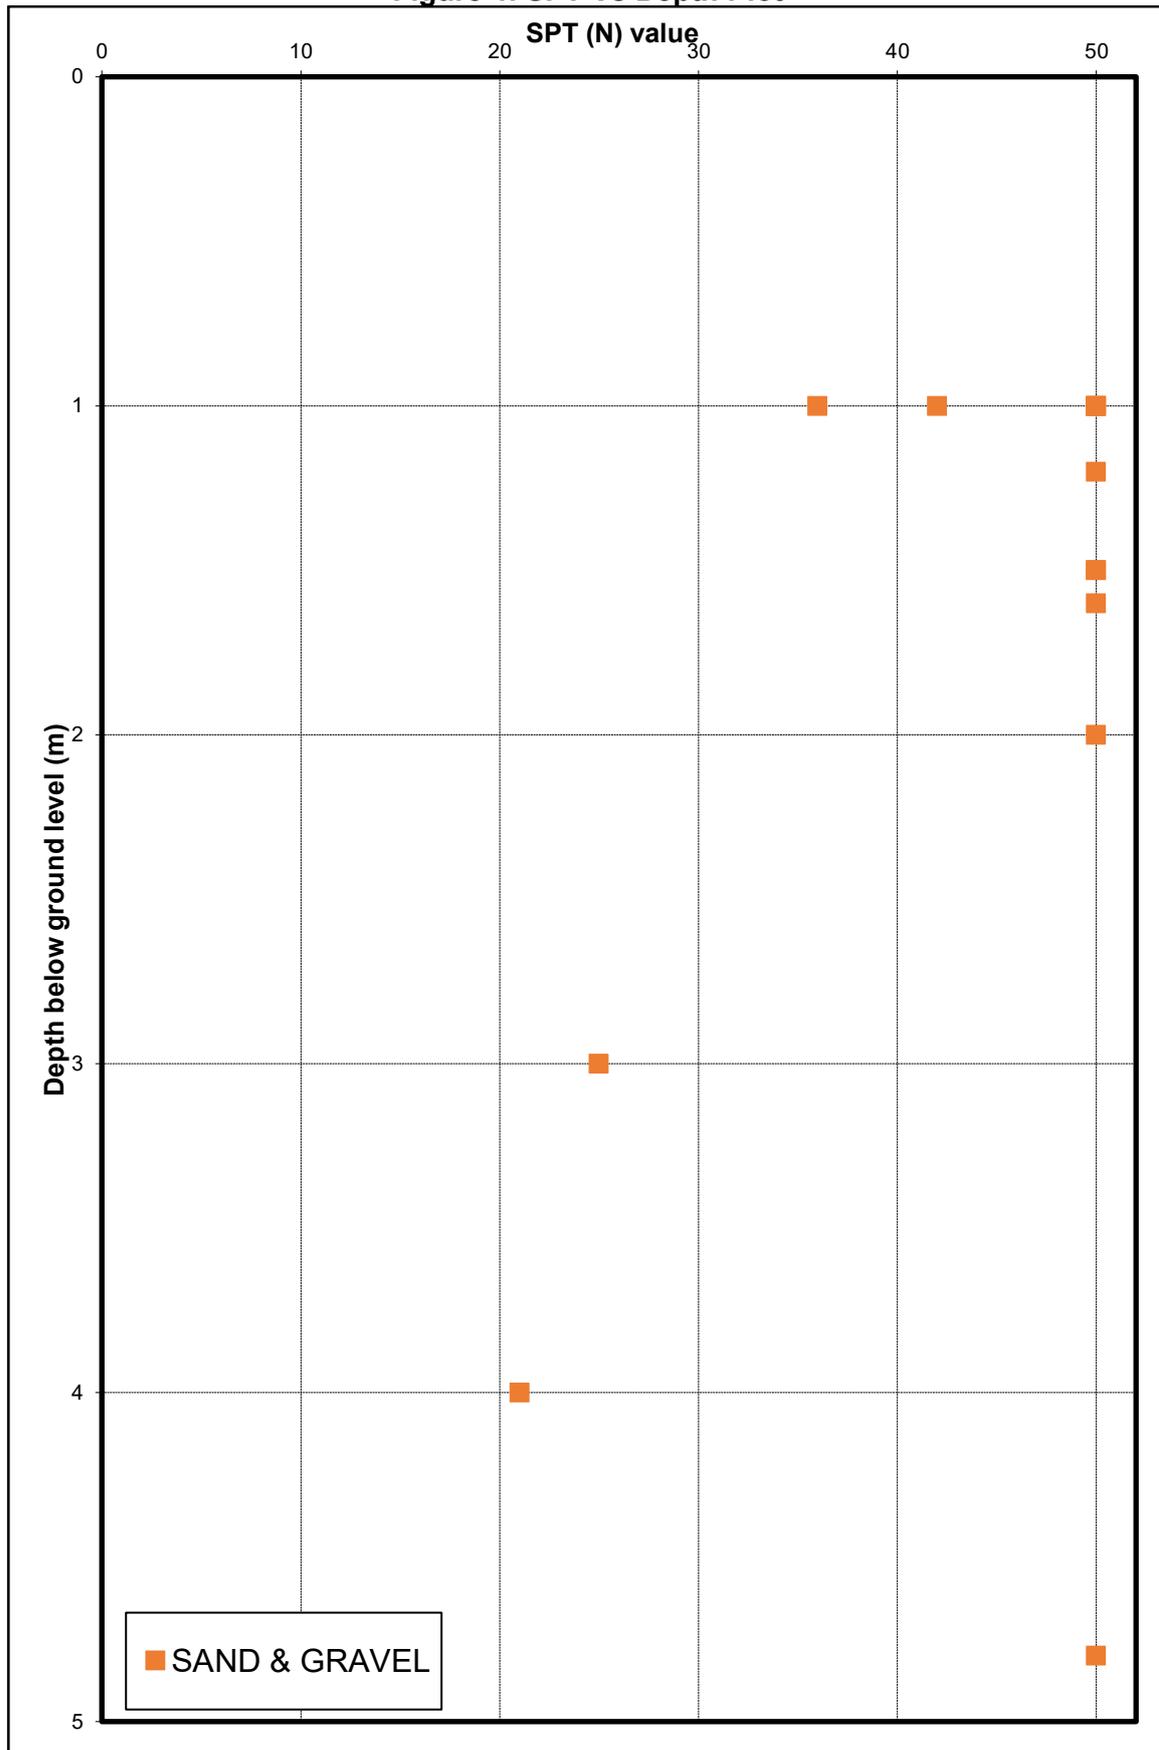
Figure 4: SPT Vs Depth Plot

Sands and Gravels were found present at depths from 0.40mbgl and were proven to a maximum depth of 1.60mbgl. 12 **SPT N** results were obtained between 1.00mbgl and 4.80mbgl with the sand and gravel materials giving a range of values from 21-50, as can be seen from the SPT Vs Depth Plot included as Figure 4. These results would suggest the underlying Sand and Gravel materials are Medium Dense to Very dense.

The results of the dynamic probing can be seen in Appendix 3 and in Figure 4.

For geotechnical design in granular soils, it is recommended that for assessing ultimate bearing capacities, where the lower values are critical, the lower value of N is used, whereas for assessing settlements average ground conditions will give a more realistic value (therefore the average N value will be used to calculate settlement).

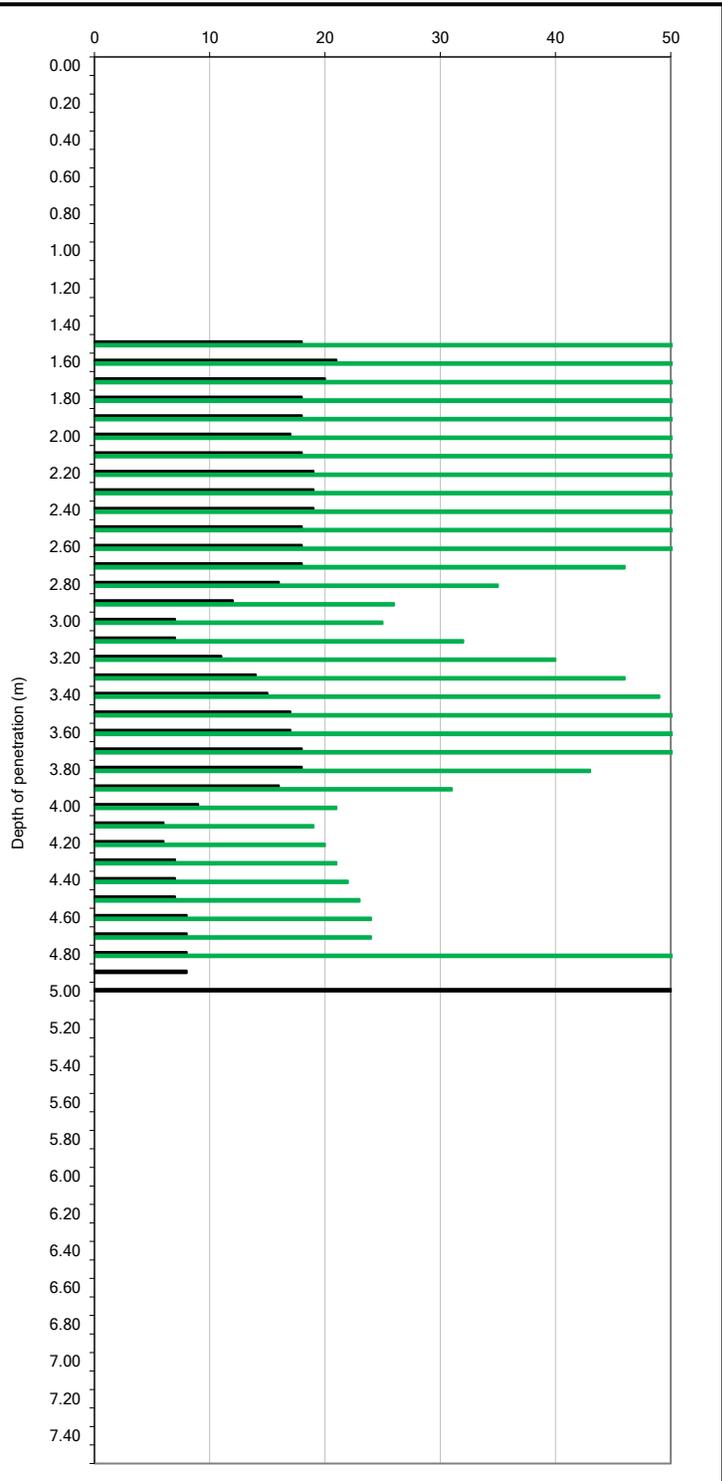
DP No: DP02

Hammer Mass: 63.5 kg Cone Dia: 50.5mm
 Drop Height: 750 mm Test by: 0

DPN₁₀₀ values (shorter bars) & equivalent SPT values (longer bars)

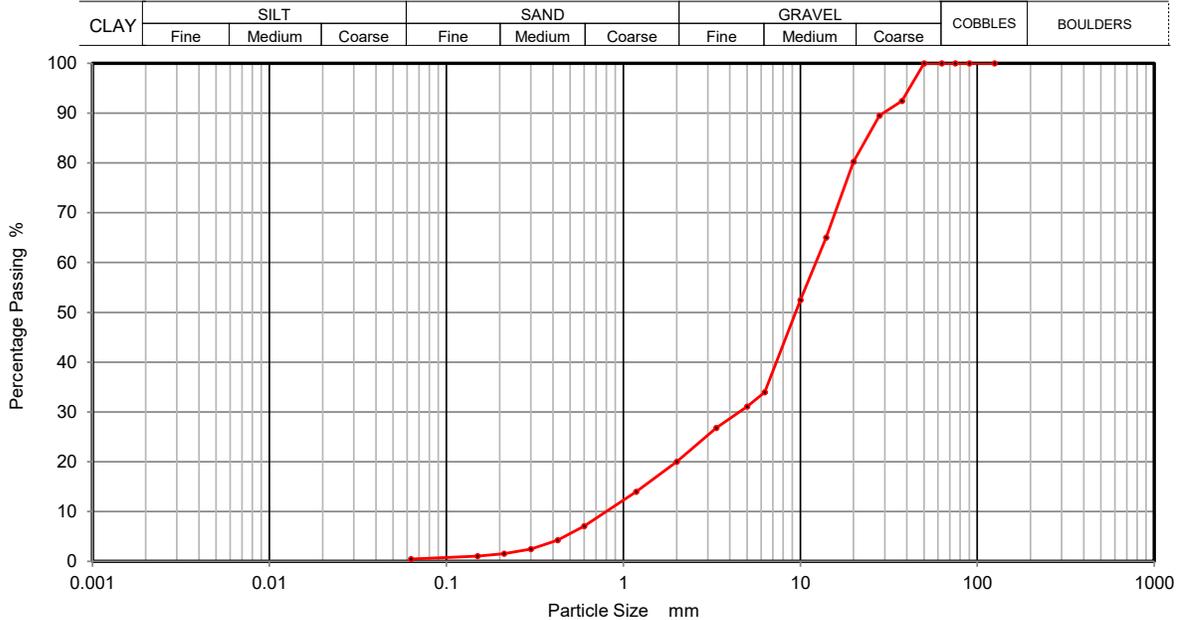
Sieving		Sedimentation	
Particle Size mm	% Passing	Particle Size mm	% Passing
125	100		
90	100		
75	100		
63	100		
50	100		
37.5	92		
28	90		
20	80		
14	65		
10	52		
6.3	34		
5	31		
3.35	27		
2	20		
1.18	14		
0.6	7		
0.425	4		
0.3	2		
0.212	2		
0.15	1		
0.063	0

Sample Proportions	% dry mass
Cobbles	0
Gravel	80
Sand	20
Silt and Clay	0

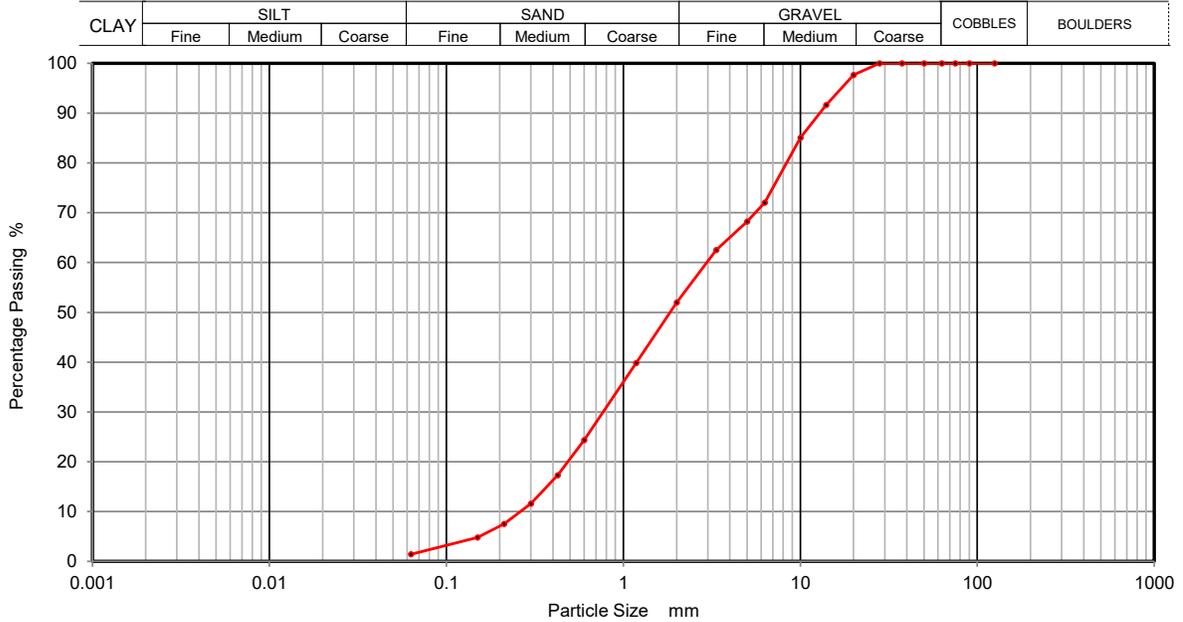
Borehole/Pit No. WS06

Project Name	Dower House Harlington	Sample No.	
Soil Description	Brown slightly silty/ clayey fine to coarse gravelly fine to coarse SAND	Depth Top	0.40
		Depth Base	1.20
Date Tested	15/03/2023	Sample Type	B

Sieving		Sedimentation	
Particle Size mm	% Passing	Particle Size mm	% Passing
125	100		
90	100		
75	100		
63	100		
50	100		
37.5	100		
28	100		
20	98		
14	92		
10	85		
6.3	72		
5	68		
3.35	63		
2	52		
1.18	40		
0.6	24		
0.425	17		
0.3	12		
0.212	7		
0.15	5		
0.063	1

Sample Proportions	% dry mass
Cobbles	0
Gravel	48
Sand	51
Silt and Clay	1
