**Re : Supplemental Letter Report detailing additional information supporting Verification Report for Douay Martyrs School Cardinal Hume Campus Development**

Douay Martyrs School, Cardinal Hume Campus, Long Lane, Ickenham, London Borough of Hillingdon UB10 8SX.

Verification Trial Pits

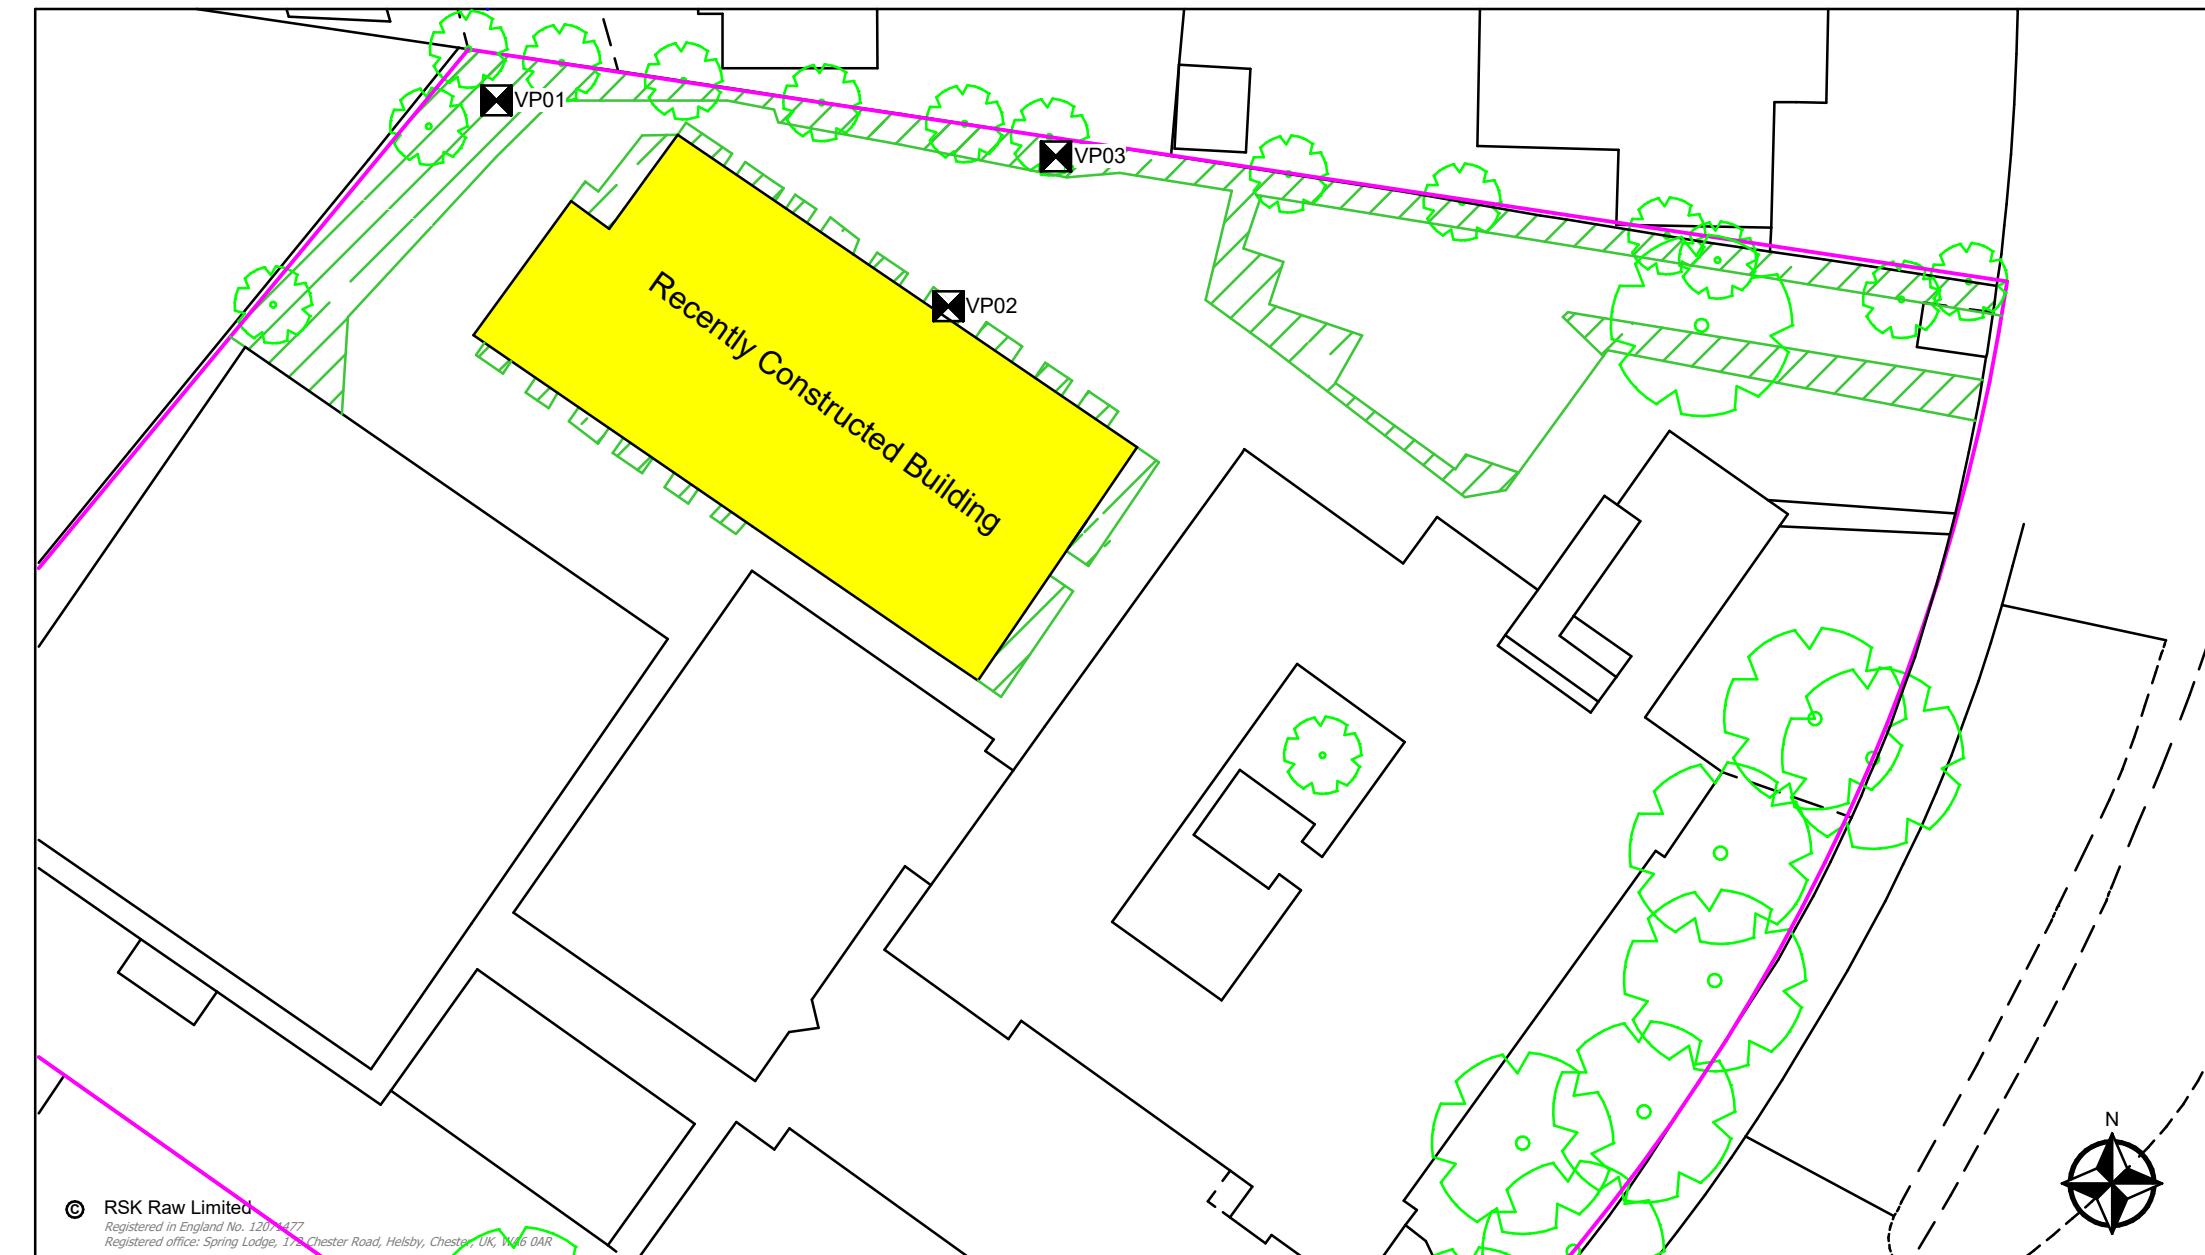
2642020-02

- Two hand dug trial pits (VP01 and VP03) advanced to 0.6 metres below ground level (mbgl) within the soft landscaping associated with the development
- One hand dug trial pit (VP02) advanced to 0.4 mbgl within the raised planter, it is RSK Raw's understanding that this depth has been agreed between Morgan Sindall and the Regulator owing to the top of the raised planter being located approximately 0.6m above ground level.

The positions are shown on drawing 2642020-02, appended.

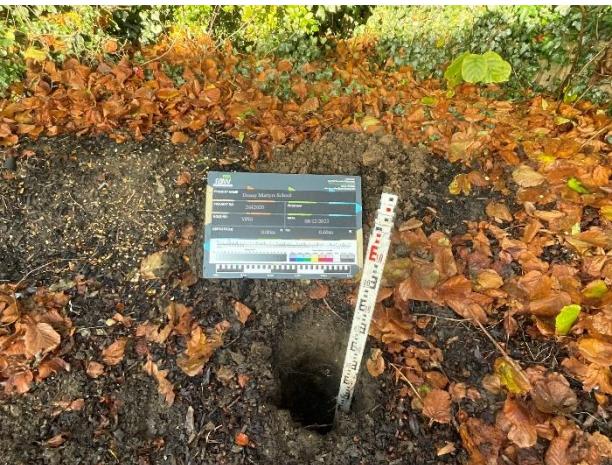
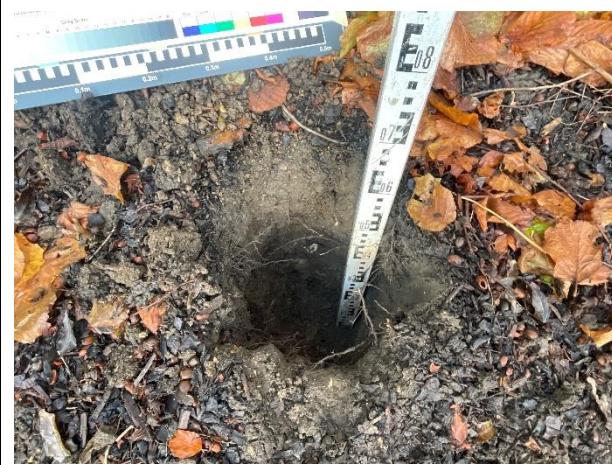
<p><b>RSK Raw Limited</b> Portland Road, Malvern WR14 2TA</p>
<b>Photo 1:</b> View of VP01	<b>Photo 2:</b> View of VP01	<b>Client:</b> Morgan Sindall

Soft dark brown sandy gravelly silt with fine fibrous rootlets, bark and organic matter.		
			0.60	-0.60

Soft light brown silty sandy gravelly clay with organic matter and fine fibrous rootlets.	End of pit at 0.60 m	
							1	
							2	
							3	
							4	
Remarks:	The trial pit position was scanned for utilities with a CAT & Genny. The trial pit was then dug to a depth of 0.6 m bgl. Reinstanted with arisings.

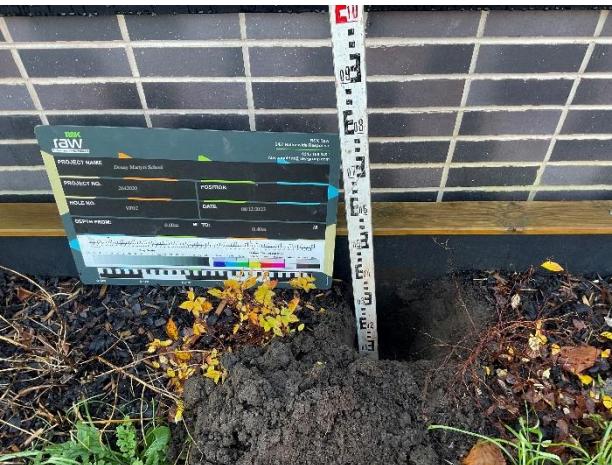
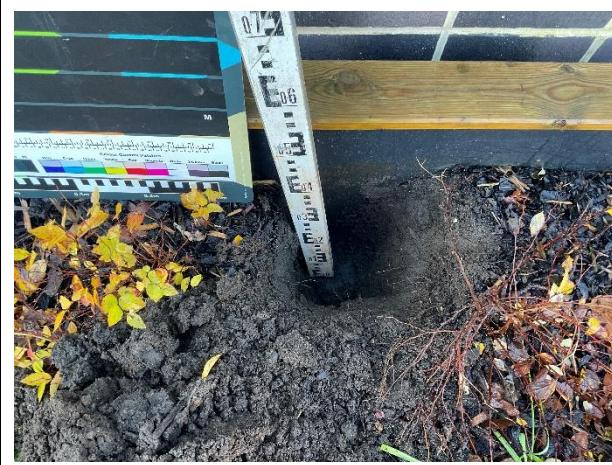
<b>Site Address:</b> Douay Martyrs School, Cardinal Hume Campus Long Lane, Ickenham, London Borough of Hillingdon UB10 8SX
<b>Photo 3:</b> View of VP02	<b>Photo 4:</b> View of VP02	<b>Project Ref:</b> 2642020

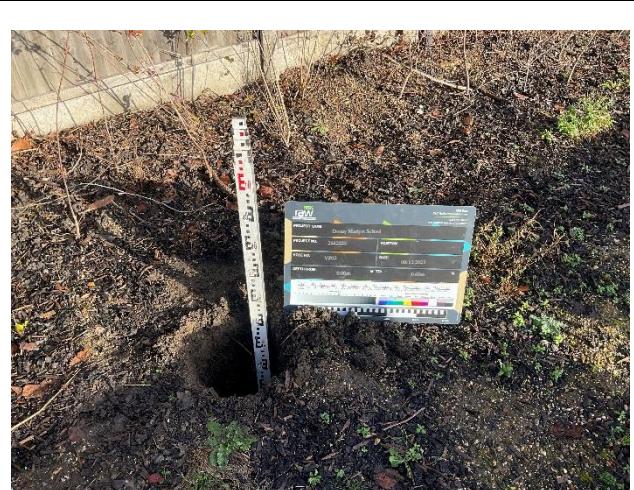
<p><b>RSK Raw Limited</b> Portland Road, Malvern WR14 2TA</p>
<b>Photo 5:</b> View of VP03	<b>Photo 6:</b> View of VP03 (water encountered at base of excavation, base of excavation observed prior to groundwater)	<b>Client:</b> Morgan Sindall

Soft dark brown sandy gravelly silt with fine fibrous rootlets, bark and organic matter.	1
				0.60

Soft light brown silty sandy gravelly clay with organic matter and fine rootlets.	2
							End of pit at 0.60 m	3
								4
Remarks:	The trial pit position was scanned for utilities with a CAT & Genny. The trial pit was then dug to a depth of 0.6 m bgl. Reinstanted with arisings.

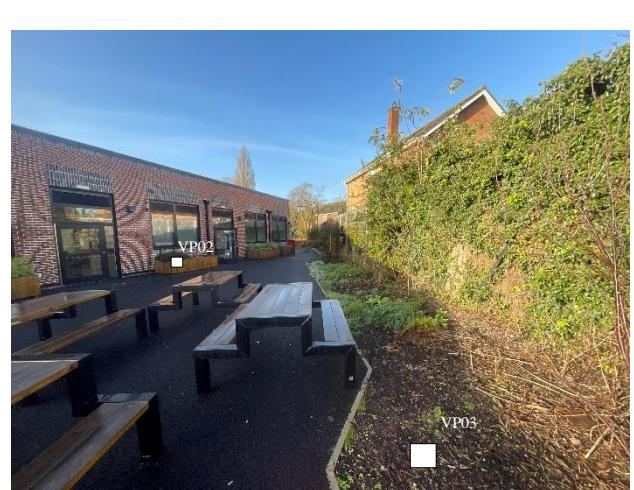
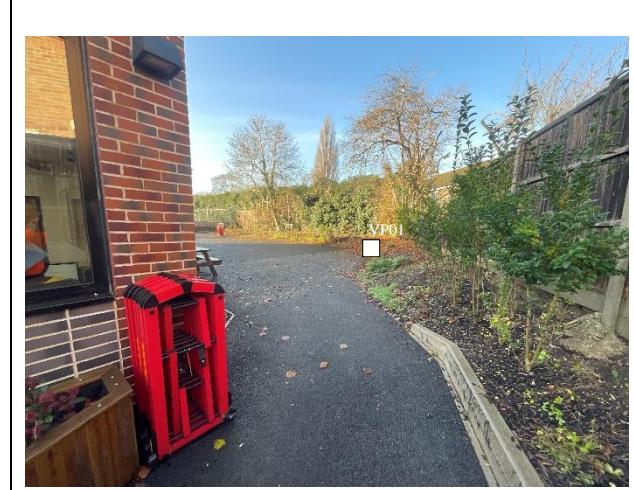
<b>Site Address:</b> Douay Martyrs School, Cardinal Hume Campus Long Lane, Ickenham, London Borough of Hillingdon UB10 8SX
<b>Photo 7:</b> View of location of VP03 and raised planter where VP02 was located.	<b>Photo 8:</b> View of location of VP01	<b>Project Ref:</b> 2642020
