18<sup>th</sup> February 2021

Our ref. LP2396/HG/1

**Re: Interim verification report for the provision of clean cover at 30-32 Blyth Road, Hayes, London**

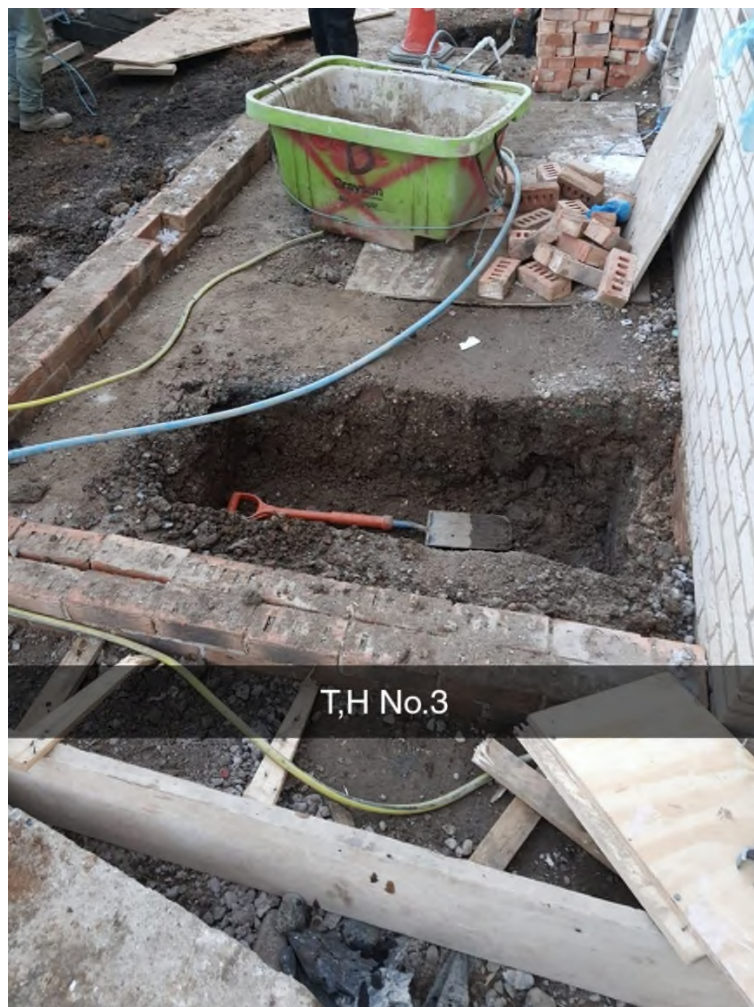
Plate 1: Plot 3 shrub planting area (Provided by Bellway).

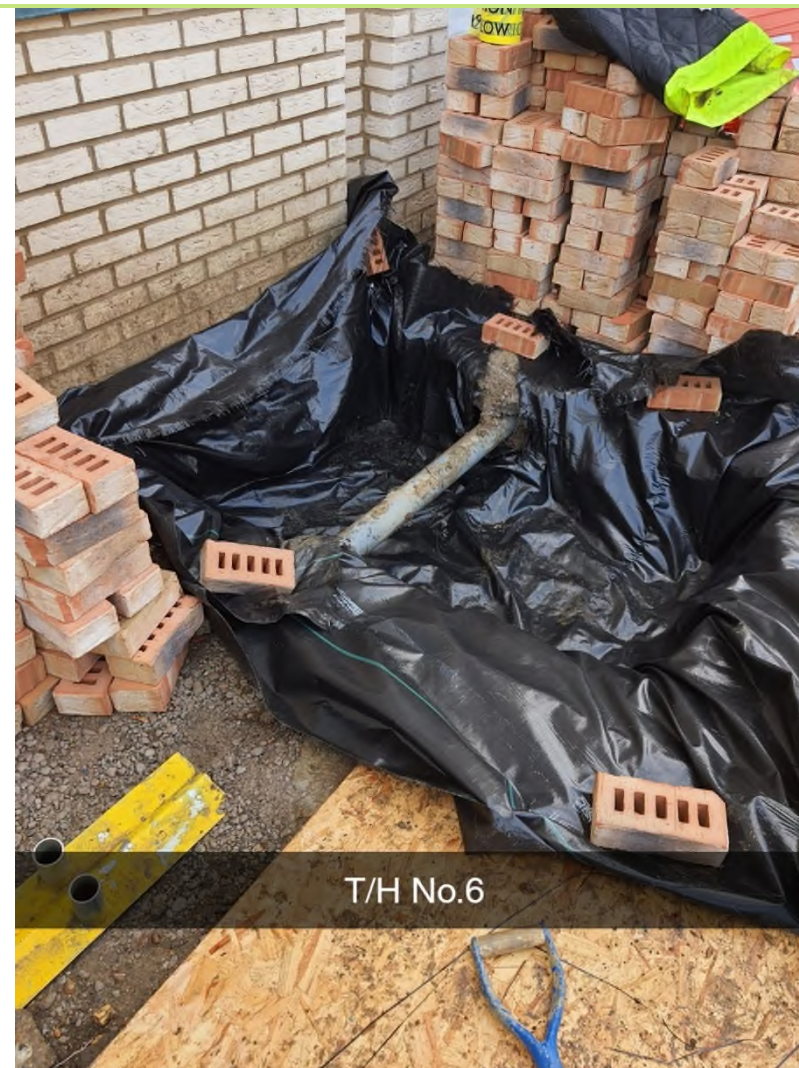
At the time of the visit only small areas of land approximately 1.5 m long by 0.80 m wide had been excavated in the plots, as shown by the photographic record provided in Appendix B. With the exception of plot 6 all voids had been lined with a geotextile membrane and filled with subsoil to ground level. Only the geotextile membrane had been placed in plot 6 at the time of the visit.

Plate 2: Plot 6 shrub planting area (Provided by Bellway).

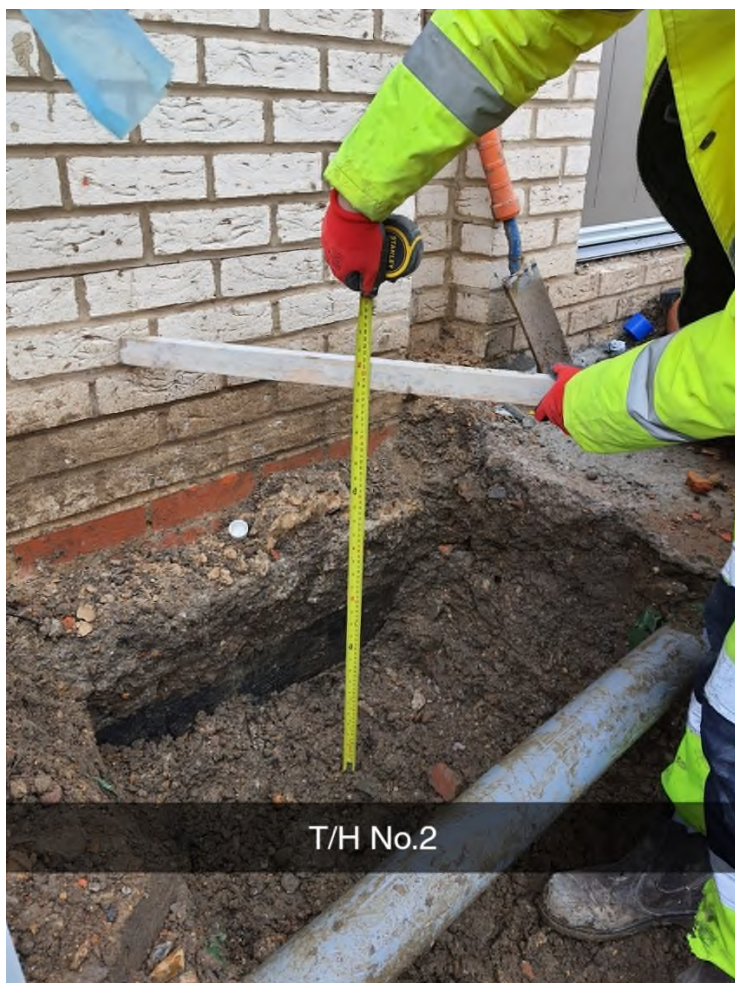
Plate 3: Plot 2 shrub planting area measurement (Provided by Bellway).

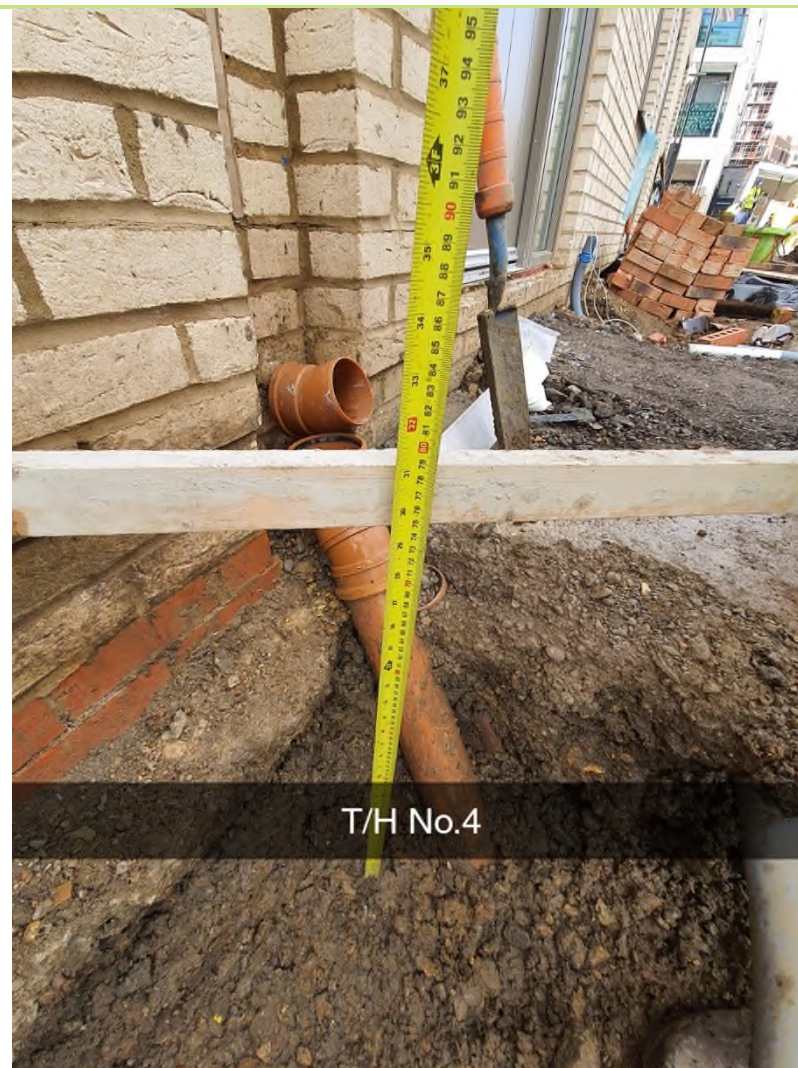
Plate 4: Plot 4 shrub planting area measurement (Provided by Bellway).

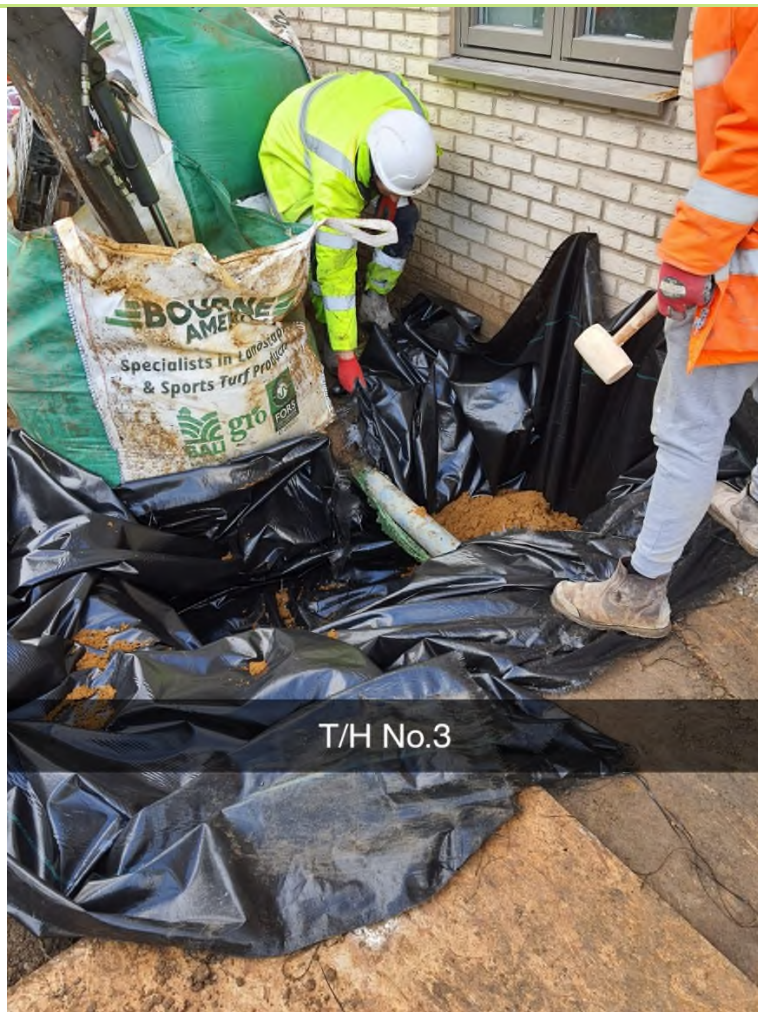
Plate 5: Plot 3 shrub planting area (Provided by Bellway).

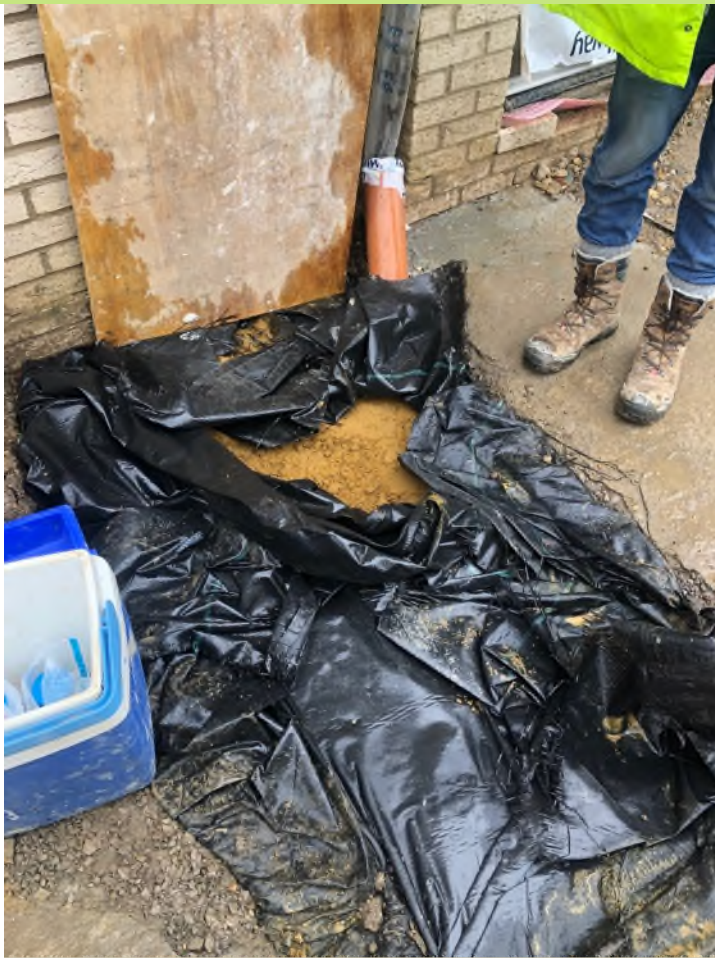
It was not possible to verify the full depth of clean cover at the time of the inspection visit due the absence of topsoil within the plots. However, samples of topsoil and subsoil were taken from the bulk bags present on site, as well as a sample of subsoil in Plot 4 for verification analysis.

Plate 7: Plot 4 with geotextile wrap around subsoil within shrub planting area from which an environmental sample was taken (Taken by LEAP Engineer).

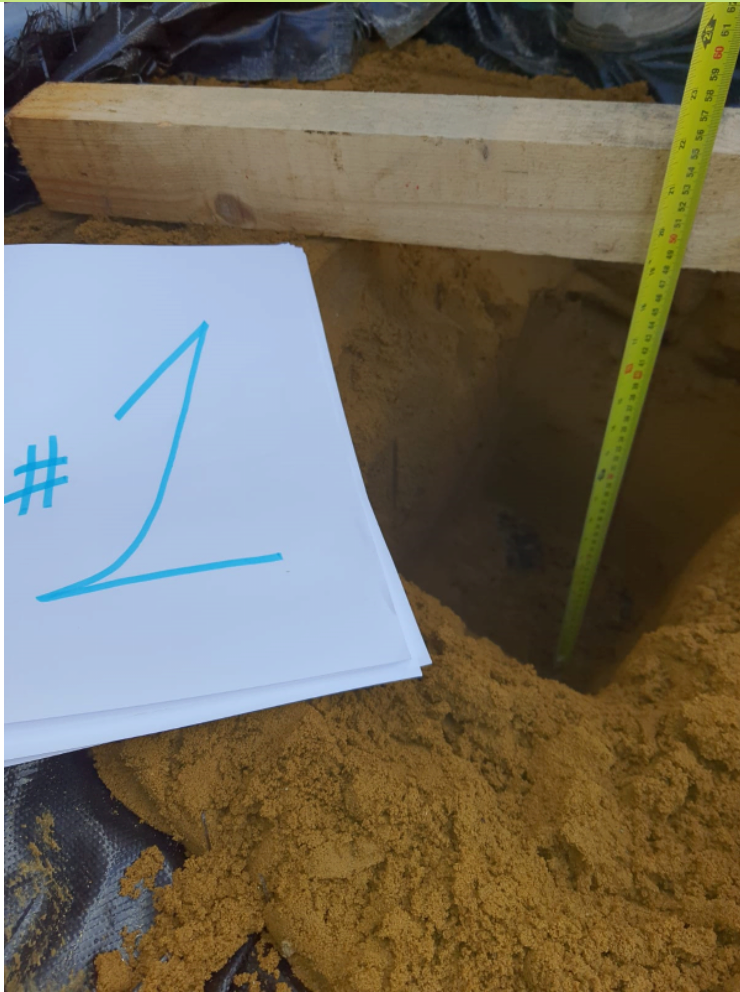
| Plot Number | Subsoil Thickness (mm) | Geotextile membrane present? | Topsoil Thickness (mm) | Overall Thickness (mm) |
|---|---|---|---|---|
| 1 | 480 | Yes | TBC | TBC |

Plate 8: Plot 1 hand dug pit with thickness of subsoils indicated (Provided by Bellway)

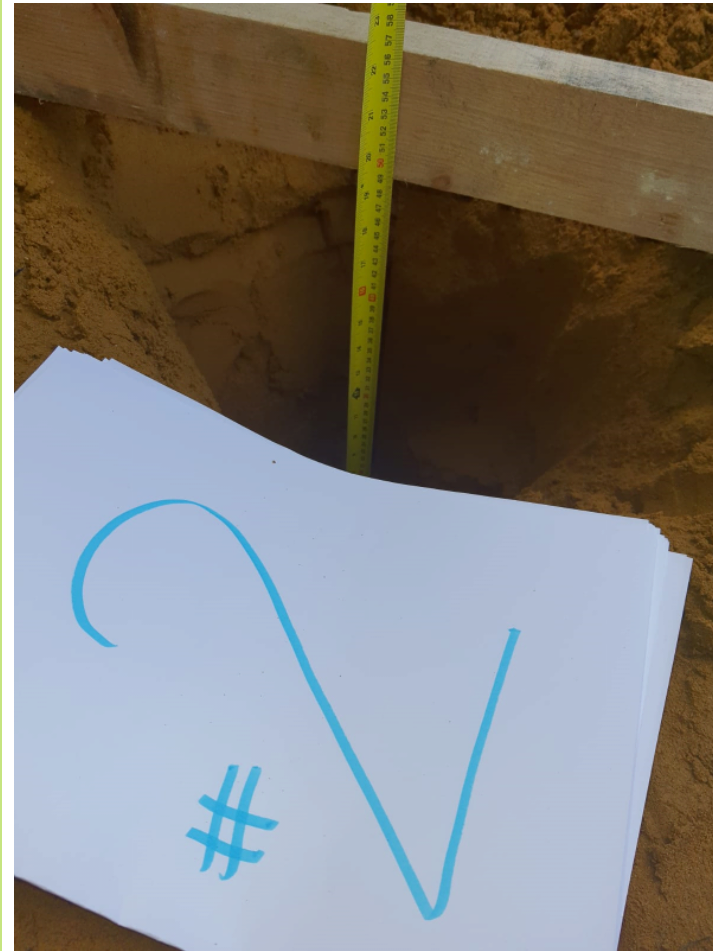
| Plot Number | Subsoil Thickness (mm) | Geotextile membrane present? | Topsoil Thickness (mm) | Overall Thickness (mm) |
|---|---|---|---|---|
| 2 | 490 | Yes | TBC | TBC |

Plate 9: Plot 2 hand dug pit with thickness of subsoils indicated (Provided by Bellway)

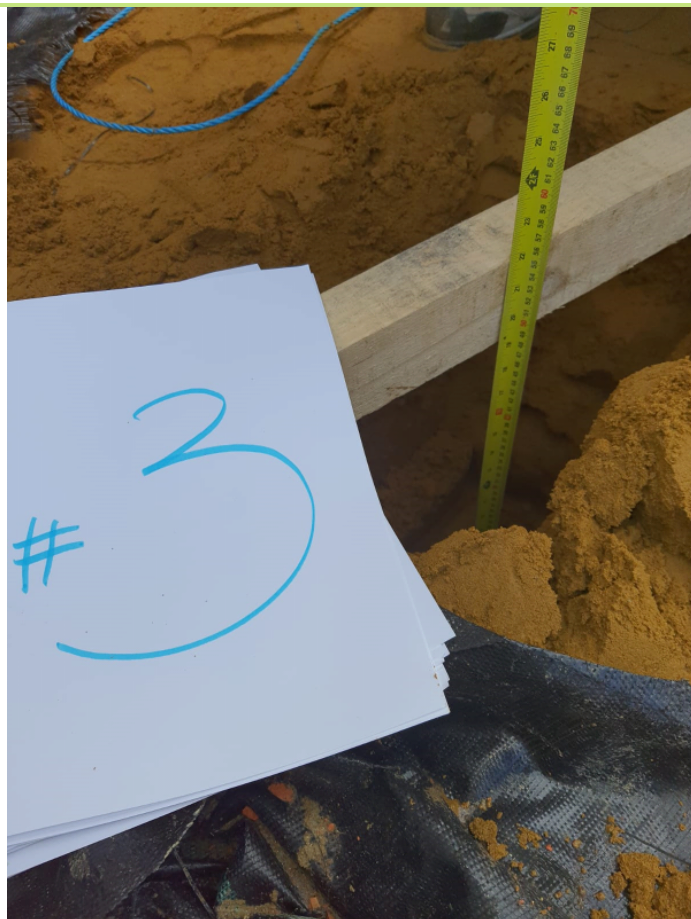
| Plot Number | Subsoil Thickness (mm) | Geotextile membrane present? | Topsoil Thickness (mm) | Overall Thickness (mm) |
|---|---|---|---|---|
| 3 | 480 | Yes | TBC | TBC |

Plate 10: Plot 3 hand dug pit with thickness of subsoils indicated (Provided by Bellway)

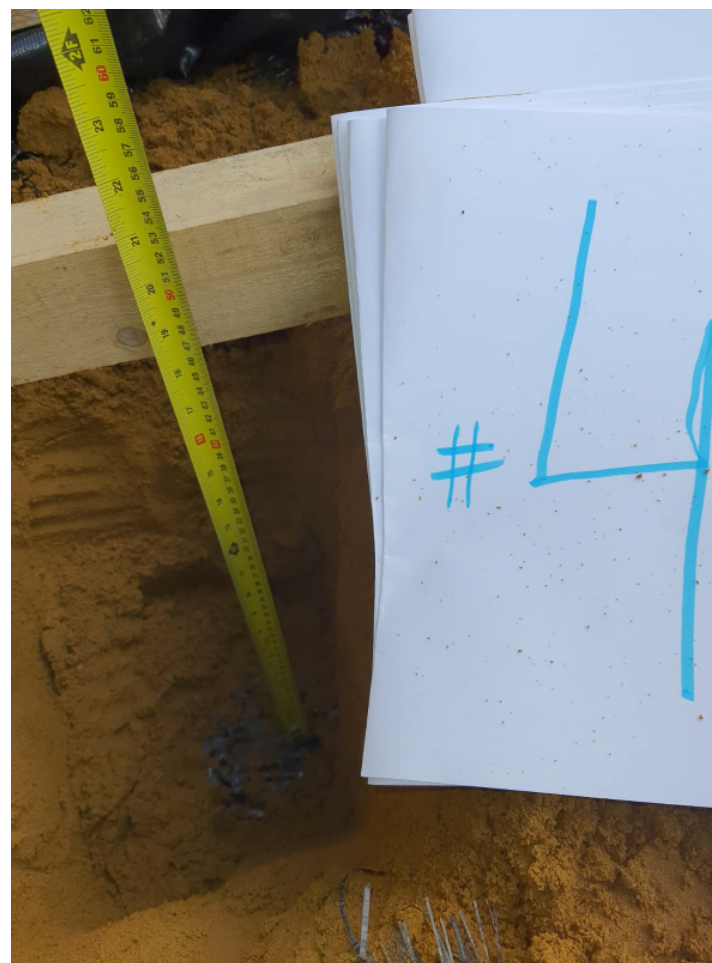
| Plot Number | Subsoil Thickness (mm) | Geotextile membrane present? | Topsoil Thickness (mm) | Overall Thickness (mm) |
|---|---|---|---|---|
| 4 | 470 | Yes | TBC | TBC |

Plate 11: Plot 4 hand dug pit with thickness of subsoils indicated (Provided by Bellway)

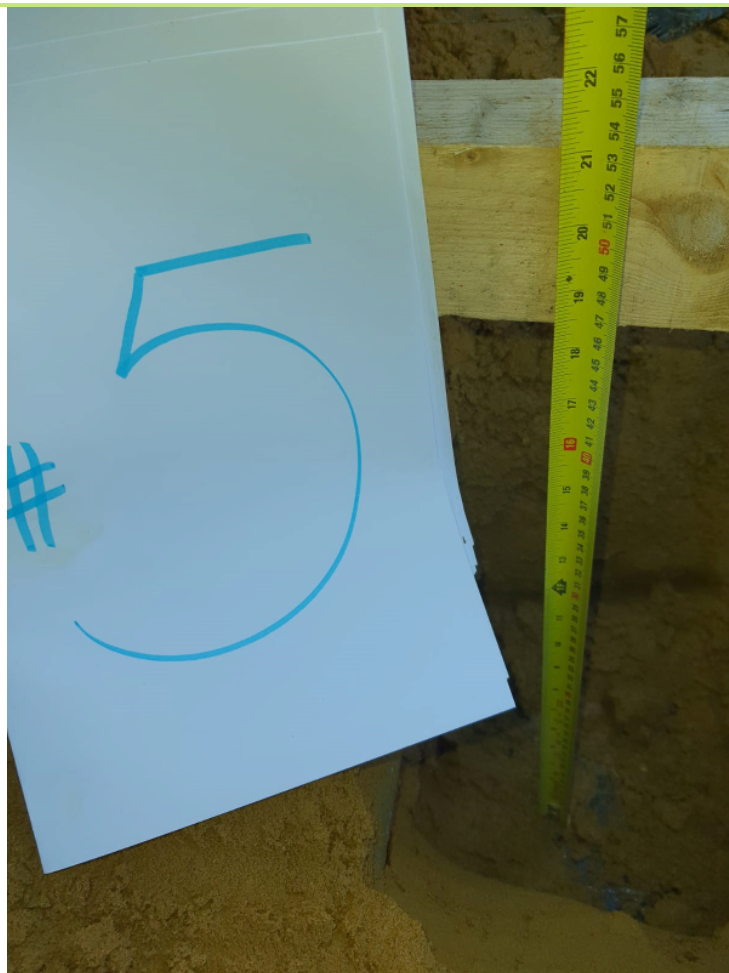
| Plot Number | Subsoil Thickness (mm) | Geotextile membrane present? | Topsoil Thickness (mm) | Overall Thickness (mm) |
|---|---|---|---|---|
| 5 | 470 | Yes | TBC | TBC |

Plate 12: Plot 5 hand dug pit with thickness of subsoils indicated (Provided by Bellway)

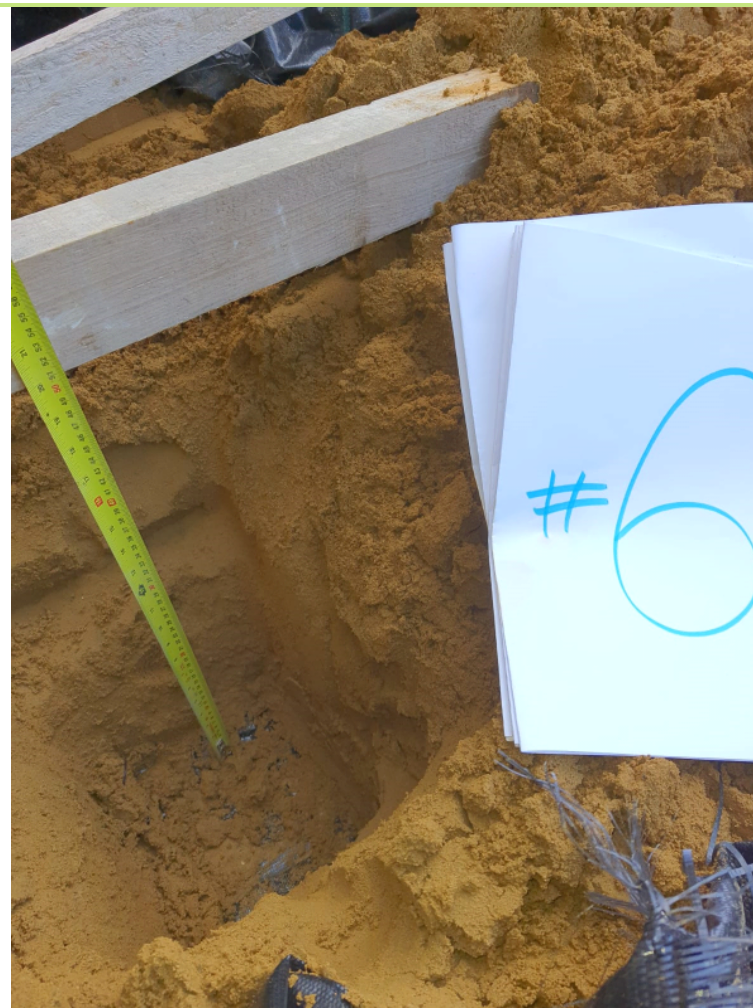
| Plot Number | Subsoil Thickness (mm) | Geotextile membrane present? | Topsoil Thickness (mm) | Overall Thickness (mm) |
|---|---|---|---|---|
| 6 | 510 | Yes | TBC | TBC |

Plate 13: Plot 6 hand dug pit with thickness of subsoils indicated (Provided by Bellway)

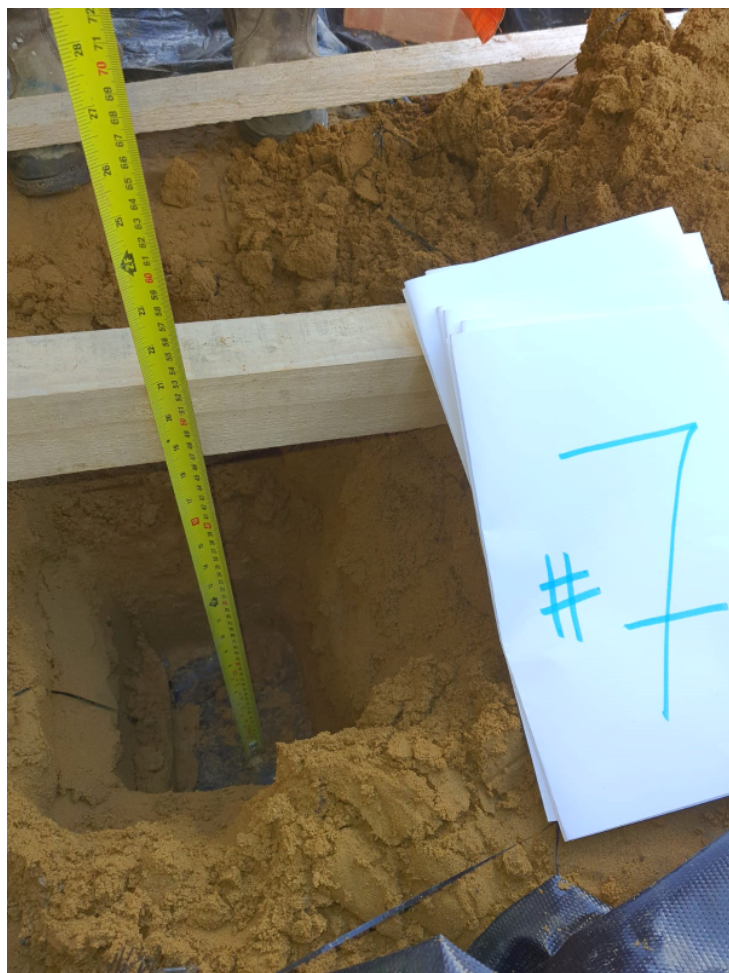
| Plot Number | Subsoil Thickness (mm) | Geotextile membrane present? | Topsoil Thickness (mm) | Overall Thickness (mm) |
|---|---|---|---|---|
| 7 | 470 | Yes | TBC | TBC |

Plate 14: Plot 7 hand dug pit with thickness of subsoils indicated (Provided by Bellway)

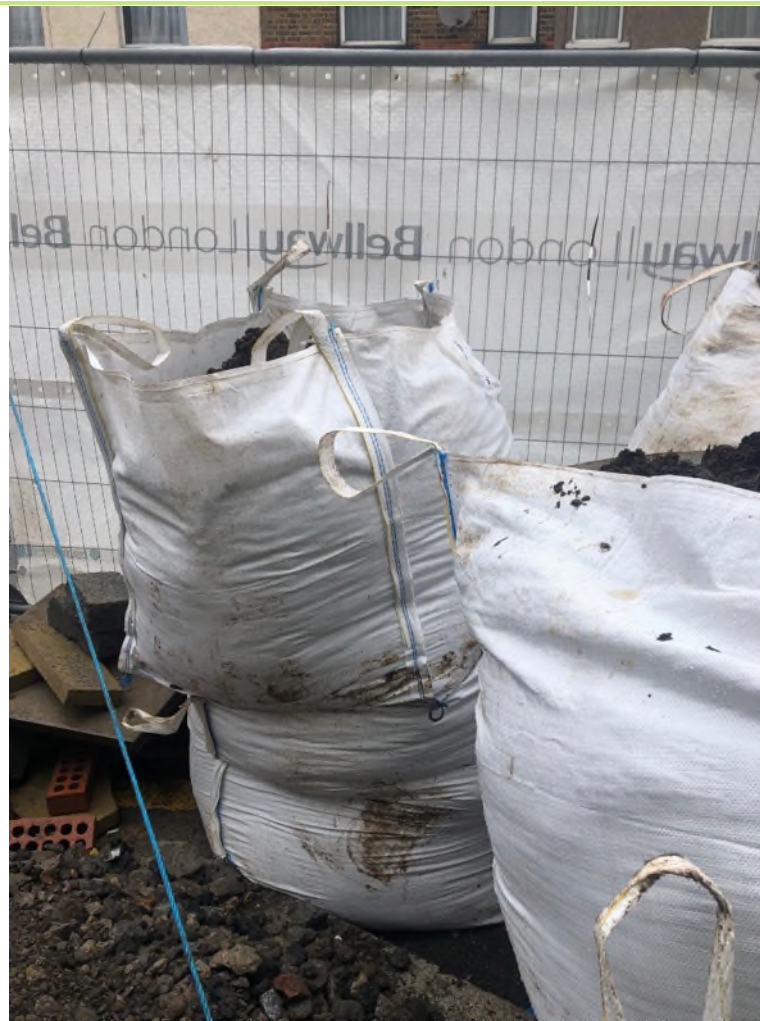
The topsoil / subsoil for use as backfill in the landscaped areas was stored on site within bulk bags, as shown in Appendix B.

Plate 15: Topsoil bulk bag 3 from which an environmental sample was taken (Taken by LEAP Engineer)

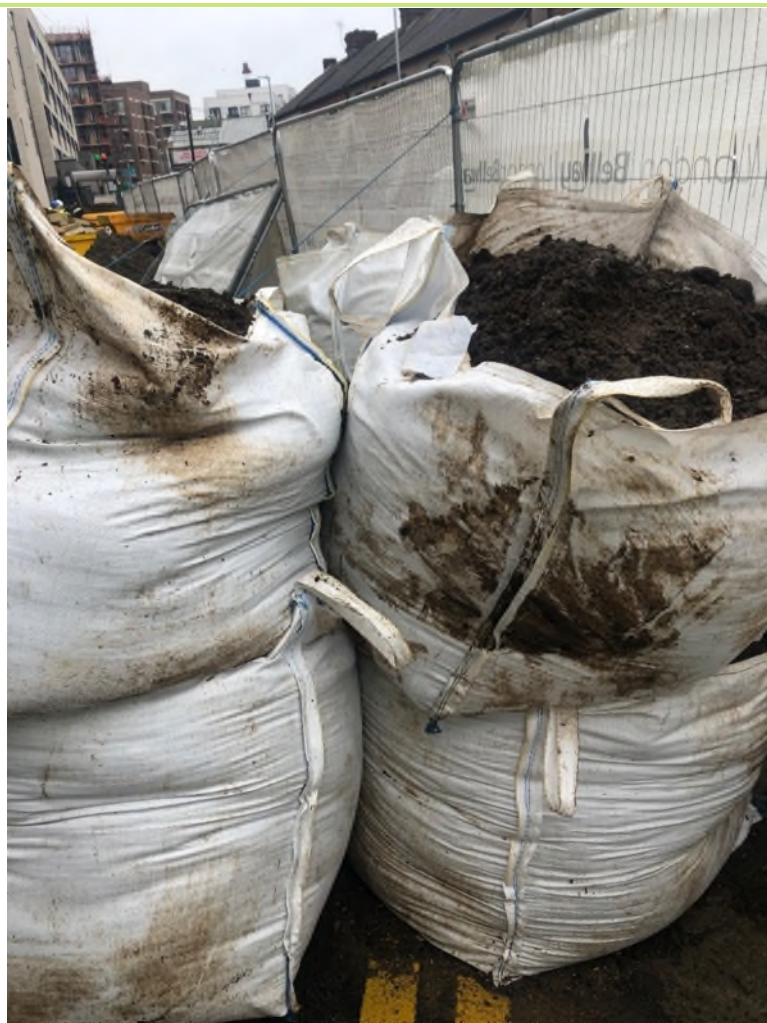
Plate 16: Topsoil bulk bags 1 and 2 from which environmental samples were taken (Taken by LEAP Engineer).

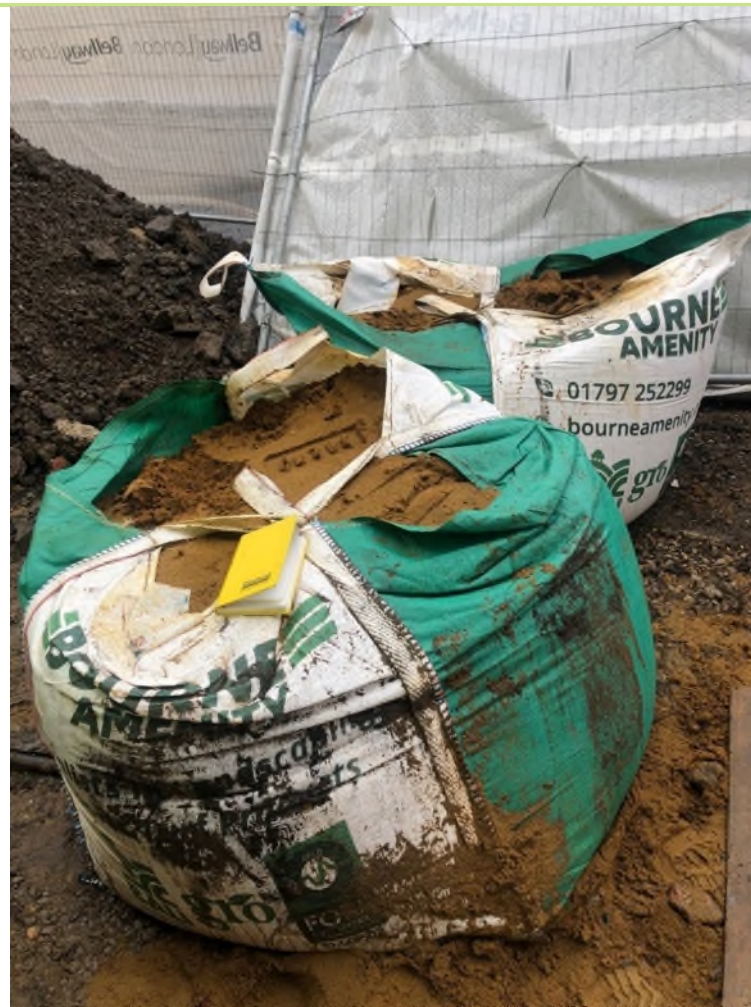
Plate 17: Subsoil bulk bags 1 and 2 from which environmental samples were taken (Taken by LEAP Engineer).
