## SiteSolutions Commercial

**2 Land At East Way, Hayes, UB8 2HX**

Report prepared for:  
London Borough of Hillingdon  
Legal Services  
Client Reference:  
at/018157/10008

Report Reference:  
AEL-1171-FSR-1018561  
National Grid Reference:  
510118,180243

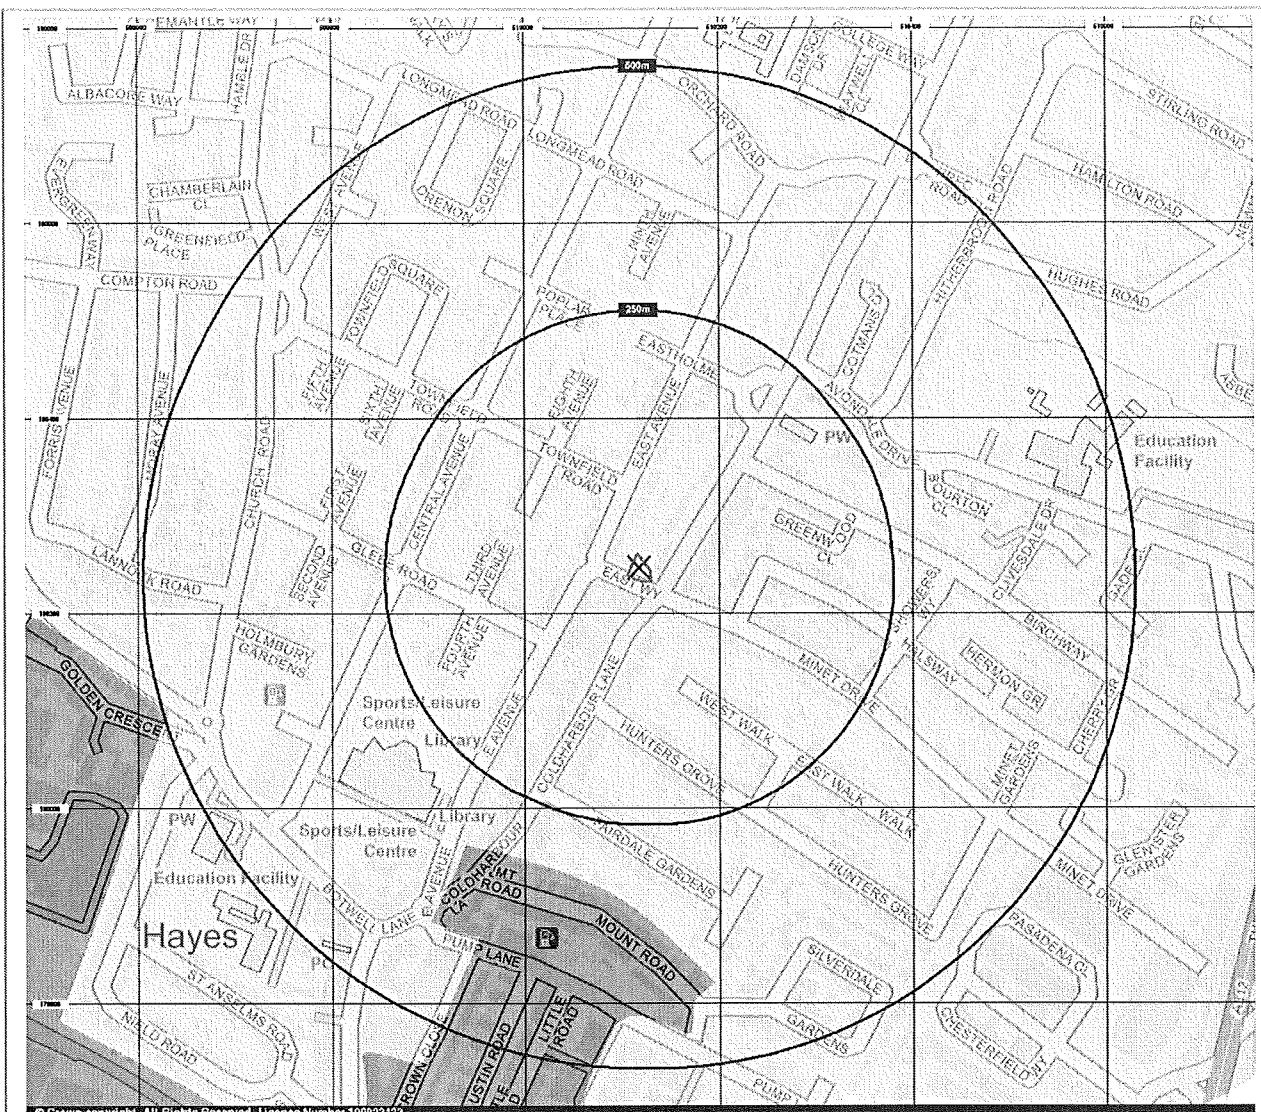
## Aquifer Designation (Superficial)

Site Boundary
	Search Buffer
	Bearing Reference Point
	N
	Principal Aquifer
	Secondary A Aquifer
	Secondary B Aquifer
	Secondary Undifferentiated
	Unproductive Strata
	Unknown

### Superficial Aquifer Designations

Map ID	Details	Distance	Direction
	Unproductive Strata  The rock layers or drift deposits have a low permeability that have negligible significance for water supply or river base flow.	On Site	-
	Unproductive Strata  The rock layers or drift deposits have a low permeability that have negligible significance for water supply or river base flow.	105m	W
	Unproductive Strata  The rock layers or drift deposits have a low permeability that have negligible significance for water supply or river base flow.	233m	S
	Unproductive Strata  The rock layers or drift deposits have a low permeability that have negligible significance for water supply or river base flow.	262m	SW
	Principal Aquifer  These aquifers are typically formed of layers of rock or drift deposits that have a high permeability and provide a high level of water storage. They may support water supply and/or base river flow on a strategic scale.	309m	S

Principal Aquifer  These aquifers are typically formed of layers of rock or drift deposits that have a high permeability and provide a high level of water storage. They may support water supply and/or base river flow on a strategic scale.	310m	W
	Principal Aquifer  These aquifers are typically formed of layers of rock or drift deposits that have a high permeability and provide a high level of water storage. They may support water supply and/or base river flow on a strategic scale.	497m	W

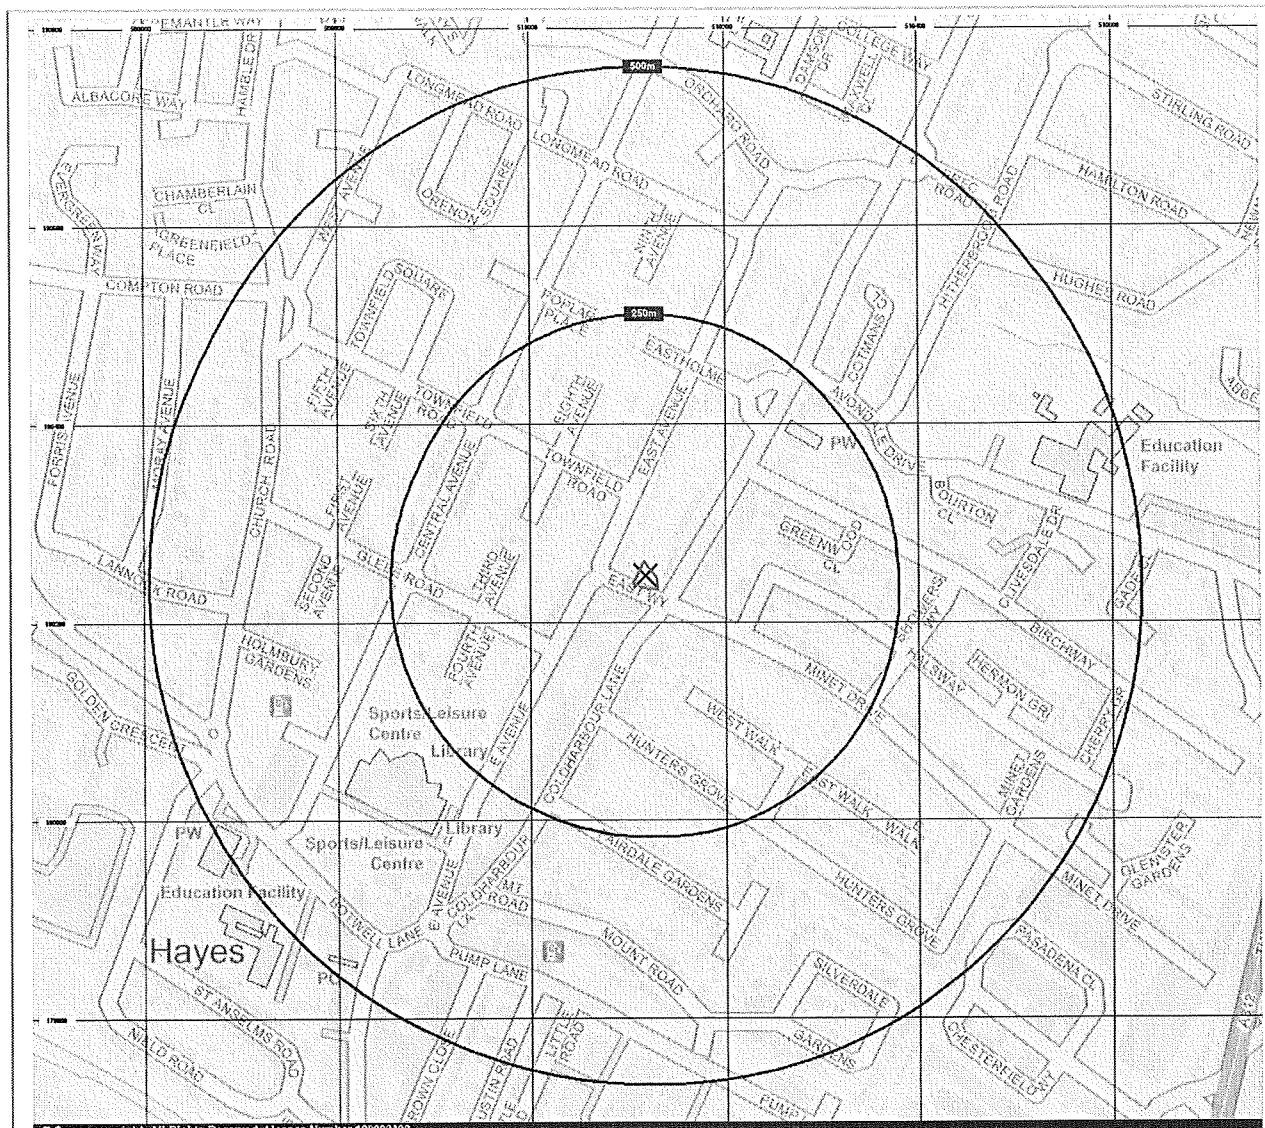
## Aquifer Designation (Bedrock)

Principal Aquifer
	Secondary A Aquifer
	Secondary B Aquifer
	Secondary Undifferentiated
	Unproductive Strata
	Unknown

### Bedrock Aquifer Designations

Map ID	Details	Distance	Direction
	Unproductive Strata  The rock layers or drift deposits have a low permeability that have negligible significance for water supply or river base flow.	On Site	-
	Unproductive Strata  The rock layers or drift deposits have a low permeability that have negligible significance for water supply or river base flow.	105m	W
	Unproductive Strata  The rock layers or drift deposits have a low permeability that have negligible significance for water supply or river base flow.	233m	S
	Unproductive Strata  The rock layers or drift deposits have a low permeability that have negligible significance for water supply or river base flow.	262m	SW
	Unproductive Strata  The rock layers or drift deposits have a low permeability that have negligible significance for water supply or river base flow.

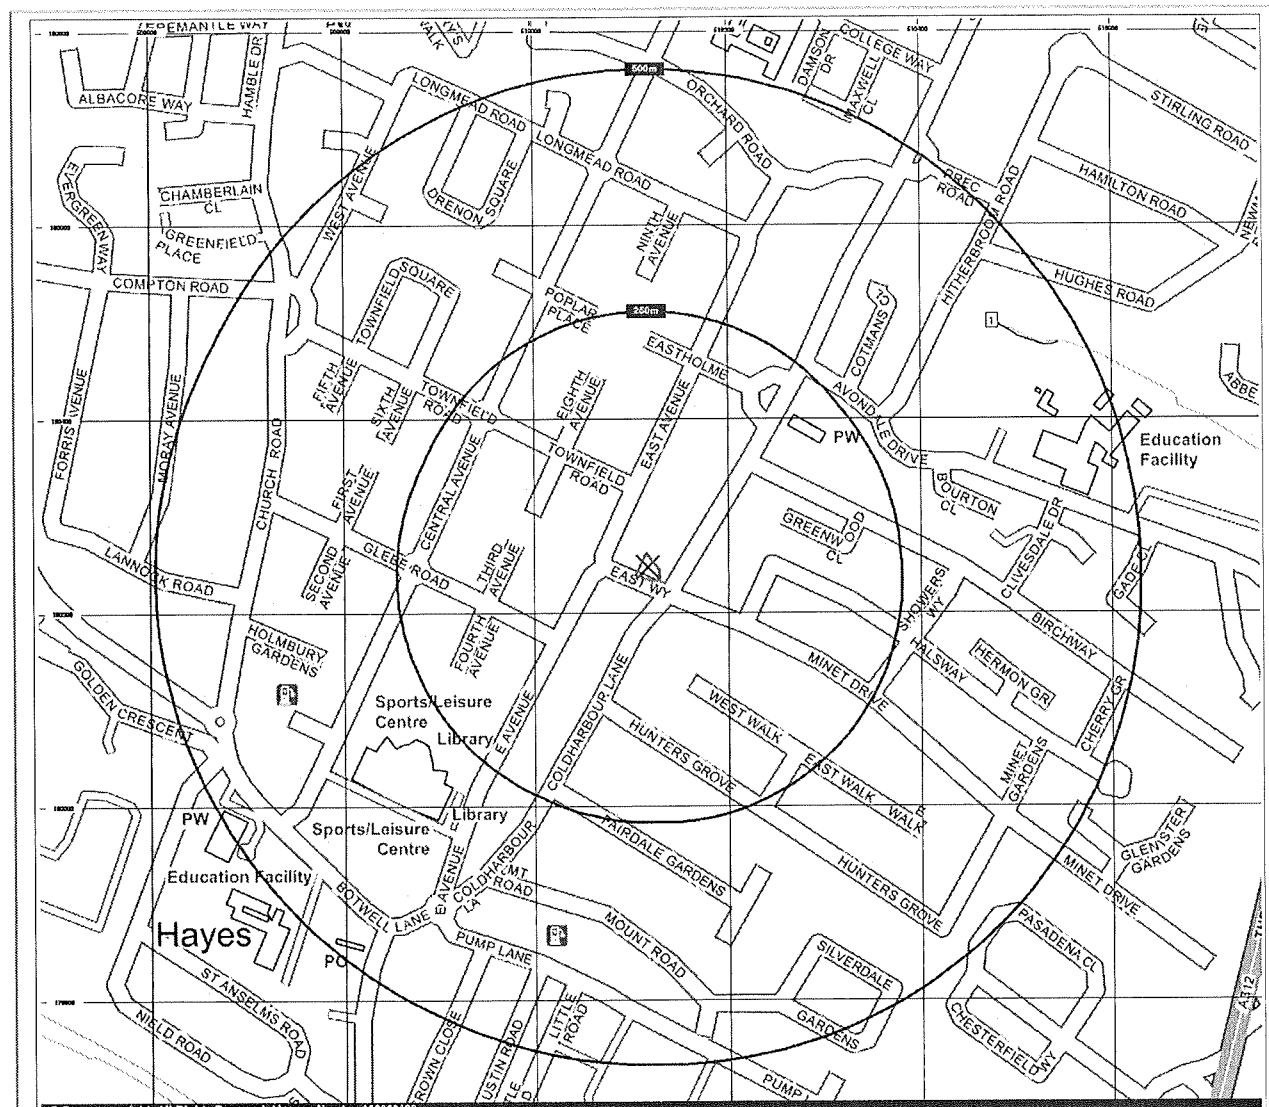
## Environmentally Sensitive Features

Site Boundary	Local Nature Reserve	Ramsar Site
Search Buffer	Marine Nature Reserve	Nearest Surface Water Feature
X Bearing Reference Point	National Nature Reserve	Site of Special Scientific Interest
N	National Park	Special Area of Conservation
Area of Outstanding Natural Beauty	National Scenic Area	Special Protection Area
Environmentally Sensitive Area	Nitrate Sensitive Area	Water Abstraction
Forest Park	Nitrate Vulnerable Zone	Historical Flood Liability

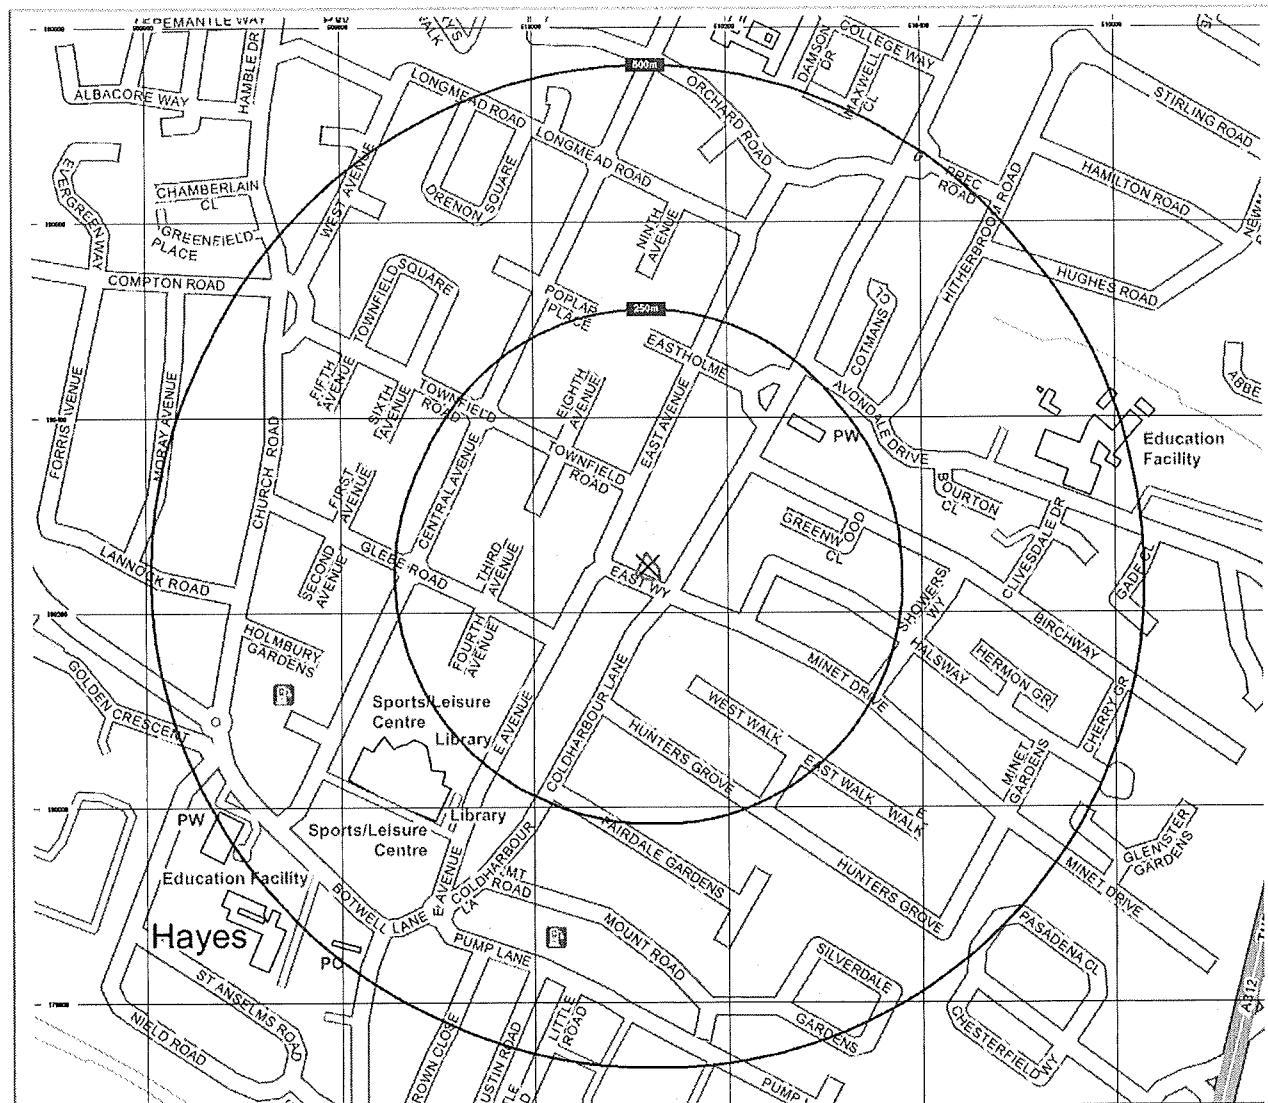
## Source Protection Zones

Site Boundary	Inner zone (Zone 1)	Total catchment (Zone 3)
Search Buffer	Inner zone - subsurface activity only (Zone 1c)	Total catchment - subsurface activity only (Zone 3c)
Bearing Reference Point	Outer zone (Zone 2)	Special interest (Zone 4)
N	Outer zone - subsurface activity only (Zone 2c)
