## **Phase I & II Geo-Environmental Assessment**

### **Crescent Parade**

Uxbridge Road  
Hillingdon  
UB10 0LG

| <b>EPS Reference Number:</b> | UK17.2816 |

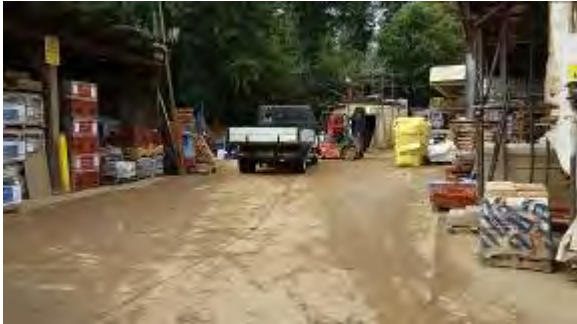
| <p>Photo 1: View looking west from the east of the site.</p> | <p>Photo 2: View looking east across the east of the site.</p> |

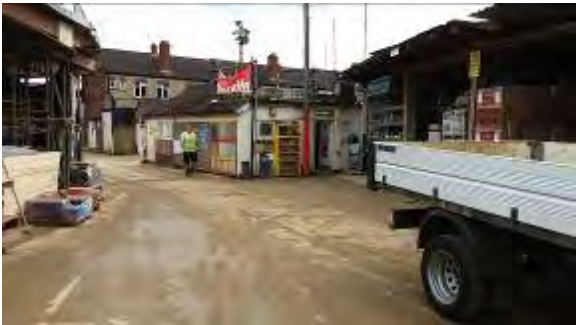
| <p>Photo 3: View looking southeast from the centre of the site.</p> | <p>Photo 4: View looking at the southwest corner of the site.</p> |

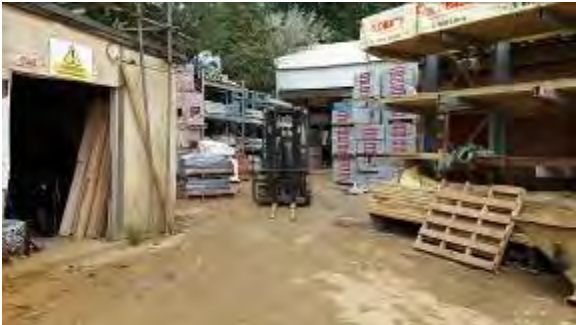
| <p>Photo 5: View looking at the northwest corner of the site.</p> | <p>Photo 6: View along the track located on the northeast boundary.</p> |
