## **Our REF: NW/WD/C2483/Verification of Remediation**

### **Ref: Horton Road, West Drayton – Verification of Remediation for Condition 10iii**

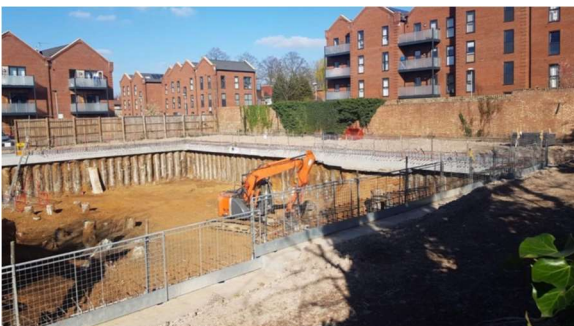
Soils contamination requiring action were for PAH in DS502, TP601 and TP604. As a result of this development these locations are either under buildings and/or hardstanding or have in fact been excavated and removed as part of the development (excavations for the basement car-park as per the photograph below). Therefore, remediation will be achieved through the development earthworks themselves. This is mitigation/remediation by source removal and/or pathway removal.

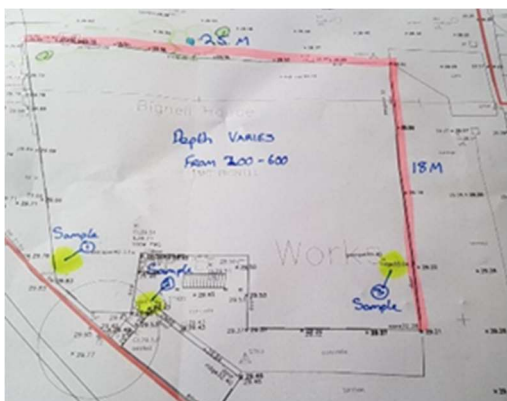
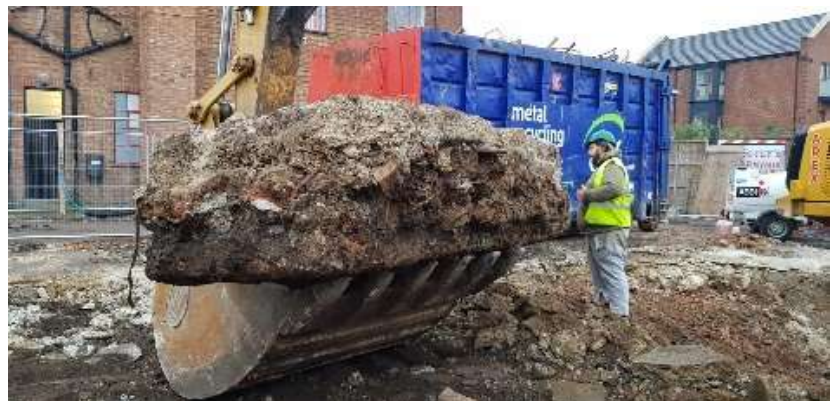
- Impressions Building – Bonded to the underside of the floor slab. None found in the soil below.
- Bignell House – Bonded and loose to the underside of the floor slab. Broken sheets and fragments found in the brick / rubble fill below the slab in isolated areas.

Attached is a hand marked sketch of samples taken (attached) in relation to asbestos report.

Area of slab 690m<sup>2</sup> X 400mm average depth (various between 600mm to 200mm)

When these areas were disturbed through excavation appropriate control measures were adopted in line with the Control of Asbestos Regulations 2012. This included dust control and disposal by our specialist contractor. Evidence of such disposal are provided within the attached file.

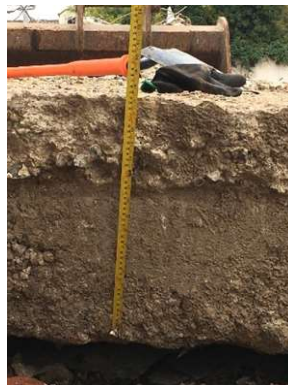
### **Impressions Building SLAB A1-3**

Photographic evidence of slab depth below.

The area of slab to the impressions building was 36m x 26m x 350mm thick.
