THE POPLARS SITE REPORT

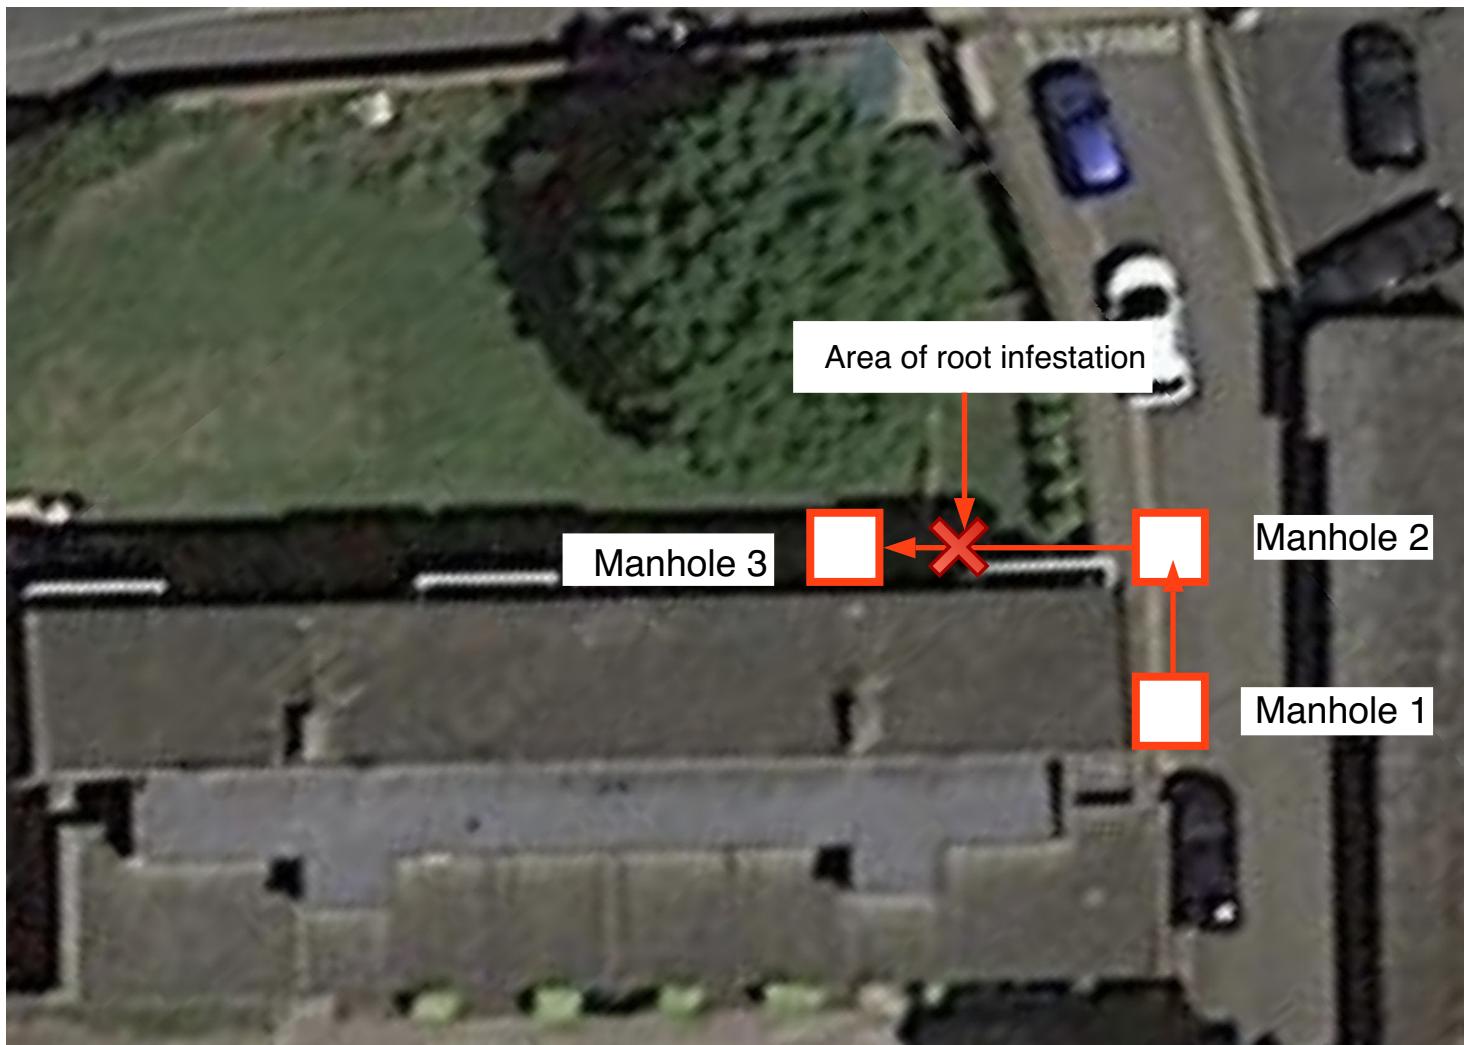
After multiple visits to site to clear ongoing foul drainage issues we decided to run a cctv unit downstream from the blocked drains once cleared. On cctv surveying this drainage it was discovered that there was mass roots at 4mtrs from manhole 2. I then reset up jetting unit and carried out root cutting to remove the bulk of the roots. Due to the ongoing issues with this drainage I would recommend lining of the drainage to stop the roots from entering the system also we could remove some of the local vegetation to stop this becoming an ongoing issue.
