# **Drainage Strategy Report**

**Southbourne Gardens, Ruislip**

**Landmark Builders Ltd**

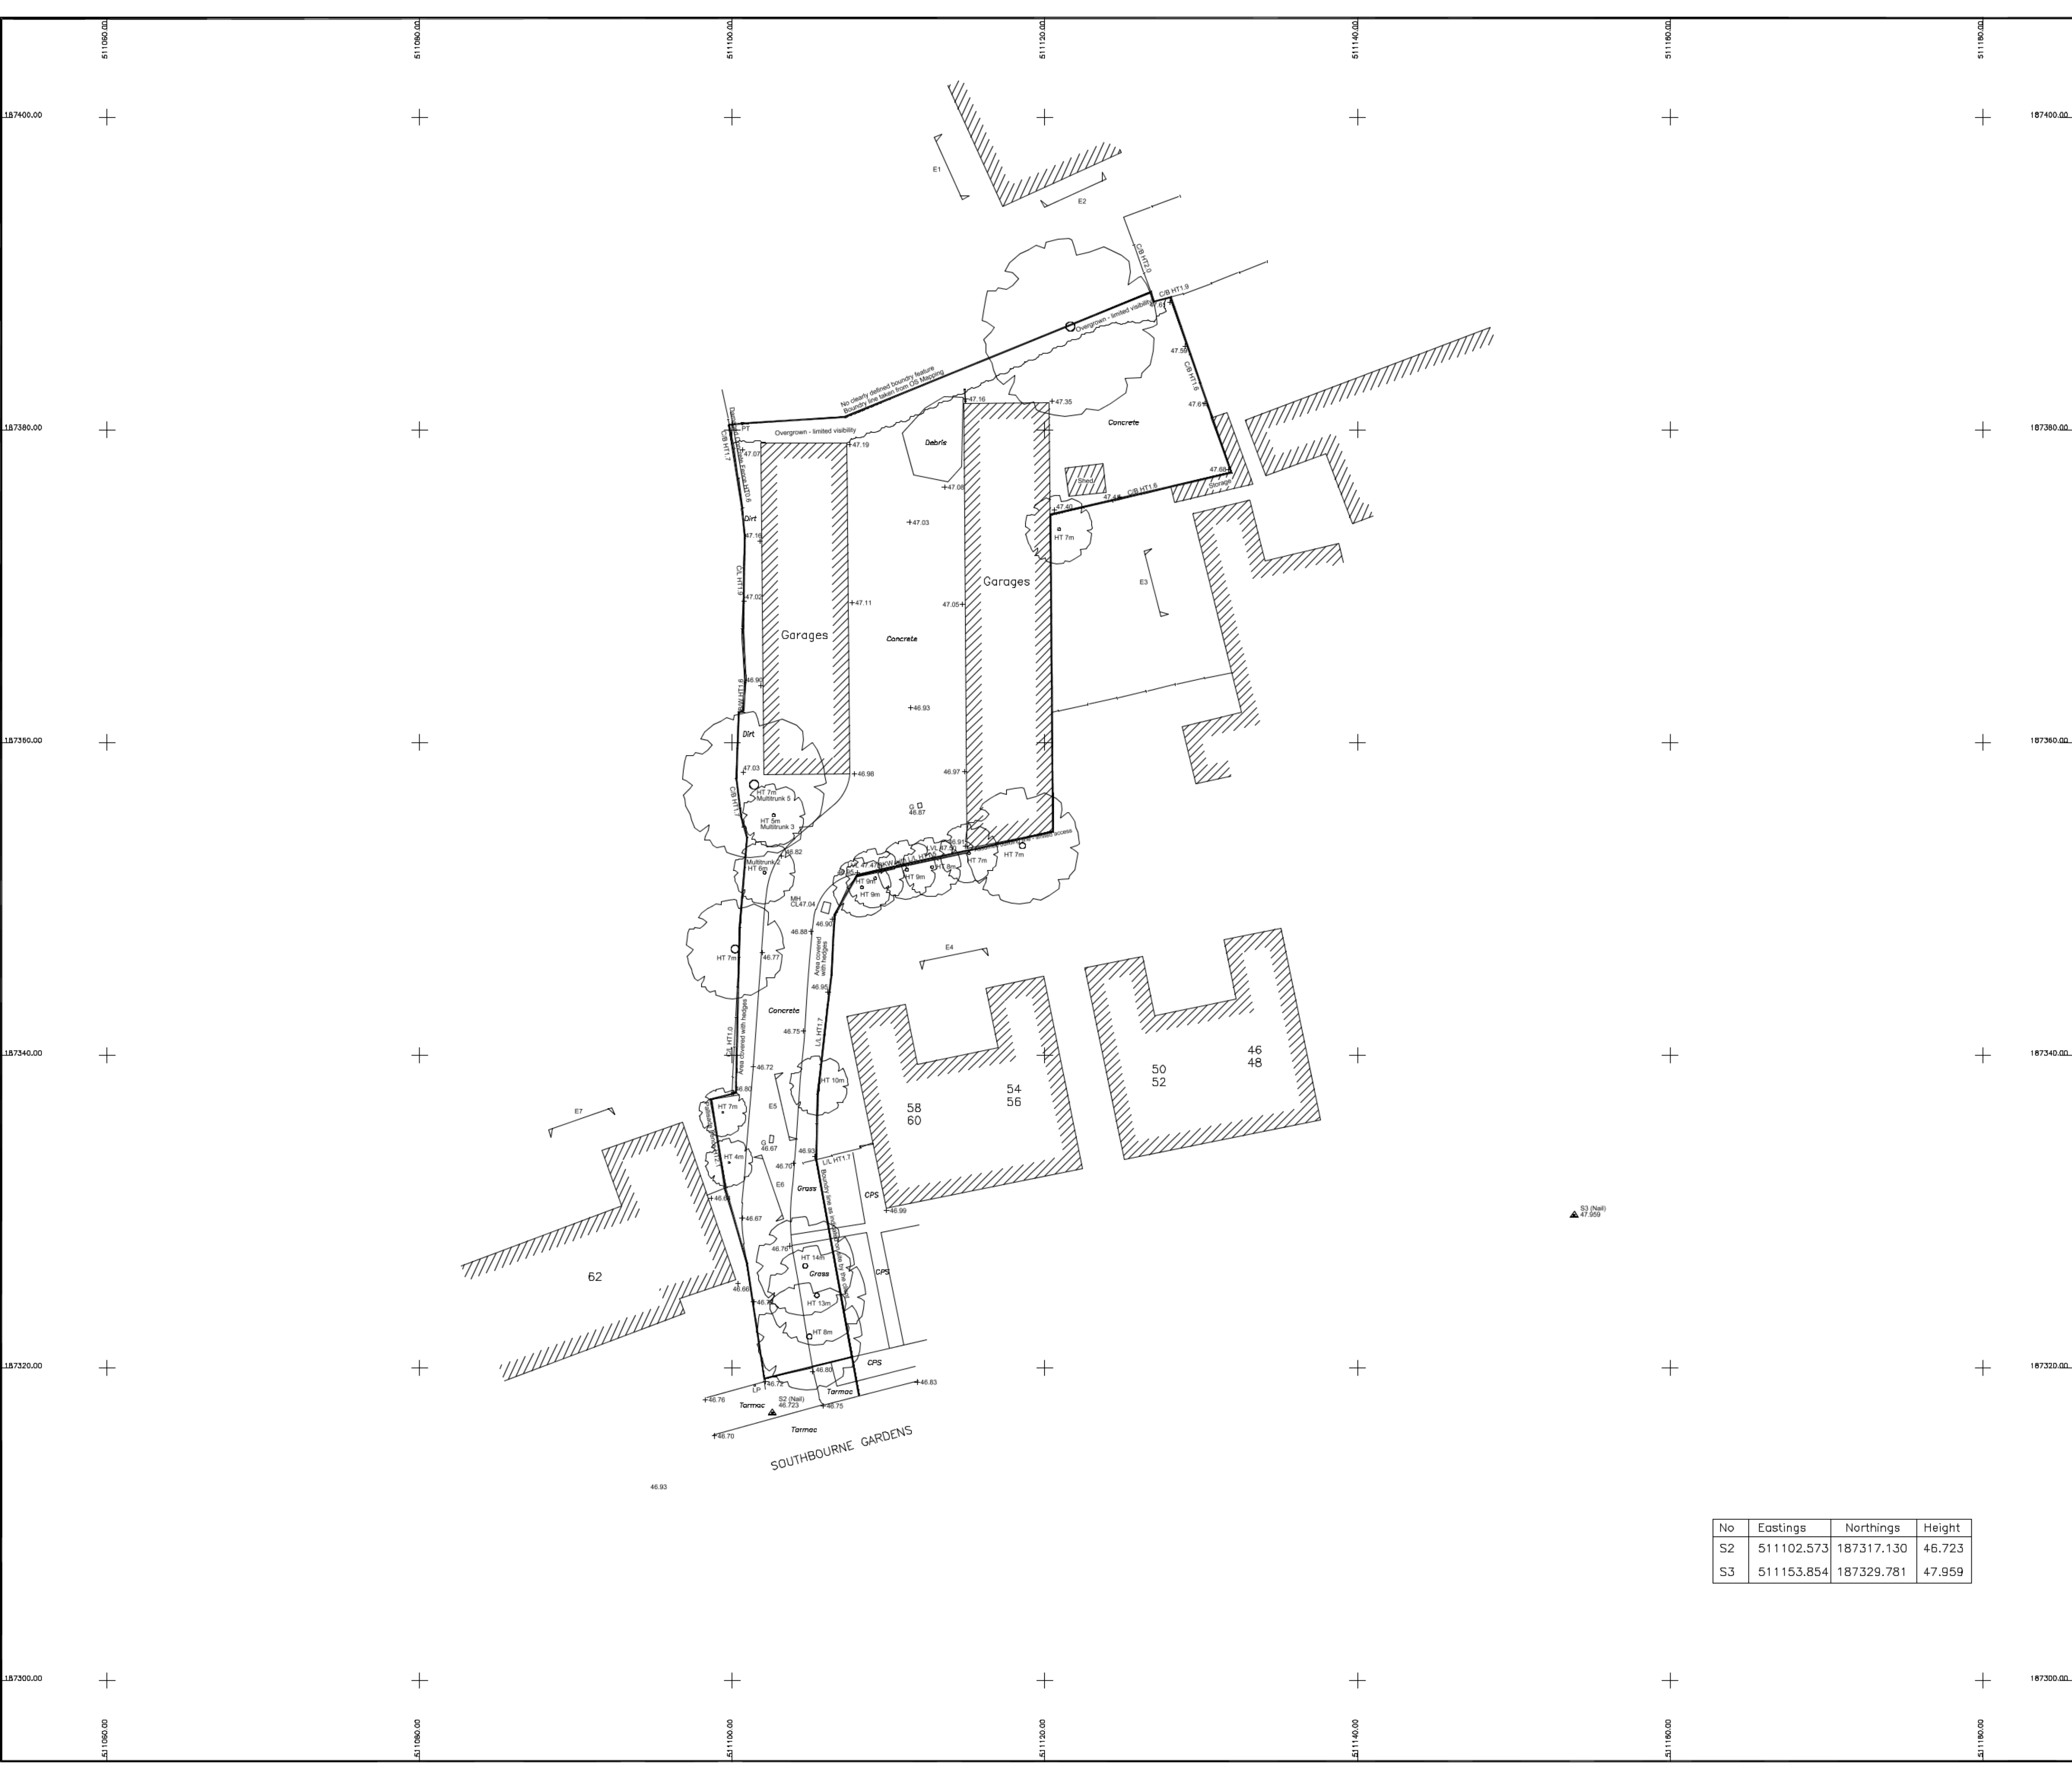
A copy of the topographical survey, drawing BA22961216\_01 – Topographical Survey by Bury Associates Ltd can be found in Appendix A.

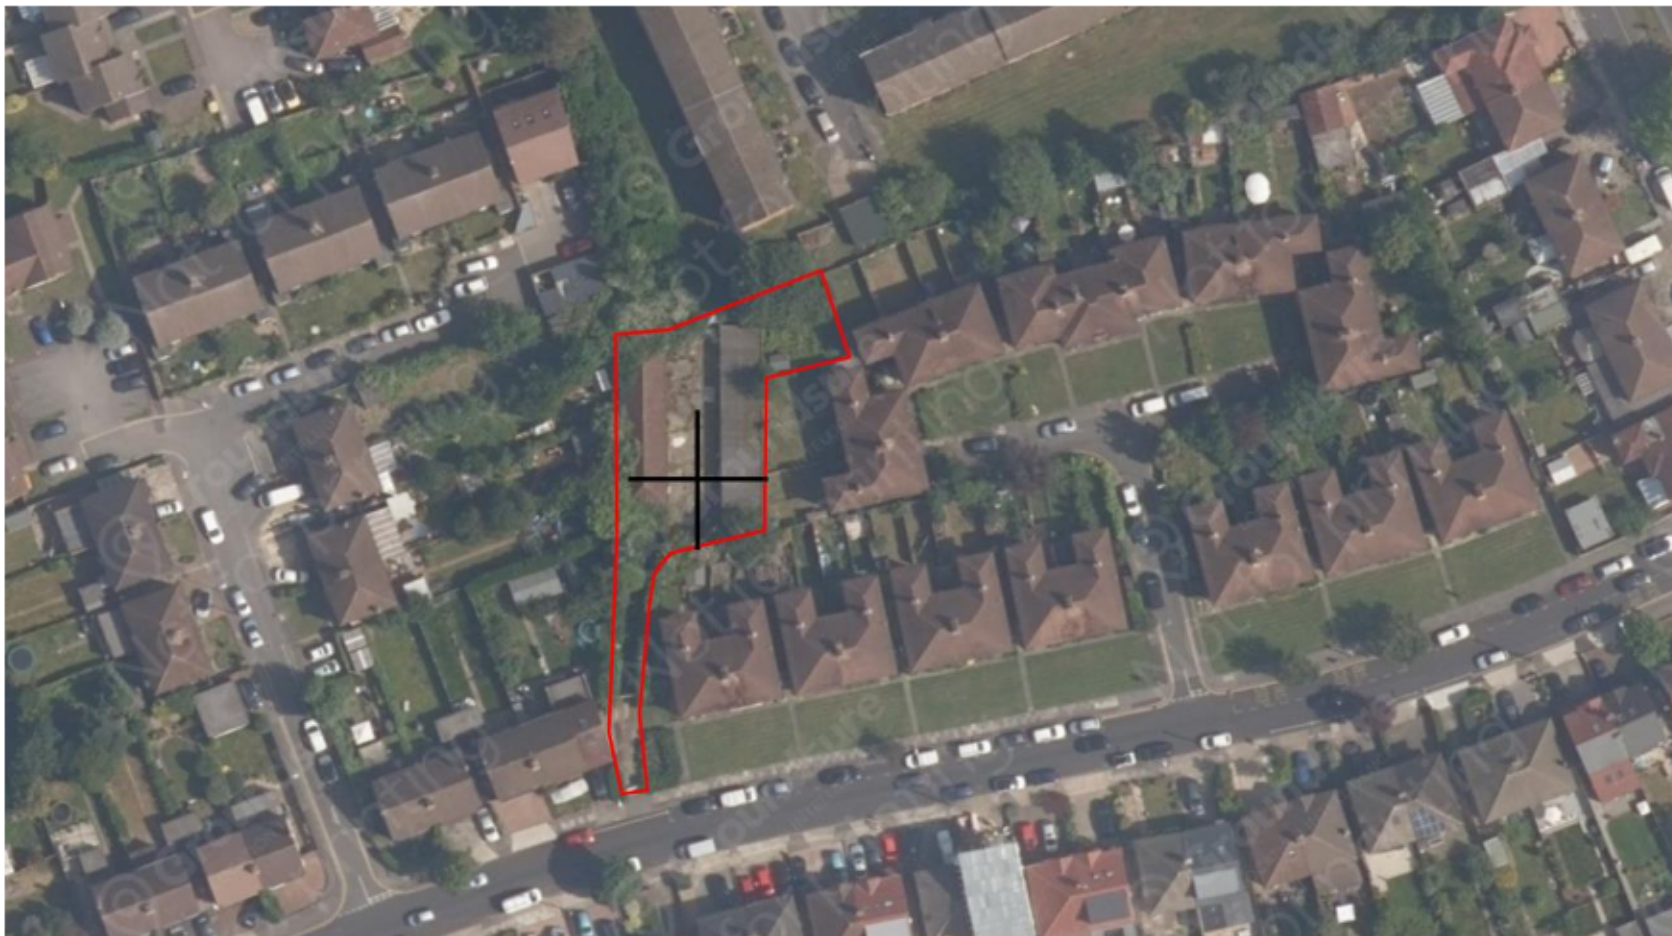
**Figure 3**

An aerial view of the site showing an approximate site boundary is given within Figure 3.

**APPROXIMATE SITE BOUNDARY**

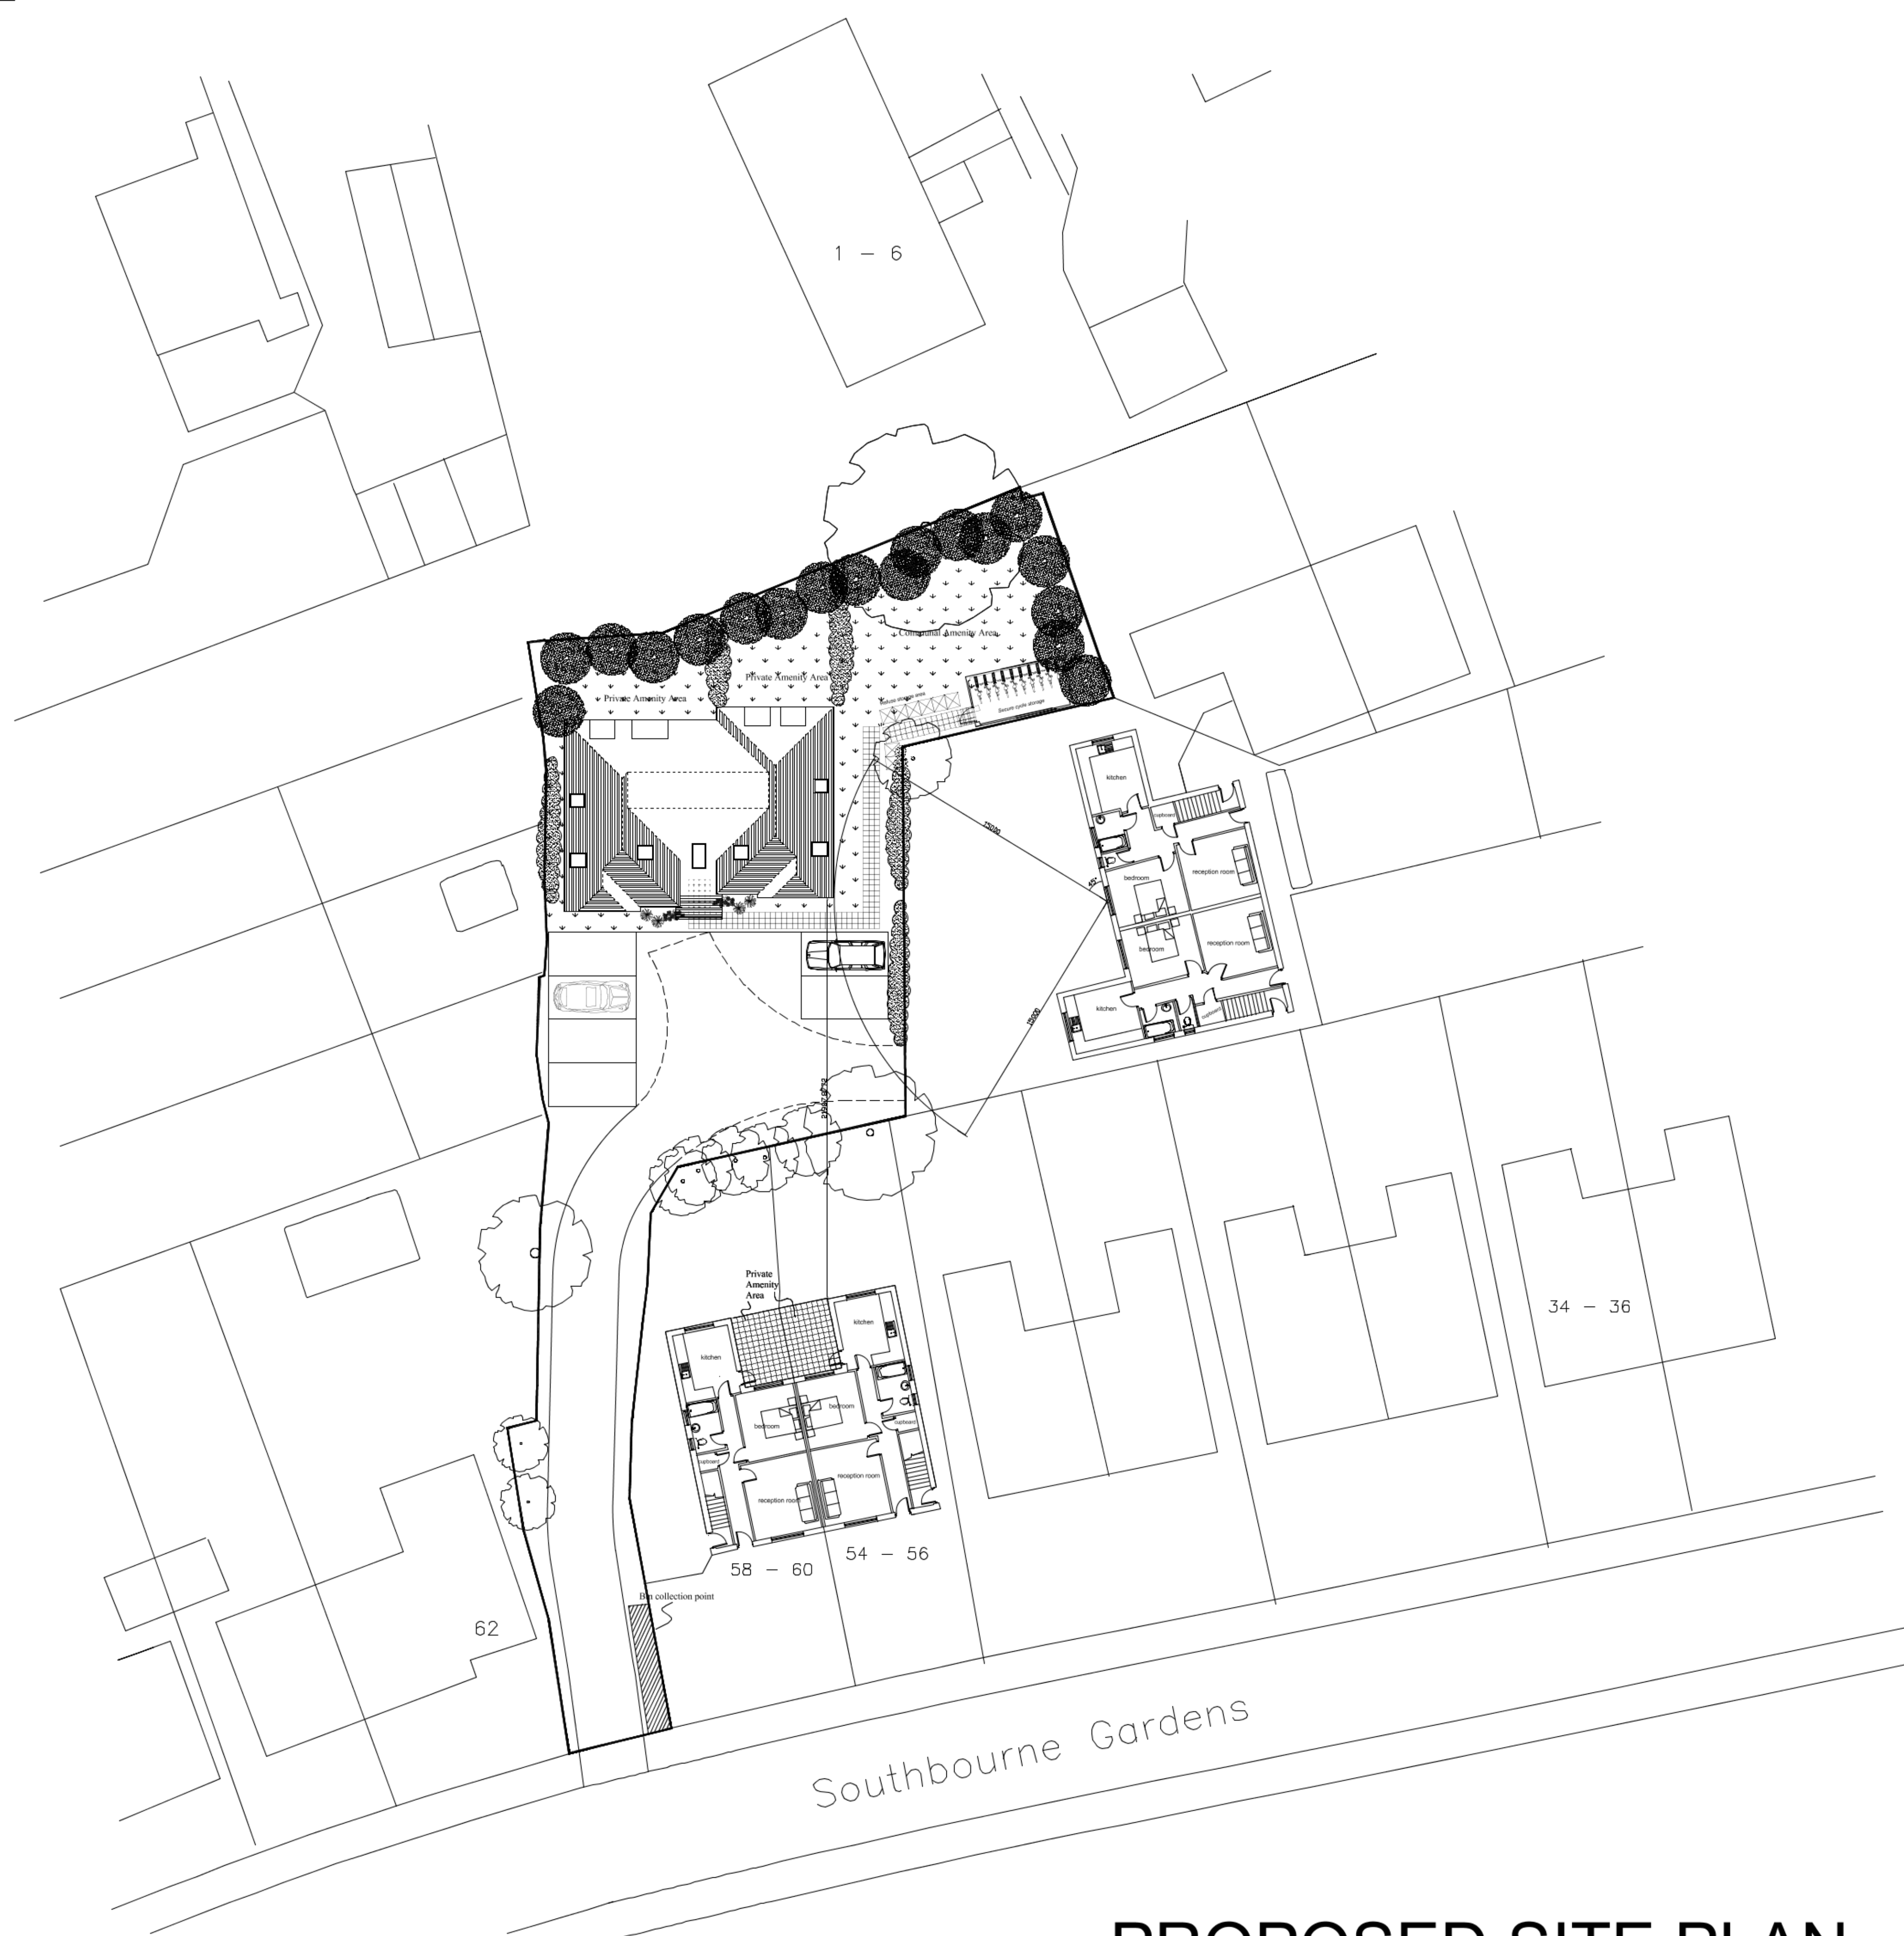
A copy of the drawing 1547.A1.PL02 – Proposed Site Plan by m. j. d. architecture showing the proposed site arrangement can be found Appendix D.
