13.0 RECOMMENDATIONS FOR CHEMICAL CONTAMINATION AND GAS

APPENDICES

FORMER MSD FACILITY, BREAKSPEAR ROAD SOUTH, ICKENHAM

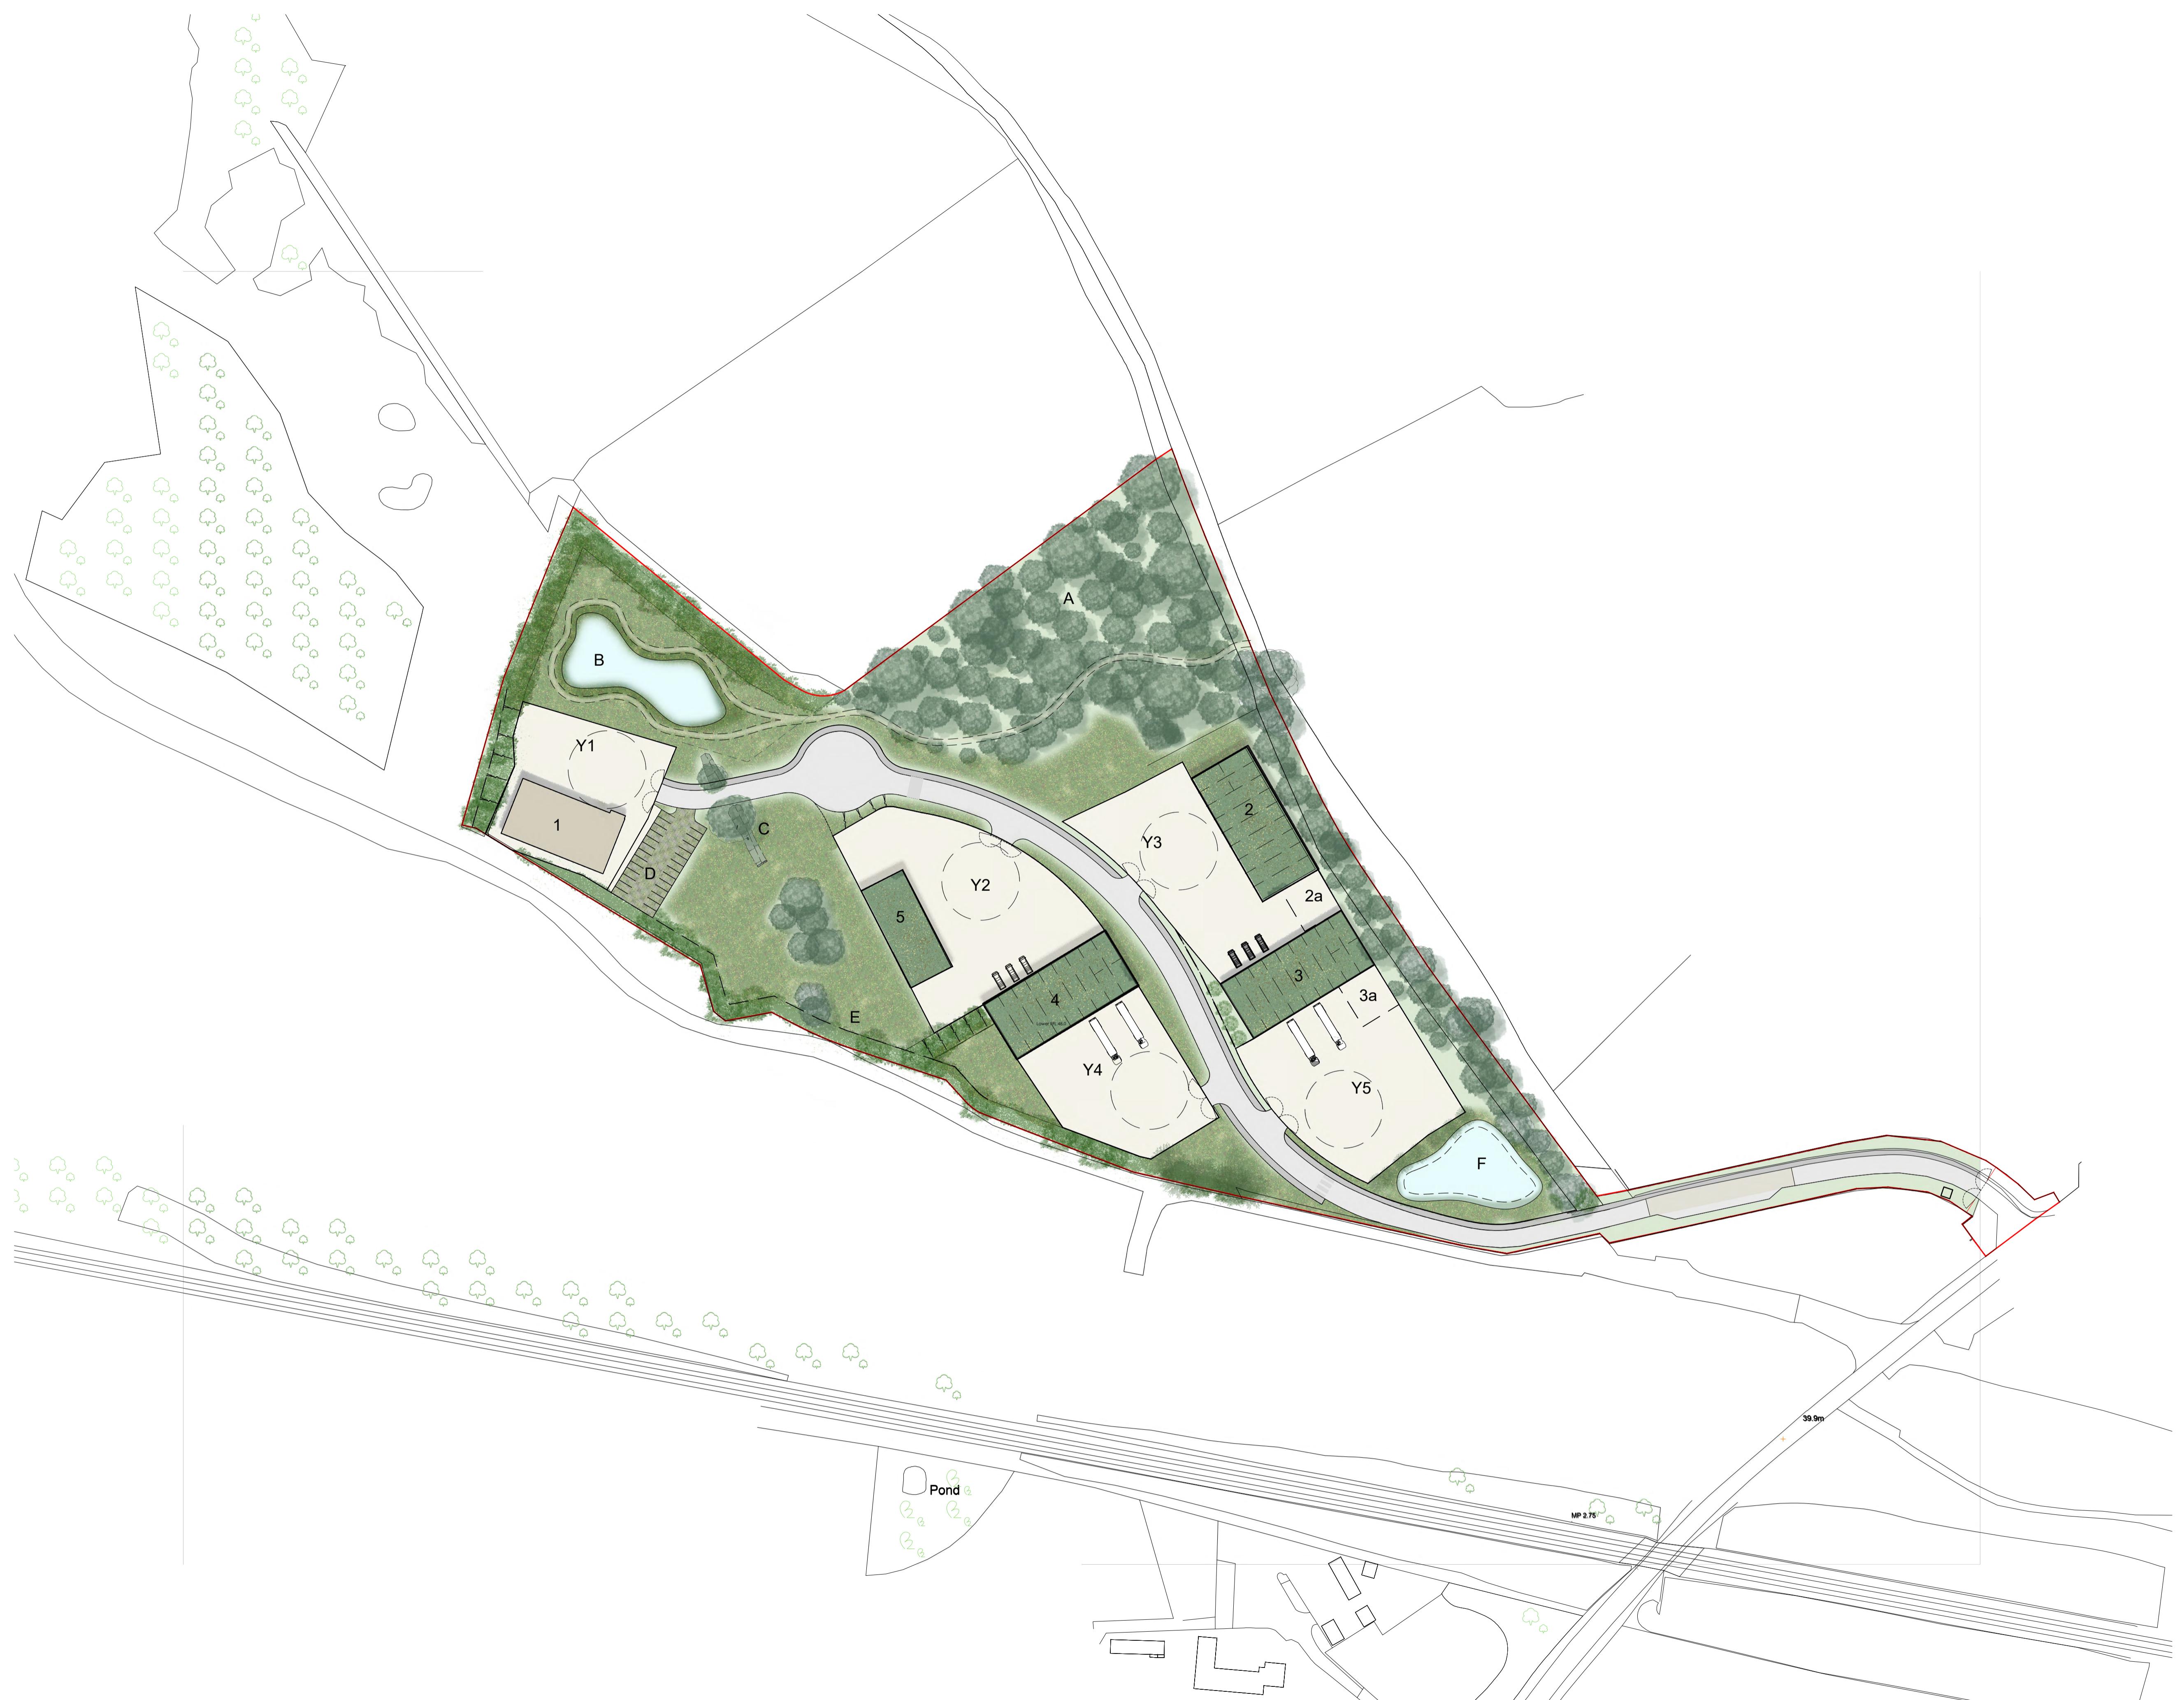
PROPOSED AREAS (GIA)	
01 - Industrial Unit / Office	645 sqm
02 - Single storey Industrial Unit	800 sqm
03 - Single storey Industrial Unit (mezzanine level)	900 sqm
04 - Single storey Industrial Unit (mezzanine level)	450 sqm
05 - Single storey Industrial Unit	900 sqm
	450 sqm
	480 sqm
Total GIA	5525 sqm
Building Areas	
GEA (Building Footprint only)	4020 sq m
Site Areas: 48,650 sq m / 12.0 acres / 4.865 HA	
Developed Areas	
Developed Land (Inc building footprints)	20,890 sq m / 5.1 acres / 2.0 HA
Soft Landscape	
27,760 sq m / 6.85 acres / 2.77 HA

KEY:	
Buildings	
1	Existing Building
2	New Warehouse
3	New Warehouse
4	New Warehouse
5	New Warehouse
Yard Space	
Y1	Storage Yard
Y2	Storage Yard
Y3	Storage Yard
Y4	Storage Yard
Y5	Storage Yard
Features	
A	Existing Woodland enhanced with new community access
B	Community wildlife pond and trail
C	Existing trees and drainage ditch retained to promote creation of wildlife corridor (consider wildlife underpass below access road)
D	Car Parking
E	New boundary planting buffer
F	Attenuation / wildlife basin

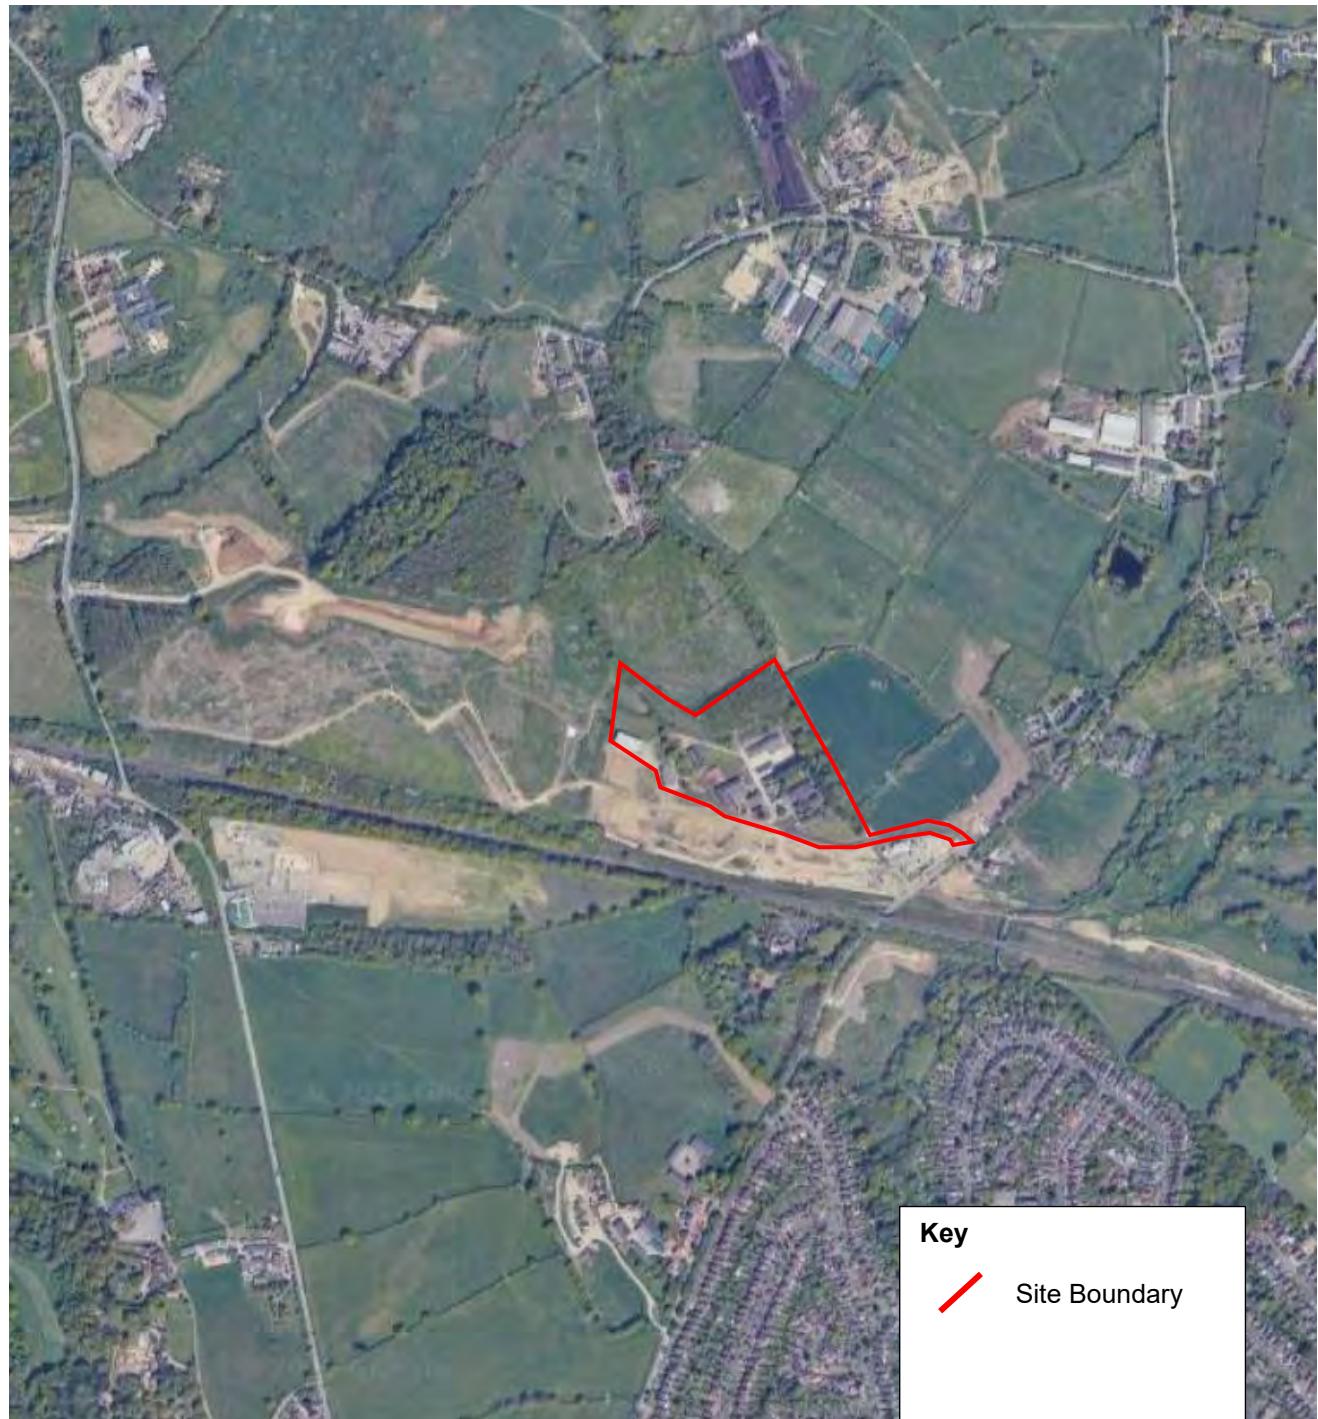
220302 Client requested amendments endorsed
 DATE DESCRIPTION MC RS A
 ARCHITECTS:
campbellarchitects
 CLIENT: Kelbray Management Services Ltd
 PROJECT: Breakspear Road South, Ickenham
 DRAWING TITLE: PROPOSED LAYOUT
 STATUS: PRELIMINARY
 SCALE: 1:1000 @ A1 DATE: 2200210
 PROJECT NUMBER: 1381 DRAWING NUMBER: D003 REVISION: A

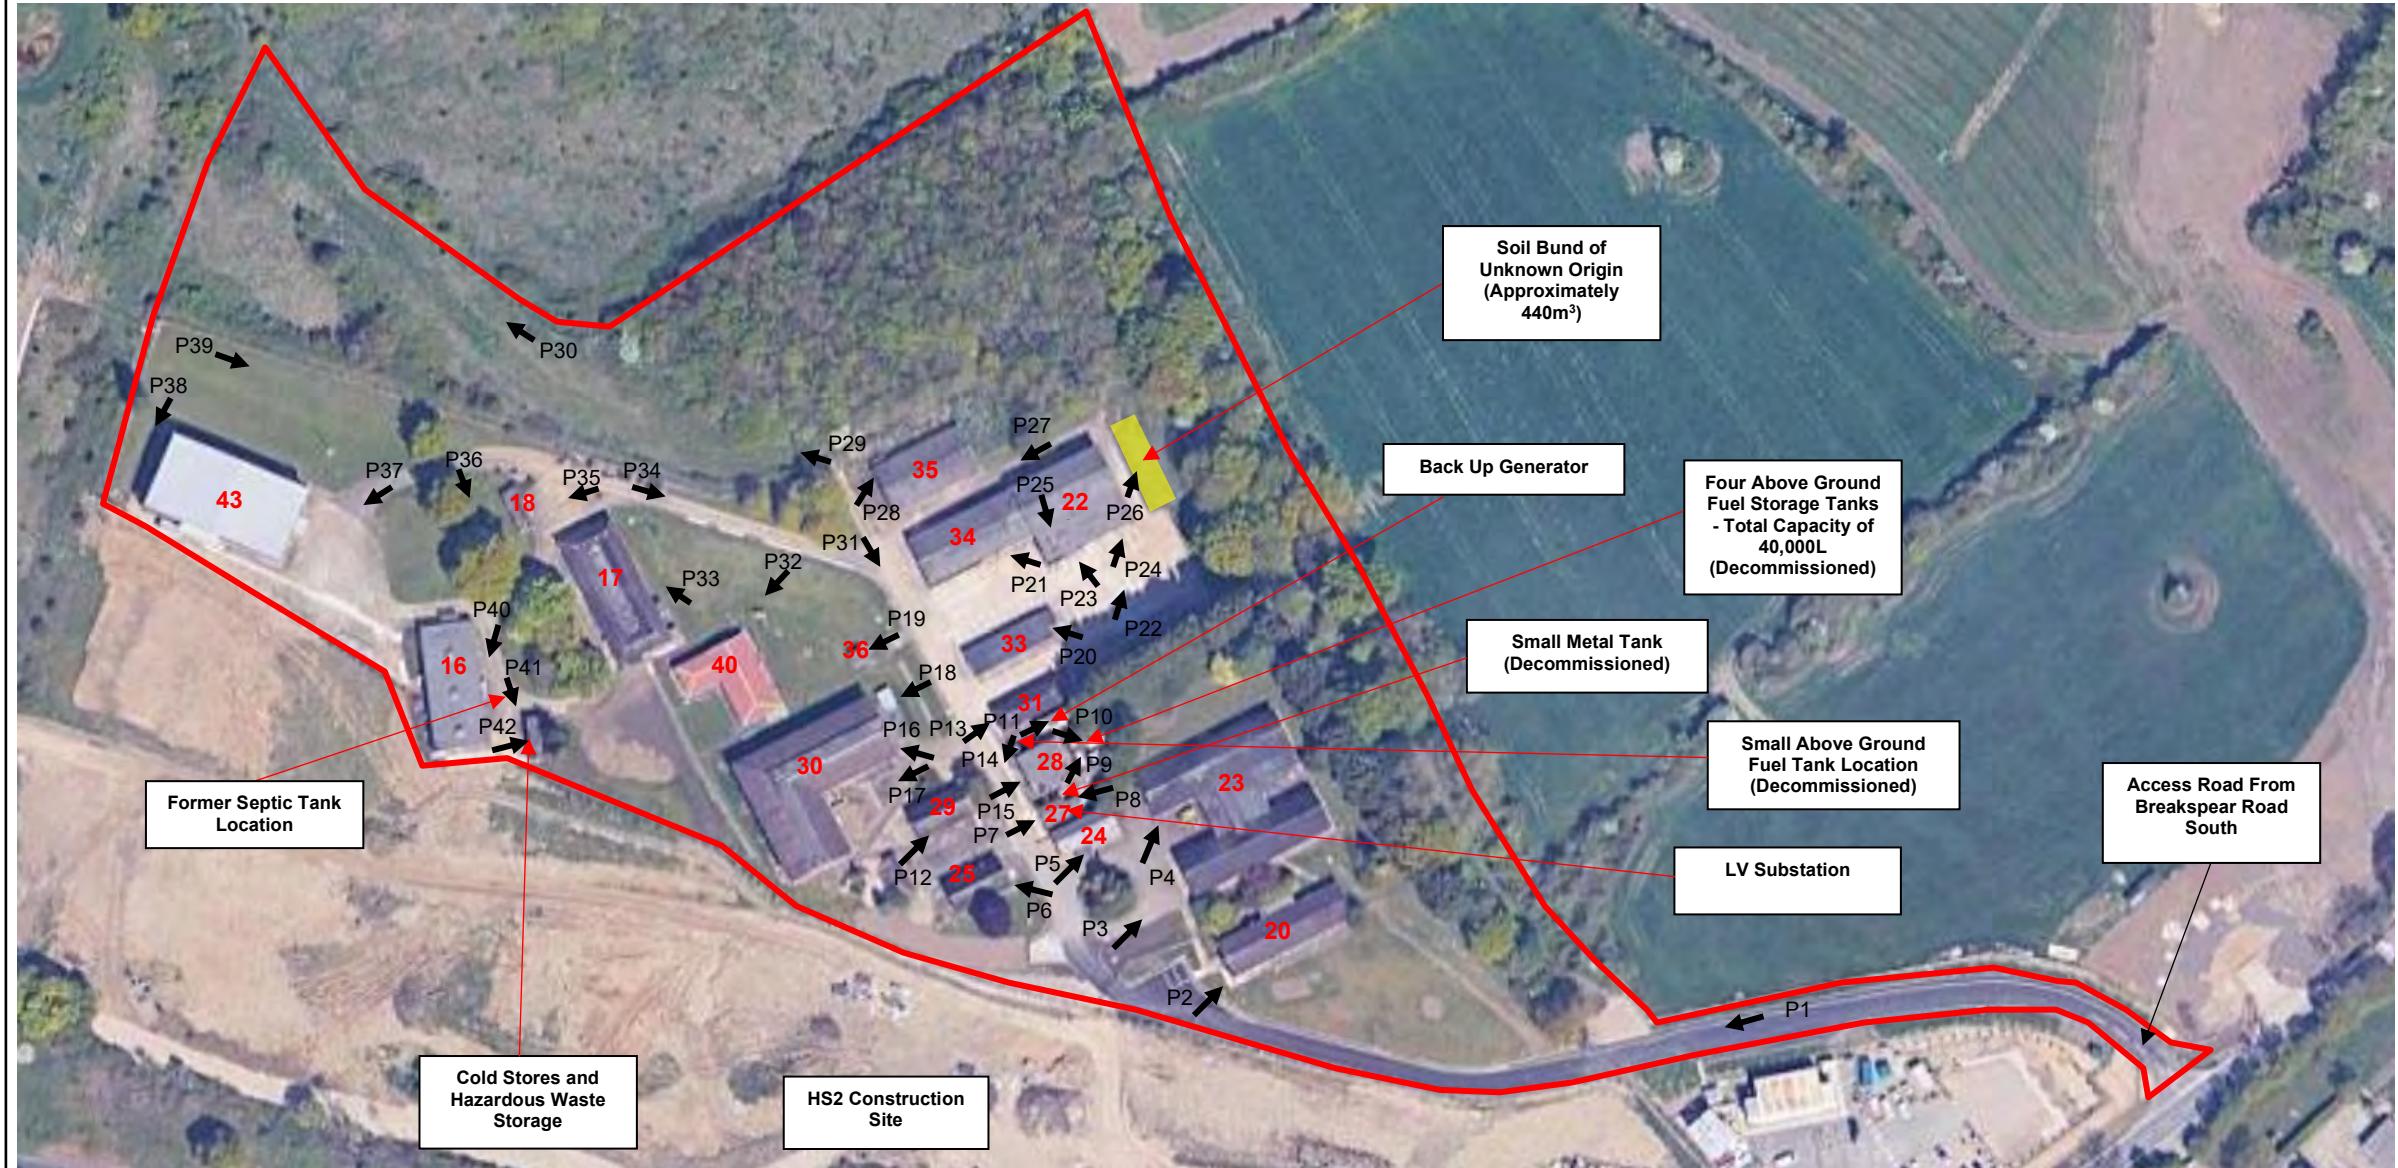
DRAWN BY DOP APPROVED BY SAG
DATE MAY 2022 SCALES NTS
DRAWING No. WB307-01/R/F/02

Building Number	Former Use
16	QC Testing Laboratories and office
17	Offices associated with 'technical operations'
18	Cold stores
20	Restaurant and office space
22	Barn storage
23	GB commercial offices
24	Telesales offices
25	Animal facilities
27	LV substation
28	Boiler plant
29	Engineering department/ H&S
30	Engineering workshop
31	Animal facilities
33	Archive
34	Barn storage
35	Barn storage
36	Hazardous materials store
40	Offices
43	Main production warehouse

DRAWING TITLE
SITE FEATURES PLAN

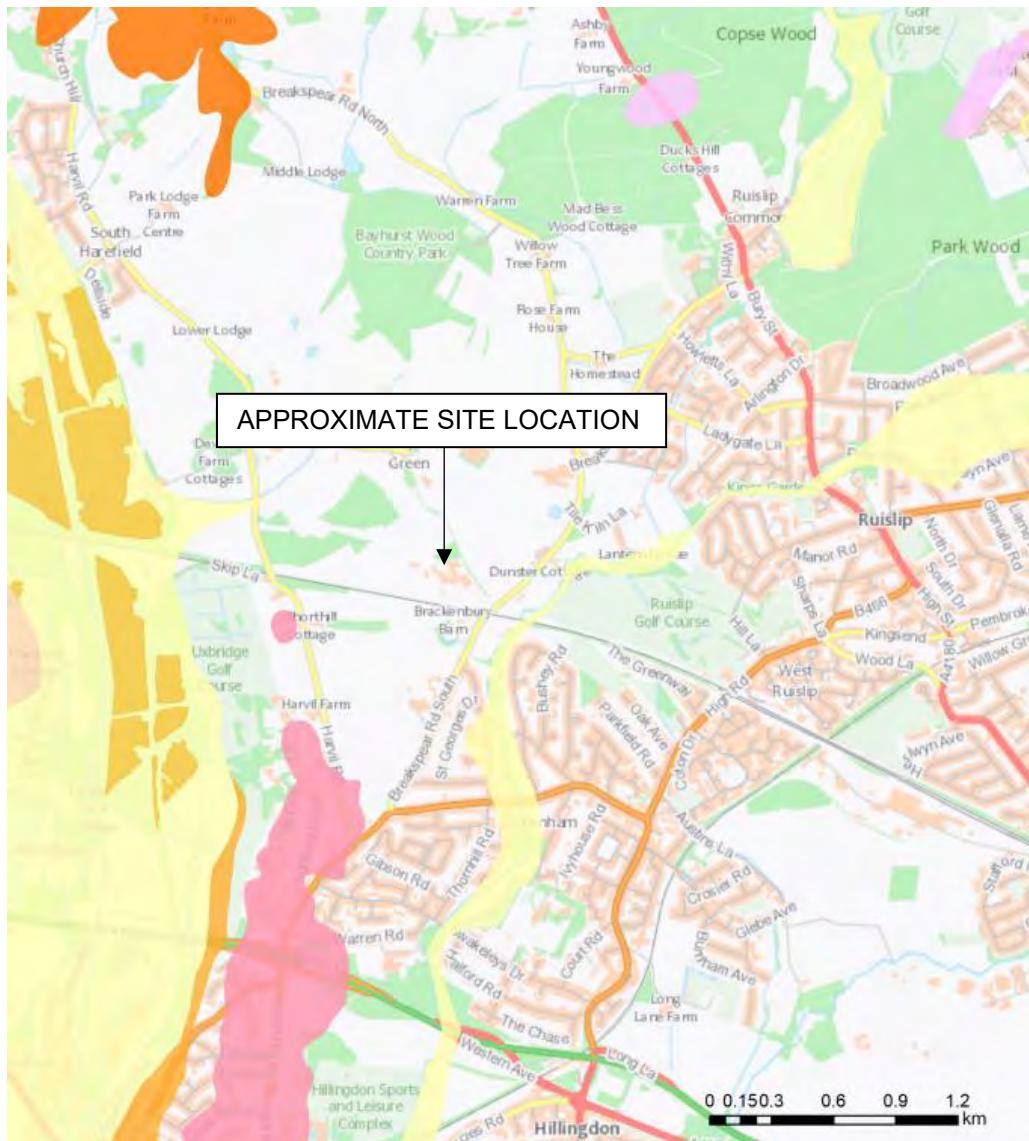
DRAWN BY DOP	APPROVED BY SAG	DATE APRIL 2022	SCALE NTS	DRAWING No. VB307-01/R/F/03
-----------------	--------------------	--------------------	--------------	--------------------------------

Superficial deposits 1:50,000 scale

SAND AND GRAVEL OF UNCERTAIN AGE AND ORIGIN - SAND AND GRAVEL
ALLUVIUM - CLAY, SILT, SAND AND GRAVEL
TAPLOW GRAVEL MEMBER - SAND AND GRAVEL
BLACK PARK GRAVEL MEMBER - SAND AND GRAVEL
HEAD - CLAY AND SILT
WINTER HILL GRAVEL - SAND AND GRAVEL
SHEPPERTON GRAVEL MEMBER - SAND AND GRAVEL
LYNCH HILL GRAVEL MEMBER - SAND AND GRAVEL
LANGLEY SILT MEMBER - CLAY AND SILT
GERRARDS CROSS GRAVEL - SAND AND GRAVEL

GEOINDEX MAPPING (SUPERFICIAL)

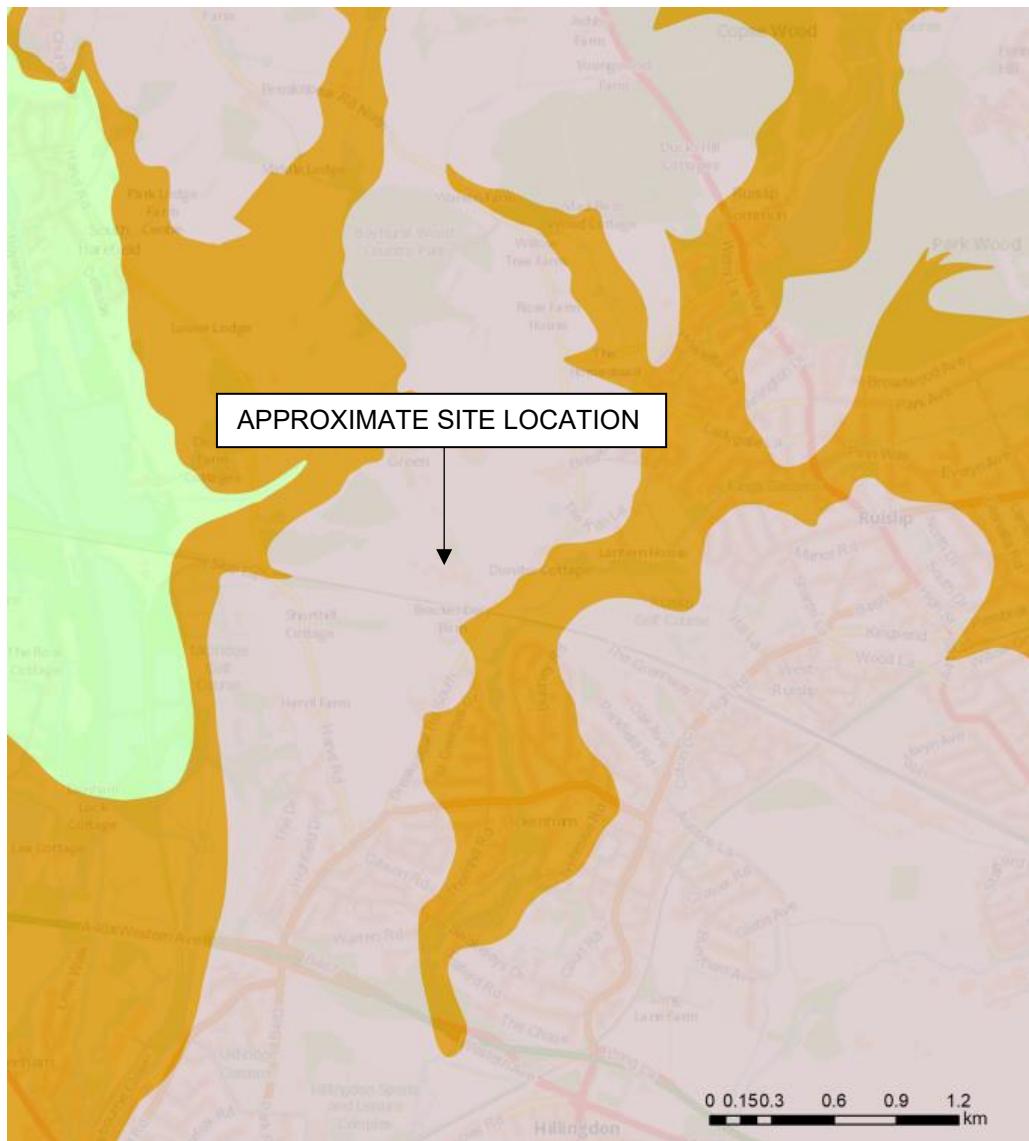
VB307-01/R/F/04

Bedrock geology 1:50,000 scale

- [LONDON CLAY FORMATION - CLAY, SILT AND SAND](#)
- [SEAFORD CHALK FORMATION AND NEWHAVEN CHALK FORMATION \(UNDIFFERENTIATED\) - CHALK](#)
- [LAMBETH GROUP - CLAY, SILT AND SAND](#)

GEOINDEX MAPPING (SOLID)
