**Report From:**  
**Circular Economy and Waste Specialists**  
**Reusefully Ltd**

**Report Prepared For:**  
**Gerald Eve**

## **Pre-Redevelopment Audit of Former MSD Site, Harefield**

**27.02.24**

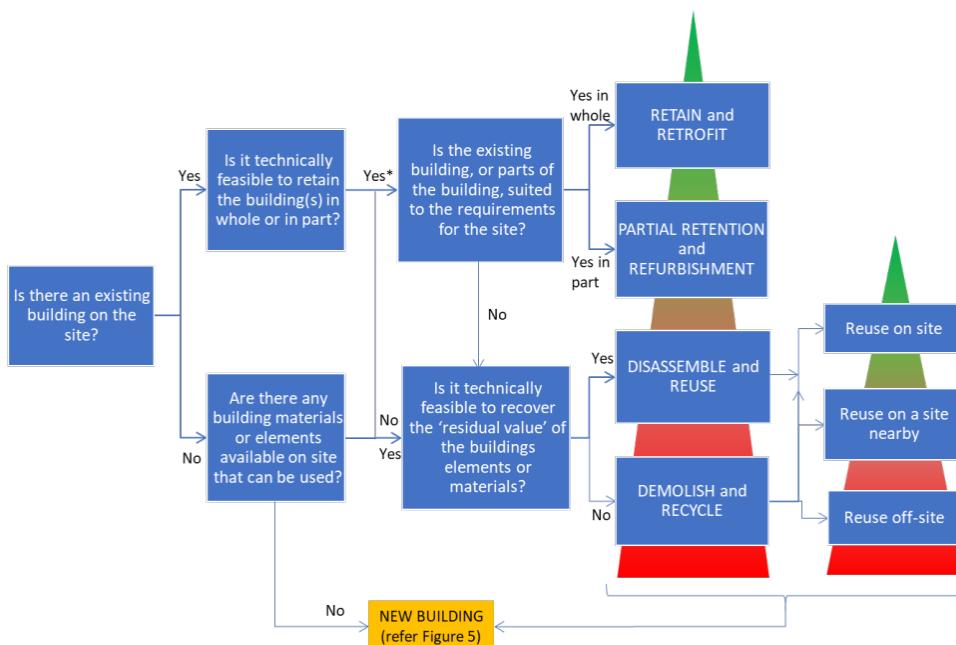
Figure 1. Decision tree for dealing with existing buildings on a site to be redeveloped, taken from the GLA Circular Economy Statement Guidance.

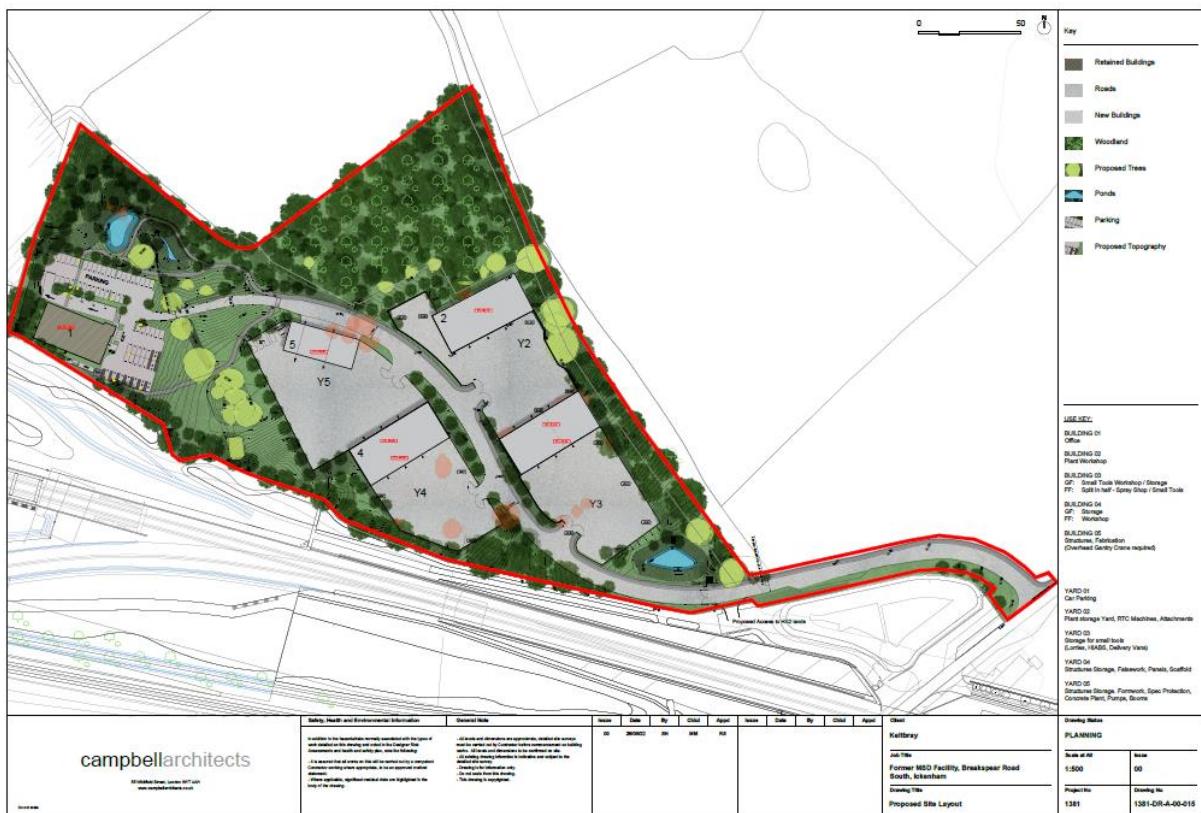
- Demolition of all buildings and structures on the site (other than building 43) to make way for four new office/industrial buildings as well as improved landscaping and ecology.
- Retention and refurbishment of Building 43.

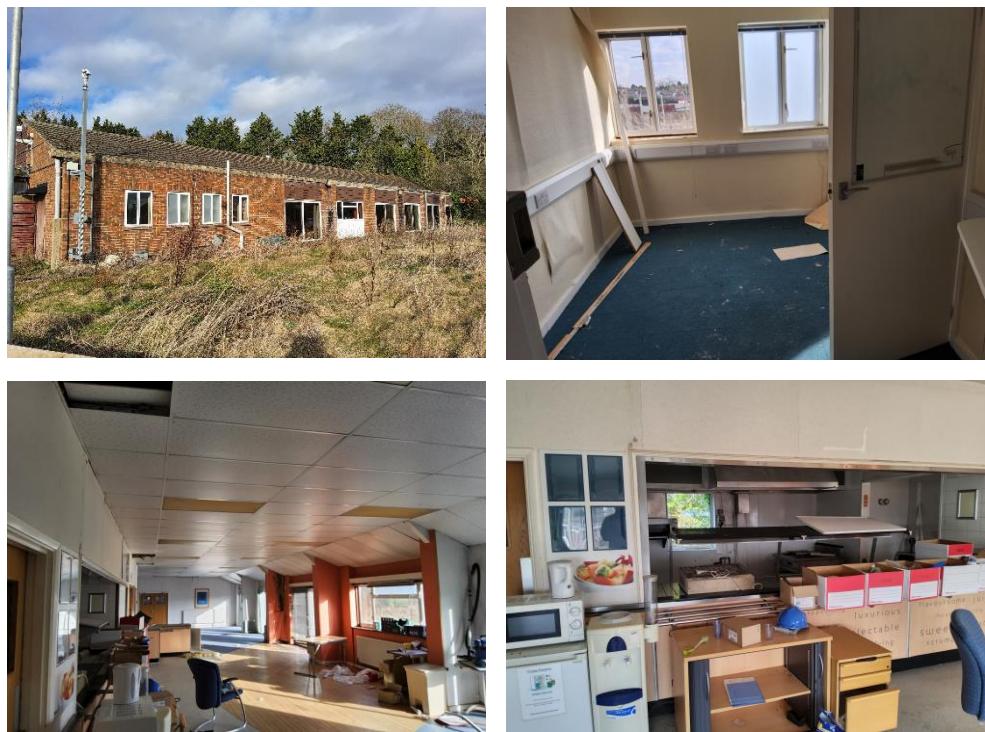
Building 20 is assumed to have been built during the mid to late 1990s based on the site's planning history. The building includes multiple small rooms with unknown uses, a large space that is assumed to have been a canteen or restaurant area, a commercial kitchen, and WC facilities.

Asset	Recommendation
<b>Building 20</b>	Retention is feasible with extensive refurbishment, however, utilisation potential seems low. Do not retain – demolish/deconstruct and recover key materials as recommended in pre-demolition audit report.
<b>Building 24</b>	Retention is feasible with extensive refurbishment, however, utilisation potential seems low. Do not retain – demolish/deconstruct and recover key materials as recommended in pre-demolition audit report.
<b>Building 25</b>	Retention is feasible with extensive refurbishment, however, utilisation potential seems low. Do not retain – demolish/deconstruct and recover key materials as recommended in pre-demolition audit report.
<b>Building 29</b>	Retention is feasible with extensive refurbishment, however, utilisation potential seems low. Do not retain – demolish/deconstruct and recover key materials as recommended in pre-demolition audit report.

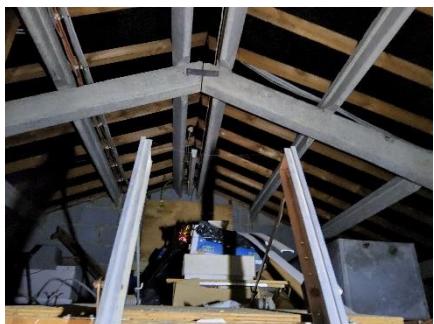
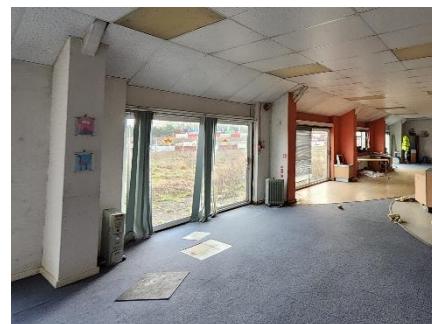
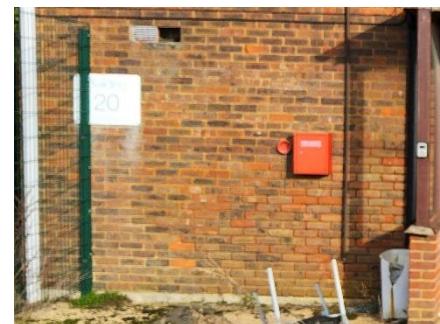
The structure of the building was not surveyed in detail; however, the assessors did not observe any major structural defects during the site visit (though note that structural elements were often concealed by floor coverings and suspended ceilings). Overall, the condition of the external walls and concrete floors and roof is assumed to be sufficient to allow continued use where no major changes are made to the building's physical architecture.

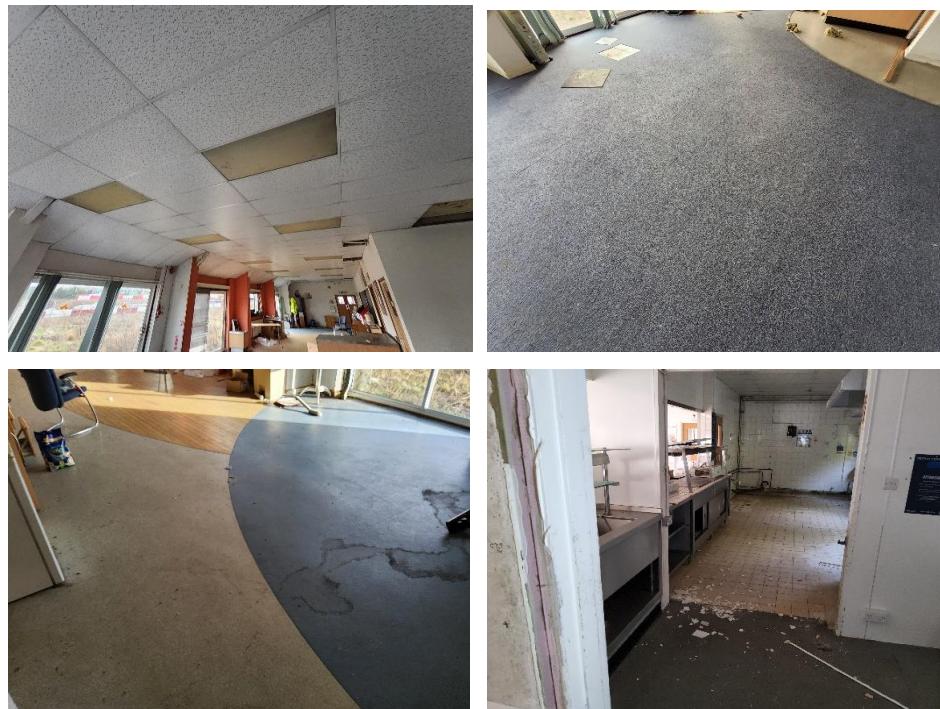
Finishes include suspended ceilings with mineral fibre ceiling tiles (poor to good condition), carpet tiles (fair to good condition), vinyl flooring (poor to fair condition), floor tiles (poor condition), timber floorboards (good condition), metal kitchen equipment (fair to good condition), and other miscellaneous items.

If retained, it is likely that a full internal refurbishment would be required to achieve levels of interior design quality and occupant comfort that are adequate for future use.

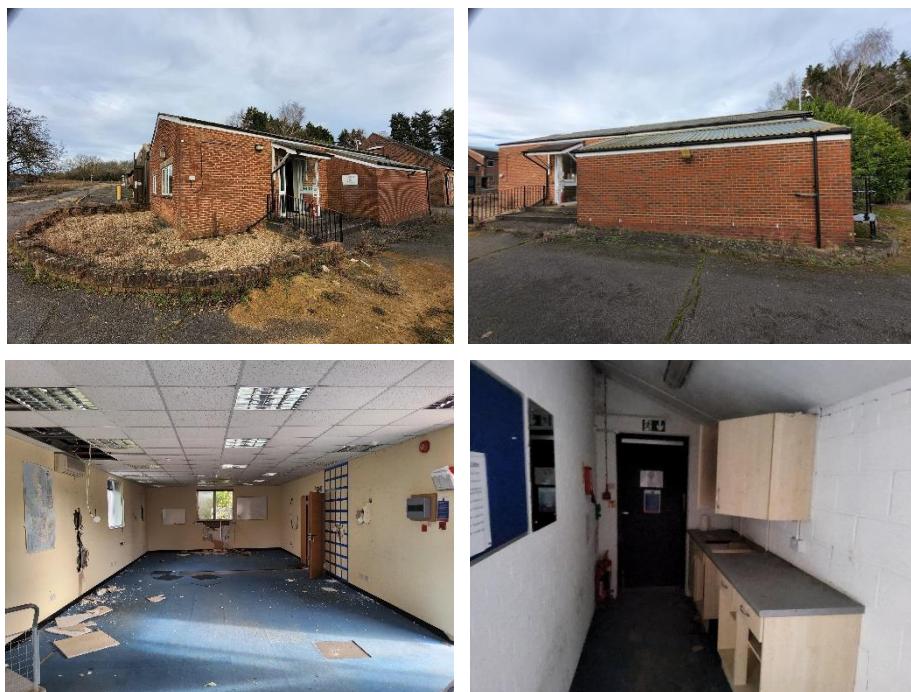
Building 24 includes an open plan office space as well as a small extension with a kitchenette.

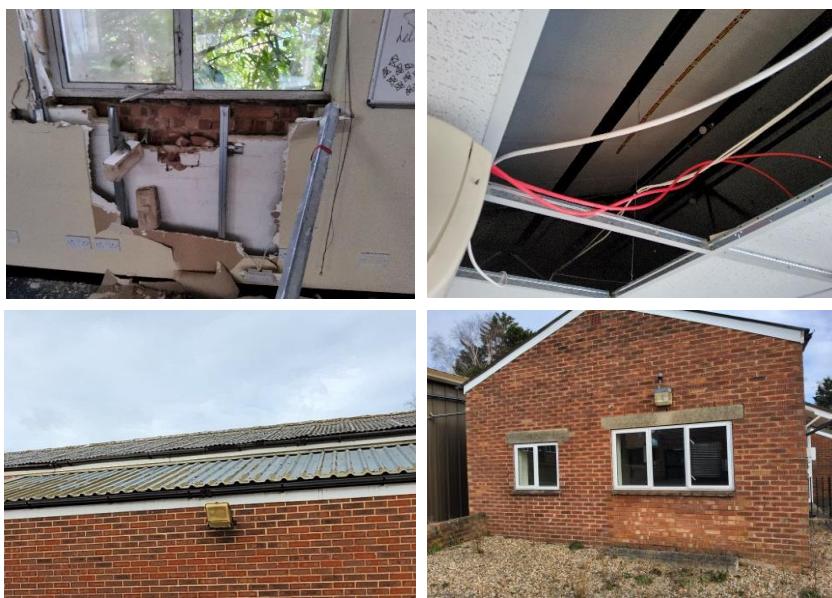
The structure of the building was not surveyed in detail; the assessors observed one structural defect during the site visit (the brick wall shown below), though there were no other major structural defects identified (though note that structural elements were often concealed by floor coverings and suspended ceilings). Overall, the condition of the external walls, concrete floors, and the roof structure is assumed to be sufficient to allow continued use where no major changes are made to the building's physical architecture.

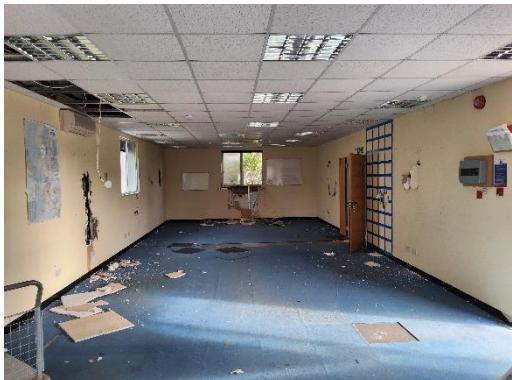
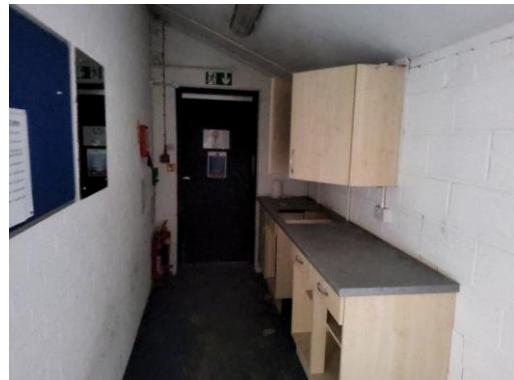
Finishes include suspended ceilings with mineral fibre ceiling tiles (poor to fair condition), carpet tiles (poor to fair condition), kitchen cabinets and worktop (good condition), and other miscellaneous items.

If retained, it is likely that a full internal refurbishment would be required to achieve levels of interior design quality and occupant comfort that are adequate for future use.

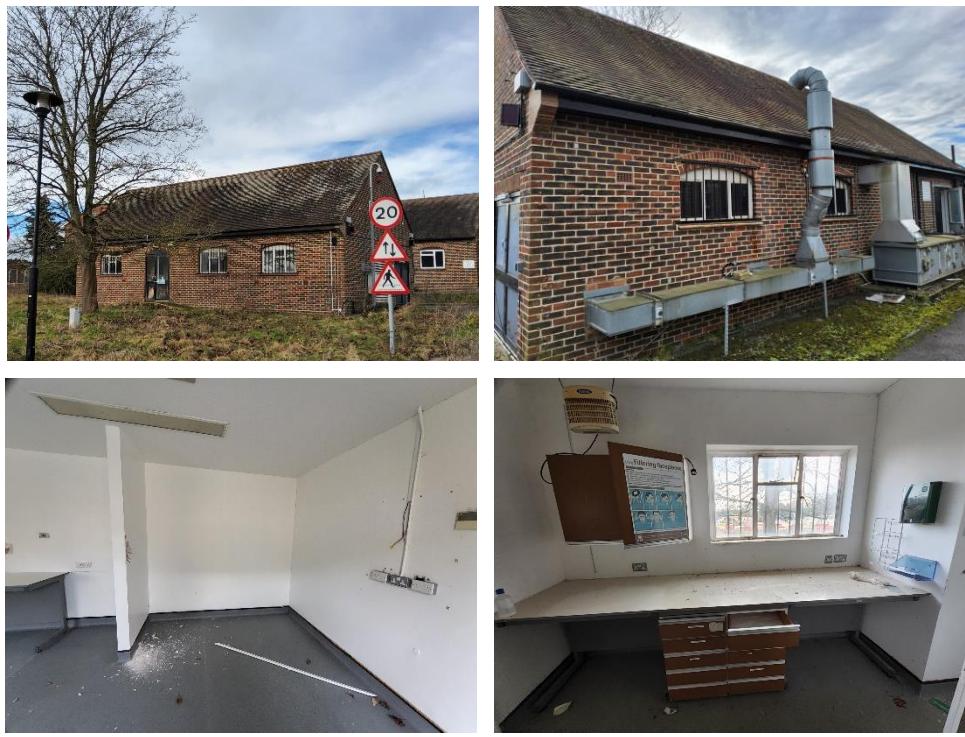
Building 25 includes multiple workshop/lab spaces.

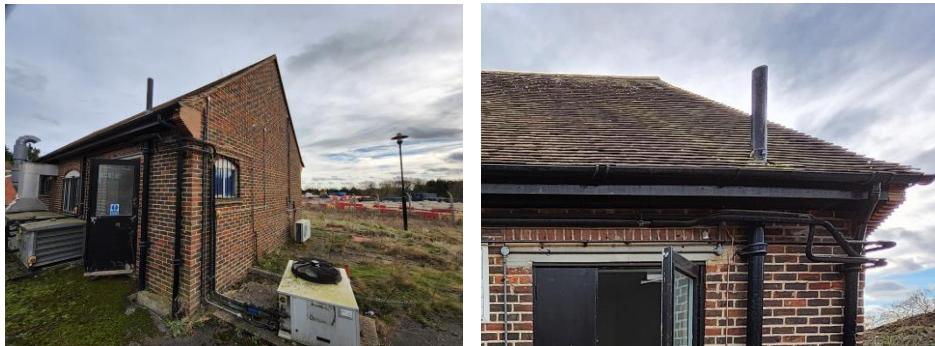
The structure of the building was not surveyed in detail; however, the assessors did not observe any major structural defects during the site visit (though note that structural elements were often concealed by floor coverings and suspended ceilings). Overall, the condition of the external walls and concrete floors and roof is assumed to be sufficient to allow continued use where no major changes are made to the building's physical architecture.

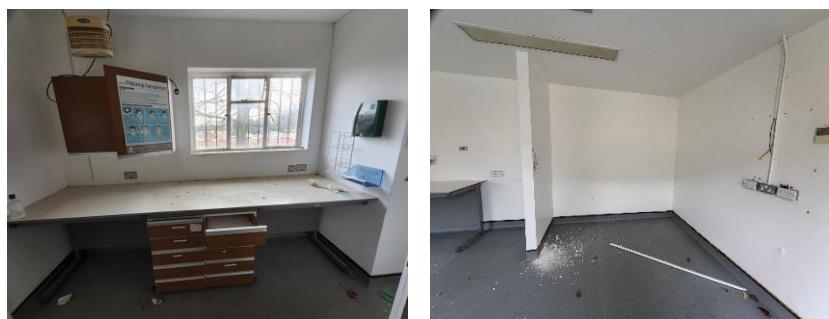
Finishes include vinyl flooring (poor condition), and other miscellaneous items.

If retained, it is likely that a full internal refurbishment would be required to achieve levels of interior design quality and occupant comfort that are adequate for future use.

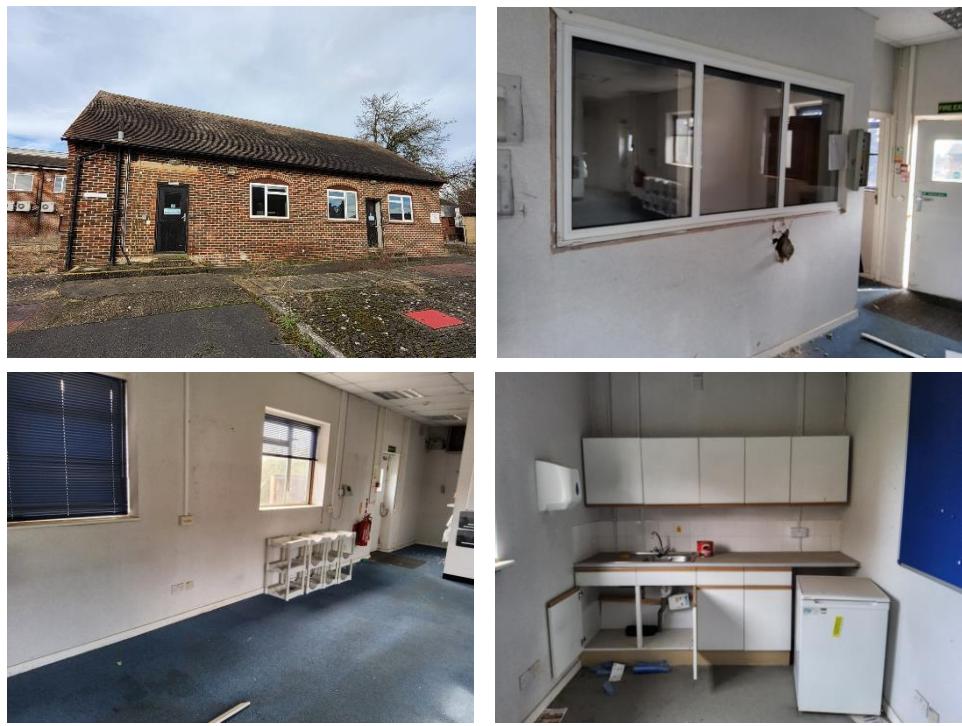
Building 29 includes an open plan office space a small meeting room and a kitchenette.

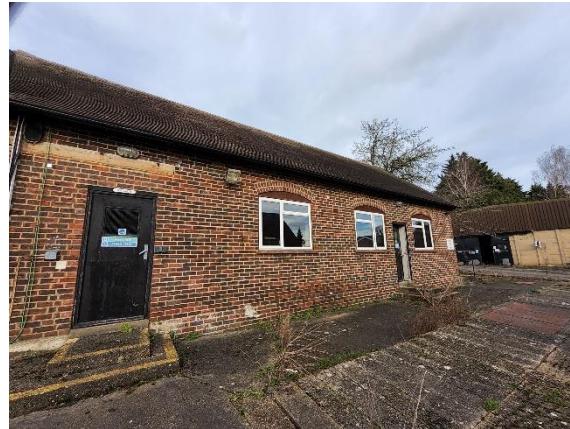
The structure of the building was not surveyed in detail; however, the assessors did not observe any major structural defects during the site visit (though note that structural elements were often concealed by floor coverings and suspended ceilings). Overall, the condition of the external walls and concrete floors and roof is assumed to be sufficient to allow continued use where no major changes are made to the building's physical architecture.

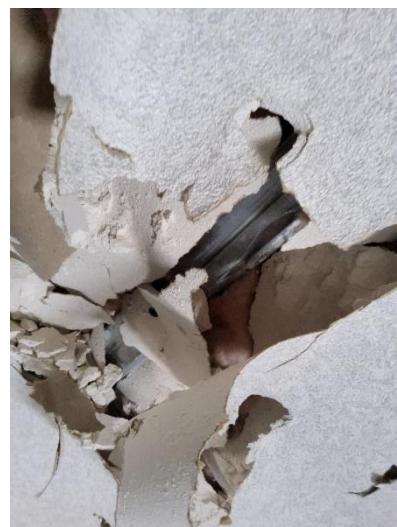
There are some metal stud internal walls not loadbearing so the internal layout may be adapted for alternative uses. If the building is retained for use as an office, these internal walls may need to be replaced based on their condition.

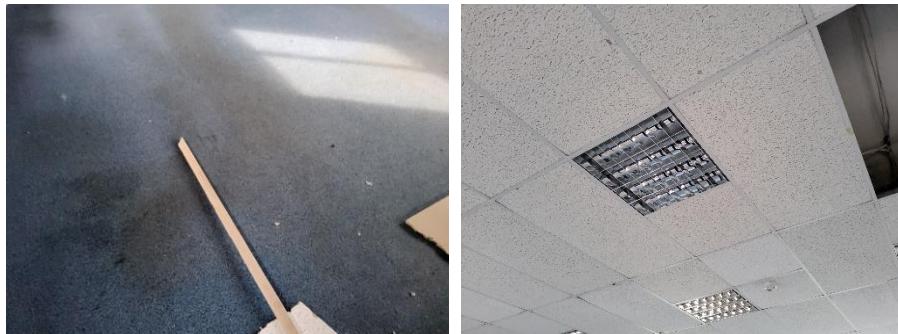
Finishes include suspended ceilings with mineral fibre ceiling tiles (poor to fair condition), carpet tiles (poor condition), vinyl flooring (poor condition), and other miscellaneous items.

If retained, it is likely that a full internal refurbishment would be required to achieve levels of interior design quality and occupant comfort that are adequate for future use.

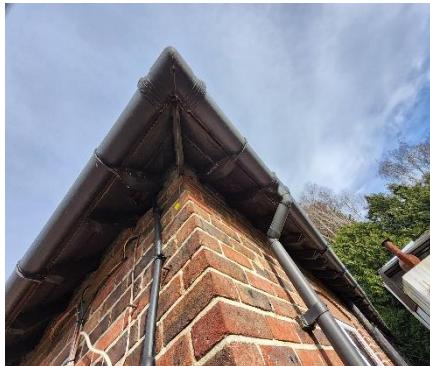
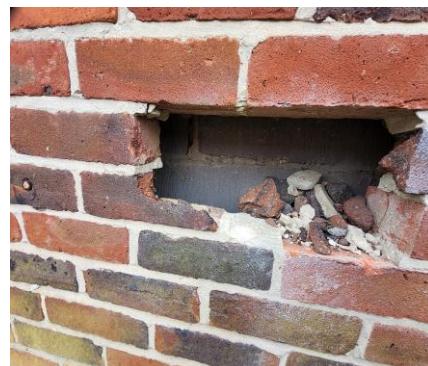
The building comprises one storey, with cavity brick and block external walls, a reinforced concrete ground floor slab, timber truss roof structure, and slate roof tiles.

The structure of the building was not surveyed in detail; however, the assessors did not observe any major structural defects during the site visit (though note that structural elements were often concealed by floor coverings and suspended ceilings). Overall, the condition of the external walls and concrete floors and roof is assumed to be sufficient to allow continued use where no major changes are made to the building's physical architecture.

<b>Building 31</b>	Retention is feasible with extensive refurbishment, however, utilisation potential seems low. Do not retain – demolish/deconstruct and recover key materials as recommended in pre-demolition audit report.
<b>Building 40</b>	Retention is feasible with extensive refurbishment, however, utilisation potential seems low. Do not retain – demolish/deconstruct and recover key materials as recommended in pre-demolition audit report.
<b>Building 17</b>	Retention is feasible with extensive refurbishment, however, utilisation potential seems low. Do not retain – demolish/deconstruct and recover key materials as recommended in pre-demolition audit report.
<b>Building 16</b>	Retention is feasible with extensive refurbishment, however, utilisation potential seems low. Do not retain – demolish/deconstruct and recover key materials as recommended in pre-demolition audit report.
<b>Building 23</b>	Retention is feasible with extensive refurbishment, however, utilisation potential seems low. Do not retain – demolish/deconstruct and recover key materials as recommended in pre-demolition audit report.

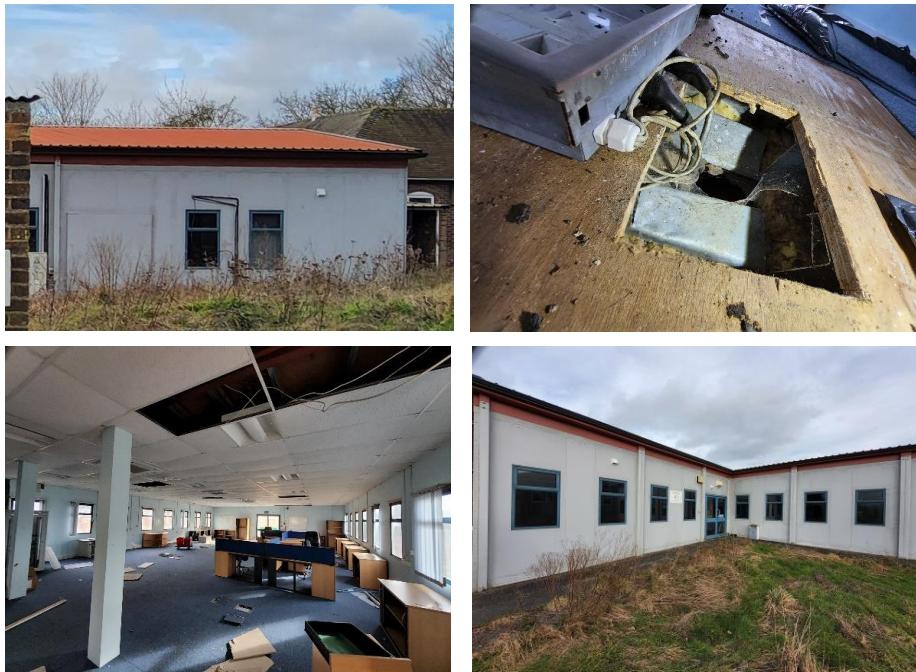
The building comprises one storey, with steel skin external walls with insulation cores, a reinforced concrete ground floor slab, steel columns, a steel floor and roof structure, and a steel sheet roof.

The structure of the building was not surveyed in detail; however, the assessors did not observe any major structural defects during the site visit (though note that structural elements were often concealed by floor coverings and suspended ceilings). Overall, the condition of the external walls and concrete floors and roof is assumed to be sufficient to allow continued use where no major changes are made to the building's physical architecture.

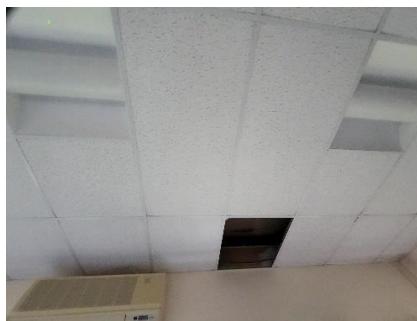
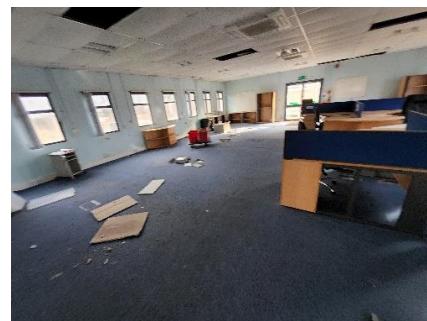
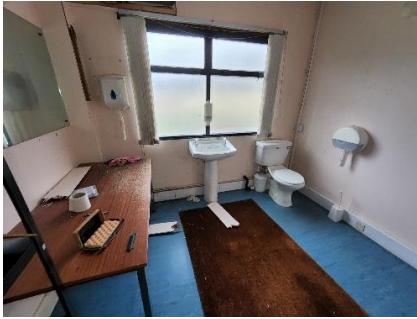
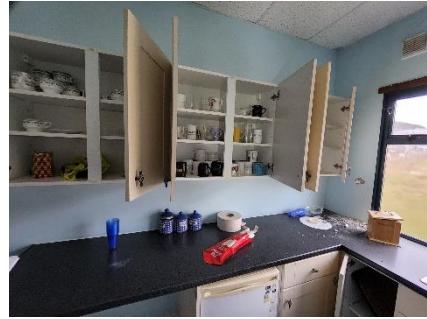
Finishes include suspended ceilings with mineral fibre ceiling tiles (fair to good condition), carpet tiles (fair to good condition), vinyl flooring (fair condition), kitchen cabinets and worktop (good

condition), and other miscellaneous items. If retained, it is likely that a full internal refurbishment would be required to achieve levels of interior design quality and occupant comfort that are adequate for future use.

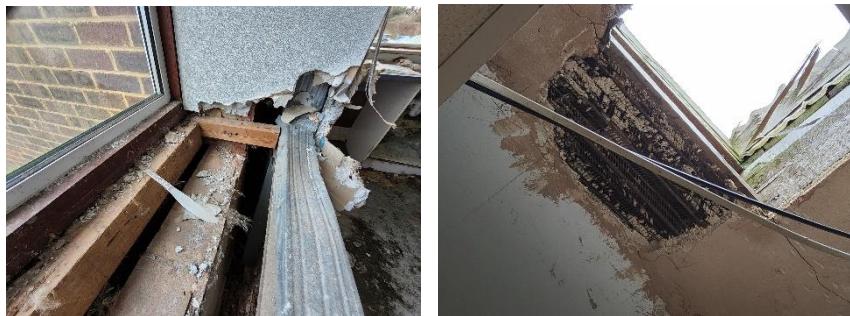
The building comprises one storey, with cavity brick and block external walls, a reinforced concrete ground floor slab, timber roof structure, and slate roof tiles. There is also a flat roof section with asphalt roofing.

The structure of the building was not surveyed in detail; however, the assessors did not observe any major structural defects during the site visit (though note that structural elements were often concealed by floor coverings and suspended ceilings). Overall, the condition of the external walls and concrete floors and roof is assumed to be sufficient to allow continued use where no major changes are made to the building's physical architecture.

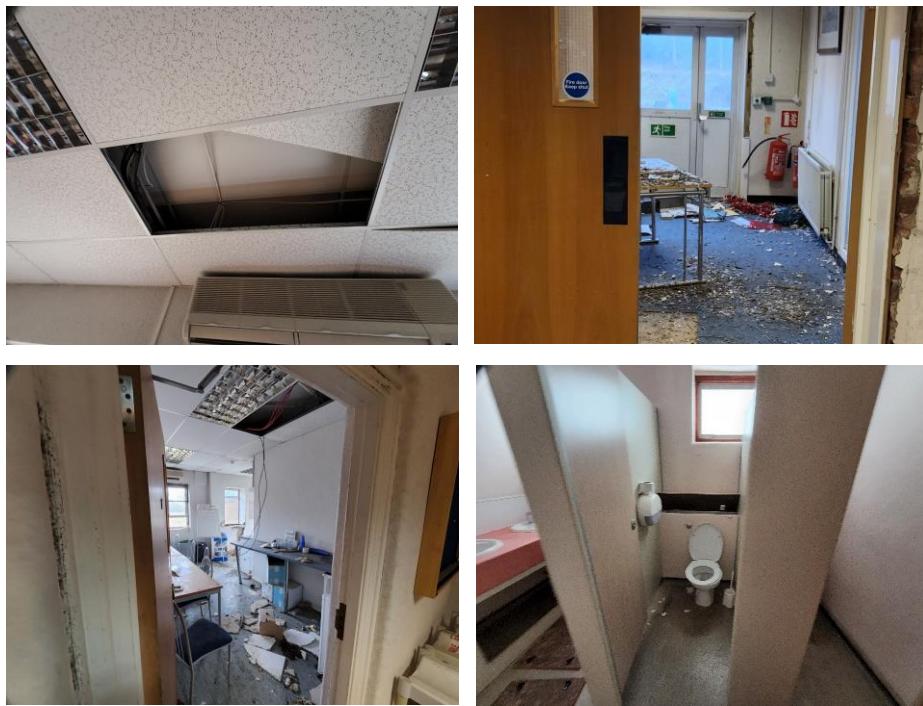
Finishes include suspended ceilings with mineral fibre ceiling tiles (fair condition), carpet tiles (poor condition), vinyl flooring (poor to fair condition), and other miscellaneous items. If retained, it is likely that a full internal refurbishment would be required to achieve levels of interior design quality and occupant comfort that are adequate for future use.

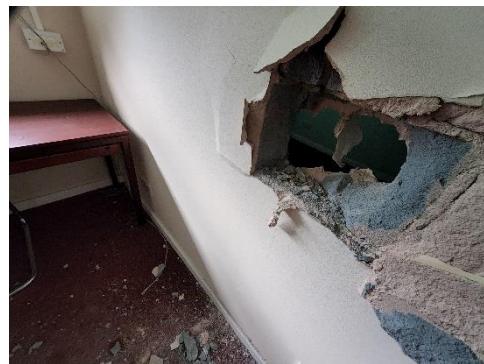
Finishes include suspended ceilings with mineral fibre ceiling tiles (poor to fair condition), carpet tiles (fair condition), vinyl flooring (poor to fair condition), kitchen cabinets (fair to good condition), and other miscellaneous items. If retained, it is likely that a partial internal refurbishment would be required to achieve levels of interior design quality and occupant comfort that are adequate for future use.

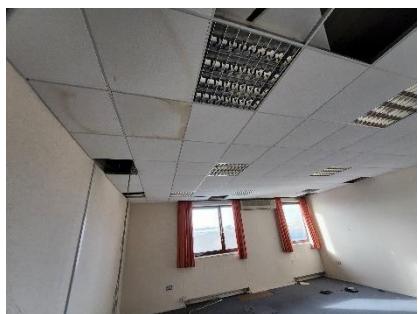
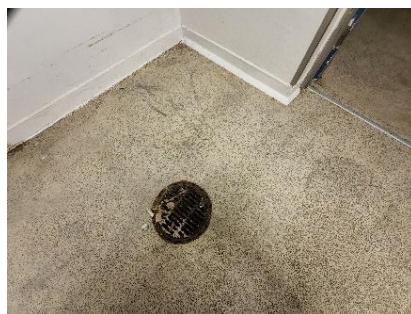
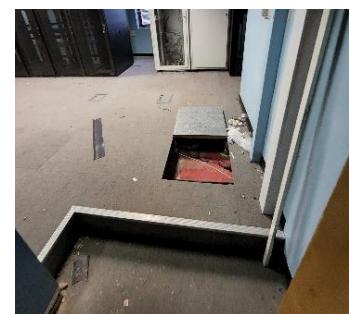
Finishes include suspended ceilings with mineral fibre ceiling tiles (fair to good condition), carpet tiles (poor to fair condition), vinyl flooring (poor condition), raised access flooring (fair condition), and other miscellaneous items. If retained, it is likely that a full internal refurbishment would be required to achieve levels of interior design quality and occupant comfort that are adequate for future use.

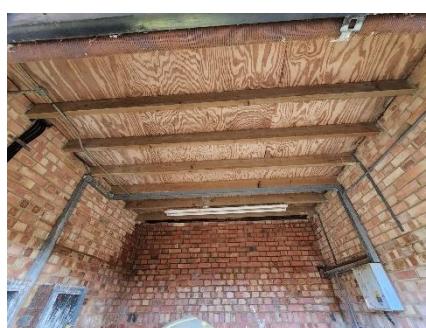
The refrigerated unit is assumed to be constructed of a steel structure with Polyurethane insulated panels.

The structure of the building was not surveyed in detail; however, the assessors did not observe any major structural defects during the site visit. Overall, the condition of the external walls, concrete floors, and roof structure is assumed to be sufficient to allow continued use where no major changes are made to the building's physical architecture.

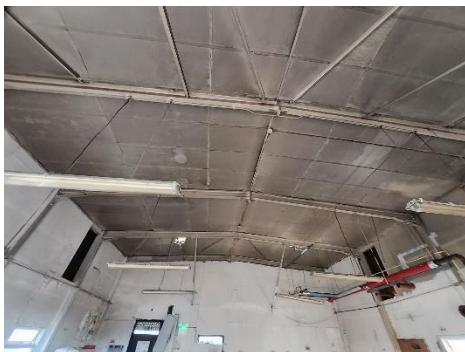
The building comprises one storey, concrete external walls, a steel portal frame structure, steel sheet walls and roof, and asbestos insulating boards internally.

The structure of the building was not surveyed in detail; however, the assessors did not observe any major structural defects during the site visit (though note that some structural elements were concealed by the internal ceiling and wall coverings). Overall, the condition of the external walls and concrete floors and the steel portal frame is assumed to be sufficient to allow continued use where no major changes are made to the building's physical architecture.

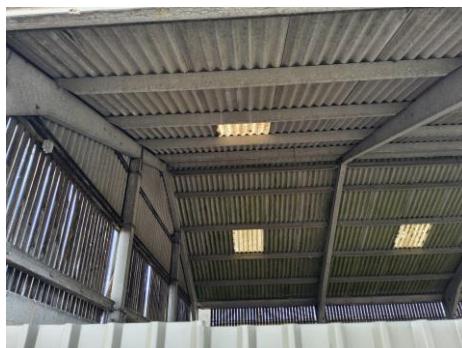
The building comprises one storey, with concrete block external walls, a reinforced concrete structure, steel sheets, timber structure mezzanine floors, and asbestos cement sheet (upper) walls and roof covering.

The structure of the building was not surveyed in detail; however, the assessors did not observe any major structural defects during the site visit. Overall, the condition of the external walls and concrete floors and roof is assumed to be sufficient to allow continued use where no major changes are made to the building's physical architecture.

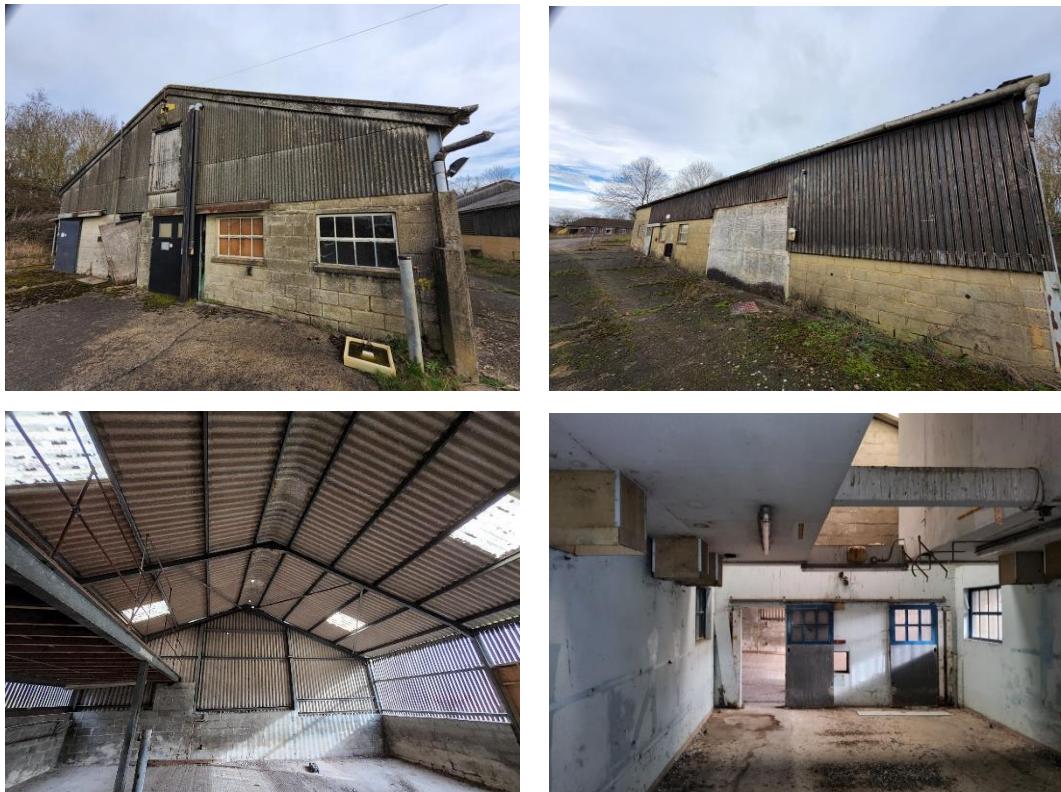
Building near 34 is a barn/ cattle building and includes multiples rooms as well as a mezzanine floor.

<b>Building near 34</b>	Utilisation potential is limited. Do not retain – demolish/deconstruct and recover key materials as recommended in pre-demolition audit report.
<b>Building near 31</b>	Utilisation potential is limited. Do not retain – demolish/deconstruct and recover key materials as recommended in pre-demolition audit report.
<b>Building 43</b>	Consider for retention and refurbishment, with some adaptation and repurposing.
<b>Externals</b>	Do not retain – demolish/deconstruct and recover key materials as recommended in pre-demolition audit report.

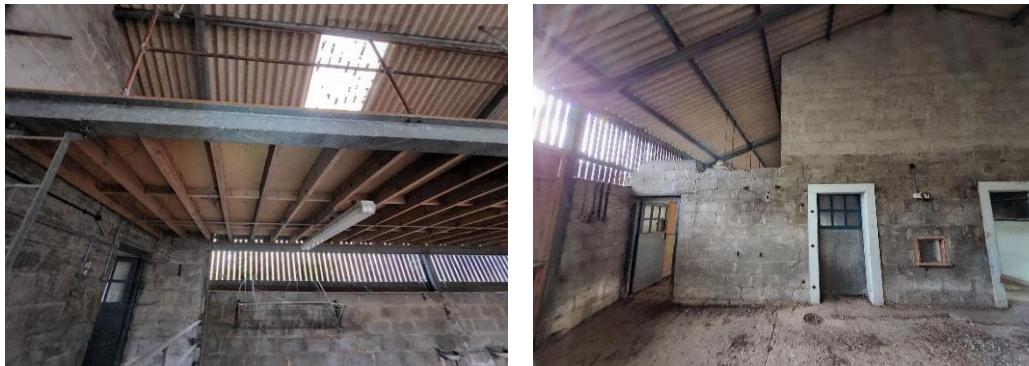
The building comprises one storey, with concrete block external walls, a steel portal frame structure, asbestos cement sheet upper walls and roof covering, and a timber structure mezzanine.

The structure of the building was not surveyed in detail; however, the assessors did not observe any major structural defects during the site visit (though note that some structural elements were concealed by wall coverings and suspended ceilings). Overall, the condition of the external walls, concrete floors and steel portal frame structure is assumed to be sufficient to allow continued use where no major changes are made to the building's physical architecture.

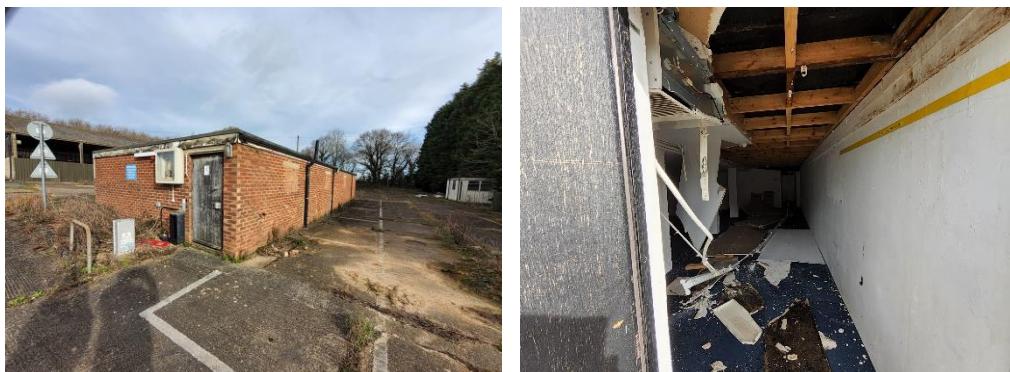
Building near 31 includes an open plan storage room, the assessors were unable to enter this building due to asbestos concerns.

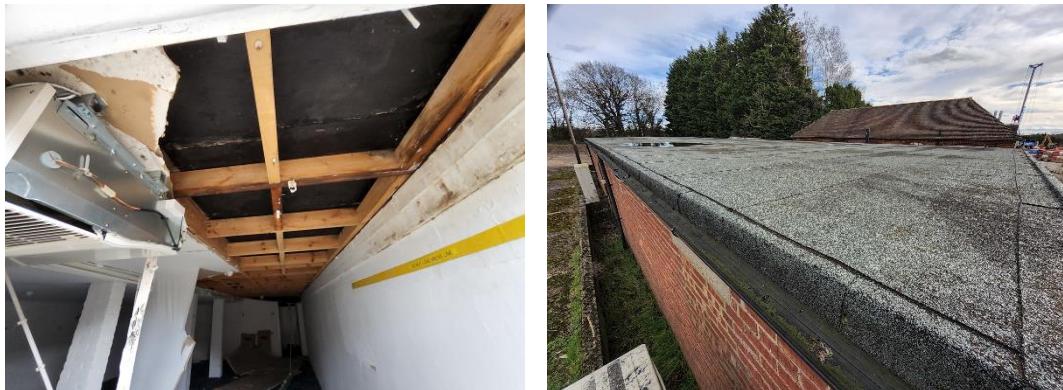
The building comprises one storey, with cavity brick and block external walls, a timber roof structure with asbestos board and asphalt roofing covering. There are also internal brick columns.

The structure of the building was not surveyed in detail; however, the assessors did not observe any major structural defects during the site visit. Overall, the condition of the external walls, concrete floors, and timber roof structure is assumed to be sufficient to allow continued use where no major changes are made to the building's physical architecture. It should be noted that the asbestos concerns should be addressed.

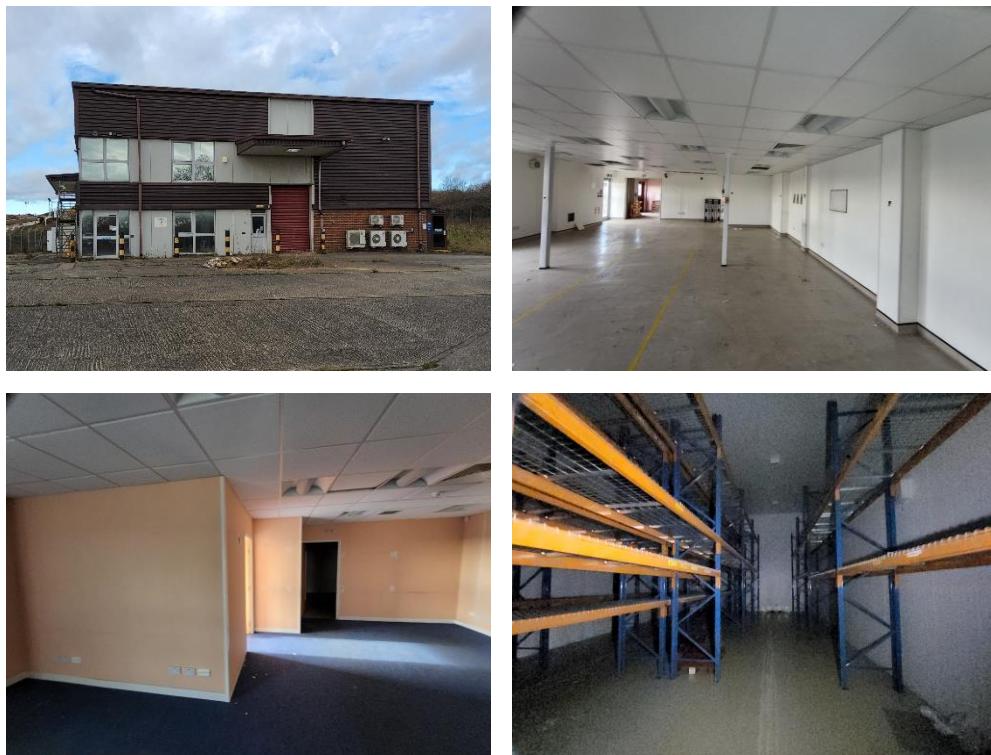
Building 43 includes ground floor storage areas, first floor office areas, a kitchen and bathroom facilities.

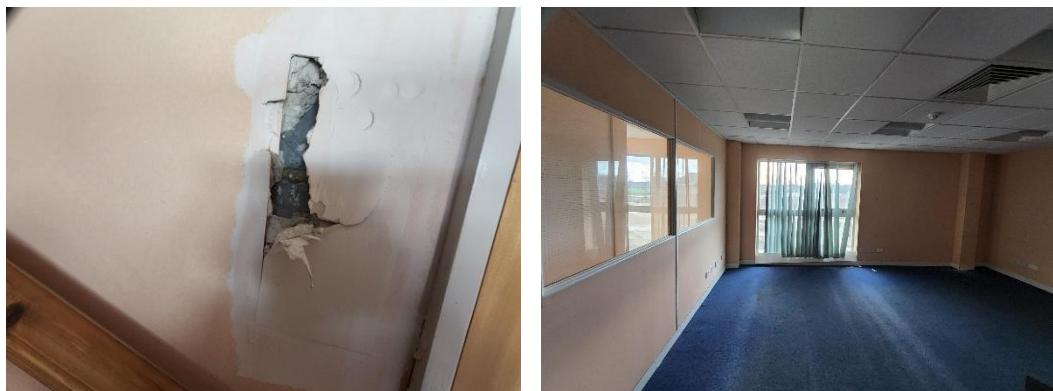
There are some metal stud and concrete block internal walls, these are not loadbearing so the internal layout could be partially adapted for alternative uses. If the building is retained for use as an industrial unit/ office, these internal walls may technically be mostly retained based on their condition (note that some walls are in poor condition).

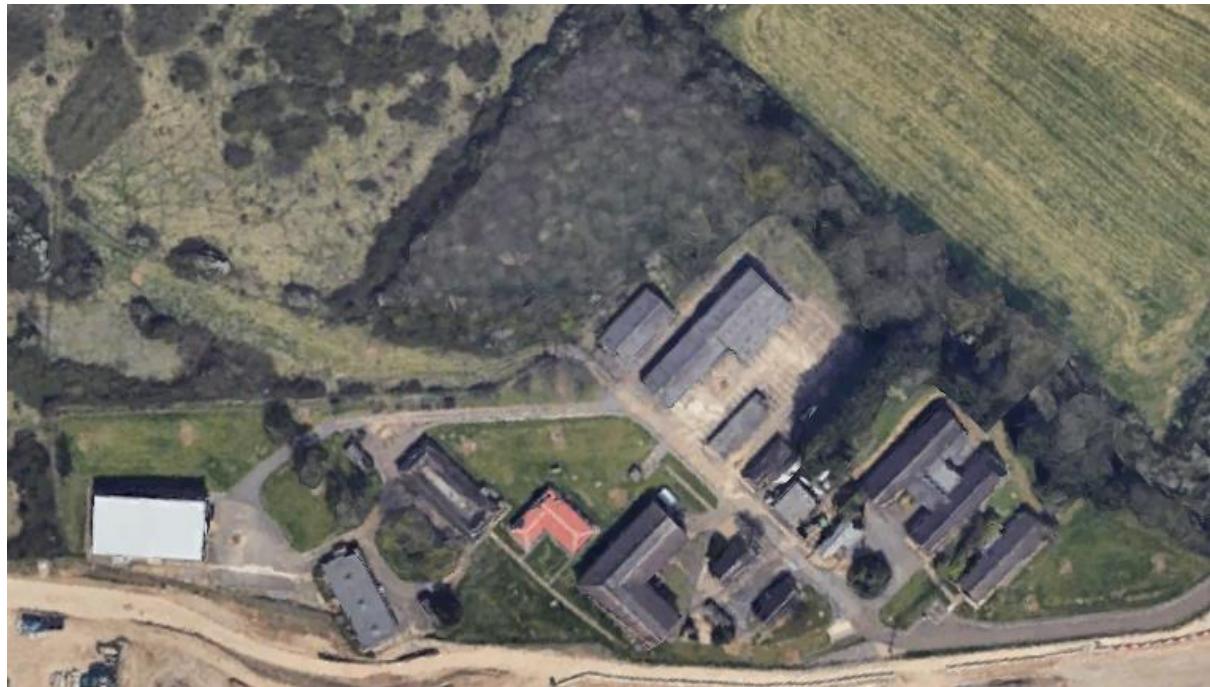
The are areas of external hardstanding as well as the road that connects the buildings on site. The hardstanding appears to have been intended for use as car parking. It appears to be in poor condition but may be suitable for use as car parking or other functions of hardstanding.

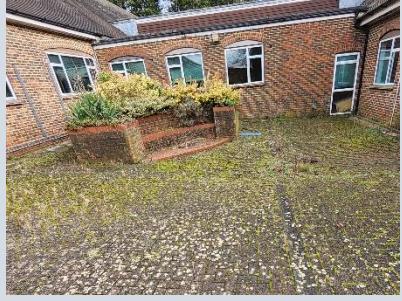
<b>Block paving outside building 23</b>	No function at present (remnant from previous buildings or functions).	Poor (cleaning and minor maintenance required)

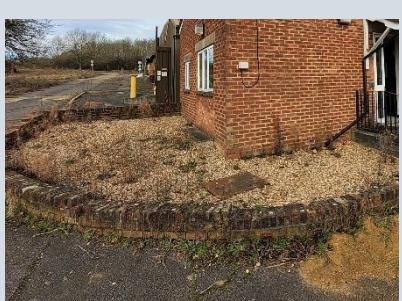
<b>Brick structure with fuel oil tank</b>	No function at present (remnant from previous buildings or functions).	Fair (fuel oil tank condition unknown)

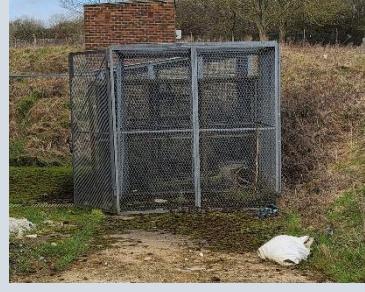
<b>Metal structure</b>	No function at present (remnant from previous buildings or functions).	Fair

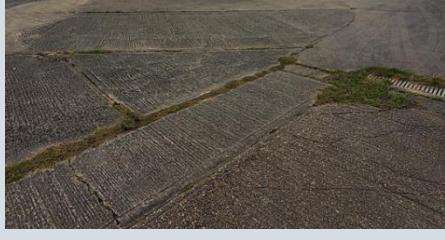
<b>External hardstanding</b>	No function at present (remnant from previous buildings or functions).	Poor

Overall, whilst many of the existing external site features may be technically suitable for future use based on their condition, they provide little function other than ancillary storage and car parking. The most useful external feature is the road on the site which is likely to be suitable for retention.
