24_PEA_BNG_11_33

Hillingdon Court Park Pavilion Parkway, Uxbridge, UB10 9JX

Project Number:	24_PEA_BNG_11_33
Report Type:	Preliminary Ecological Appraisal Report (PEAR)
Site Address:	Hillingdon Court Park Pavilion Parkway, Uxbridge, UB10 9JX

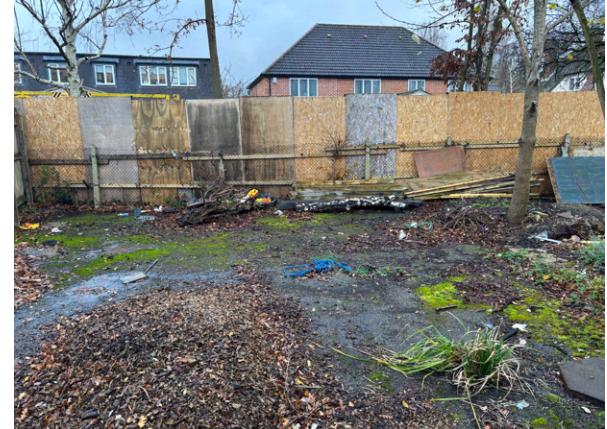
Image 1

Habitats and Target Notes	Description	Supporting Photo
u1b5: Developed land - sealed surface	<p>u1b5: Developed land – sealed surface. The habitat comprises B1, areas of hardstanding, including tarmac and concrete paving blocks, associated with the existing pavilion building (B1). Vegetation cover is minimal, with occasional colonisation by pioneer species such as dandelion (<i>Taraxacum officinale</i>), common nettle (<i>Urtica dioica</i>), and ribwort plantain (<i>Plantago lanceolata</i>) in cracks and edges of the sealed surfaces. These features are typical of low-disturbance sealed surfaces that offer negligible ecological value beyond supporting invertebrates tolerant of urbanised conditions. The physical condition of this habitat is poor and does not provide significant connectivity or resources for higher ecological functionality.</p>

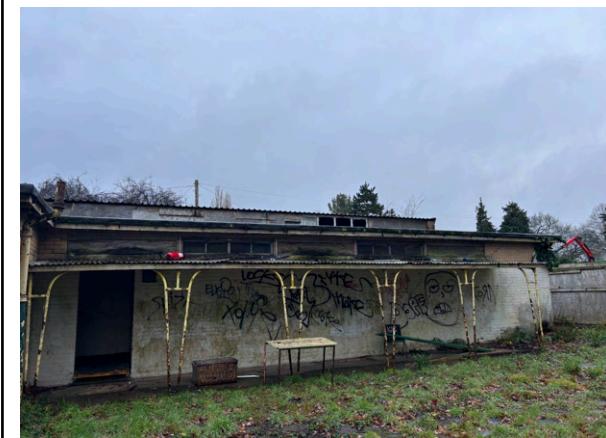
Image 2 (B1)

The northern elevation of B1 consists of brickwork significantly weathered by age and exposure, with patches of moss and lichen growth indicating a lack of maintenance. Windows and doors on this elevation are either broken or missing, potentially allowing access for wildlife such as birds or bats. While no direct evidence of roosting was observed within the photos, structural features could provide opportunities for crevice-dwelling species.

The eastern elevation features more extensive degradation, including sections of crumbling brickwork and vegetation growing adjacent to the wall, such as nettles and brambles. These plants may provide some limited habitat for invertebrates but are not indicative of high ecological value. The gaps and cracks noted in this elevation could also present potential roosting or sheltering opportunities for bats or small mammals.

The southern elevation of B1 displays extensive wear, with corrugated metal roofing sheets overhanging sections of brickwork. This elevation is partially shaded by nearby vegetation, which may encourage moisture retention and the growth of mosses. While the roof structure does not appear to offer significant potential for bat use due to its degraded state, the sheltered and shaded environment may attract opportunistic species, such as nesting birds.

The western elevation is characterized by large stretches of intact but aging brickwork. This side of the building appears relatively stable compared to other elevations. However, the overall disrepair of the structure, including potential access points such as broken windows and missing fittings, contributes to the potential for opportunistic colonization by birds or bats. The surrounding modified grassland offers minimal transition habitat but may indirectly support species visiting the structure.

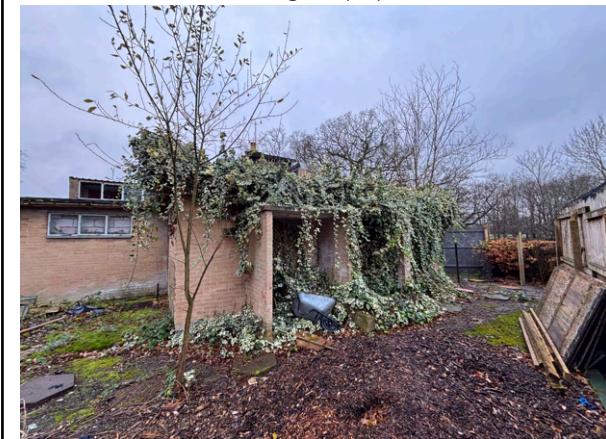
Image 3 (B1)

The flat felt roof, combined with sections of corrugated iron, is largely degraded, with patches of damage visible in multiple areas. These features limit suitability for sustained use by wildlife; however, small crevices in the felt or gaps in the corrugation may still allow access or temporary use by invertebrates or opportunistic bat species. The absence of roof insulation further reduces its ecological value.

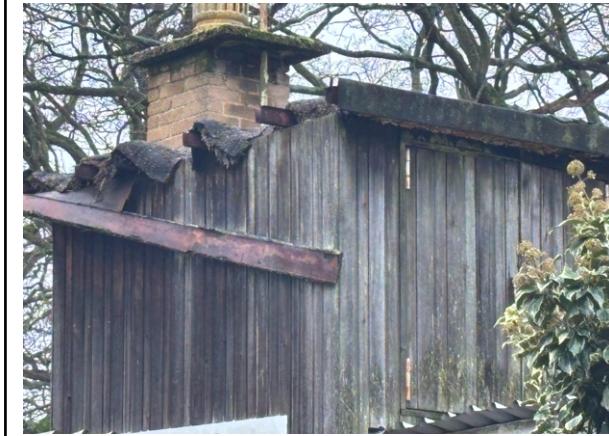
Image 4 (PRF's)

Comments and justifications: The derelict structure of B1 exhibits some potential roosting features, such as cracks in the brickwork and damaged roofing, but these are limited in extent and quality. No evidence of bat activity was observed during the survey. The surrounding habitat is urbanized and fragmented, reducing suitability.

- 8.15 A new bat roost should be created on-site to offset the loss of PRFs. It is recommended that the roost be suitable for crevice dwelling species which are most likely to utilise the existing structures. Where possible, bat roosts should be incorporated into the proposed built footprint to ensure that permanent features are created.

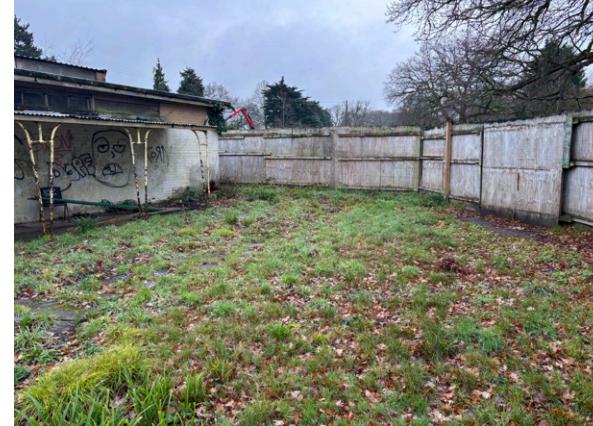
Image 9

Image 8 (B1 internal)
g4: Modified grassland	<p>g4: Modified grassland. The habitat comprises a moderately-sized area of modified grassland with sward heights varying between 5 cm and 20 cm. Species composition includes perennial ryegrass (<i>Lolium perenne</i>), reed grass (<i>Calamagrostis</i> species), common nettle (<i>Urtica dioica</i>), bramble (<i>Rubus fruticosus</i> agg.), and nipplewort (<i>Lapsana communis</i>). Drooping sedge (<i>Carex pendula</i>) is also present in localized patches. The vegetation structure is indicative of degraded grassland with reduced species diversity and a dominance of competitive species, particularly in disturbed areas. The condition is poor, with limited potential for supporting higher-value flora or fauna. Connectivity to other habitats is minimal, and ongoing management would be required to prevent further decline or encroachment of invasive species. The habitat was assessed as being in poor condition.</p>

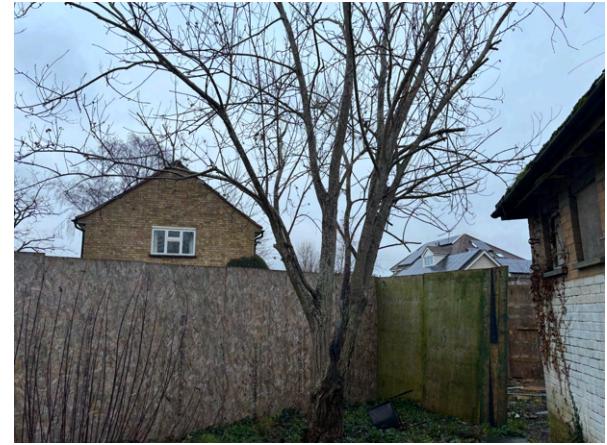
Image 13 - T1

Image 12
u1a3: Urban Tree	<p>u1a3: Urban Tree. The habitat includes four individual urban trees of varying condition and maturity.</p> <p>Tree 1: Ash (<i>Fraxinus excelsior</i>), approximately 12 metres in height with a split trunk and a diameter at breast height (DBH) of 1.68 metres. The tree is in poor condition, with visible signs of structural instability and reduced canopy density.</p> <p>Tree 2: Ash (<i>Fraxinus excelsior</i>), approximately 9 metres in height with a DBH of 0.69 metres. This tree is also in poor condition, exhibiting similar canopy thinning and limited structural integrity.</p> <p>Tree 3: Cabbage tree (<i>Cordyline australis</i>), approximately 4 metres in height with a DBH of 0.72 metres. The tree is in moderate condition and displays a dense canopy, typical of its species in an urban setting.</p>

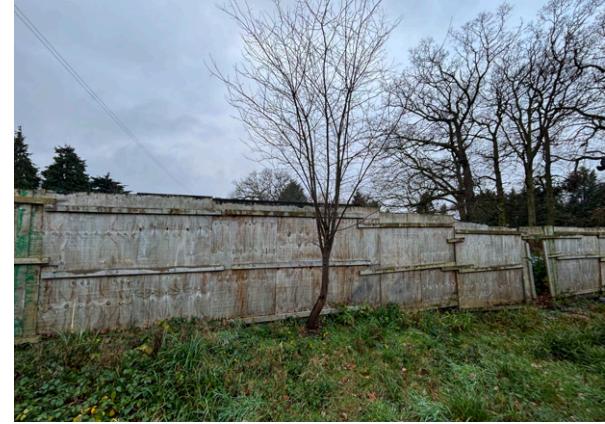
Tree 4: Cherry Plum (*Prunus cerasifera*), approximately 5 metres in height with a DBH of 0.29 metres. This tree is in **poor condition** with evidence of reduced vigour and limited canopy growth.

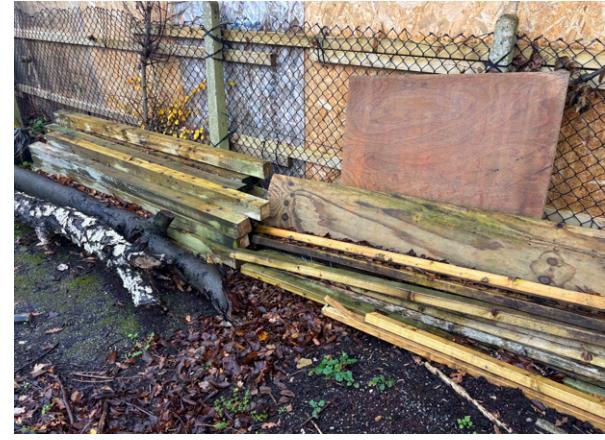
Image 17 - TN1

Image 16 - T4
Target Notes	<p>TN1: A pile of wood and building materials located in the eastern corner of the site. This feature may offer potential refuge for small mammals and invertebrates. The pile could also provide overwintering opportunities for hedgehogs (<i>Erinaceus europaeus</i>), a Priority Species under the UK Biodiversity Action Plan. However, its isolated nature and proximity to disturbed habitats likely limit its overall ecological significance. Regular disturbance or removal of the material would reduce its value as a semi-natural refuge.</p>

- 8.11 Any necessary excavation of animal burrows should be done carefully to avoid unnecessary suffering (such as crushing or asphyxiation).
- 8.12 During hibernation season (October to March), piles of leaf litter and logs should be retained to ensure hibernating hedgehogs are not harmed. If removal is unavoidable, the piles must be carefully checked before burning.

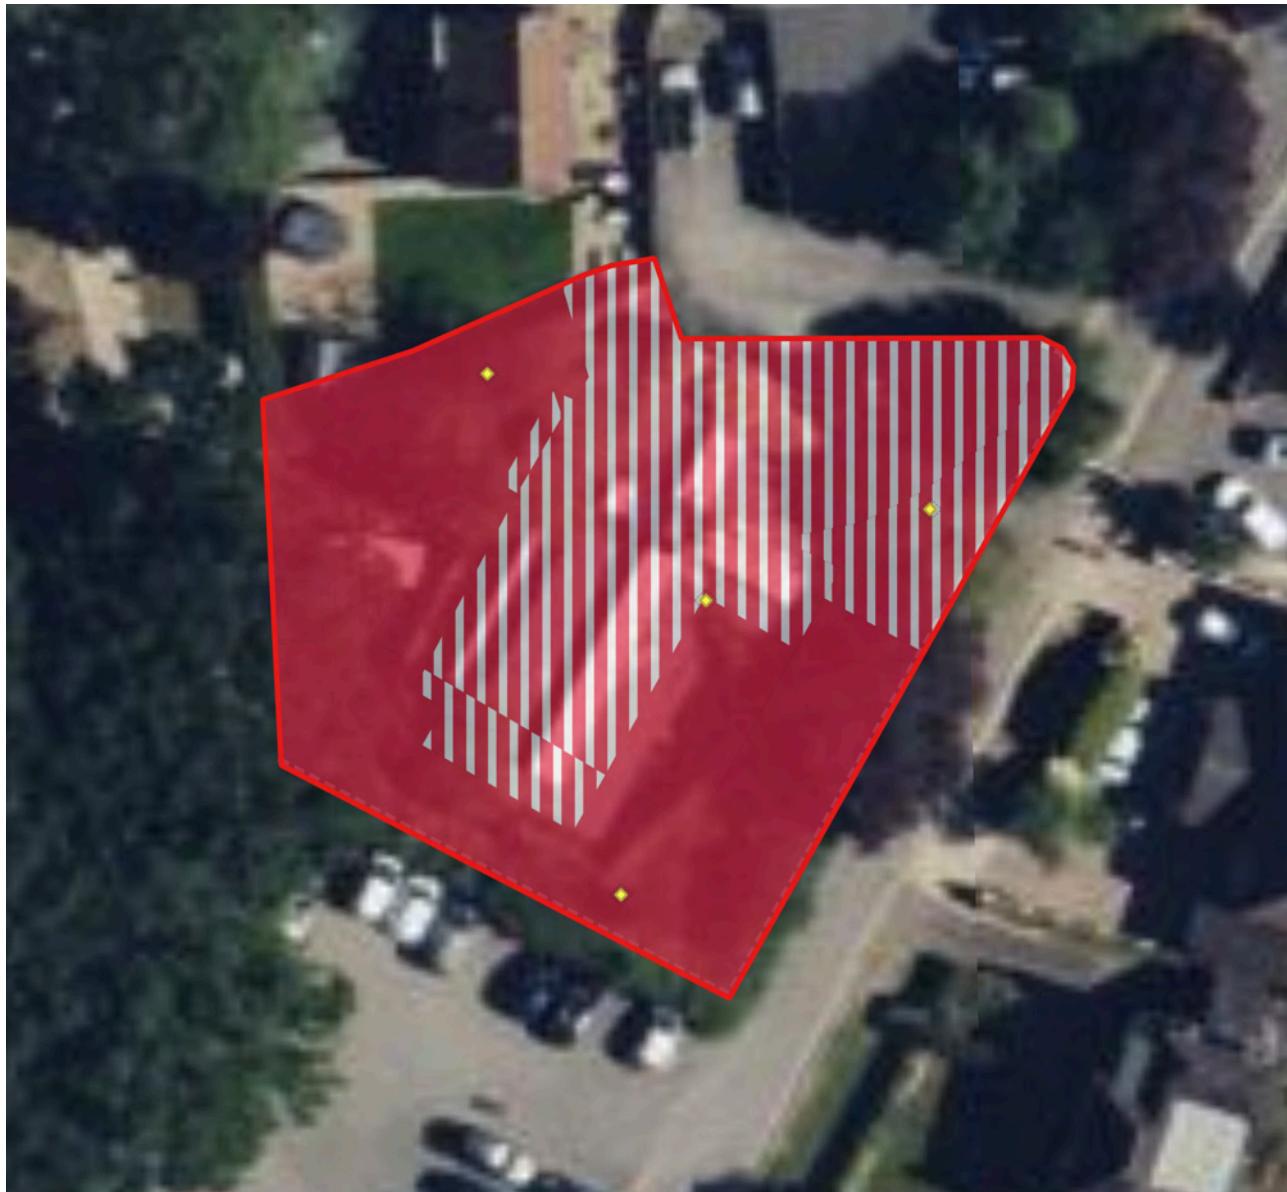
A3.1 The Site Habitat Map was produced in accordance with the UK Habitat Classification Manual (Butcher et al., 2020).
