Nestles Avenue

Geotechnical Design Report

Project No: P450512

P450512-REP-003

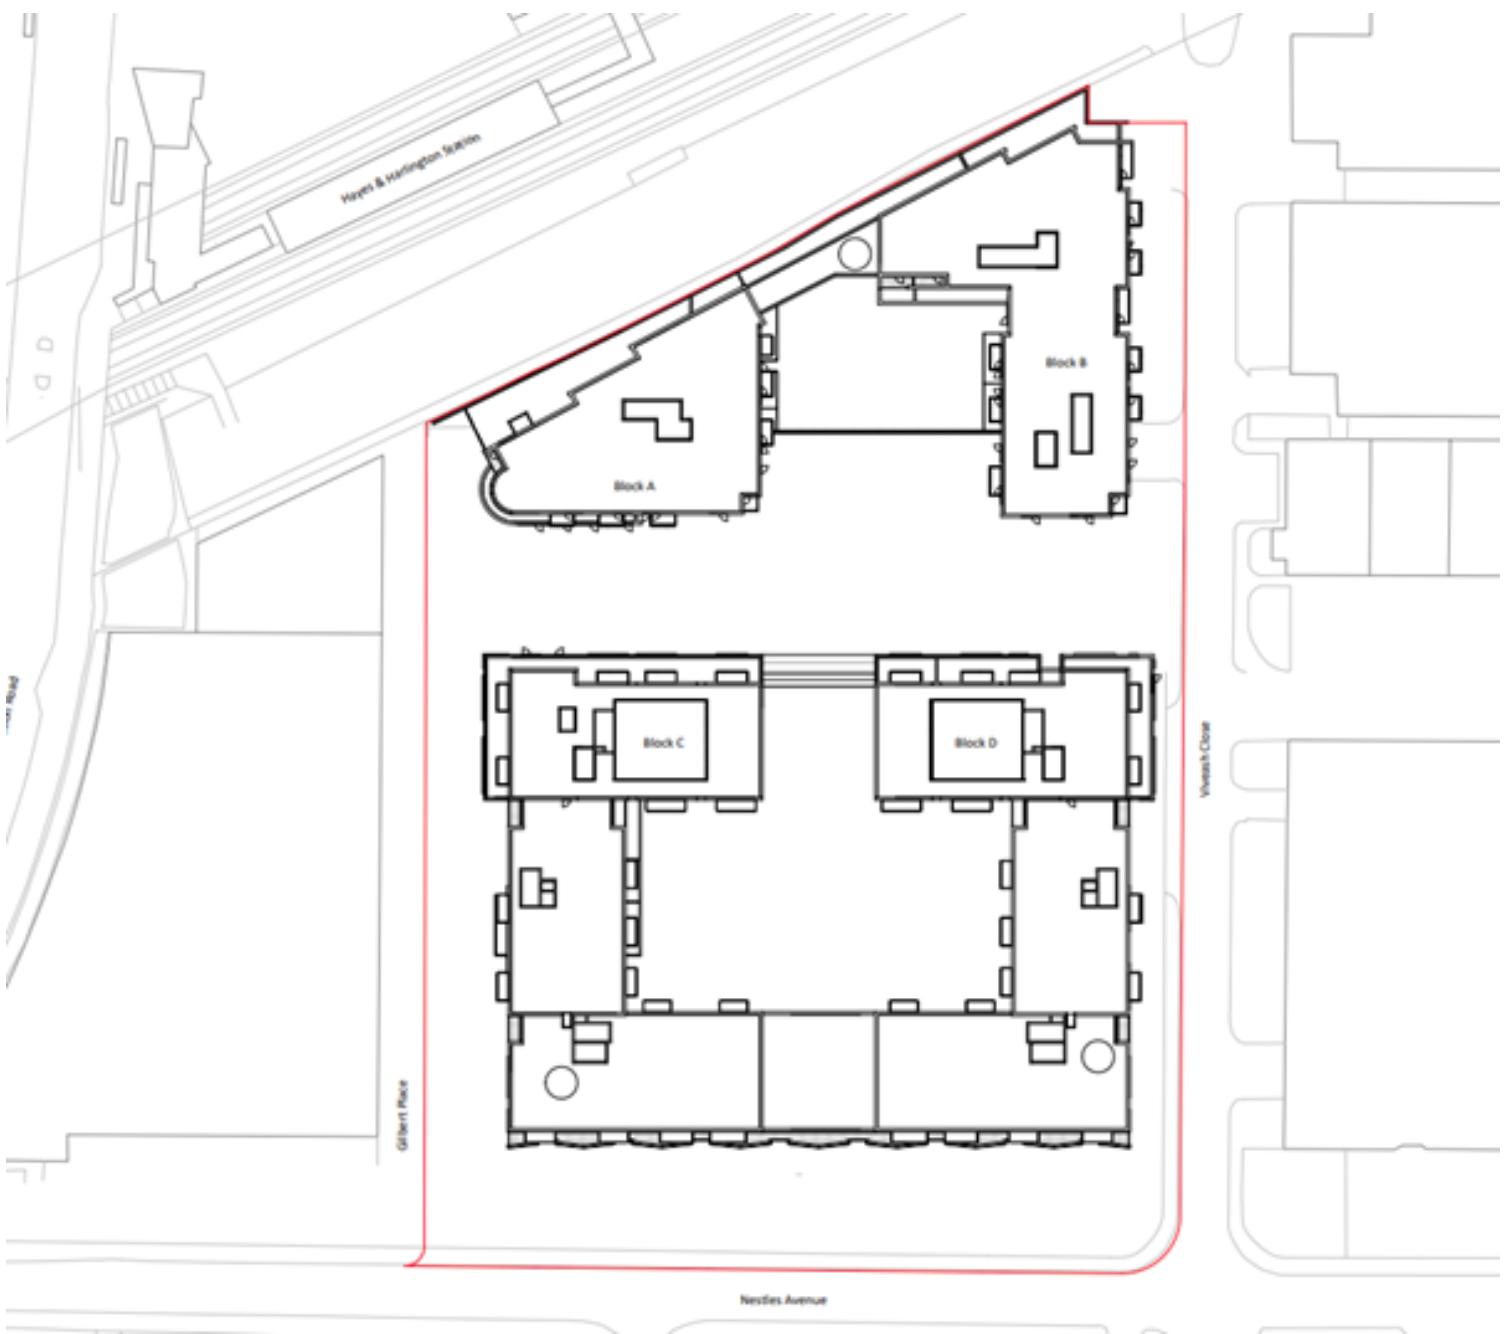
Figure 2-4 Proposed plan layout

The architectural drawing scheme is presented in Figures 2-4, 2-5, and 2-6.

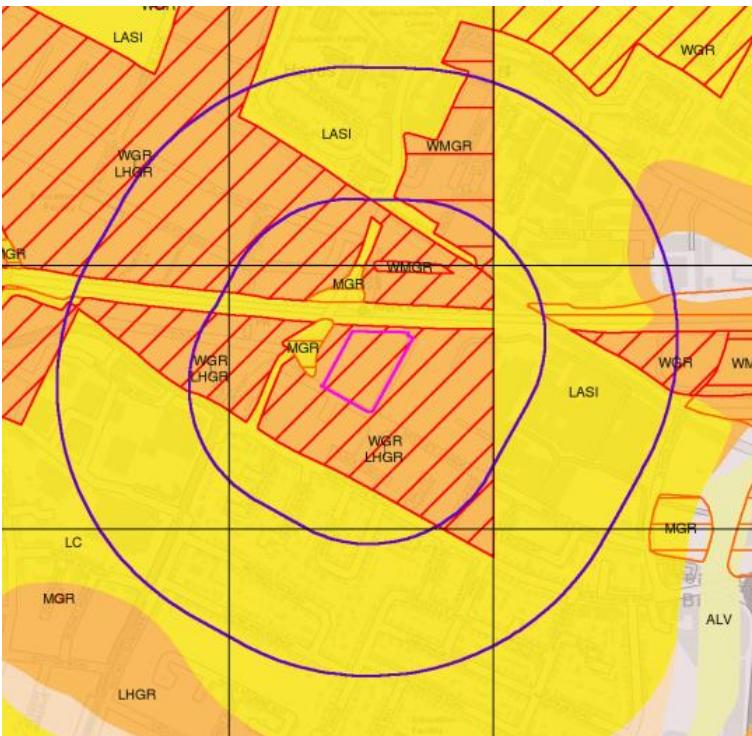
Figure 3-1 1:10,000 Geological map

Figure 3-1 shows the location of the development within the context of a regional geological map. The geological map indicates the site to be underlain by worked Made Ground, although the source of this is not clear from historic map and may be associated with the former brickfields to the north of the site, prior to 1914, or the National Filling Factory munitions factory which occupied the site during the First World War. The areas of worked Made Ground tie in with the gaps in the Langley Silt, therefore it is possible that the superficial deposits have been removed.

Based on the geological map, the site is anticipated to comprise Made Ground, underlain by the Lynch Hill Gravel Member which is further underlain by the London Clay Formation, Lambeth Group, Thanet Sands and Chalk.

Approximate site location shown in magenta

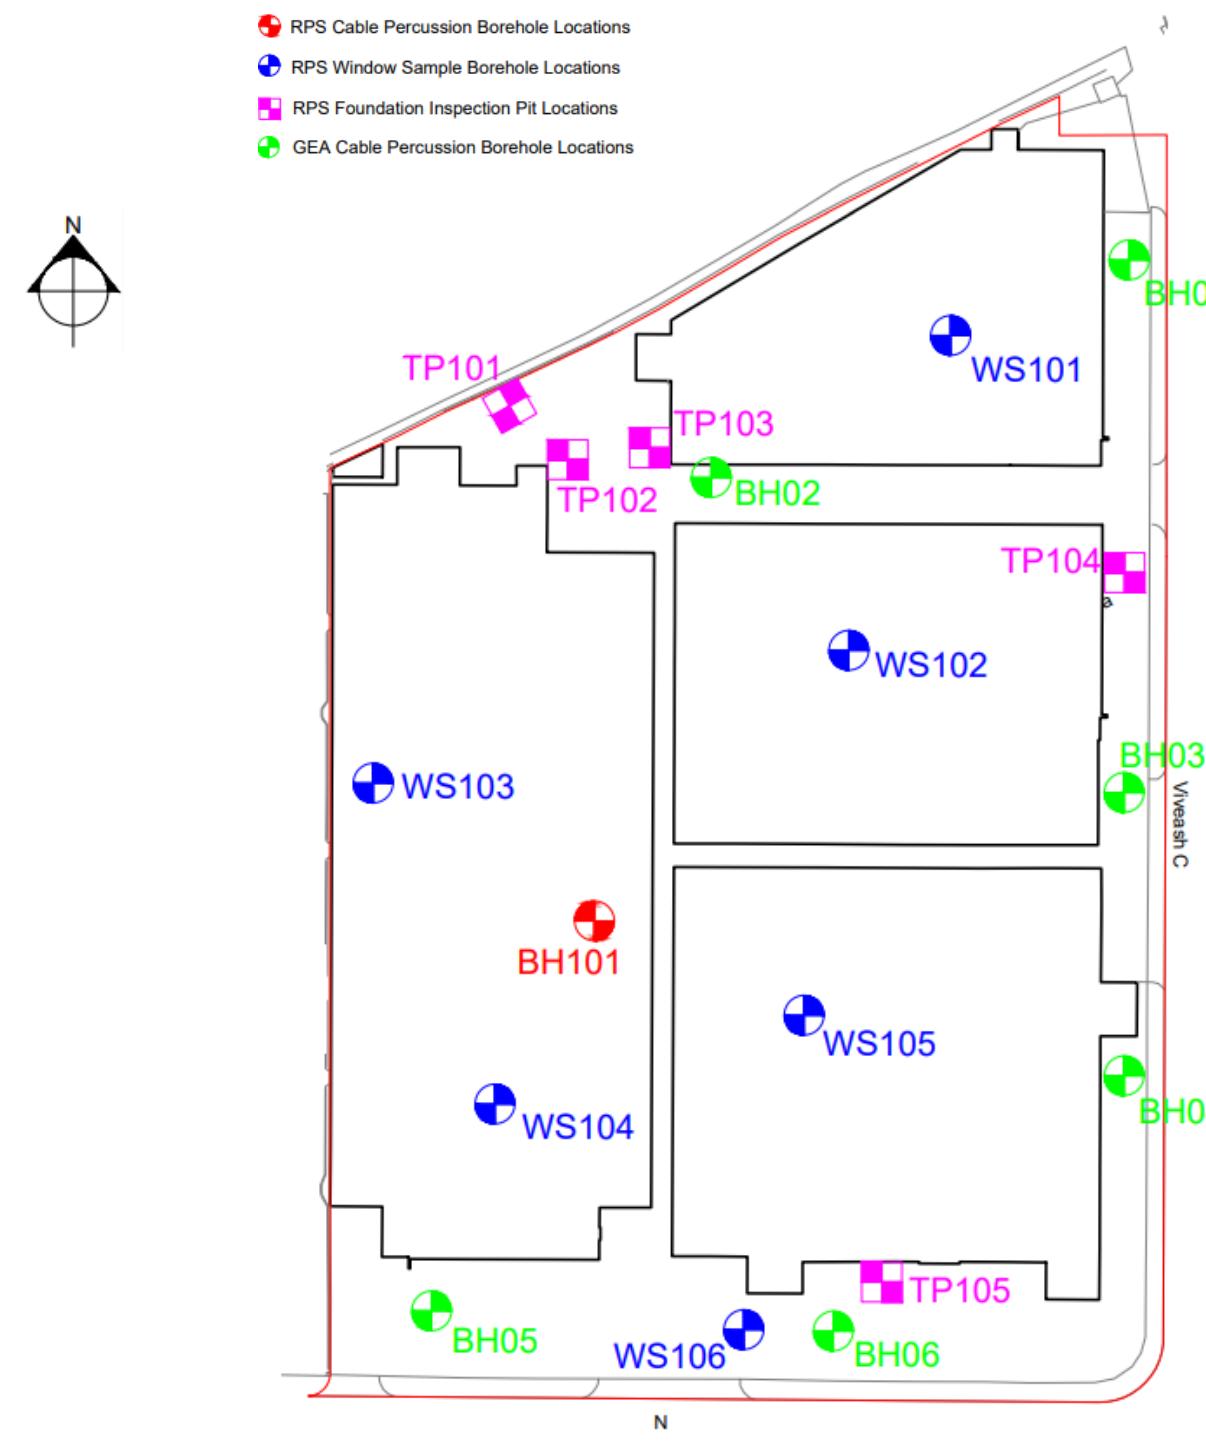
4.3. Figure 4-2 RPS Exploratory hole location planMonitoring Well Installations

- 1 cable percussive boreholes to a depth of 30.00 metres below ground level (m bgl) (BH101).
- 5 window samples boreholes to depths of between 1.00 m and 1.50 m bgl (WS102 to WS106).
- Installation of a gas and groundwater monitoring well standpipe within the cable percussive borehole.
- Installation of gas and groundwater monitoring well standpipes to various depths within three of the window sample boreholes.
- Excavation of 5 hand dug foundation inspection pits to a maximum depth of 1.20 m bgl.
- On site screening analysis of soil samples for ionisable Volatile Organic Compounds (iVOCs) using a Photo-ionisation Detector (PID).
- Sampling and testing testing of selected soil and groundwater samples for contamination and geotechnical purposes.
- 6no. groundwater and ground gas monitoring readings from monitoring wells.

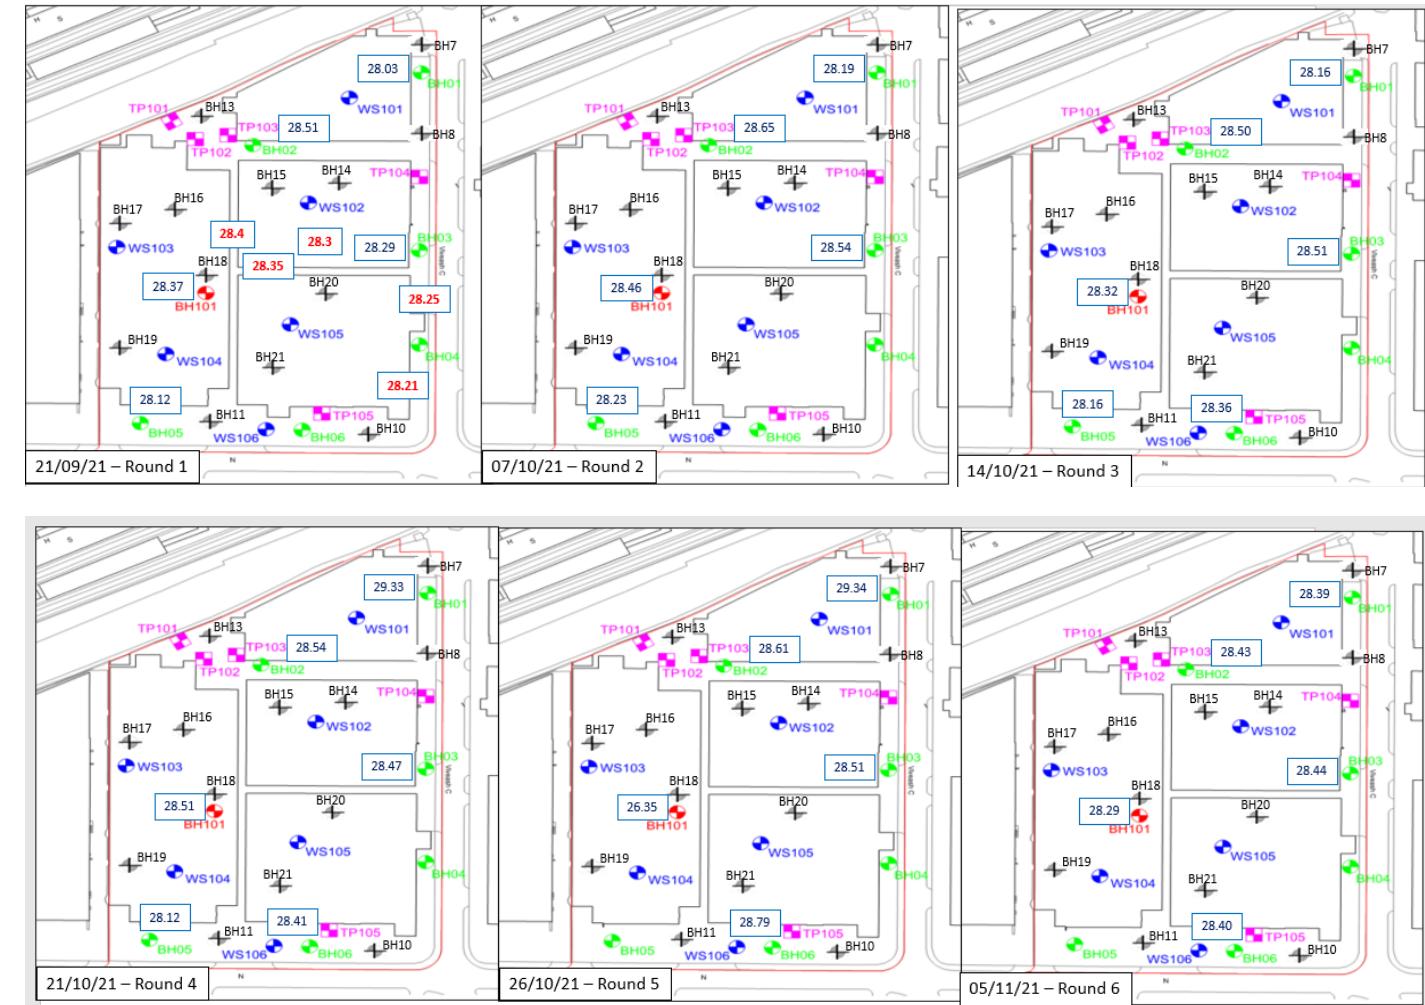
Figure 5-5 Groundwater Elevations Data

The groundwater dip data is diagrammatically presented in Figure 5-5 as elevations in m aOD.

The calculated groundwater elevations do not indicate a consistent groundwater flow direction across all monitoring rounds.

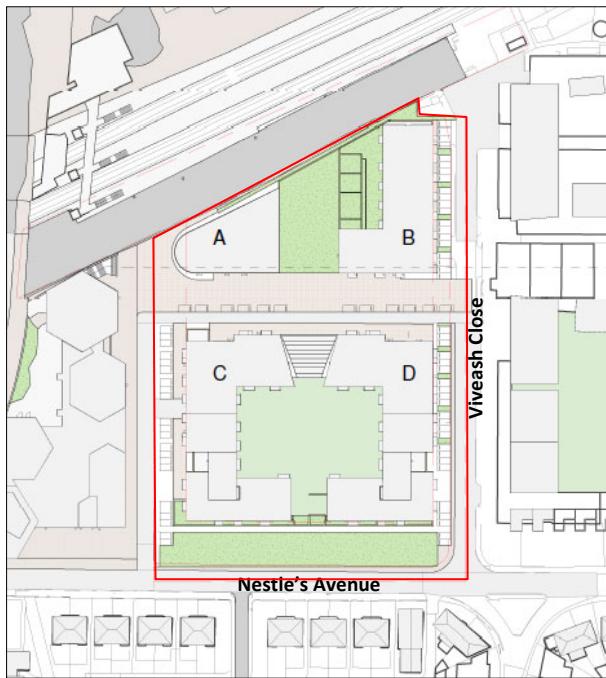
It is understood that it is proposed to demolish the existing buildings and subsequently construct four new apartment blocks, rising to between four storeys and eleven storeys, with commercial units at ground floor level. There are no basements included within the proposals. The buildings will be surrounded by areas of soft landscaping that will comprise managed communal space.

Proposed site plan (from drawing TFP-03-site arrangement-03-100, dated 18/01/16, provided by the consulting engineers)

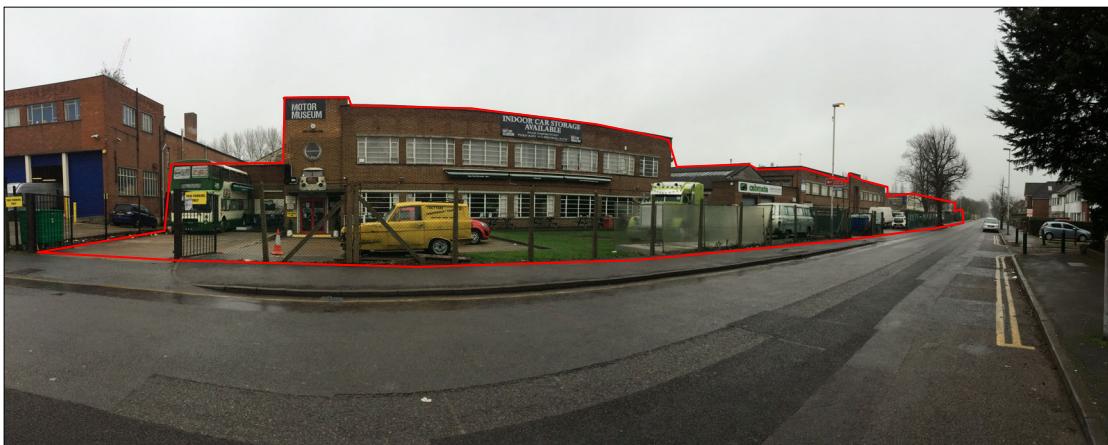
Panoramic view of the southern elevation of the site along Nestles Avenue, including the London Motor Museum occupying the western portion of the site. To the east of this is the extension to No 233 Claremont House and then the main building, which occupies the southern portion of the site. There is soft landscaping and hardstanding to the front of both buildings.

The museum is a two-storey flat roofed building fronting onto Nestles Avenue to the south, with single storey extensions to the east and west. It was empty at the time of the investigation with no visible signs of contamination being noted. A car park is located at the front of the building and is in relatively good condition, with minor cracks, scars and service covers in the concrete surfacing. The majority of the site is roughly level although Nestles Avenue to the south is at a slightly higher elevation than the buildings fronting the road, with the hardstanding in this portion of the site sloping down slightly towards the buildings. The car park to the north of the site is approximately 1 m higher than the site; a brick retaining wall supports the northern elevation of the site.

No 233 to 236 Claremont House is a two-storey flat roof brick building located to the east of the museum and occupies the southernmost portion of the site. A tall single storey extension with an industrial style roof adjoins the building to the east, which is separated from the museum by an alleyway. At the time of the investigation the buildings were being used as storage areas and no potential sources of contamination were identified.

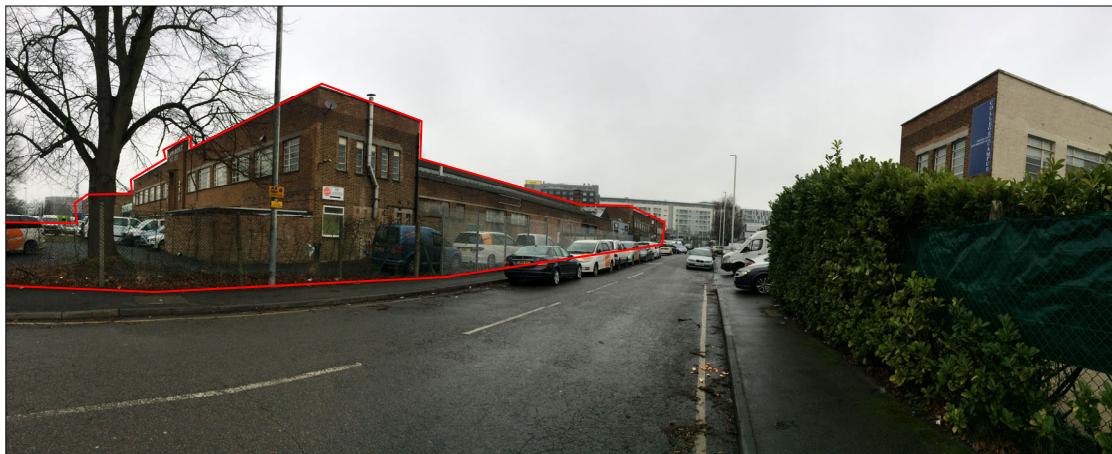
Panoramic view of the eastern elevation of the site along Viveash Close, including No 236 Claremont House on the corner.

Asbestos cement warning labels are present along the buildings in the alleyway between the two buildings fronting Viveash Close. It is likely that other asbestos containing materials are present throughout the structures and an asbestos survey will be required for the site.

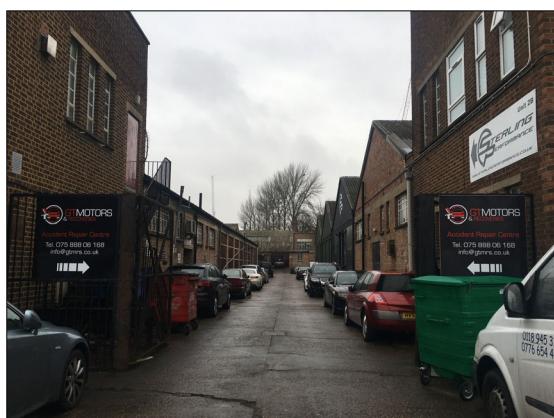
Looking roughly west at the alleyway between the two buildings fronting Viveash Close, which are occupied by numerous garage businesses and workshops

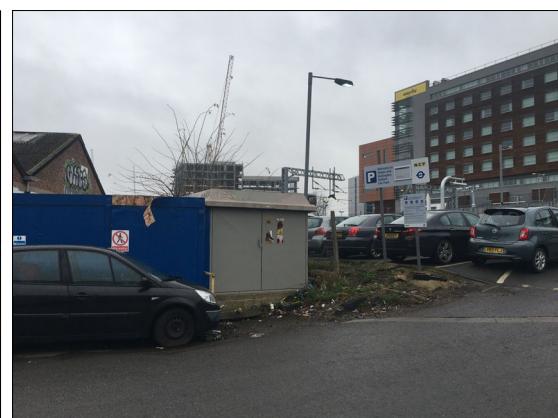
Looking roughly northwest at the electricity substation outside the northeastern corner of the site, beyond which is the car park bordering the site to the north

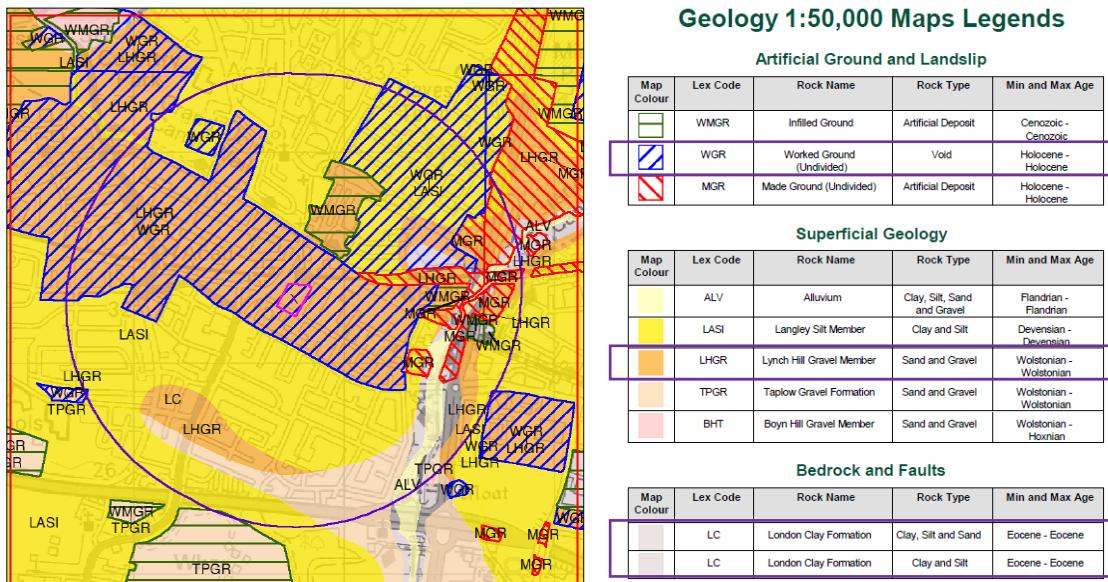
The British Geological Survey (BGS) map of the area (Sheet 269), as reproduced by Envirocheck and shown on the extract below, indicates the site to be underlain by the Lynch Hill Gravel Member over the London Clay Formation. The Lynch Hill Gravel typically comprises sand and gravel, locally with lenses of clay, silt or peat. The London Clay Formation typically comprises homogenous, slightly calcareous silty clay to very silty clay, with some beds of clayey silt grading to silty fine-grained sand.

The site is also within an area of worked ground. It is possible that the worked ground is associated with the brickfields that were present in the surrounding area until around 1914. It is however unclear as to why the site has been included as being underlain by worked ground, as the historic maps after 1864 do not indicate the site to have been occupied by any activity that would result in worked ground.
