16.5. Defending the UK From Aerial Attack

The following risk mitigation measures are recommended to support the proposed works at the 233-236 Nestles Avenue site.

Client: **GEA Ltd**Project: **233-236 Nestles Avenue**Ref: **DA8572-00**Source: Middx.net/articles/munitionsgallery

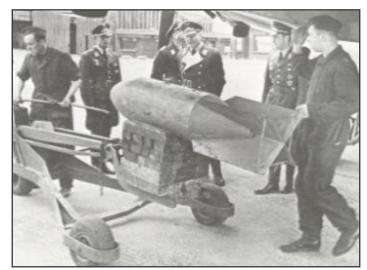
SC 250kg High Explosive Bomb

Bomb Weight	245-256kg (540-564lb)

Explosive Weight	125-130kg (276-287lb)		
Fuze Type	Electrical impact/mechanical time delay fuze.		
Bomb Dimensions	1640 x 512mm (64.57 x 20.16in)		
Body Diameter	368mm (14.5in)		
Use	Against railway installations, embankments, flyovers, underpasses, large buildings and below-ground installations.		
Remarks	It could be carried by almost all German bomber aircraft, and was used to notable effect by the Junkers Ju-87 Stuka (Sturzkampfflugzeug or dive-bomber).

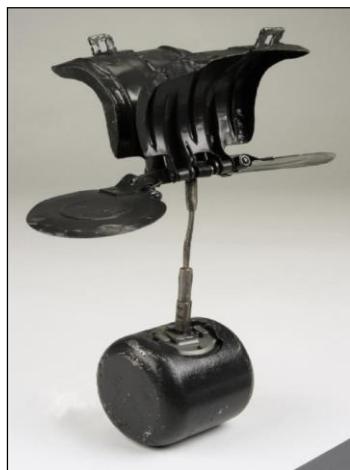
Bomb Weight	2kg (4.41lb)
Explosive Weight	7.5oz (225 grams) of Amatol surrounded by a layer of bituminous composition.
Fuze Type	41 fuze (time), 67 fuze (clockwork time delay) or 70 fuze (anti-handling device)
Body Diameter	3in (7.62 cm) diameter, 3.1in (7.874) long
Use	Designed as an anti-personnel/ fragmentation weapon. They were delivered by air, being dropped in containers of 23-144 sub-munitions that opened at a predetermined height, thus scattering the bombs.
Remarks	Very rare. First used against Ipswich in 1940, but were also dropped on Kingston upon Hull, Grimsby and Cleethorpes in June 1943, amongst various other targets in UK. As the bombs fell the outer case flicked open by springs which caused four light metal drogues with a protruding 5 inch steel cable to deploy in the form of a parachute & wind vane which armed the device as it span.

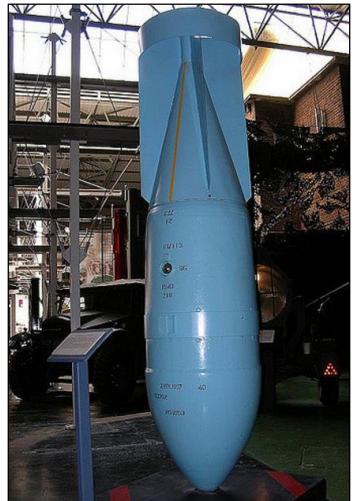
SC 1000kg

Bomb Weight	993-1027kg (2,189-2,264lb)
Explosive Weight	530-620kg (1168-1367lb)
Fuze Type	Electrical impact/mechanical time delay fuze.
Filling	Mixture of 40% amatol and 60% TNT, but when used as an anti-shipping bomb it was filled with Trialen 105, a mixture of 15% RDX, 70% TNT and 15% aluminium powder.
Bomb Dimensions	2800 x 654mm (110 x 25.8in)
Body Diameter	654mm (18.5in)
Use	SC type bombs are General Purpose Bombs used primarily for general demolition work. Constructed of parallel walls with comparatively heavy noses. They are usually of three piece welded construction

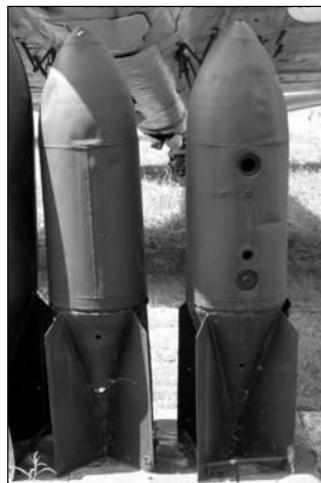
Flam C-250 Oil Bomb

Bomb Weight	125kg (276lb)
Explosive Weight	1kg (2.2lb)
Fuze Type	Super-fast electrical impact fuze
Filling	Mixture of 30% petrol and 70% crude oil
Bomb Dimensions	1,650 x 512.2mm (65 x 20.2in)
Body Diameter	368mm (14.5in)
Use	Often used for surprise attacks on ground troops, against troop barracks and industrial installations. Thin casing – not designed for ground penetration

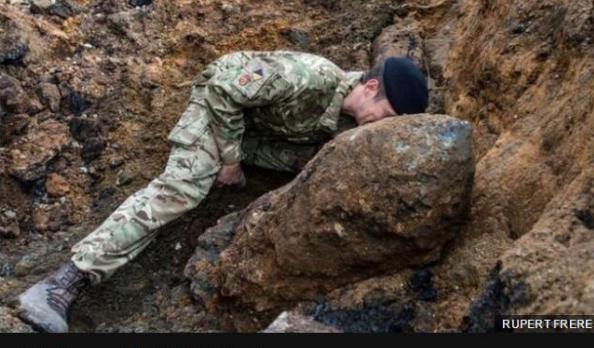
The bomb measured about 5ft (1.5m) in length

An unexploded World War Two bomb found in south London has been driven away safely under police and Army escort.

The 500lb (250kg) device was found on a building site in Grange Walk, Bermondsey on Monday.

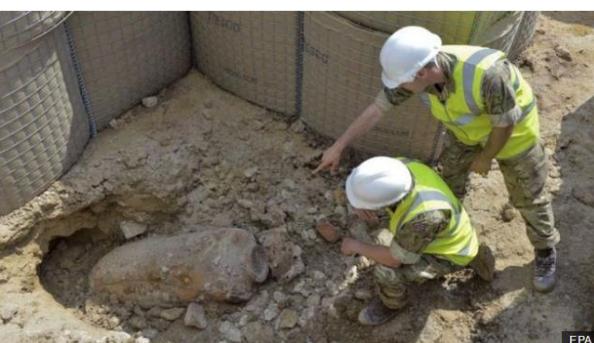
The bomb was found on the site of a former school on Thursday

A 500lb World War Two bomb found on the site of a former school in Bath has been defused and made safe.

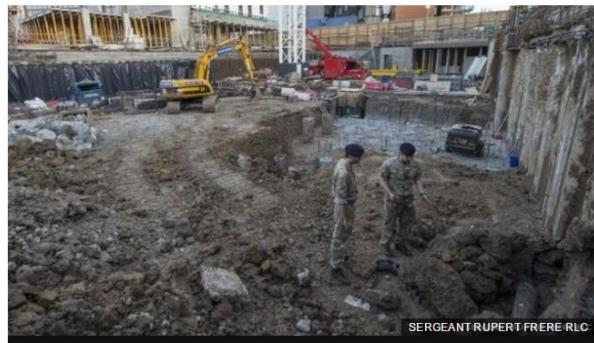
A blast wall was put up around the bomb to minimise damage if it exploded

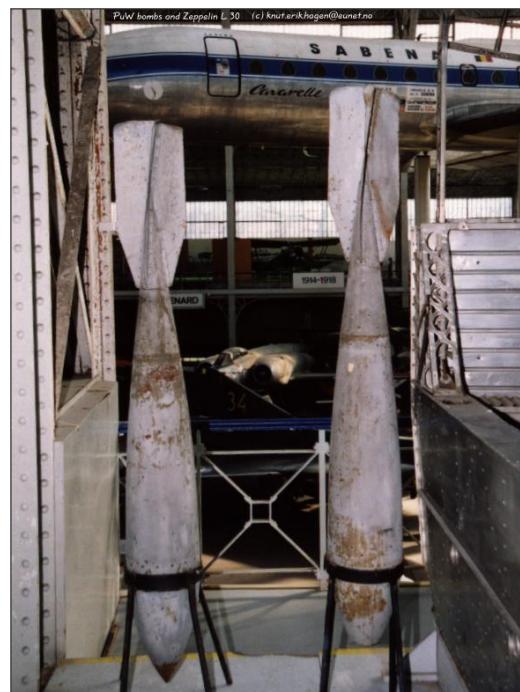
Examples of 50 and 100kg German WWI bombs

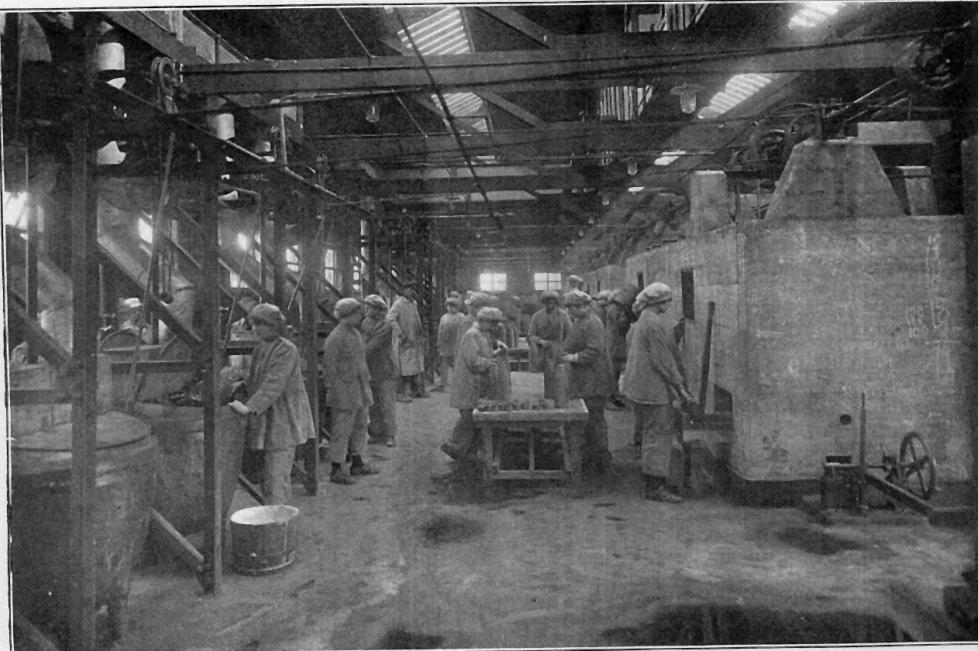
Mechanical Shell Filling, Amatol Section. Shells are filled by extruder machines inside the armoured concrete chambers on the right, so that in the event of an explosion no one would be injured.

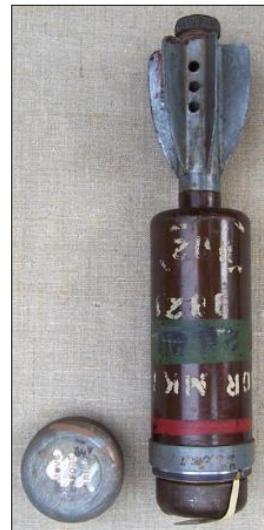
Weight	1.02kg (2.25lb)
Maximum Range	460m (500yards)
Filling	200g RDX/TNT
Dimensions	51 x 290mm (2in x 11.4 in)
Fuze Type	An impact fuze which detonates the fuze booster charge and in turn the high explosive charge.
Use	It had greater range and firepower over hand and rifle grenades, and was used to attack targets behind cover with high explosive rounds.
Identification	HE has a rounded edge to a flat back. Can either be a black body colour with red and yellow band or dark green with yellow band. Brass cap on top. Practice will have hole all the way through the top.

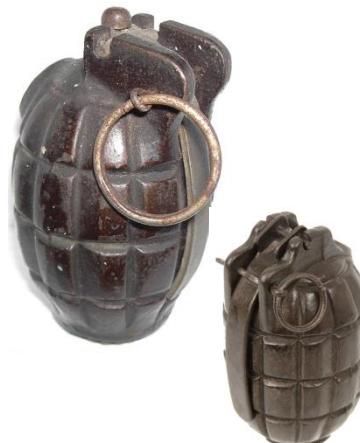
No. 36 'Mills' Grenade

Weight	765g filled (1lb 11.25oz)
Explosive Weight	71g (2oz) filling.
Fuze Type	4-7 second delay hand-throwing fuze. No. 6 Detonator
Dimensions	95 x 61mm (4 x 2.4in)
Use	Fragmentation explosive at approx. 30m range 100m range of damage.
Remarks	First introduced in 1915 its classic grooved, cast-iron 'pineapple' design was designed to provide uniform fragmentation. The detonator is inserted before use after removing the base plug.

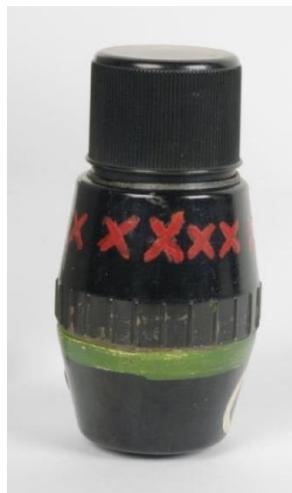
No. 69 Grenade

Weight	383g (13.5oz)
Fill Weight	93g (3.25 oz) of either Amatol, Baratol or Lyddite
Fuze Type	'All-ways' Fuze. Compromised of a safety cap, a weighted streamer attached to a steel ball bearing and a safety bolt designed to detonate from any point of impact.
Dimensions	115 x 60mm (4.5 x 2 .4 in)
Use	A blast grenade for use as an offensive weapon. Detonator was inserted before use.
Remarks	Introduced December 1940 and made from the plastic Bakelite as opposed to conventional metals. Detection is difficult due to this low metal content.

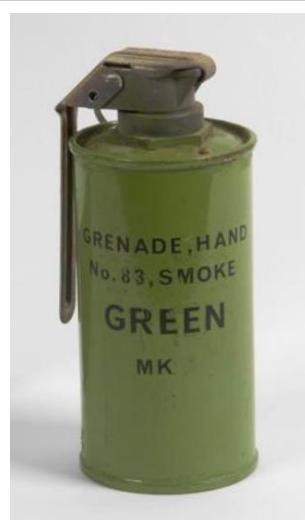
No. 83 Smoke Grenade

Weight	Approx. 680g (1.5lb)
Explosive Weight	Approx. 170-200g. (6-7 oz)
Fuze Type	Originally used a friction system using a match head composition. Later developed to a striker lever ignition system.
Dimensions	Approx. 62 x 140mm (2.44 x 5.5 in)
Use	Use as a target or landing zone marking device and as a screening method for troop / unit movement.
Remarks	This basic design stayed relatively unchanged up to the 1980's. The letters CCC were often etched into the body of the grenade in the colour of the smoke.

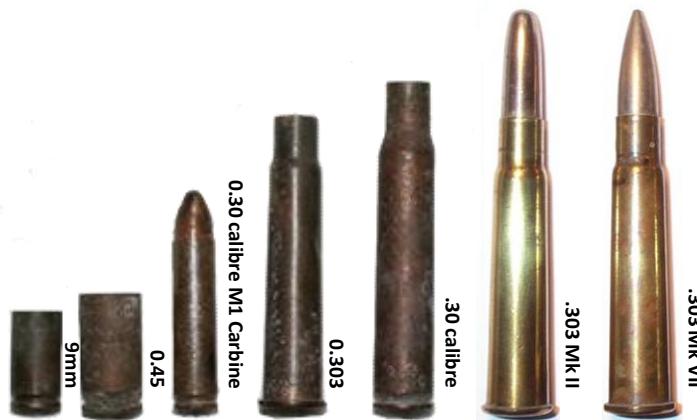
.303 Rifle

Examples of British Small Arms Ammunition

Bullet Diameter	7.92mm
Case length	56.44mm
Overall length	78.11mm
Type	Rifle Ammunition
Propellant	Originally black powder. Later Cordite followed by Nitrocellulose
Remarks	First produced in 1889 and still in use today, the .303inch cartridge has progressed through ten 'marks' which eventually extended to a total of around 26 variations.

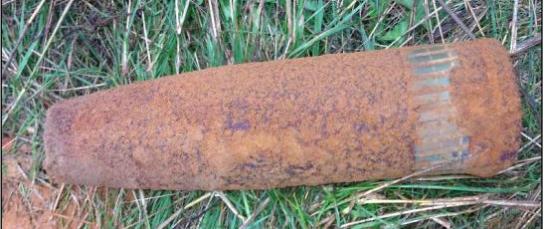
3.7 Inch QF Anti-Aircraft Projectile

Projectile Weight	28lb (12.6 kg)

Explosive Weight	2.52lbs		
Fuze Type	Mechanical Time Fuze		
Dimensions	3.7in x 14.7in (94mm x 360mm)		
Rate of Fire	10 to 20 rounds per minute		
Use	The 3.7in AA Mk 1-3 were the standard Heavy Anti-Aircraft guns of the British Army.

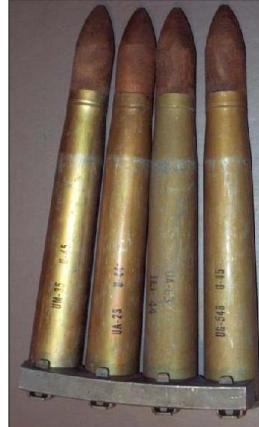
Projectile Weight	1.96lb (0.86kg)

Explosive Weight	300g (0.6lb)			
Fuze Type	Impact Fuze			
Rate of Fire	120 rounds per minute			
Projectile Dimensions	40 x 180mm			
Ceiling	23,000ft (7000m)			
Remarks	Light quick fire high explosive anti-aircraft projectile. Each projectile fitted with small tracer element. If no target hit, shell would explode when tracer burnt out. Designed to engage aircraft flying below 2,000ft

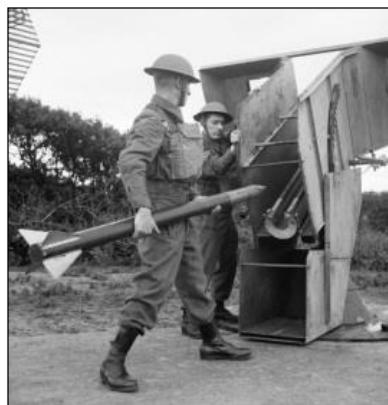
HE Projectile Weight	3.4kg (7.6lb)

Explosive Weight	0.96kg (2.13lb)		
Filling	High Explosive – TNT. Fitted with aerial burst fuzing		
Dimensions of projectile	236 x 83mm (9.29 x 3.25in)		
Remarks	As a short range rocket-firing anti-aircraft weapon developed for the Royal Navy. It was used extensively by British ships during the early days of World War II. The UP was also used in ground-based single and 128-round launchers known as Z Batteries. Shell consists of a steel cylinder reduced in diameter at the base and threaded externally to screw into the shell ring of the rocket motor
