<b>GEA</b> <b>Geotechnical &amp; Environmental Associates</b> Widbury Barn   Widbury Hill   Ware   SG12 7QE						<b>Site</b> 233-236 Nestles Avenue, Hayes & Harlington, London UB3 4SH	<b>Number</b> <b>BH8</b>
<b>Excavation Method</b> Opendrive Percussive Sampler (Terrier rig)	<b>Dimensions</b>		<b>Ground Level (mOD)</b>		<b>Client</b> Buckleuch Property		<b>Job Number</b> J19090
	<b>Location</b>		<b>Dates</b> 23/04/2019		<b>Agent</b> Gardiner and Theobald		<b>Sheet</b> 1/1
Depth (m)	Sample / Tests	Water Depth (m)	Field Records	Level (mOD)	Depth (m) (Thickness)	Description	Legend

**FAC AL GRO D I V S IGA IO R POR**  
2 - 2 estles Avenue

- 1.1.1 RPS Consulting Services Ltd (RPS) was commissioned by DML Group to undertake a programme of ground investigation works at 233-236 Nestles Avenue, Hayes, UB3 4SH. A site location plan is provided as *Figure 1*.

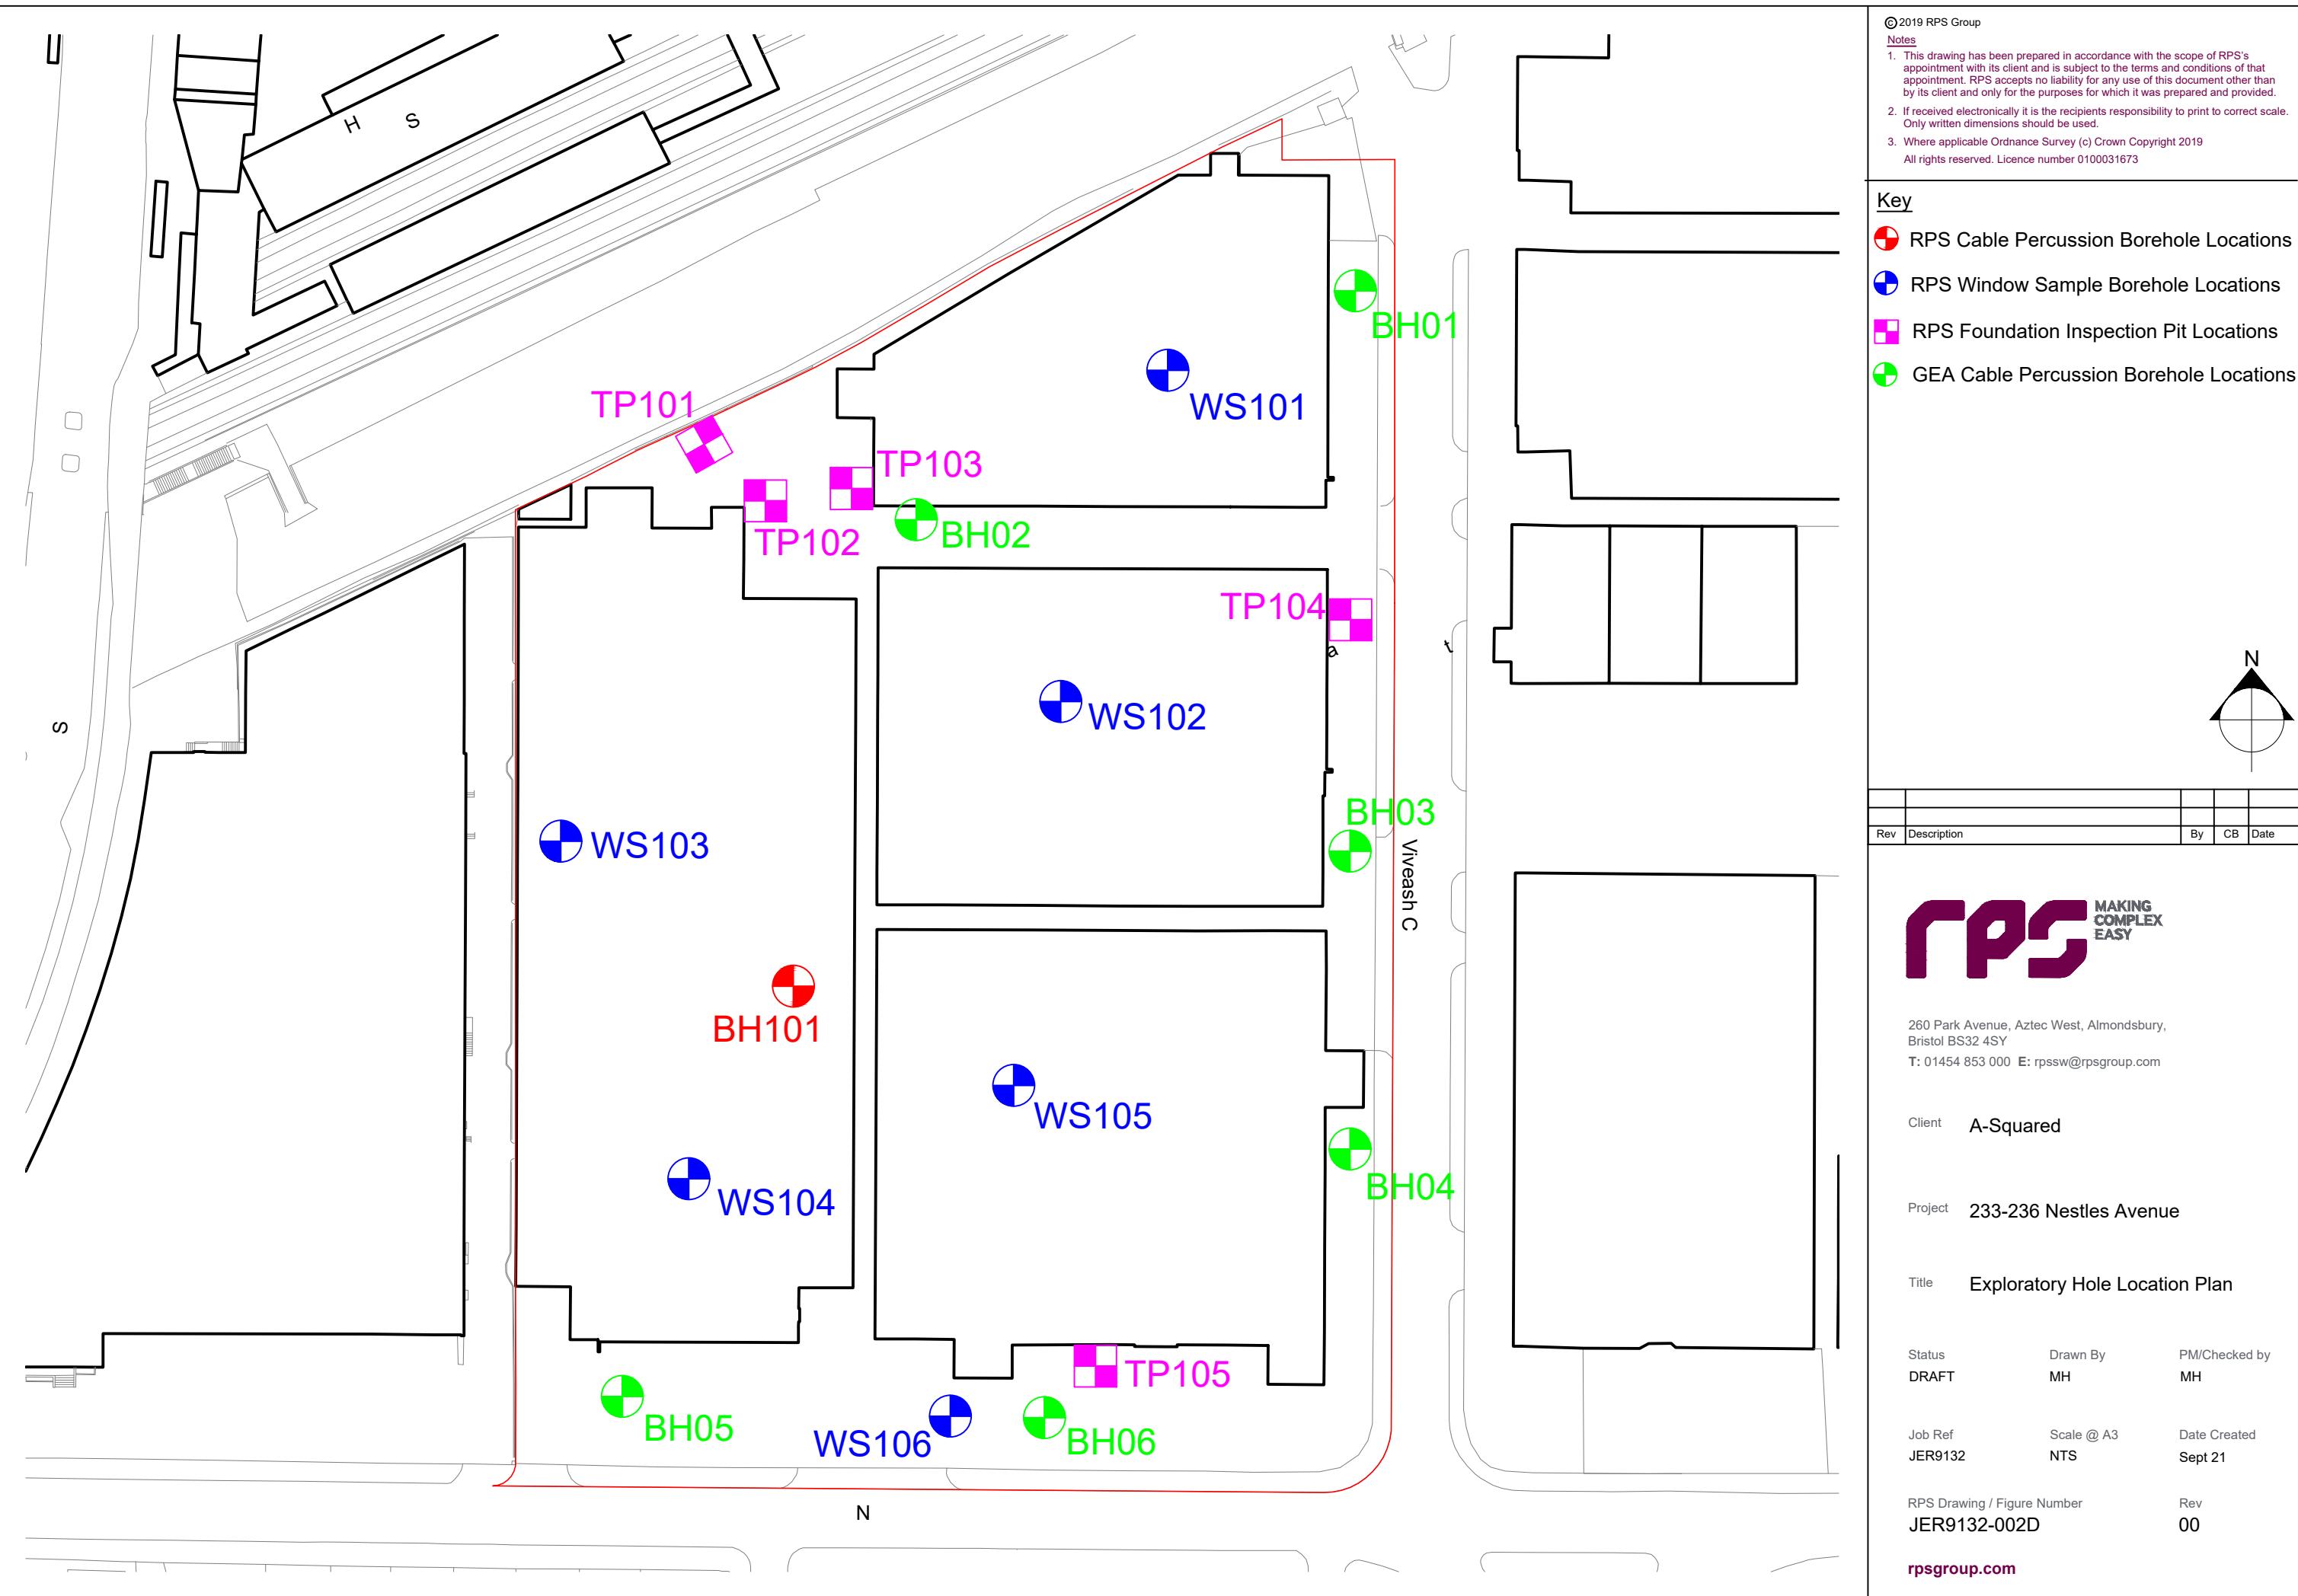
- 1.1.2 At the time of the ground investigation works the site was vacant and comprised a number of warehouse type units with associated areas of external hardstanding. The warehouse in the west of the site had formerly been a motor museum whilst the remaining warehouses had been used as garages and storage for car parts. The site occupied an area of approximately 1.56ha and was rectangular in shape. The site boundary is indicated on *Figure 2*.

2.1.3 The locations of the exploratory holes are shown on *Figure 2* and the exploratory hole logs are provided in *Appendix A*.

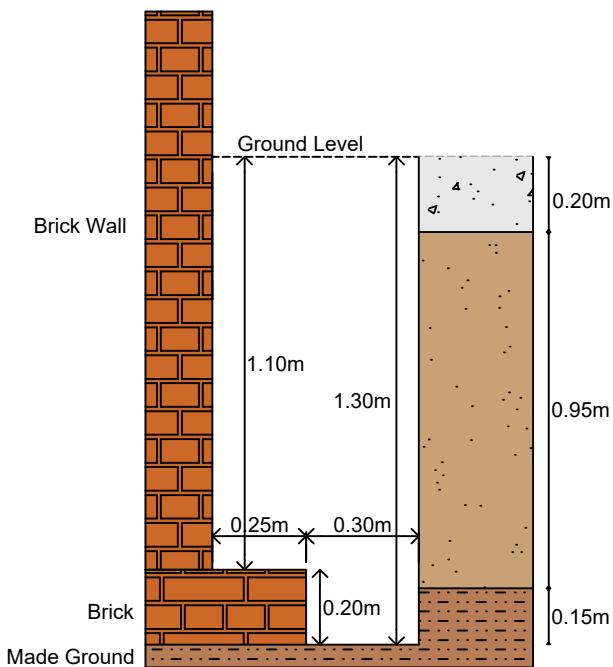
**TP101**
**Section AA'**

0.00 - 0.20 - Concrete.

0.40 - 1.20 - Soft to firm orange brown slightly gravelly clay with occasional black ash pockets (2cm x 2cm). Gravel is angular to subangular fine to coarse of brick.  
 (Made Ground)

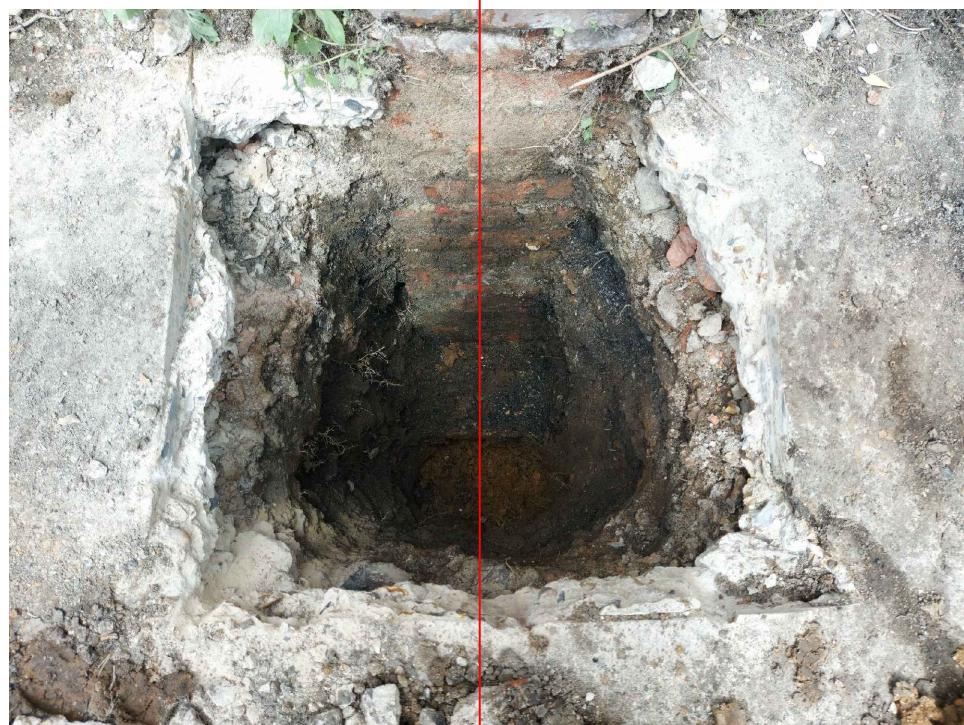
**A'**

Depth (m bgl)	Description
0.00 - 0.25	- Reinforced Concrete
0.05 - 0.40	- Brown slightly sandy slightly gravelly clay. Gravel is angular to subangular fine to coarse of flint, brick, coal, concrete and occasional oyster shells. Sand is medium to coarse. (Made Ground)
0.40 - 1.20	- Soft orange brown slightly gravelly clay. Gravel is angular to subangular fine to coarse of brick. (Made Ground)

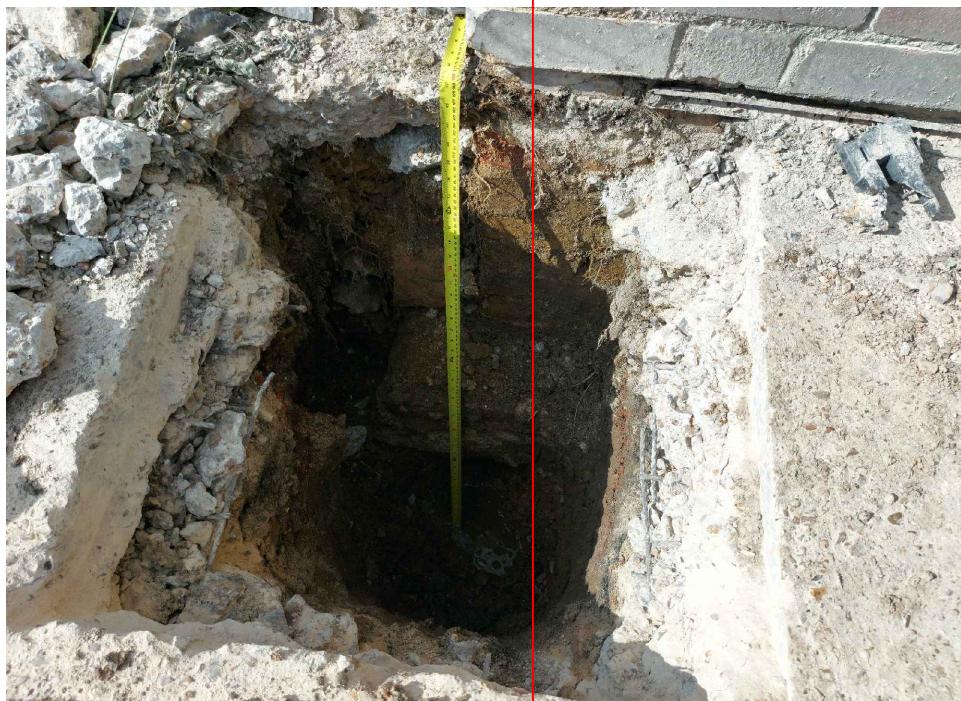
A'  
 A

1. Trial pit terminated at 0.90m bgl.
2. Trial pit was stable upon completion.
3. Trial pit was dry.
4. Trial pit was backfilled with arisings.
5. Environmental Sample taken at 0.50m bgl.
6. Eastings: 509771, Northings: 179356.
7. Ground Level: 31.57m AOD.

Depth (m bgl)	Description
0.00 - 0.05	- Concrete
0.05 - 0.40	- Grey angular coarse gravel of brick and concrete with high cobble content of brick and concrete.
0.40 - 0.90	- Brown slightly gravelly sandy clay with low cobble content of concrete and brick. Gravel is angular to subangular fine to coarse of flint, concrete, brick and coal. Sand is fine to coarse. (Made Ground)
0.90 - 1.30	- Orange brown sandy angular to subrounded fine to coarse flint gravel

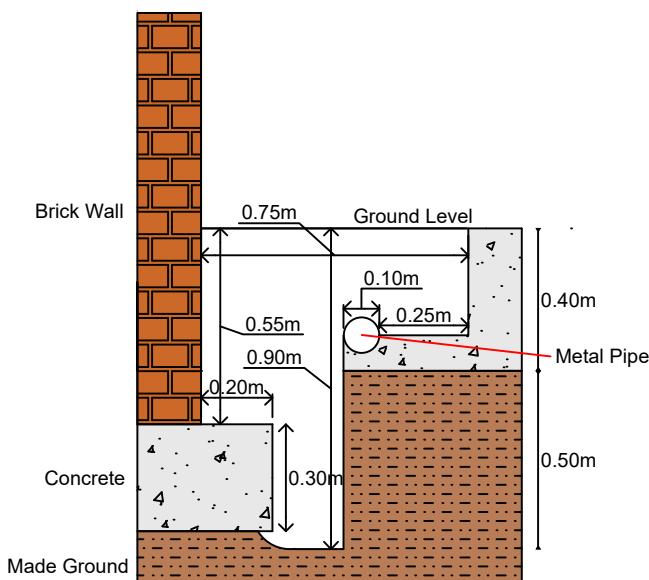
TP103

Depth (m bgl)	Description
0.00 - 0.40	- Concrete
0.40 - 0.90	- Orange brown slightly silty sandy clayey gravel. Gravel is angular to subangular fine to coarse of flint, concrete, brick, coal, clinker and oyster shells. Sand is fine to coarse. (Made Ground)

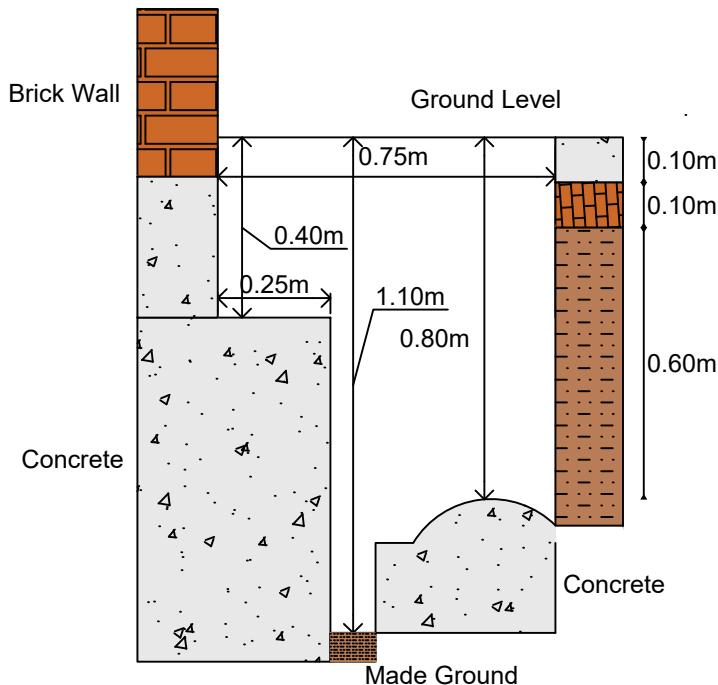
**TP105**
**Section AA'**

1.00 - 1.10 - Yellow brown sandy subrounded to rounded flint to medium flint gravel. Sand is fine to medium. (Lynch Hill Gravel Member)
