**Arboricultural Implications  
Assessment  
for a proposed development  
at  
Land adjacent to Green End  
17 Dene Road  
Northwood  
HA6 2BS  
Rev C**

**Client: AJA Taylor and Co Ltd  
1a Eastbury Road  
Northwood  
Middx  
HA6 3BG**

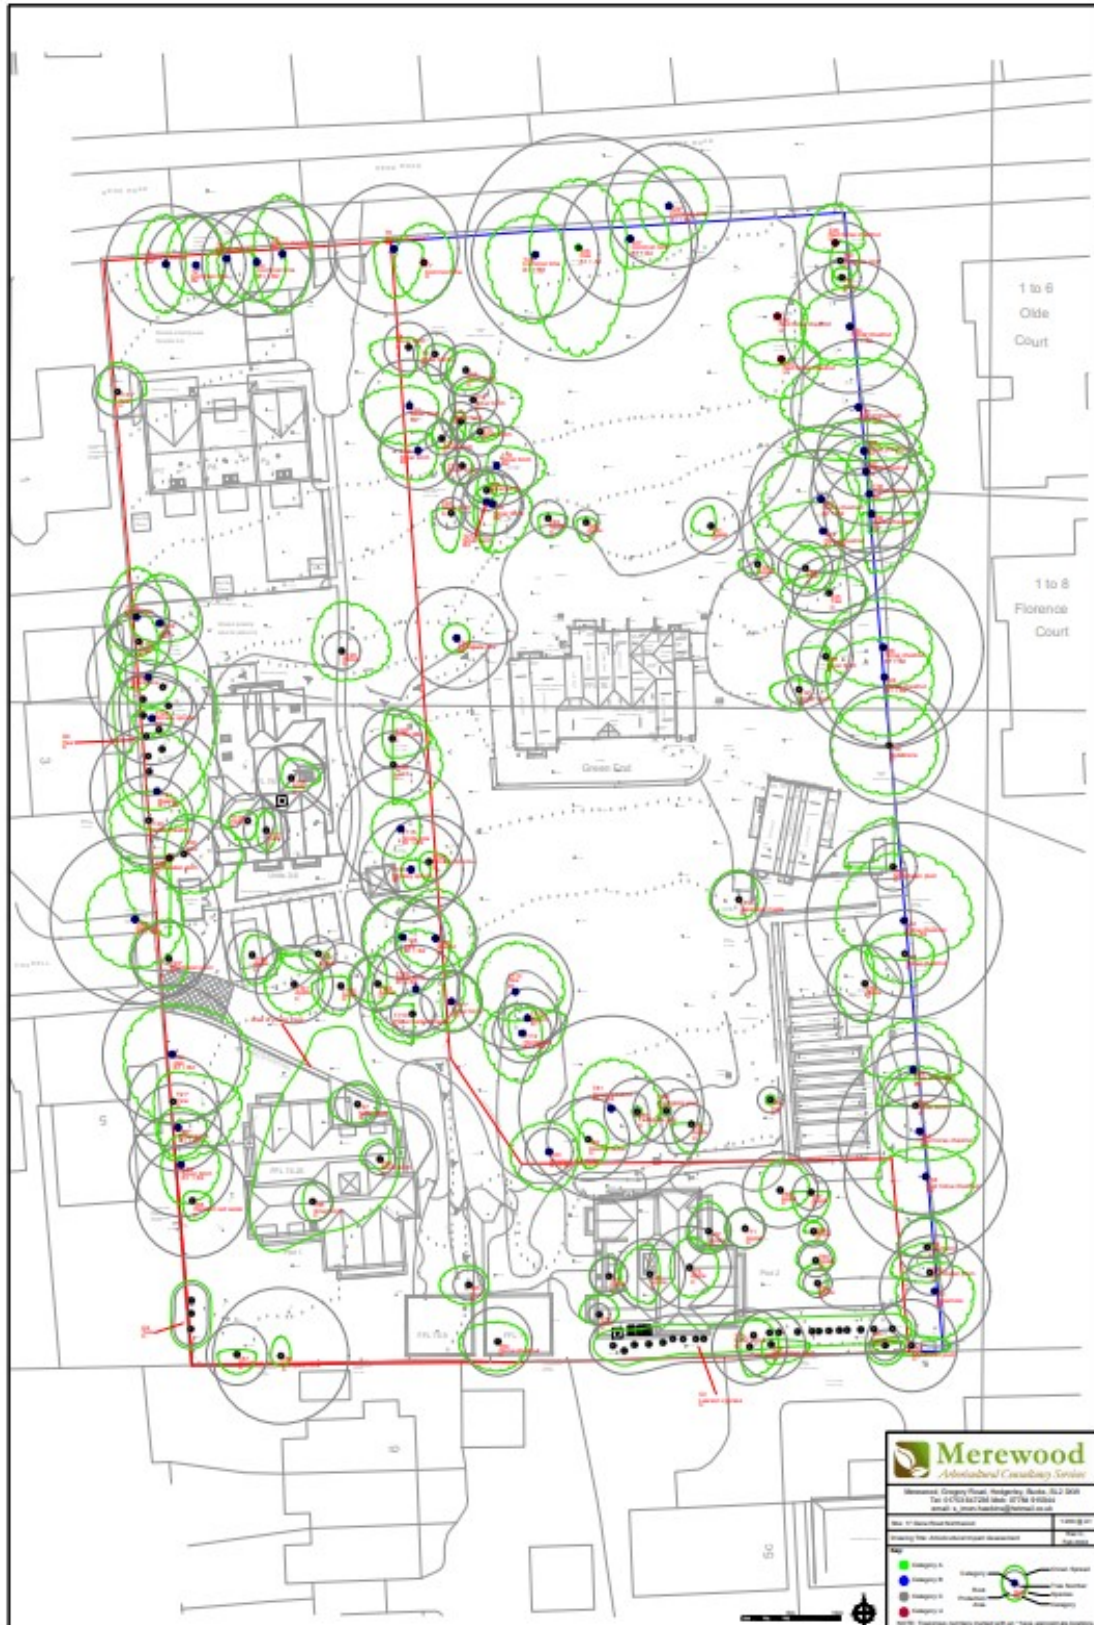
## Appendix 4 Impact Assessment Plan

- 3.5.2 There are a couple of exceptions where the footing of the new buildings will encroach marginally onto RPA's, For example Plot 1 encroaches very slightly onto the RPA of the western red cedar (T88) by an insignificant amount.

- 3.5.3 Plot 2 encroaches very slightly onto the RPA of the dawn redwood (T81), whilst units 3-5 encroach a little onto the RPA of the beech (T121). These are very small encroachments that will not harm the trees in question.
