## Executive Summary

Delta-Simons Environmental Consultants Limited (“Delta-Simons”) was instructed by St James Place UK Plc c/o Orchard Street Investment Management LLP (the “Client”) to prepare a Preliminary Geo-Environmental Risk Assessment for vacant commercial properties located off Stone Close, West Drayton, UB7 8JU (the “Site”).

The proposed development for the Site is the demolition of existing structures and the construction of a new vehicle servicing garage.

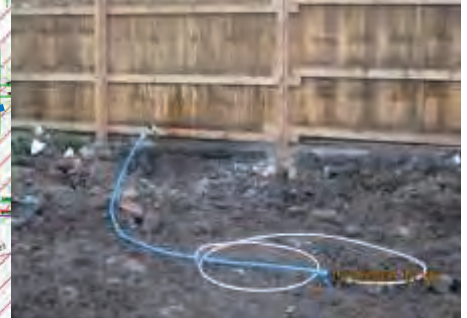
Live water to the boundary

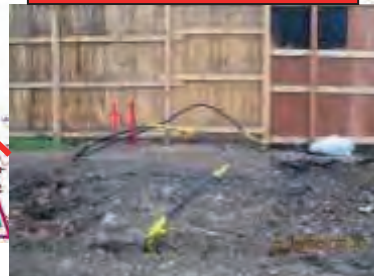
Live electrical supplies

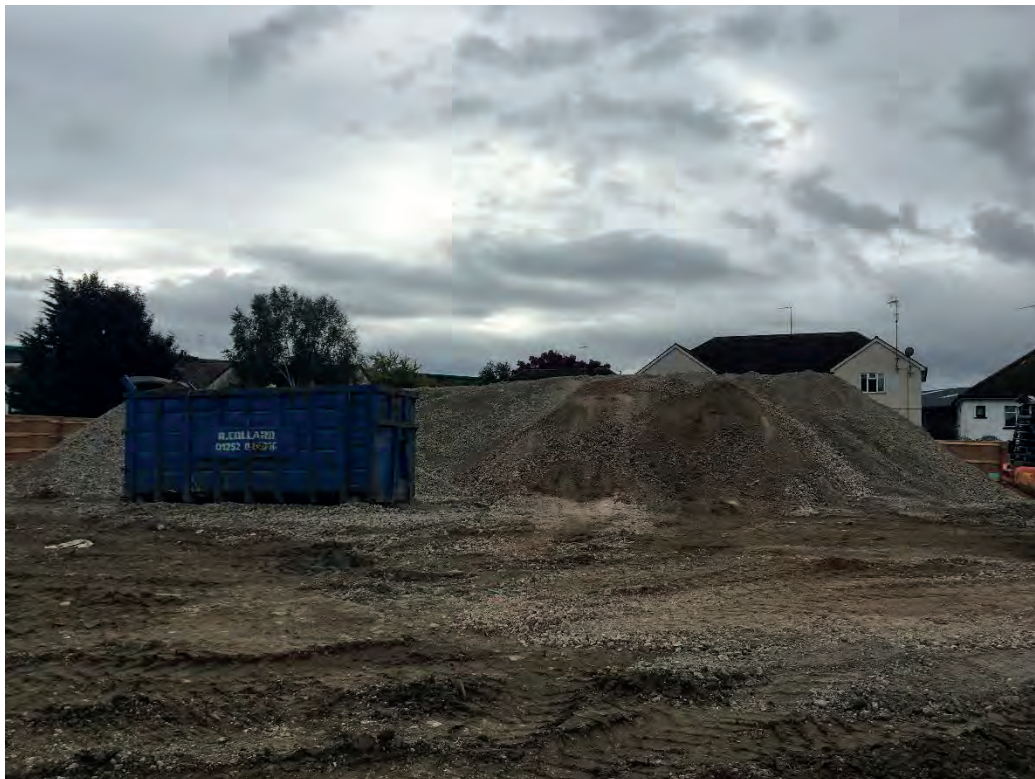
Fig 2. Stockpiled won site material, located in the southern part of the Site.

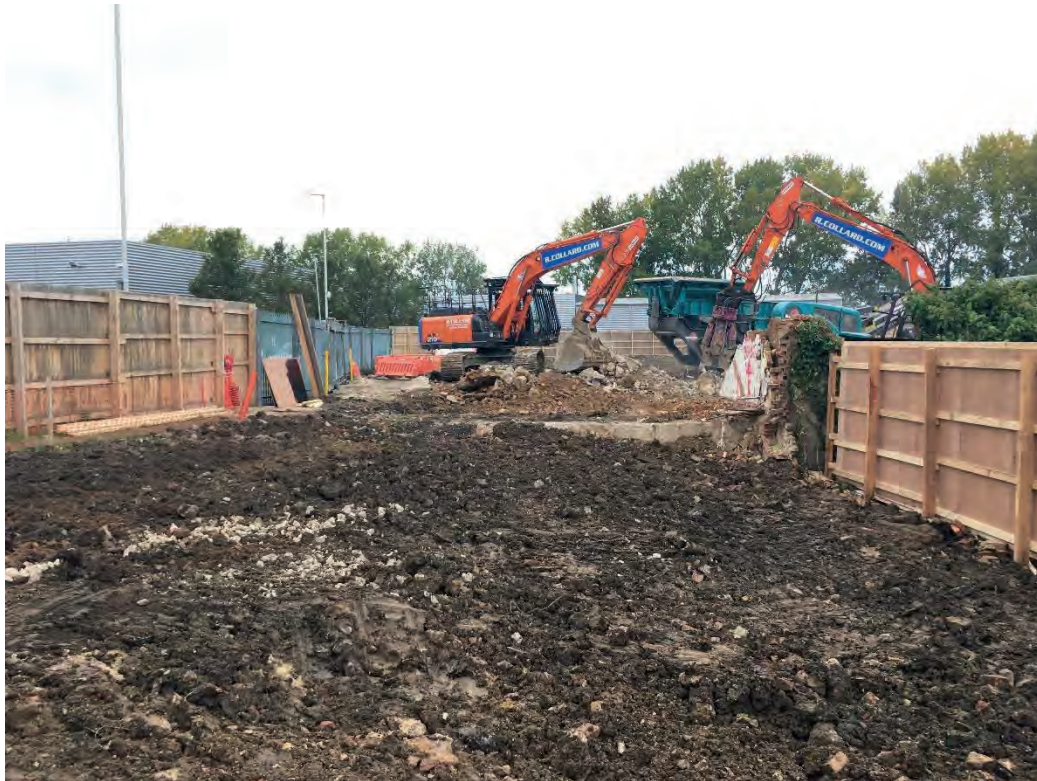
Fig 3. RCollard carrying out screening of the won site material.
