PHASE 1 SITE INVESTIGATION

75A, Bridge Road, Uxbridge

J&J Transport

Project No. 001AJTP1

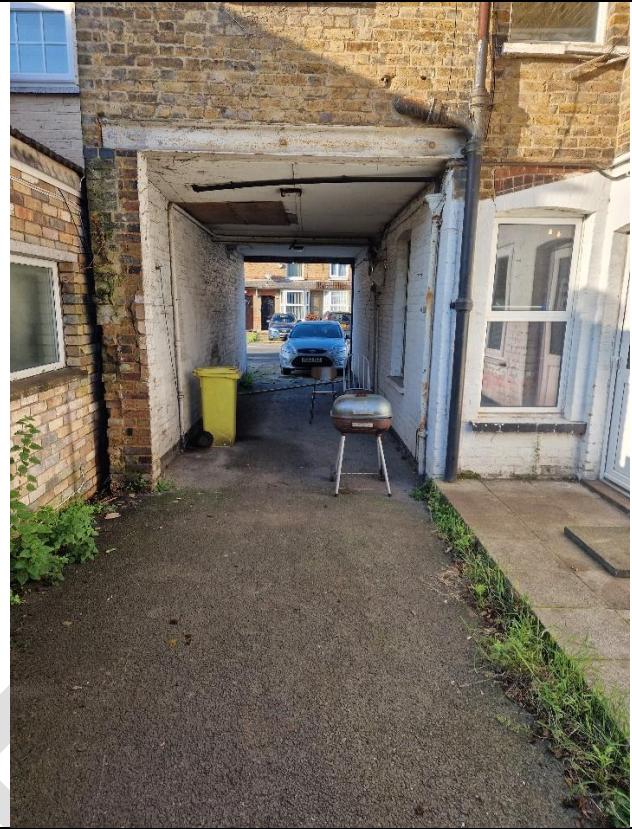
Figure 2. The undercroft and drive

The site was visited 7th December 2022 to allow a visual inspection to take place. The site was observed to comprise a driveway to the front that access the former workshop to the rear via an archway. The driveway was surfaced with tarmac in poor condition with fracturing evident. This access the remainder of the site via an archway. The main part of the site had concrete surfacing present. This was in fair condition with some cracking evident and service entries present.

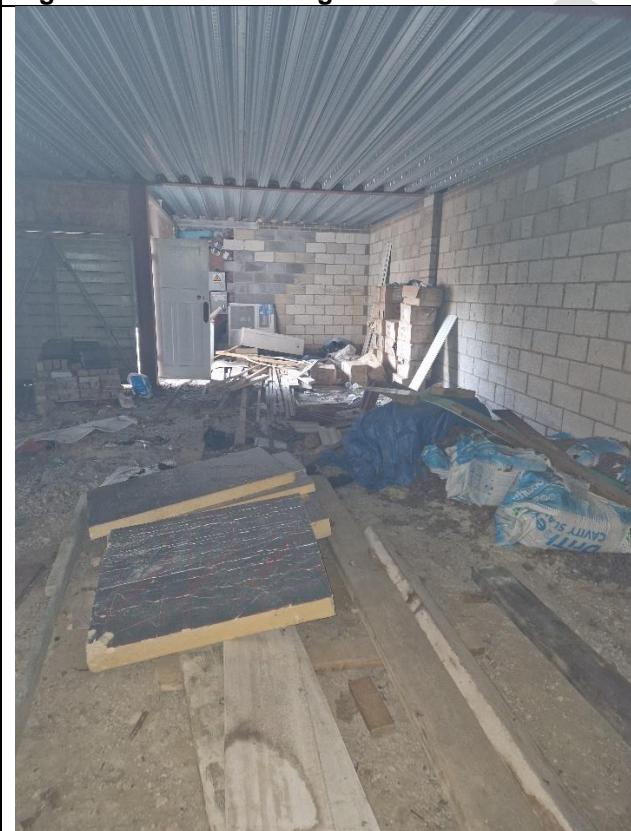
Figure 3. Building interior

The building itself was largely brick built with slate roof and is understood to have been the manufacturer of aircraft seat frames. At the time of the visit, the original flooring of concrete had been broken up leaving rubble in its place. Building materials and planks of wood were evident. To the west of the building adjacent to the border with residential properties, domestic rubbish was present.

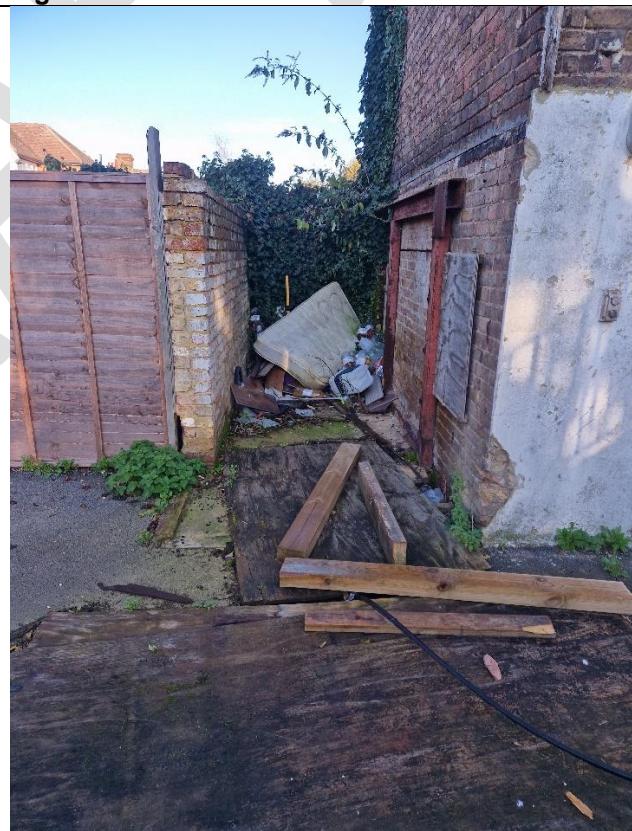
Figure 4. Domestic waste to the west of workshop.
