# REMEDIATION VERIFICATION

**SOLIS MEWS**

**256 Field End Road**

Report produced in relation to planning application ref: 73733/APP/2019/3766 section 7C.

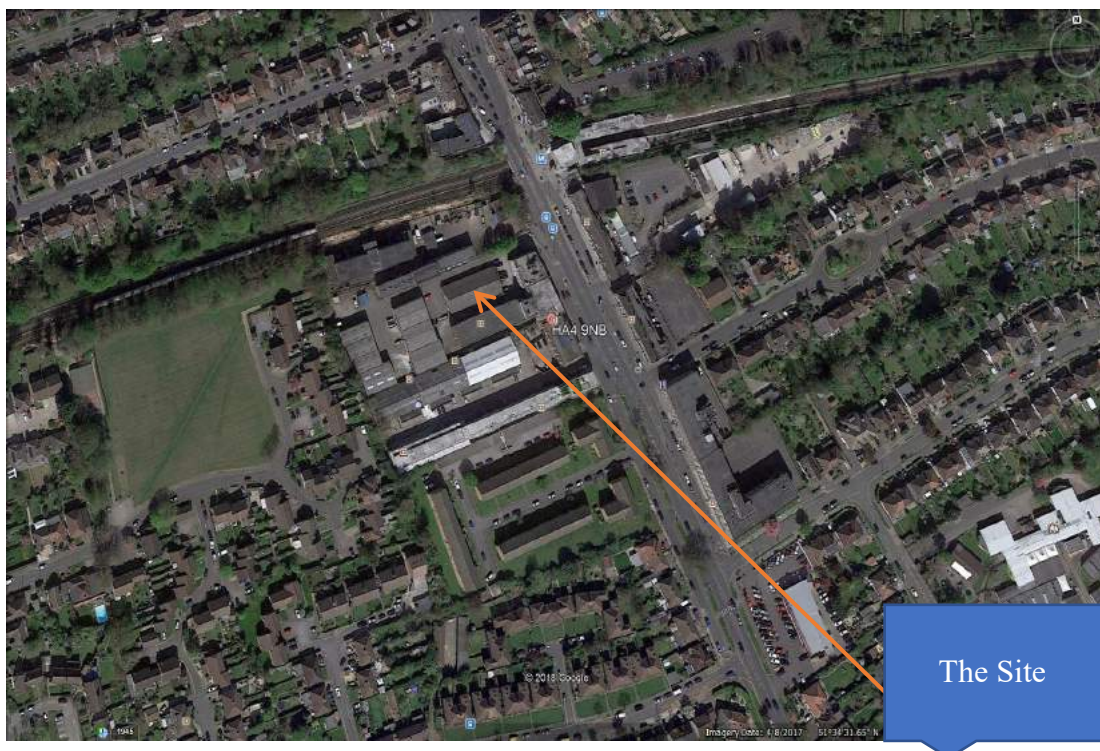
The site is a relatively modern building located within Eastcote Town Centre to the rear of taller office buildings along Field End Road and is near to local bus stops and Eastcote Rail Station.

The building is two storey, with accommodation contained within its pitched roof, and sits to the rear of 260 Field End Road and is accessed via a private access road. The existing internals are to be demolished and internally fitted out to provide new accommodation.

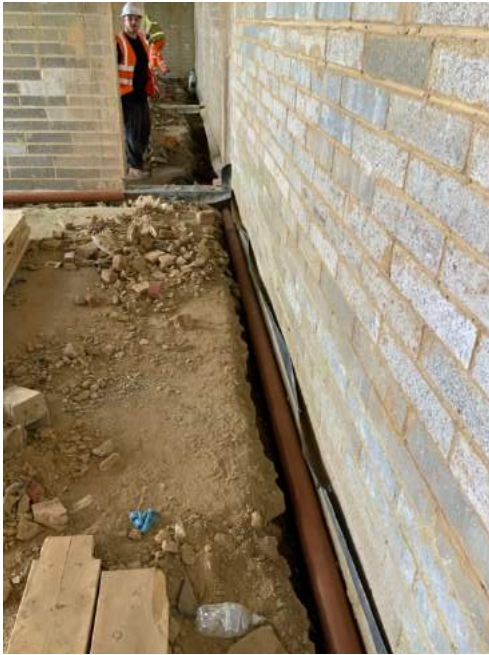
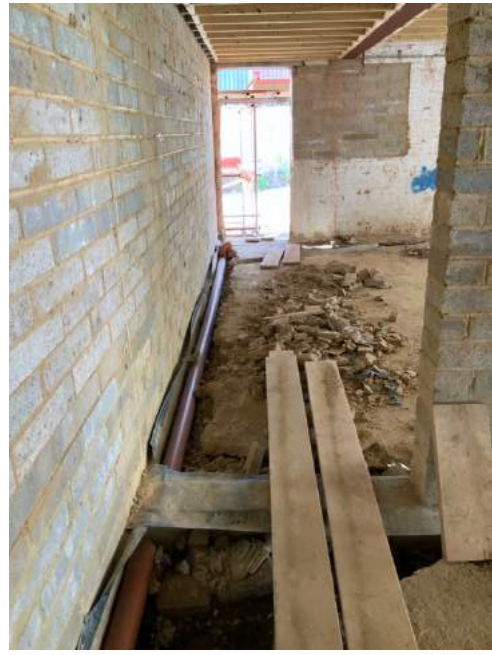
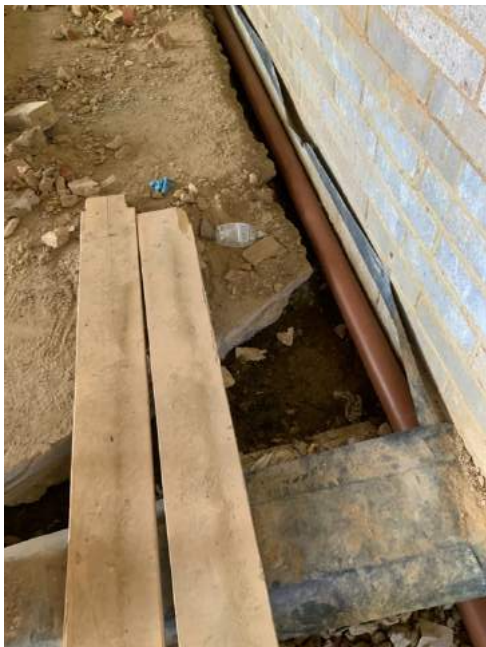
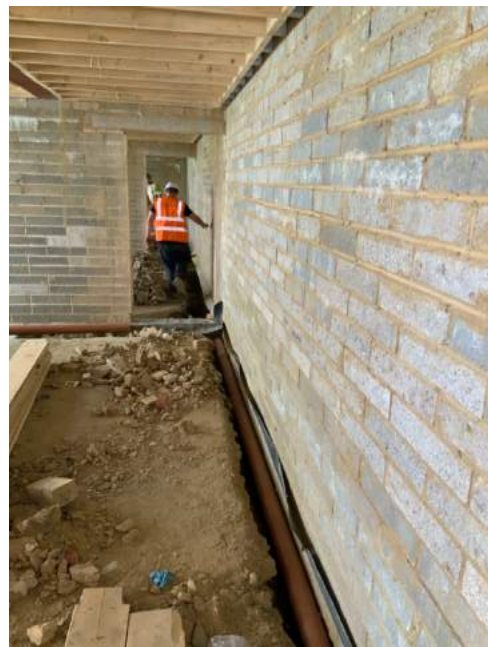
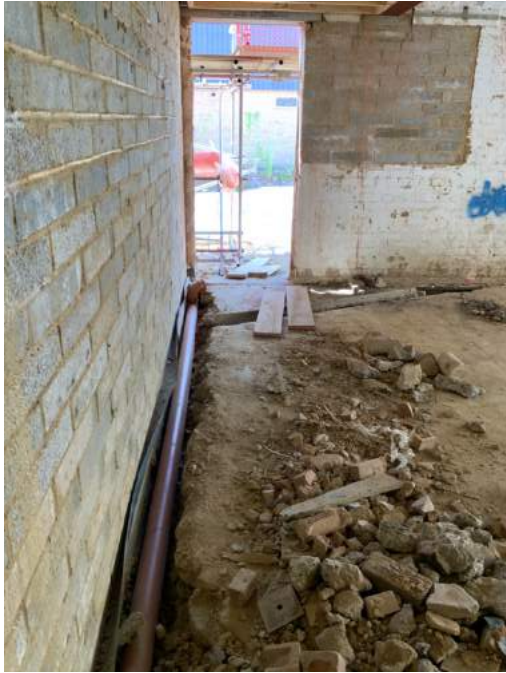
In order to accommodate new foul drainage areas of the site were excavated although only to limited depths ranging from 0.6 m to 0.1m. Where ground was excavated as much as possible was returned limiting the amount to be removed from site.

The works were inspected by our Structural Engineers on the 31<sup>st</sup> August and the 7<sup>th</sup> September 2020 to ensure the design was in accordance with the approved design shown on PRP drawing 81475/101/P2.

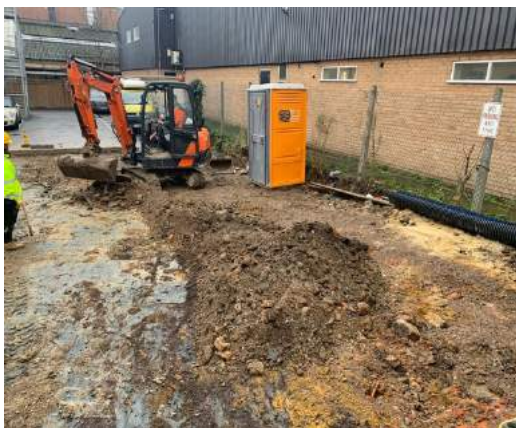
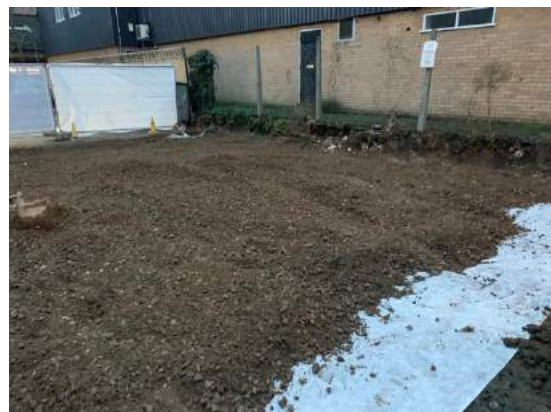
The works were started to the car park area on the 9<sup>th</sup> November 2020 by our ground works contractor. Again a watching brief was employed to monitor any areas of contamination during all the works. A depth of 250mm was removed from the site area, but most of this was the additional type 1 added before the construction works started. The material was excavated and then removed by a licensed waste carrier.

Once the redundant material was removed the area was proof rolled and a geotextile membrane was added to the whole site area. Following on from this type 1 was imported and compacted in accordance with the PRP specification shown below.

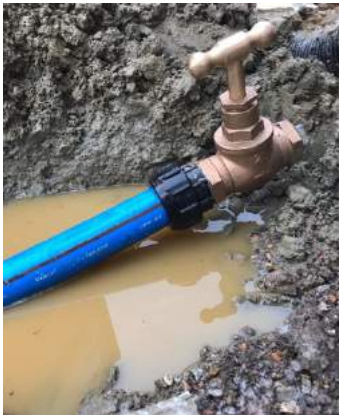
## New water main barrier pipe

As recommended by Affinity Water the new water main has been installed utilising a barrier pipe as can be seen in the photograph and identified by the black strip.

The new water main supply to the project is a 63mm barrier pipe in accordance with Affinity Water's requirements.
