Crown Trading Centre, Hayes Remediation Method Statement

May 2023

Job number/document number: 0097-R002i3				
Report prepared for: Adam McAviney Senior Design Manager Henry Construction Projects Ltd Parkway Farm, Church Road Cranford, Middlesex TW5 9RY				
Version	Description	Author	Reviewed	Date
1	Draft	Kene Onwubuya	Dave Rutherford	02.05.23
2	Final (following client comments)	Kene Onwubuya	Dave Rutherford	03.05.23
3	Final (following additional ground gas information)	Kene Onwubuya	Dave Rutherford	05.05.23

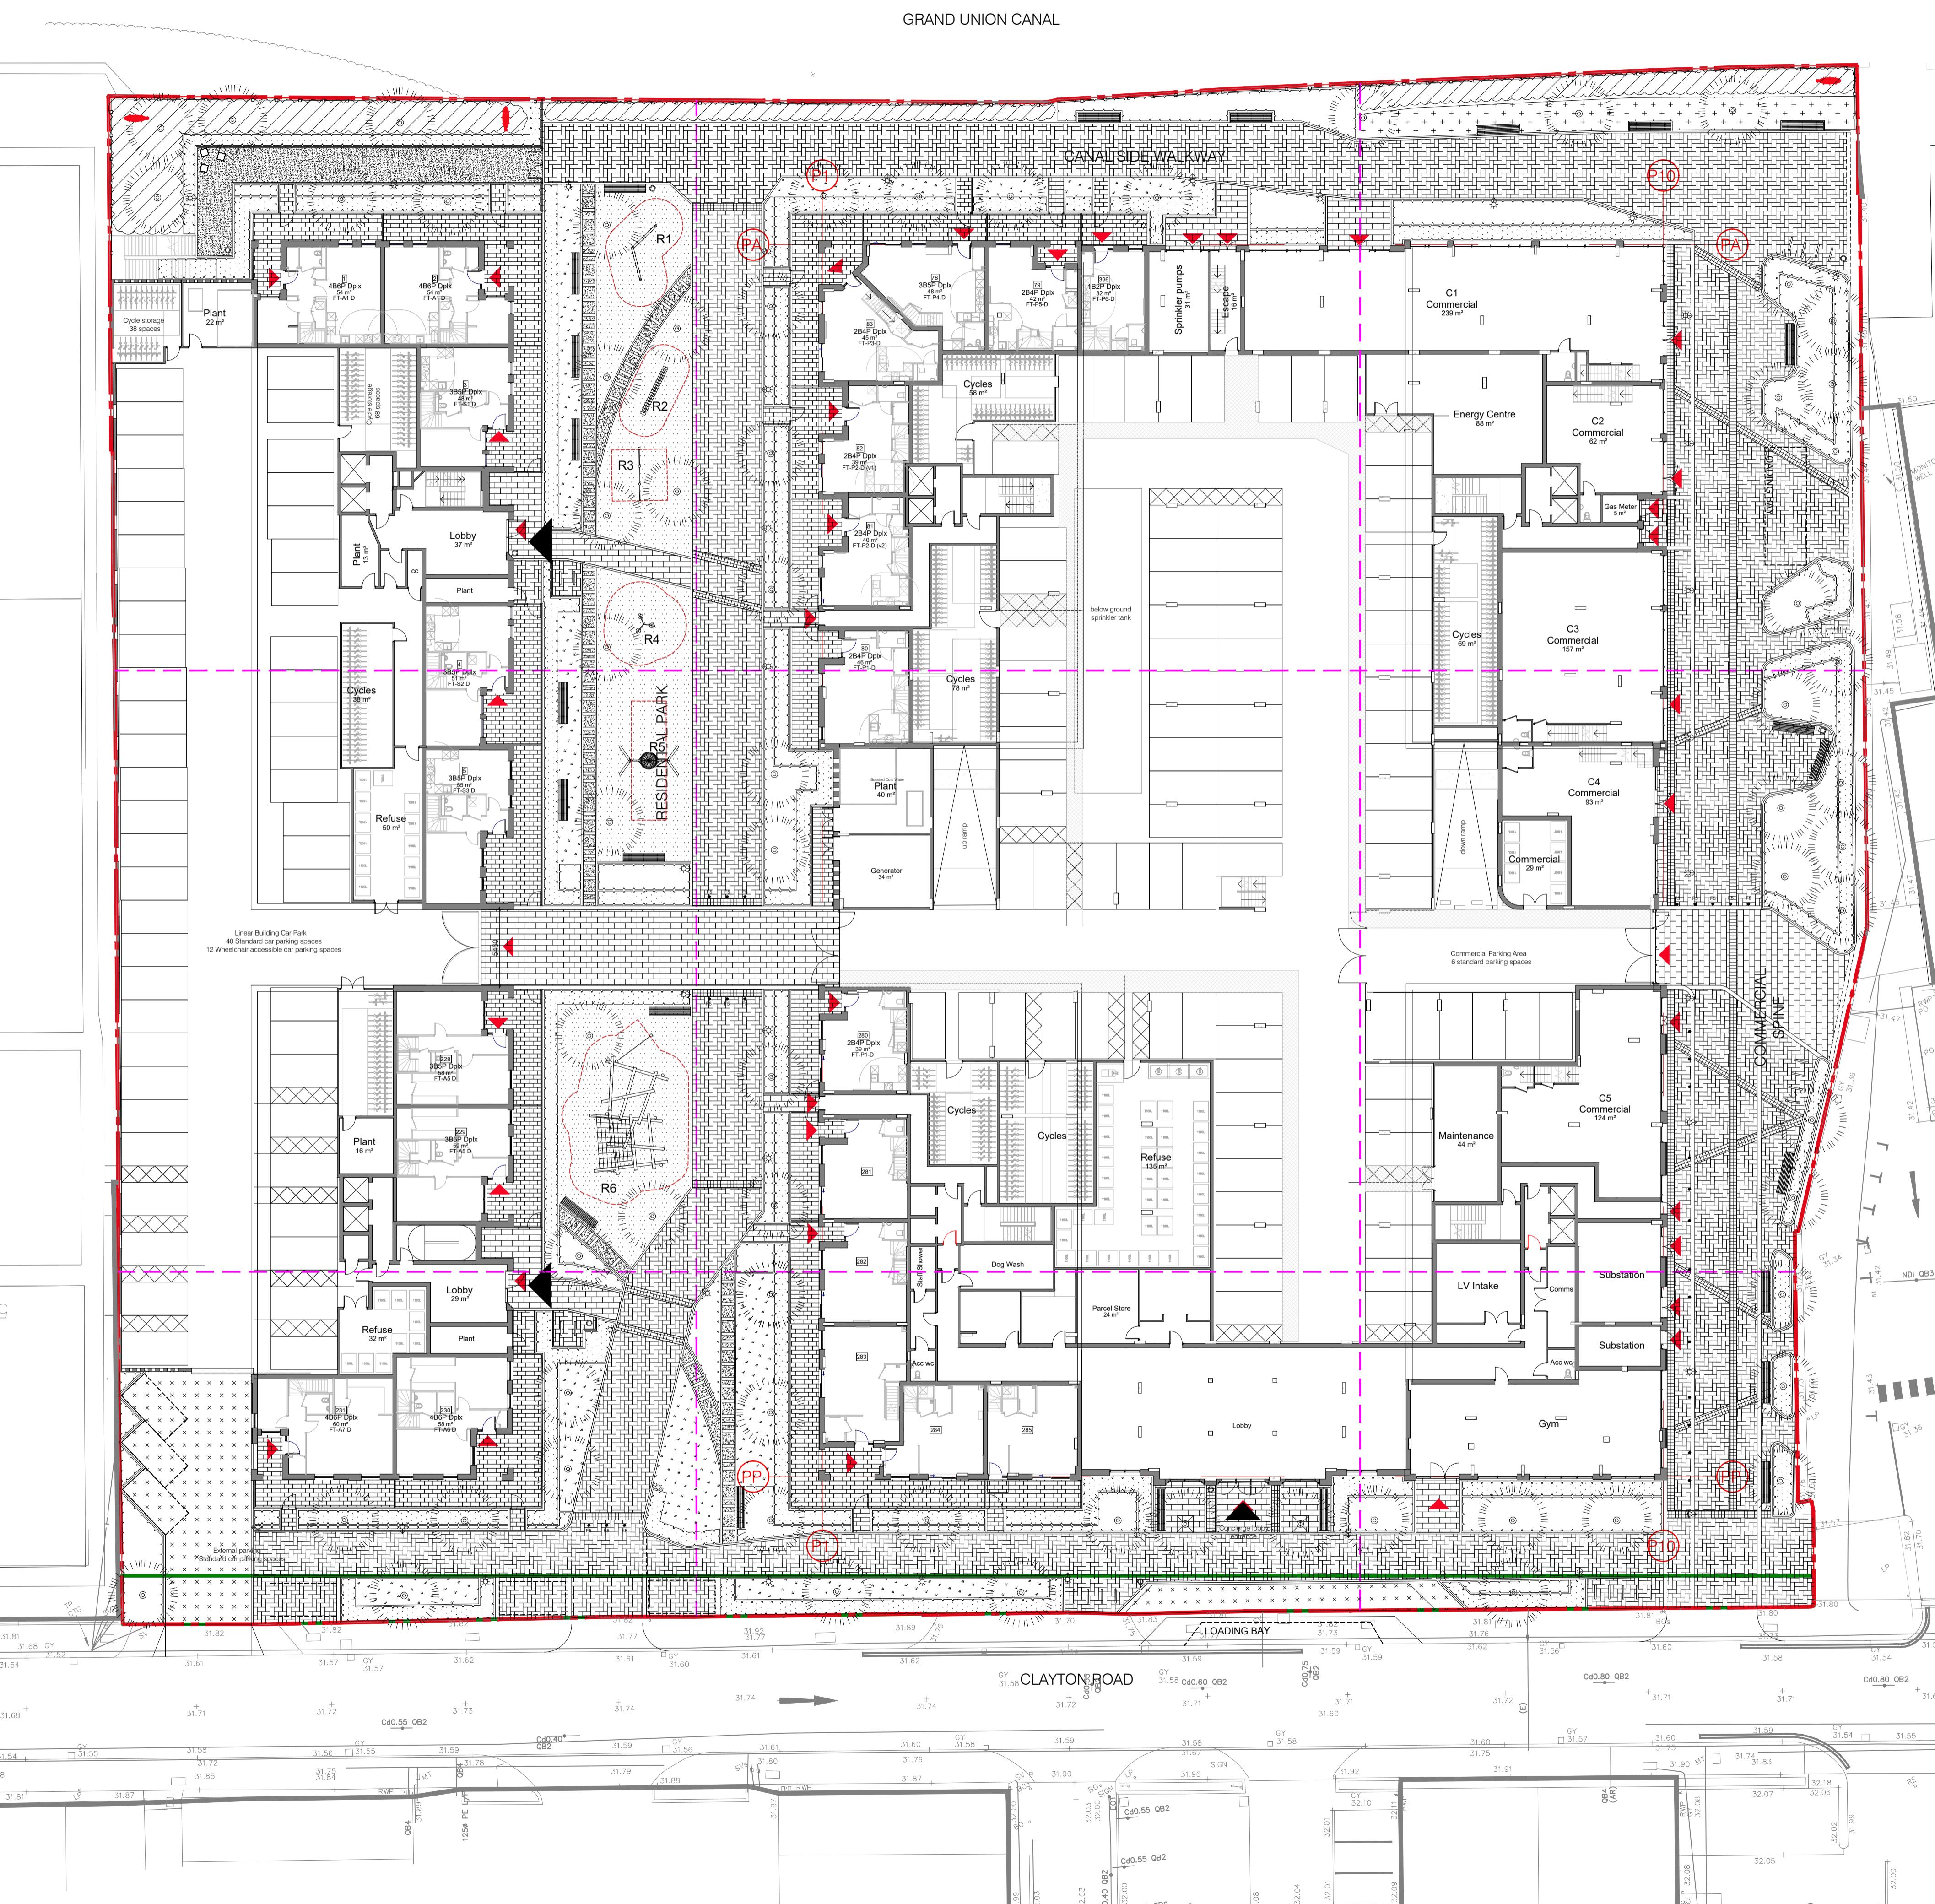
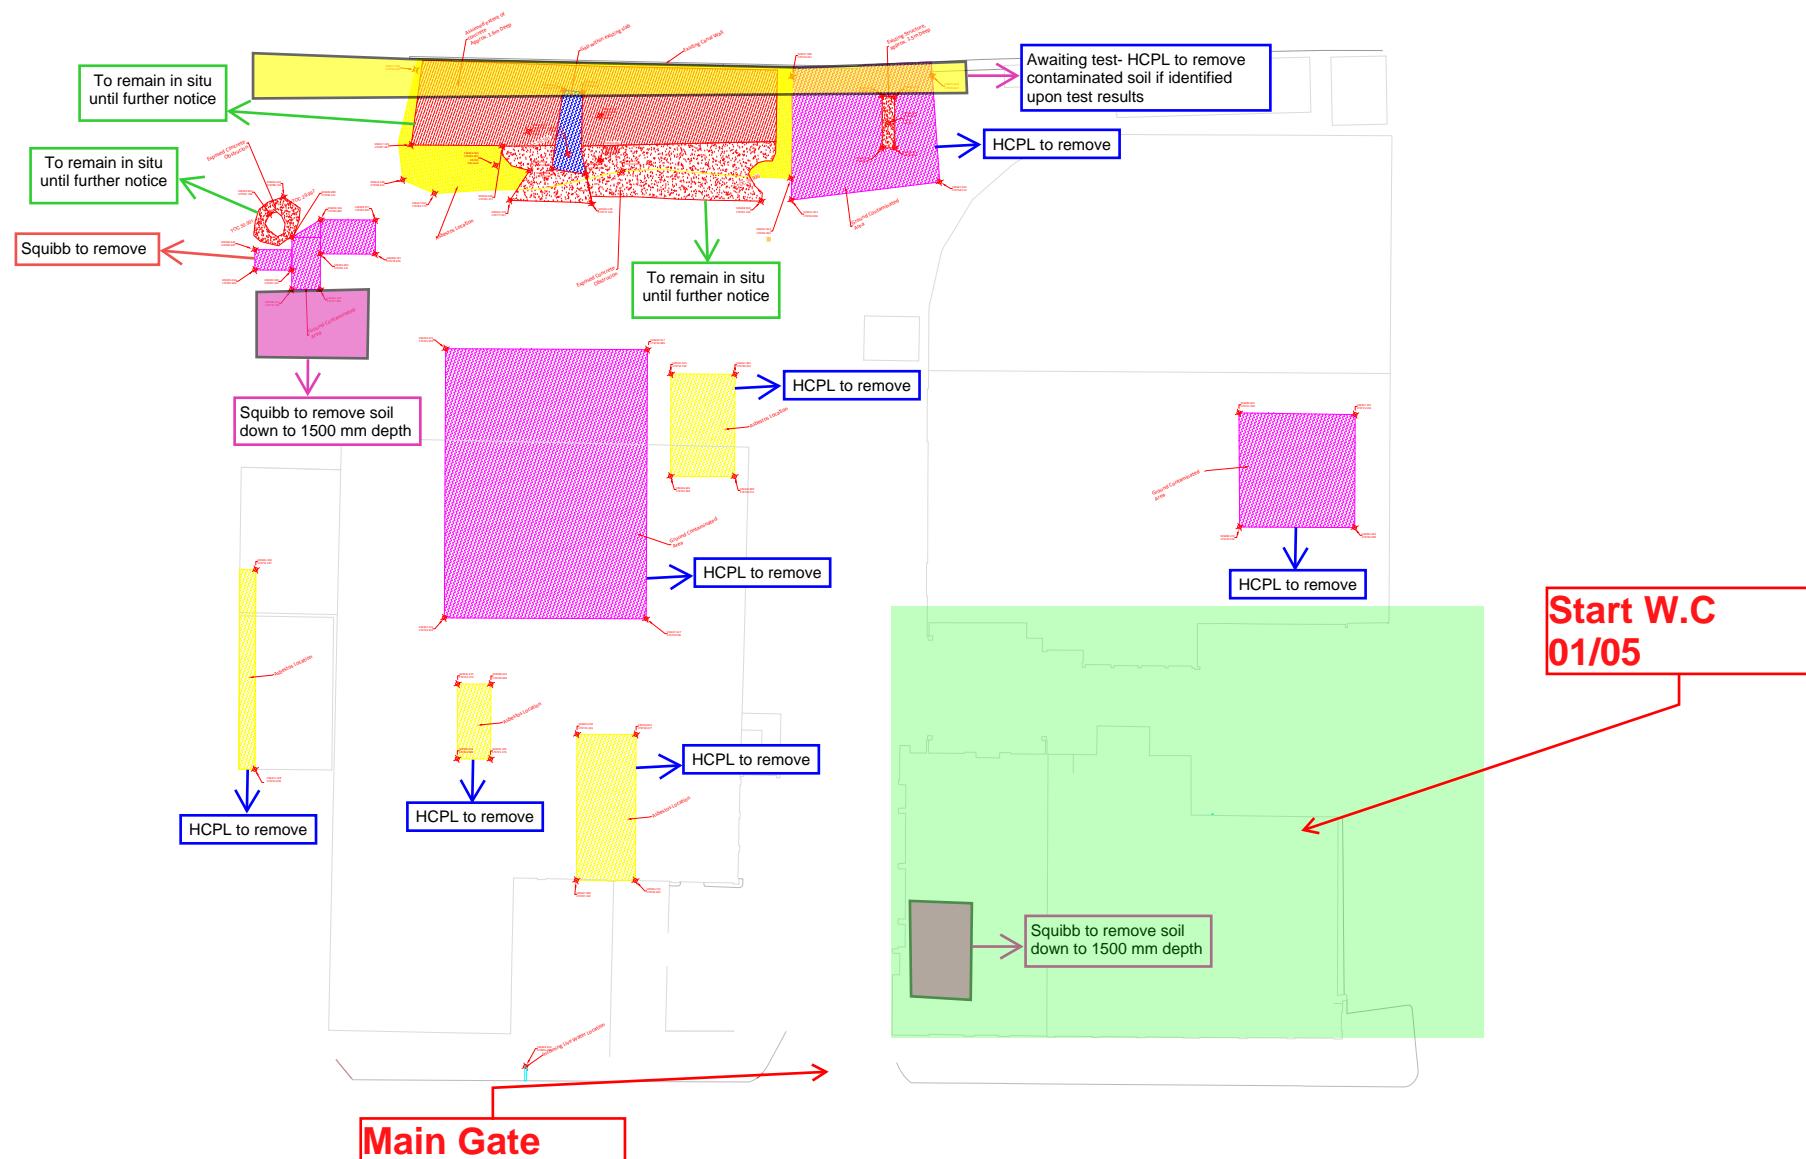
Key

- Assumed Obstructions in Ground
- Exposed Concrete Obstructions
- Gap Between Concrete Slabs
- Asbestos
- Contaminated Ground
