**Contaminated Land,  
Phase 1 Desktop Study,  
6 The Runway, Ruislip,  
HA4 6SE**

**On behalf of Skyline Construction Group**

REPORT DATE: 5 January 2021

REPORT REF: TBCT/21/01/SCG/TR/CLR

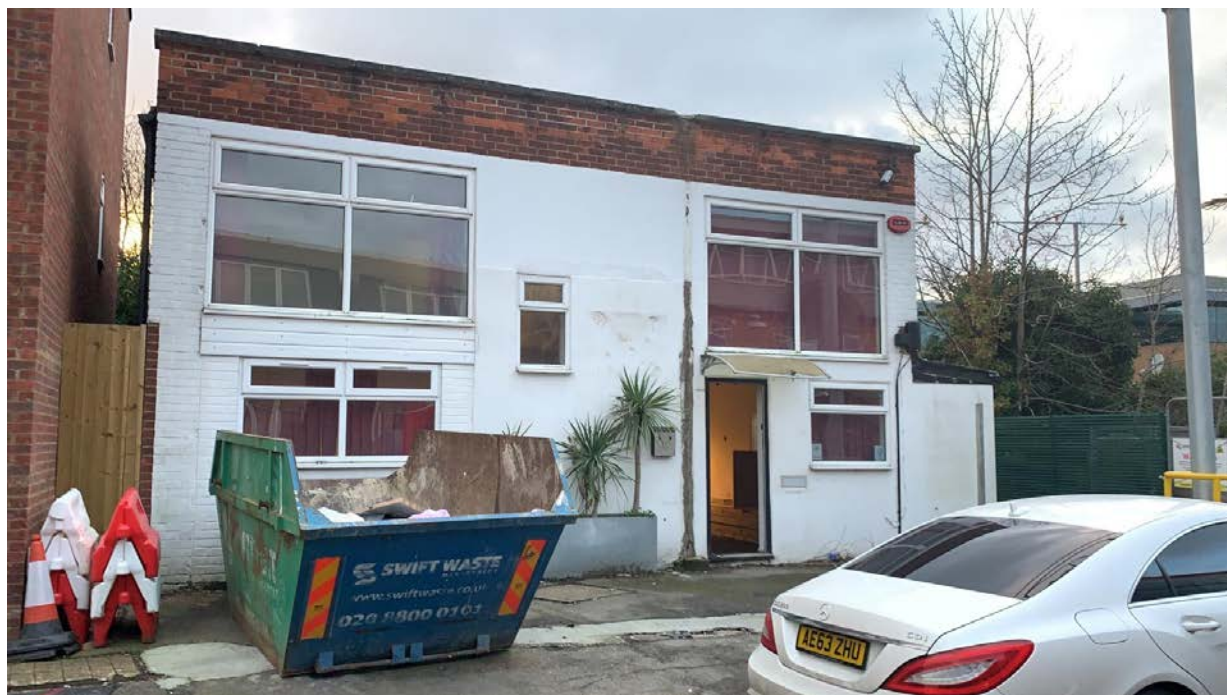
Photograph 1: View of front of the property.

| Section | | Description / Information | | |
|---|---|---|---|---|
| Site layout, activities, structures and operations: | <p>The site currently comprises a two-storey office building of brick construction (Photograph 1). The building was segregated into separate office room areas (Photograph 2), a small kitchen and bathroom area was also evident. The site is currently set in a predominantly residential/commercial area (Photograph 4).</p> <p>No bulk storage of waste was observed. No bulk storage of chemicals, fuels etc. was observed. No visual signs of ground contamination were observed inside the building or outside the building during the walkover.</p> | | | |

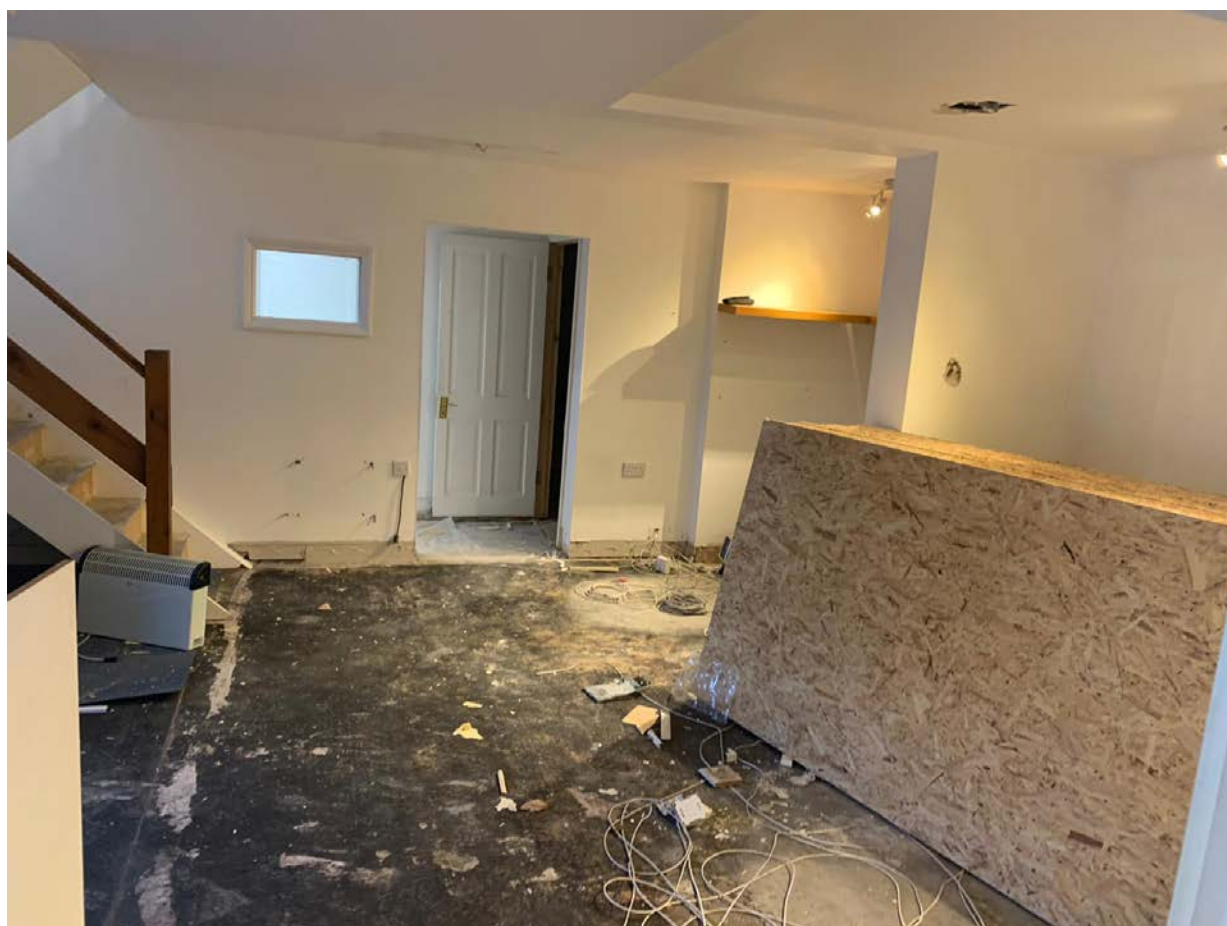
Photograph 2: View inside the property

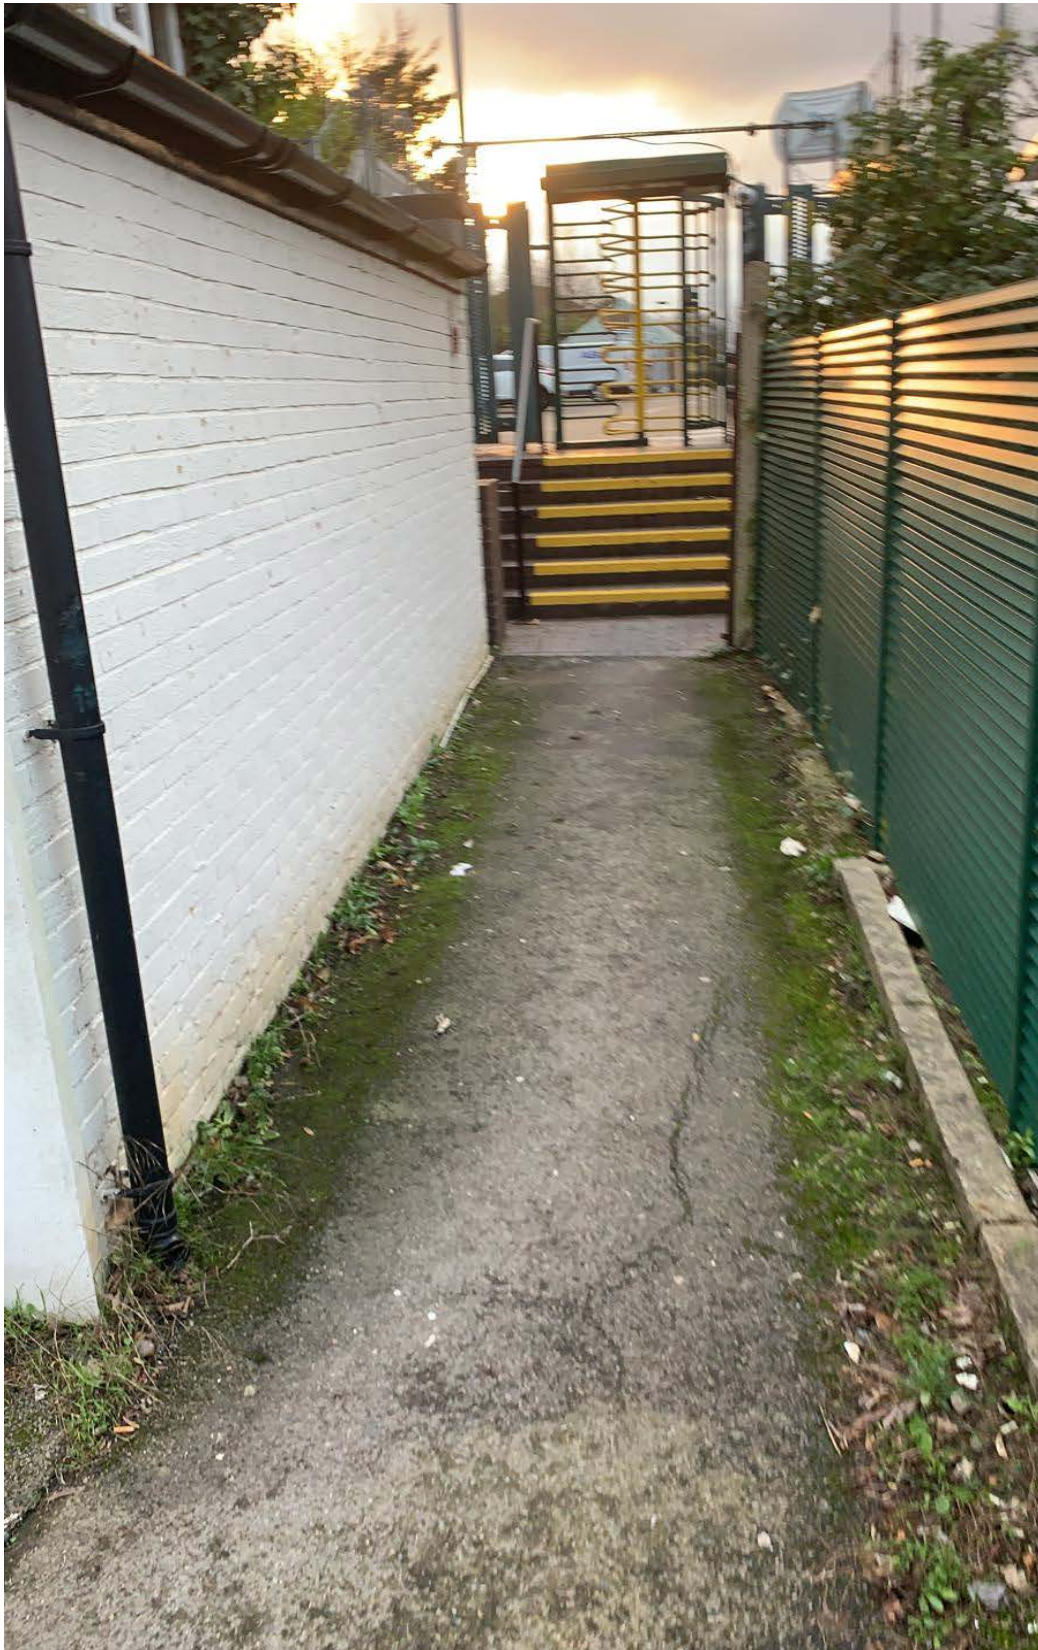
Photograph 3: View to the side of the property

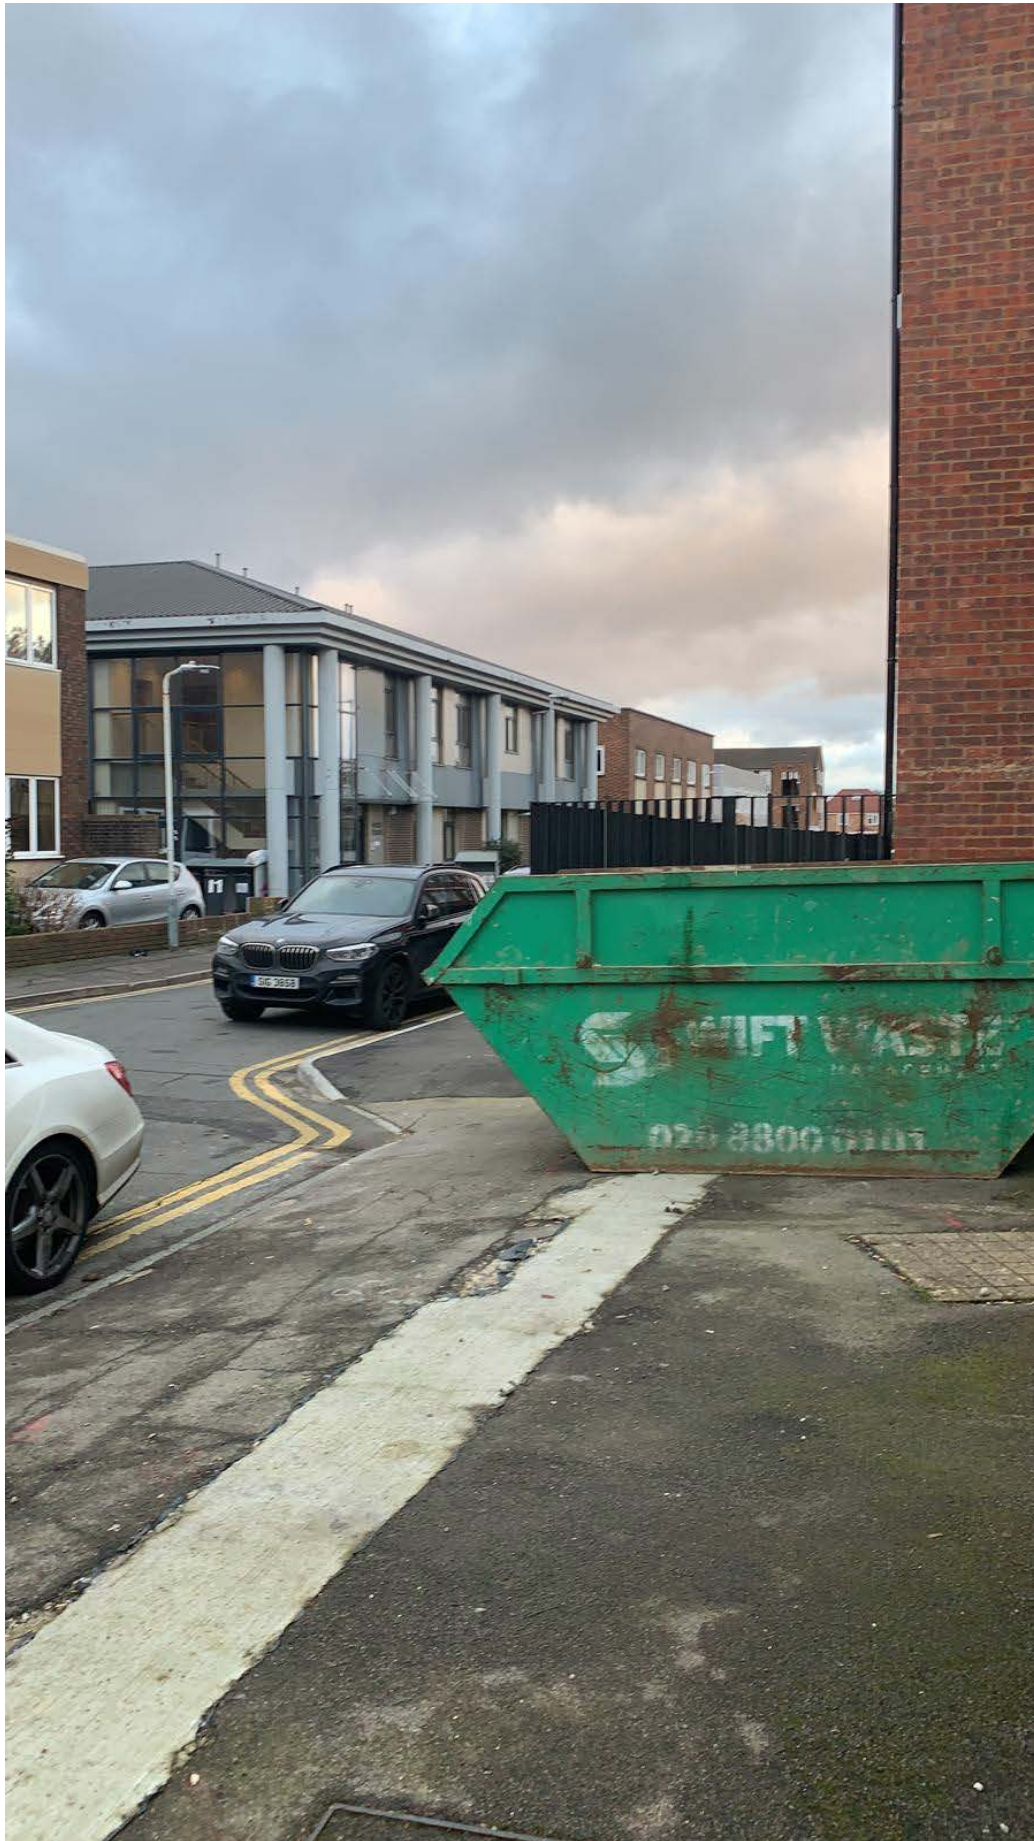
Photograph 4: View from site looking northeast
