Phase 1: Preliminary Risk Assessment

Land Adjacent to Building 2, Status Park, Nobel Drive, Harlington, Hayes UB3 5EY

Project no.:		Project name:		
8127		Land at Status Park, Nobel Drive		
Version:	Written by:	Checked by:	Authorised by:	Date:
V1	Diarmuid Mac Aodha Bhui	Stefan Cannon	Richard Schofield	07 November 2022
V2	Diarmuid Mac Aodha Bhui	Stefan Cannon	Richard Schofield	10 February 2022

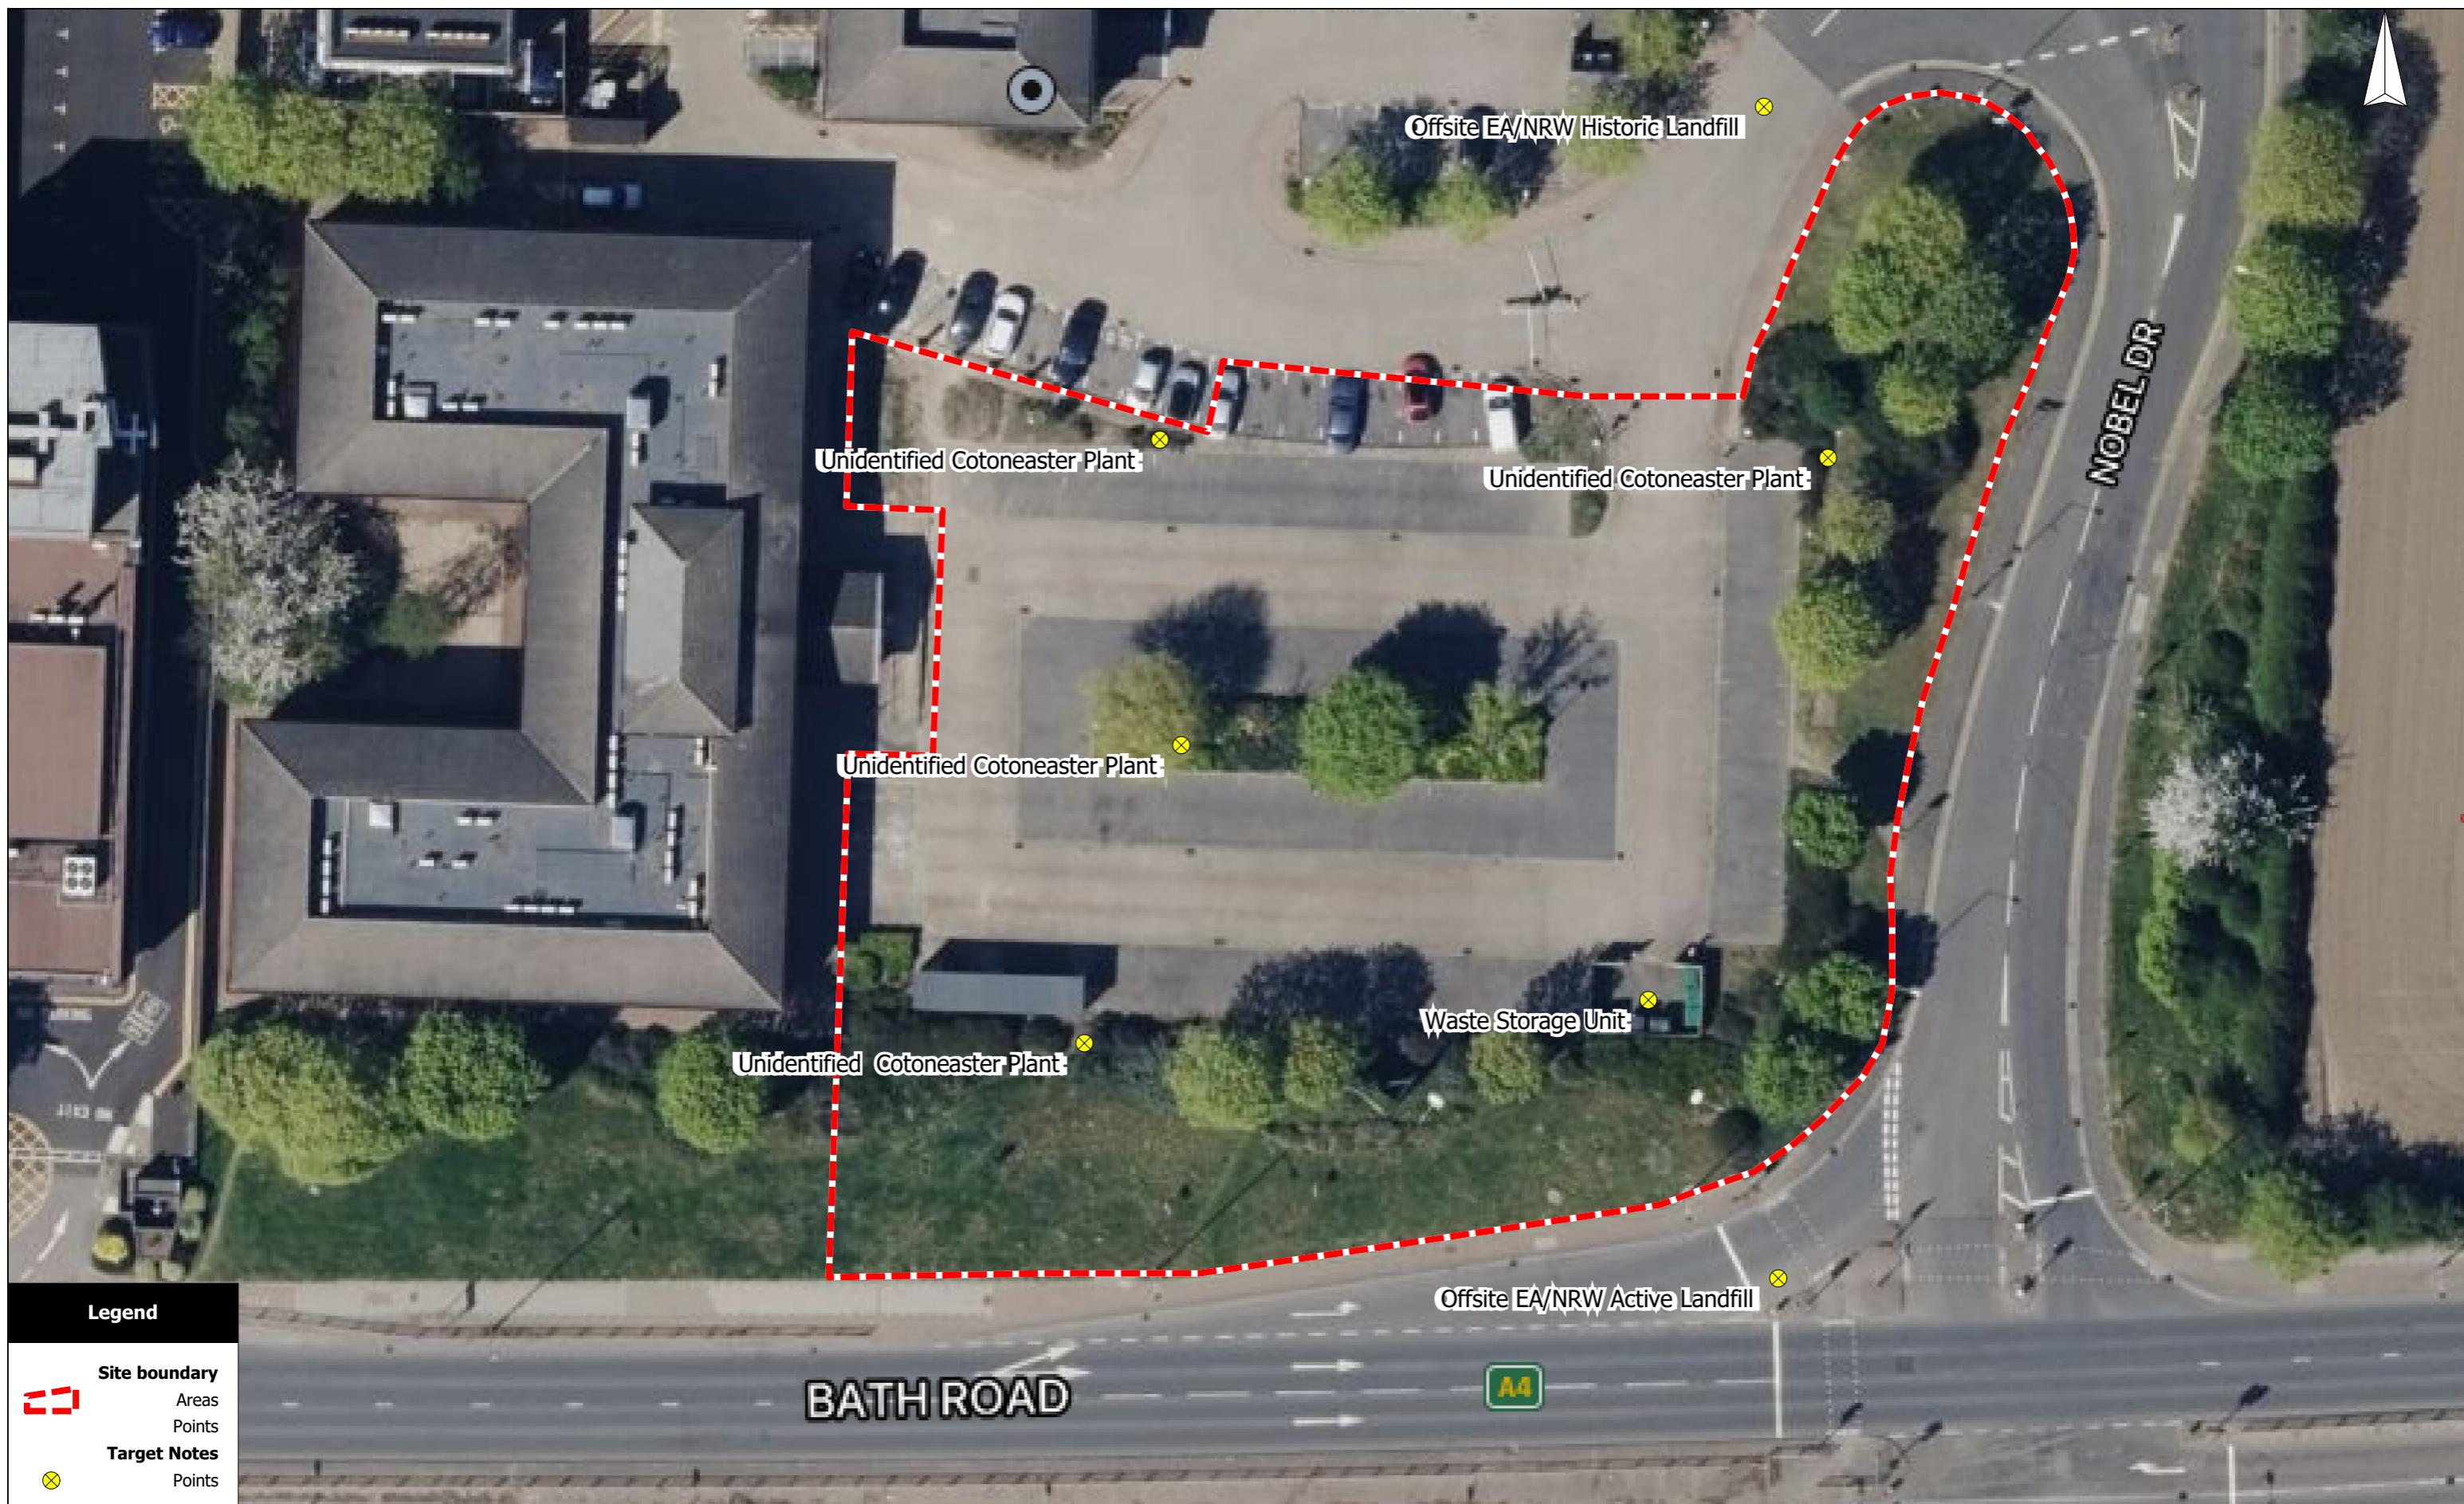
**Figure 1: PRA Survey at
Land Adjacent to Building 2, Status Park, Nobel Drive,
Harlington, Hayes UB3 5EY**

- 5.4 There were several metal-grate drains across the site that could act as pathways for contaminants from the surface to the soils beneath. Other potential pathways include the joints between the bricks and small cracks seen in the tarmac. There was no obvious staining on the surfaces of the site. Where soils were at the surface, kerbstones separated them from the tarmac, as well as being upslope of the camber of the carpark.

- 5.7 One manhole cover was observed on the site where the new development is proposed. This is at the western end of the central planted area.
- 5.8 Building 2 is surrounded by several rodent traps by the base of the walls, with three of these being within two metres of the western site boundary.
