**PHASE 2 GEO-ENVIRONMENTAL INVESTIGATION  
of a site at  
UXBRIDGE INDUSTRIAL ESTATE, ARUNDEL ROAD,  
UXBRIDGE  
for  
CYRIL LEONARD LTD**

**Project No 1833  
Report ref: 1833-P2GE-1-B  
Issued: 29 September 2020  
Revision: B**

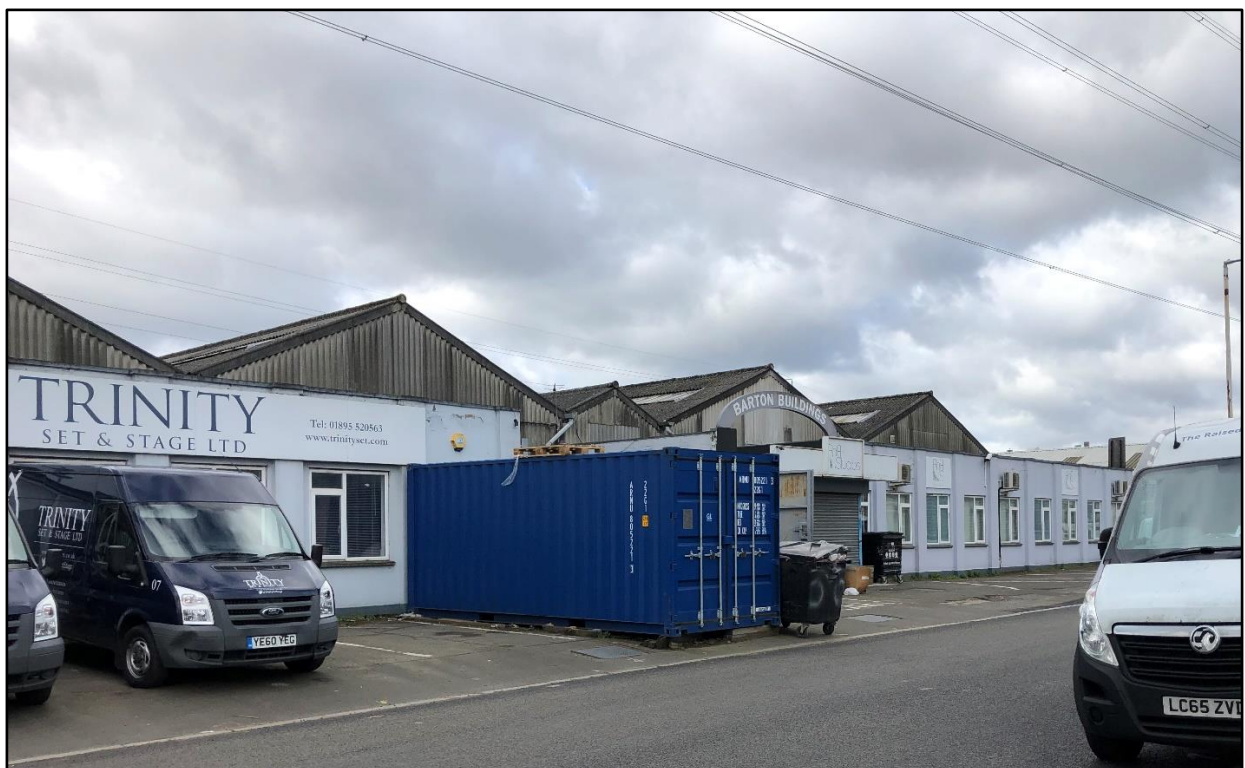
**Photograph 1: View of the site from Arundel Road**

The units form a 'U' shape around a small yard on the north of the site and occupy the greater part of the site. An access road runs along the north edge of the site from Arundel Rd to the yard. The access road and yard are concrete surfaced. There is an electrical sub-station in the yard. There are parking spaces along Arundel road frontage, which is asphalt surfaced, there is also a shipping container located on the frontage.

The main buildings are generally brick built, single storey with pitched roofs with skylights, while the RnR building and the entrance to the Trinity unit have flat roofs. The floors appear to be concrete slabs.

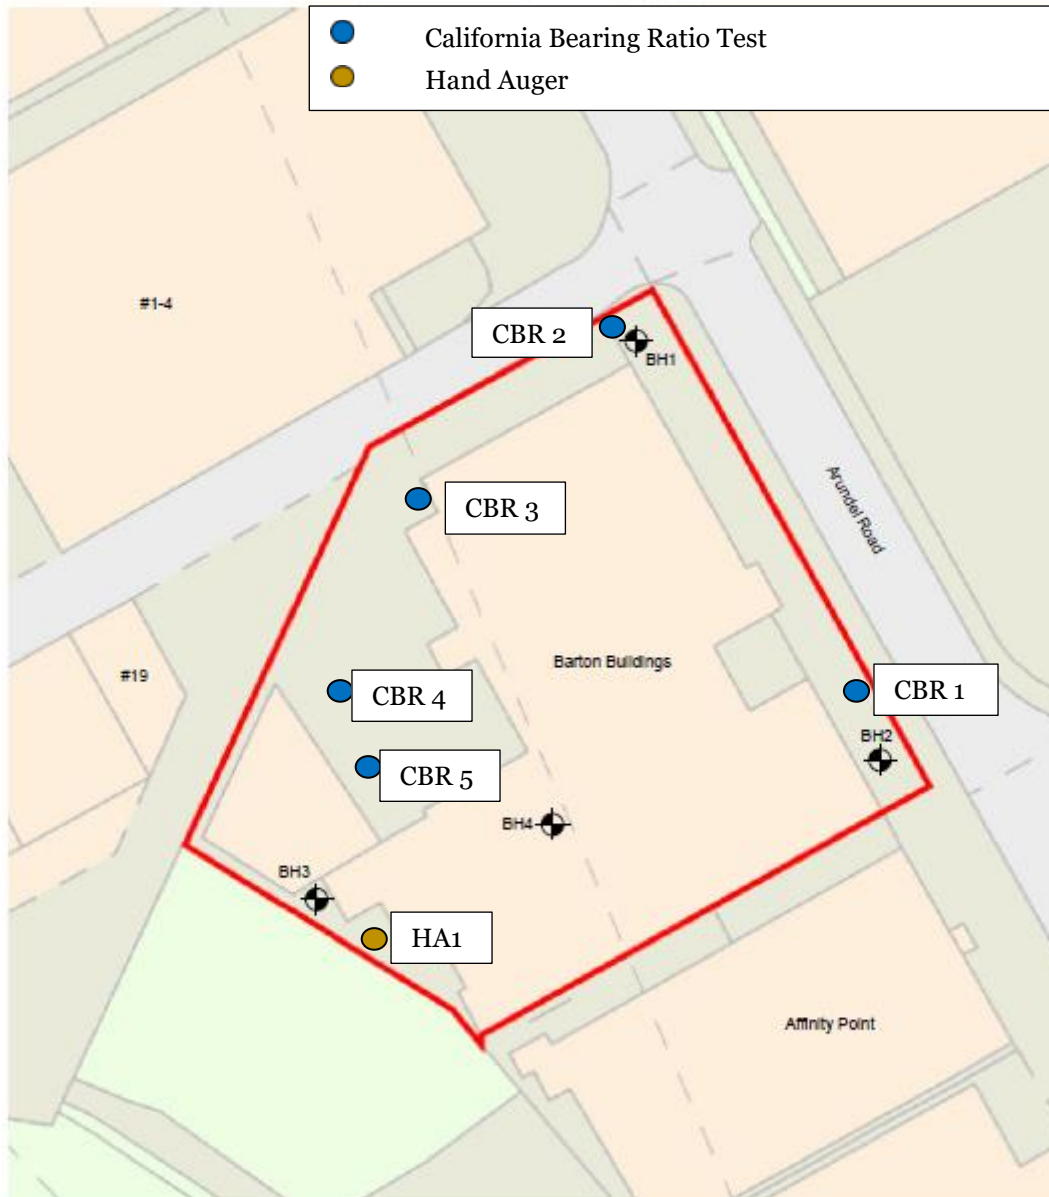
## **Appendix B – Site Works Plan**

**Survey date:** 29-30/07/2020
