Phase 2 Ground Investigation Report

Abellio Bus Garage,
North Hyde Gardens,
Hayes,
UB3 4QQ

A REPORT PREPARED FOR AND ON BEHALF OF:
Ark Data Centres Limited

Issue Date: 05 November 2021
Revision No: B
Revision Date: 18 October 2022

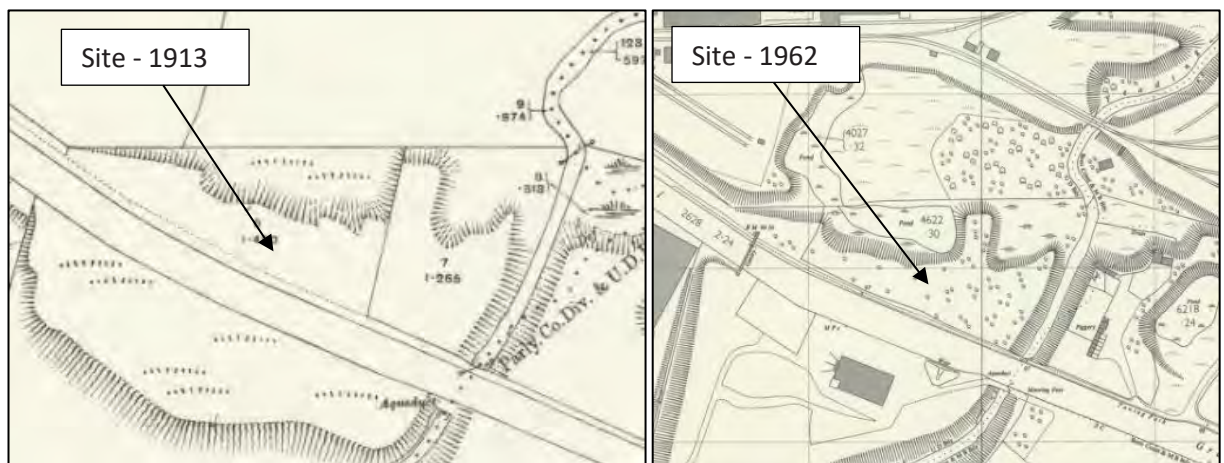
Plate 2. Historical Mapping

In addition, historical mapping dated 1913 indicates the site to have been raised at this time, remaining in this condition until at least 1962, with marshland present at a lower level to the north of the site. This is presented in Plate 2 below.
