Validation Report

Rowlheys Place, West Drayton, Middlesex UB7 9NQ

London Borough of Hillingdon Council

Reference: 22220/VR Rev1.0
March 2026

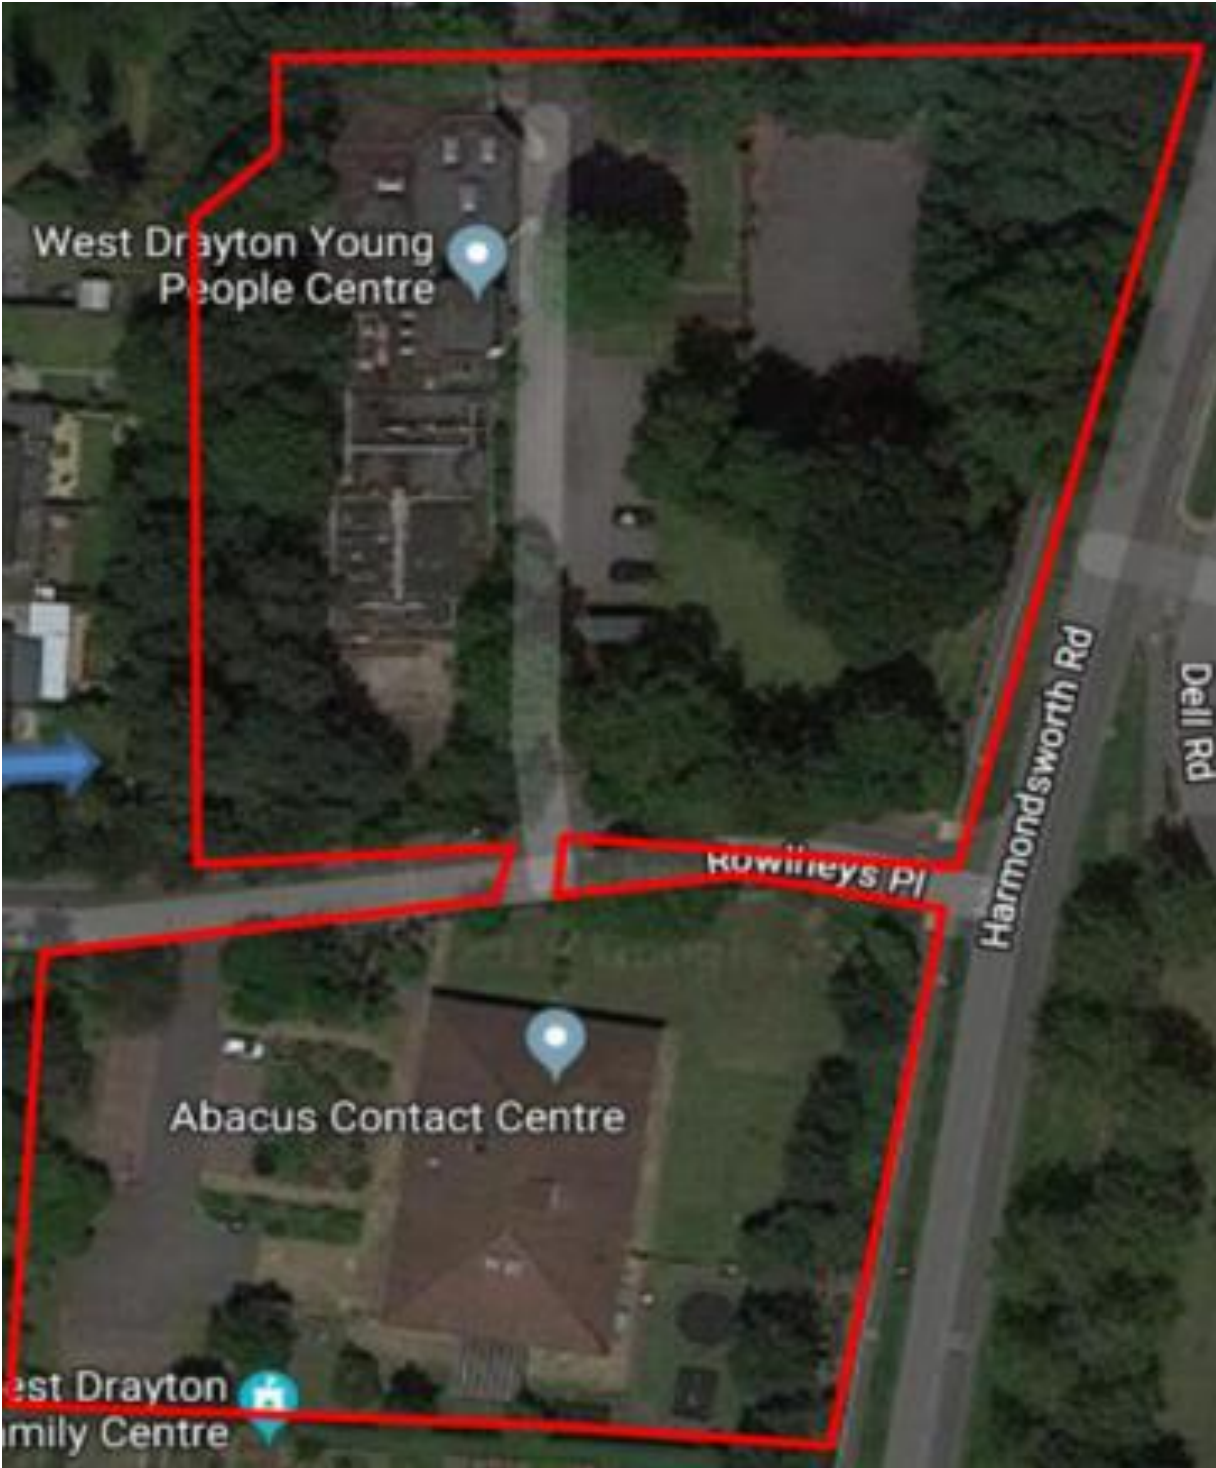
Figure 2 – Aerial Photograph

An aerial photograph of the site and its close environs before the completion of the development has been included in Figure 2 for reference.

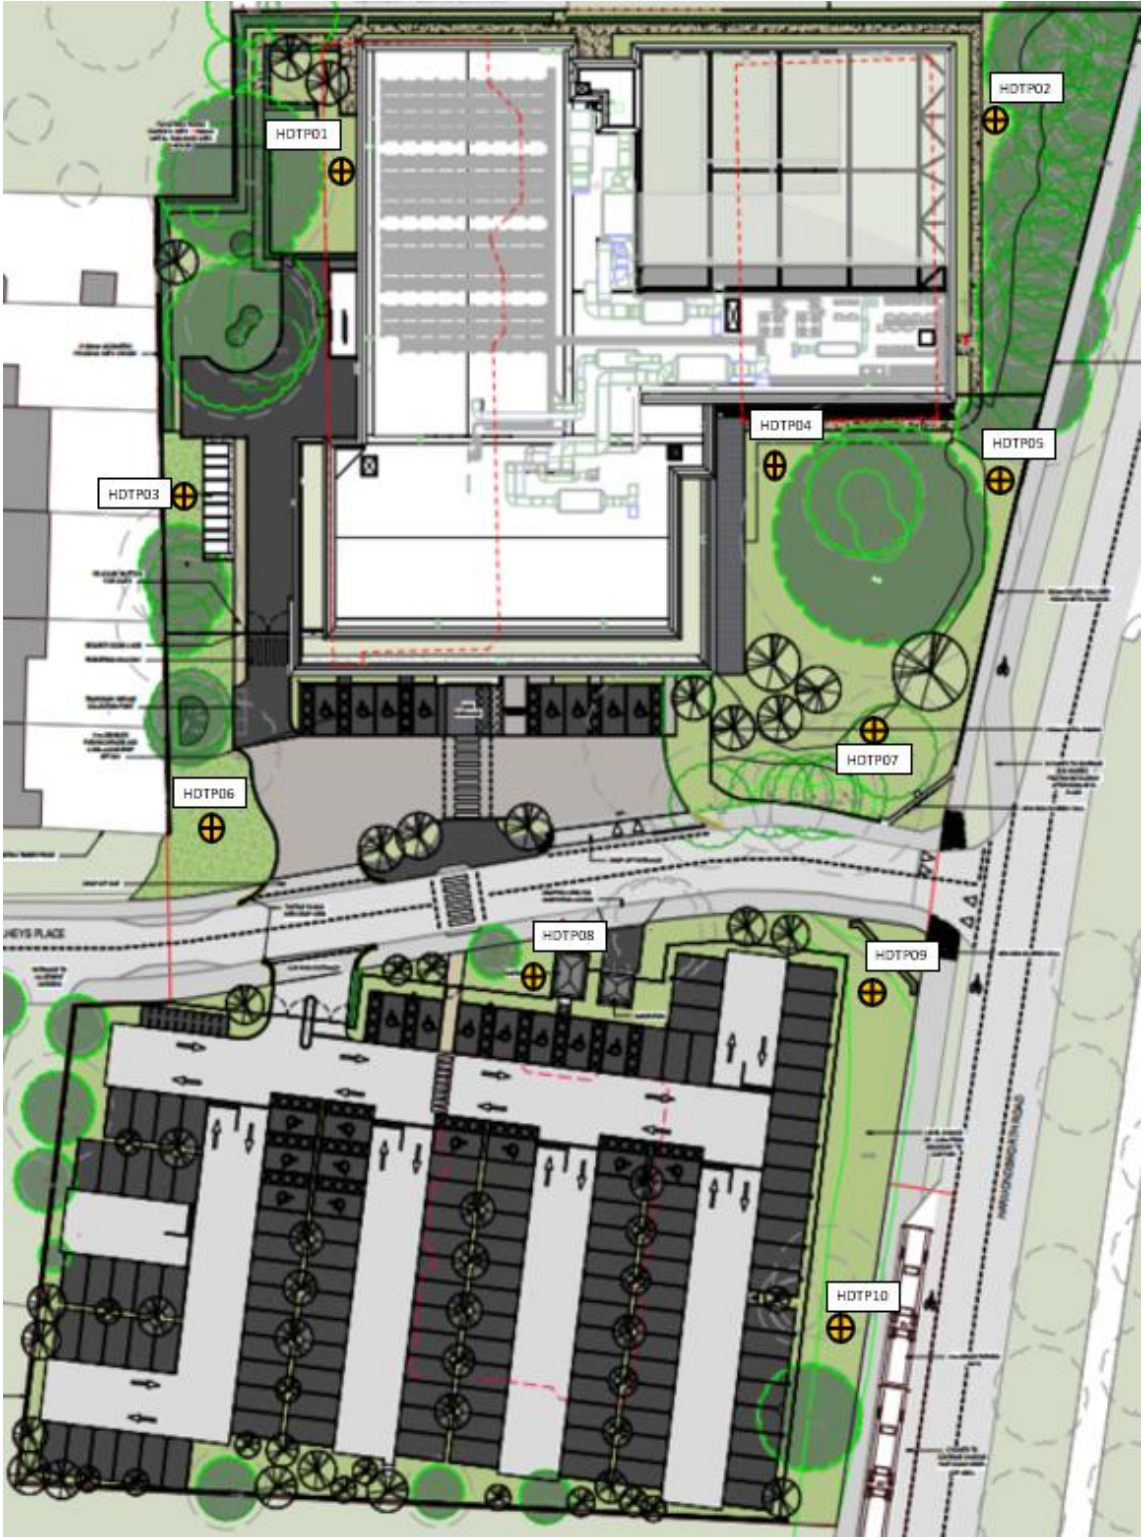
Figure 3 – Validation Sampling Locations

Samples were taken from the formation level and cover soils in ten locations (HDTP01 to HDTP10) within the soft landscaping across the site to verify their suitability for use. Sampling and validation works were undertaken across two visits on 1st December 2025 and 30th January 2026. It must be noted that construction works were in the final stages of completion during the latter visit, with some topsoil still to be placed in the areas of HDTP04 and HDTP05. As such, samples were taken from the adjacent topsoil stockpile that was to be used as cover soils in these areas, as confirmed by the contractor on site.

None of the tested samples recorded an exceedance of the relevant criteria for the development end-use, and as such demonstrated their suitability for use.
