Detailed Unexploded Ordnance (UXO) Risk Assessment

Project Name	Beaches Yard
Client	Harvest Land Management Ltd.
Site Address	Beaches Yard, Horton Road, West Drayton, UB7 8HX
Report Reference	DA15689-00
Date	25 th May 2022
Originator	HS

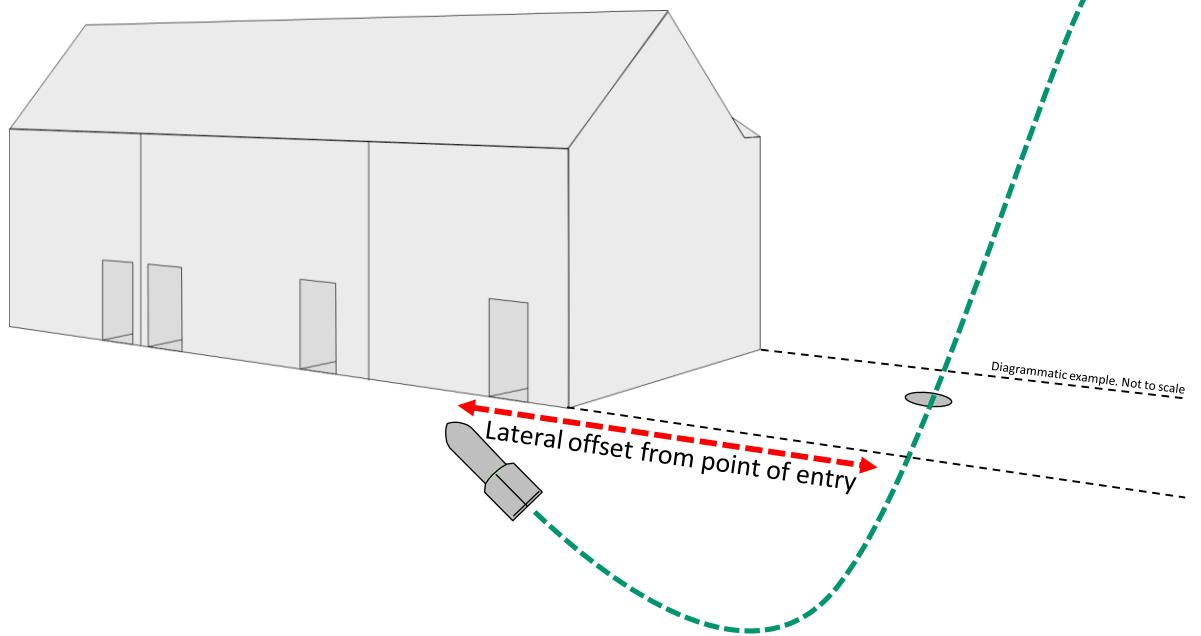
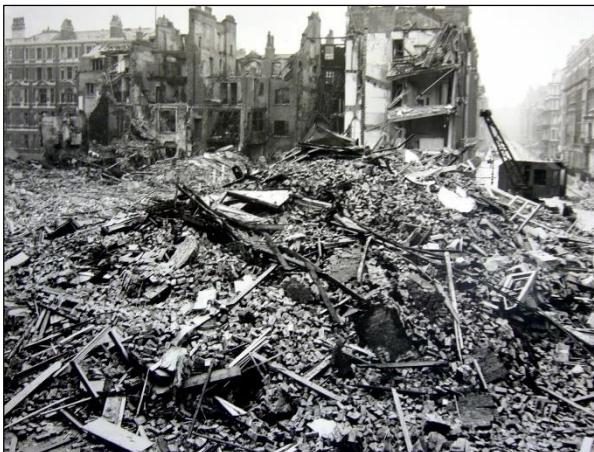
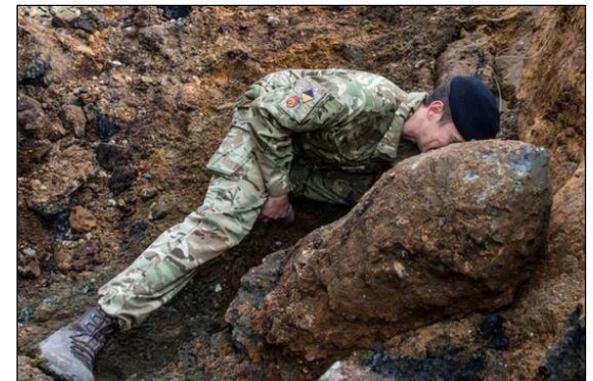
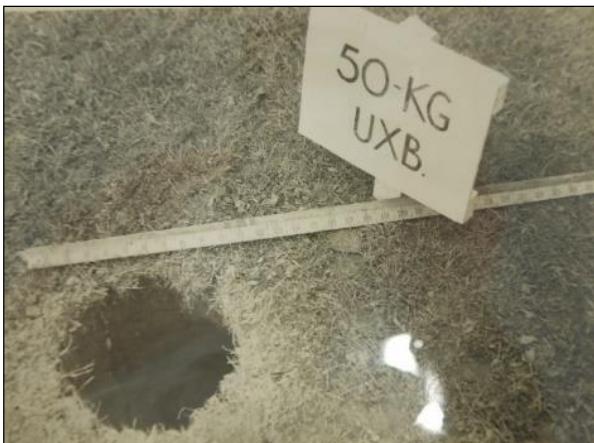
Top: J-curve Effect - Due to angle of entry, unexploded bombs would often end their trajectory at a lateral offset from point of entry, often ending up beneath adjacent extant structures/sites. The photograph above shows 250kg bomb found in Bermondsey pointing upwards, demonstrating 'J-curve'

One of the most common scenarios for UXO going unnoticed was when a UXB fell into a 'bomb site' (such as the area shown **Top Left**), the entry hole of the bomb obscured by any debris and rubble present. Note that the entry hole of a 50kg UXB could be as little as 20cm in diameter (**Left**).

J-curve is the term used to describe the characteristic curve commonly followed by an aerial delivered bomb dropped from height after it penetrates the ground. Typically, as the bomb is slowed by its passage through underlying soils, its trajectory curves towards the surface. Many UXBs are found with their nose cone pointing upwards as a result of this effect. More importantly, however, is the resulting horizontal offset from the point of entry. This is typically a distance of about one third of the bomb's penetration depth, but can be higher in certain conditions (see **Annex F**).

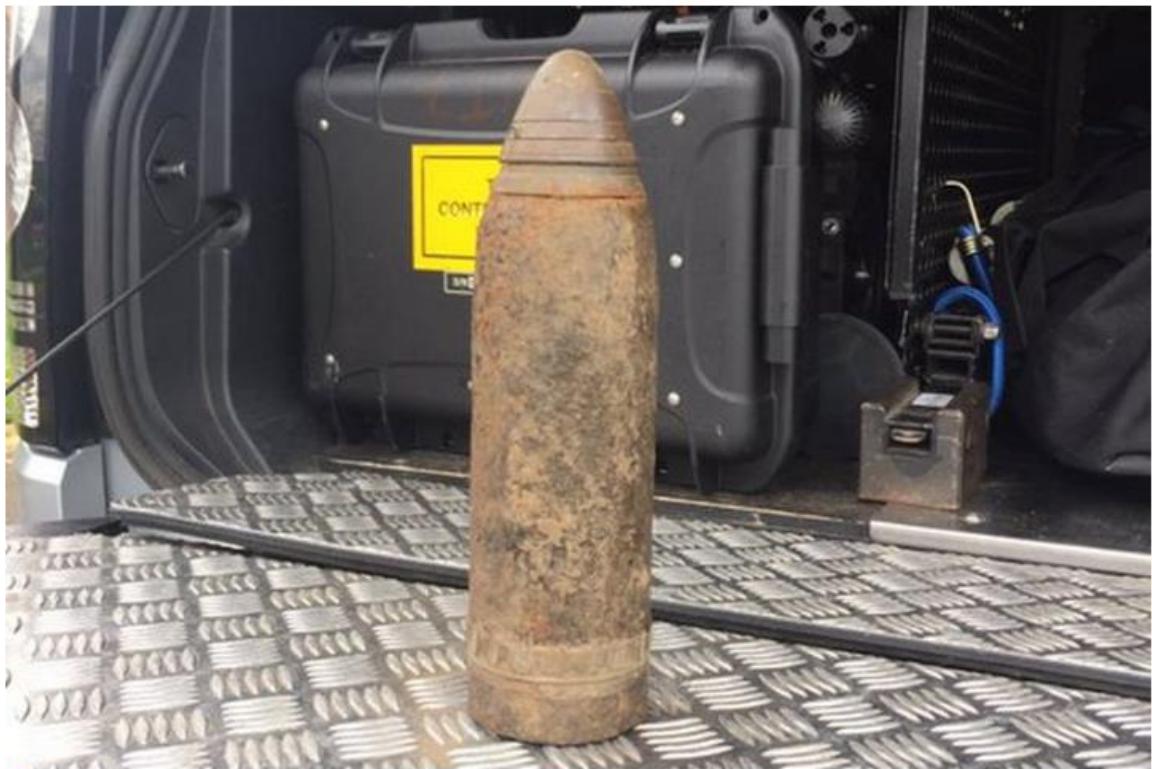
West Drayton gardener discovers a First World War bomb in an allotment

■ The bomb landed in West Drayton more than 100 years ago (Image: Met Police)

An allotment gardener in [West Drayton](#) was shocked to find an unexploded First World War bomb underground.

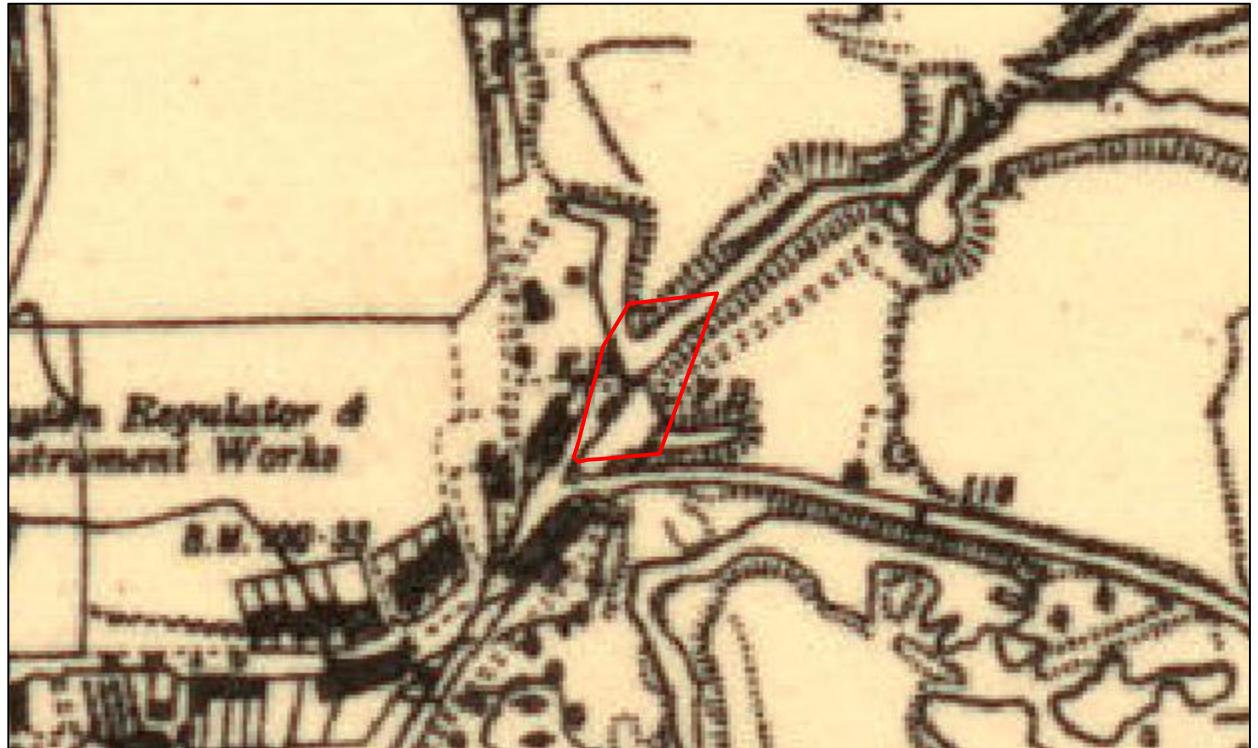
Night Bombing up to 7th October 1940

● ● Recorded bomb strike

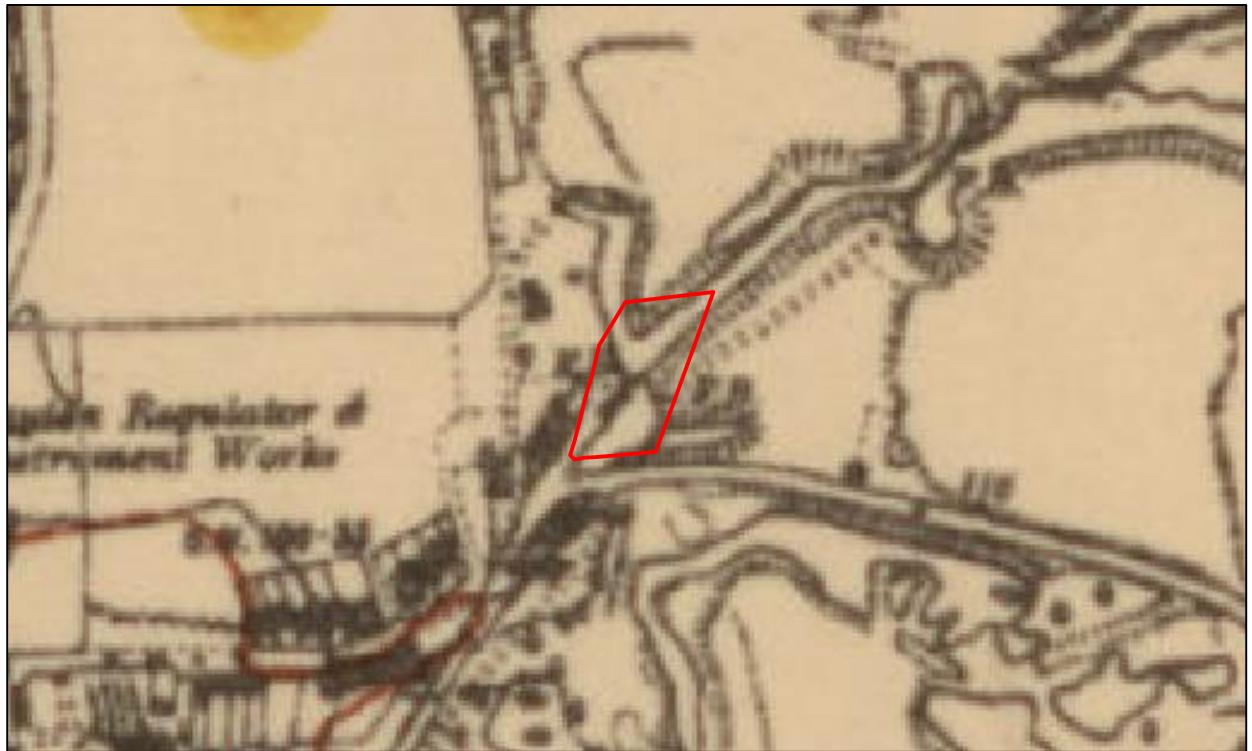
21st – 28th October 1940

Recorded HE bomb strike

Recorded UXB strike

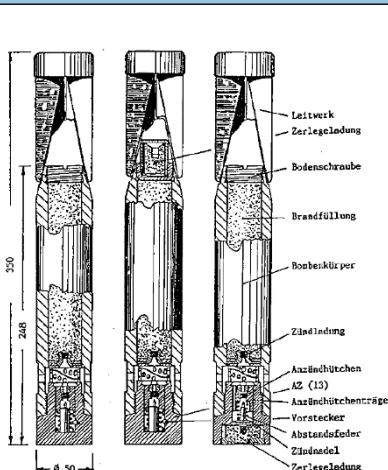
1kg Incendiary Bomb

Bomb Weight	1.0 and 1.3kg (2.2 and 2.87lb)
Explosive Weight	680gm (1.3lb) Thermite
Fuze Type	Impact fuze
Bomb Dimensions	350 x 50mm (13.8 x 1.97in)
Body Diameter	50mm (1.97in)
Use	As incendiary – dropped in clusters against towns and industrial complexes
Remarks	Magnesium alloy case. Sometimes fitted with high explosive charge. The body is a cylindrical alloy casting threaded internally at the nose to receive the fuze holder and fuze.

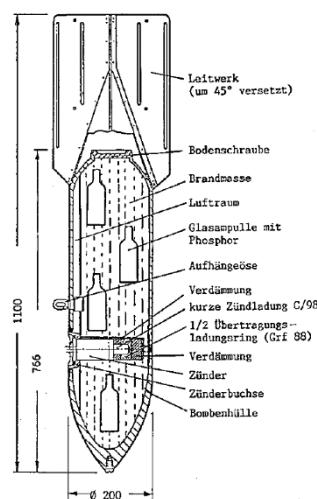
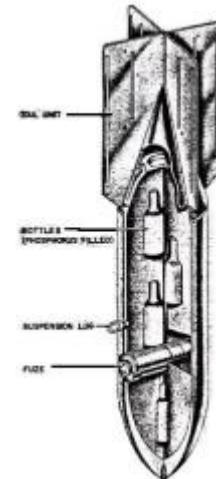
C50 A Incendiary Bomb

Bomb Weight	c41kg (90.4lb)
Explosive Weight	0.03kg (0.066lb)
Incendiary Filling	12kg (25.5lb) liquid filling with phosphor igniters in glass phials. Benzine 85%; Phosphorus 4%; Pure Rubber 10%
Fuze Type	Electrical impact fuze
Bomb Dimensions	1,100 x 280mm (43.2 x 8in)
Use	Against all targets where an incendiary effect is to be expected
Remarks	Early fill was a phosphorous/carbon disulphide incendiary mixture

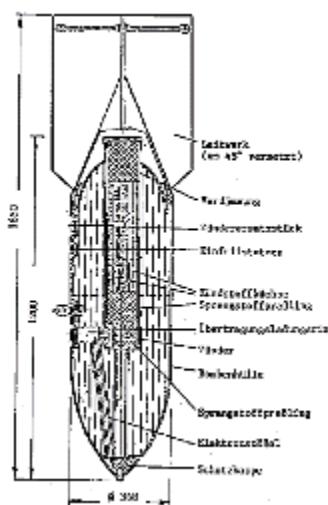
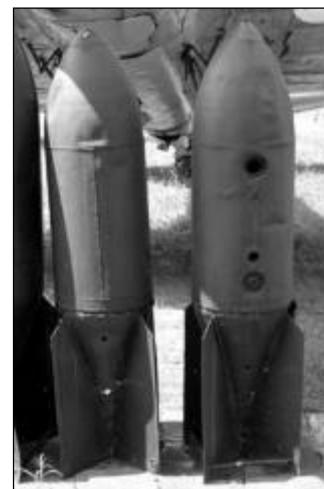
Flam C-250 Oil Bomb

Bomb Weight	125kg (276lb)
Explosive Weight	1kg (2.2lb)
Fuze Type	Super-fast electrical impact fuze
Filling	Mixture of 30% petrol and 70% crude oil
Bomb Dimensions	1,650 x 512.2mm (65 x 20.2in)
Body Diameter	368mm (14.5in)
Use	Often used for surprise attacks on living targets, against troop barracks and industrial installations. Thin casing – not designed for ground penetration

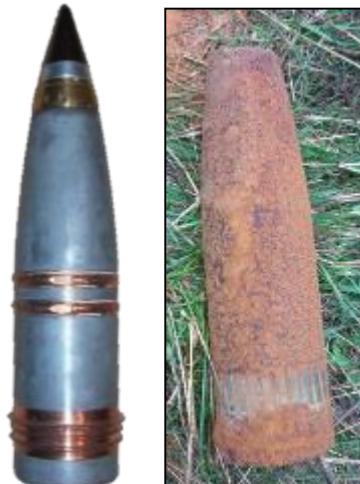
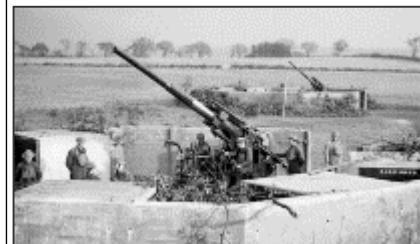
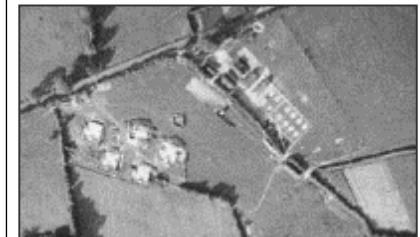
QF 3.7 Inch WWII Anti-Aircraft Projectile

Projectile Weight	28lb (12.6 kg)
Explosive Weight	2.52lbs
Fuze Type	Mechanical Time Fuze
Dimensions	3.7in x 14.7in (94mm x 360mm)
Rate of Fire	10 to 20 rounds per minute
Use	High Explosive Anti-Aircraft projectile. 4.5in projectiles were also used in this role.
Ceiling	30,000ft to 59,000ft

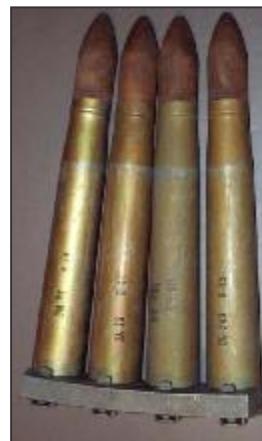
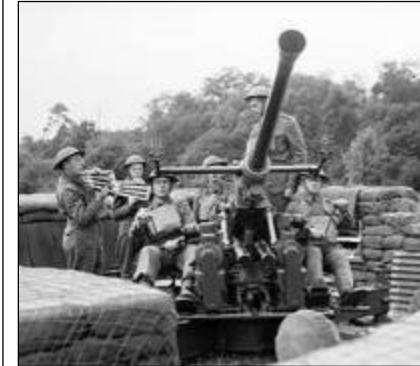
40mm Bofors Projectile

Projectile Weight	1.96lb (0.86kg)
Explosive Weight	300g (0.6lb)
Fuze Type	Proximity and Mechanical Time Fuze
Rate of Fire	120 rounds per minute
Projectile Dimensions	40mm x 310mm (1.6in x 12.2in)
Ceiling	23,000ft (7000m)

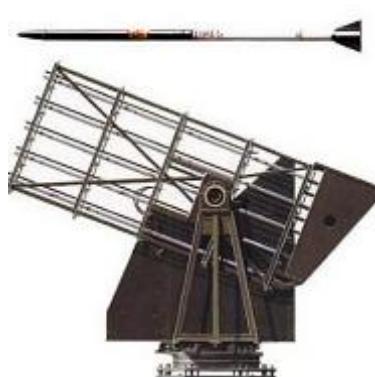
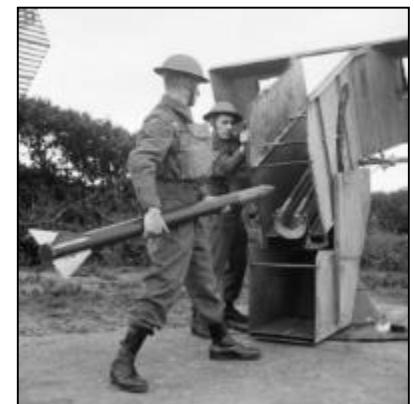
Unrotated Projectile (UP) – Z Battery

Projectile Weight	84lb (24.5kg)
Warhead Weight	4.28lb (1.94kg)
Warhead	Aerial Mine with a No. 700 / 720 fuze
Filling	High Explosive
Dimensions	1930mm x 82.6mm (76 x 3.25in)
Use	As a short range rocket-firing anti-aircraft weapon developed for the Royal Navy. It was used extensively by British ships during the early days of World War II. The UP was also used in ground-based single and 128-round launchers known as Z Batteries.
