**TUSCANY, OAK GLADE, NORTHWOOD,  
HA6 2TY**

**PRELIMINARY BAT ROOST  
ASSESSMENT**

Report No: RT-MME-152842-02

Date: October 2020

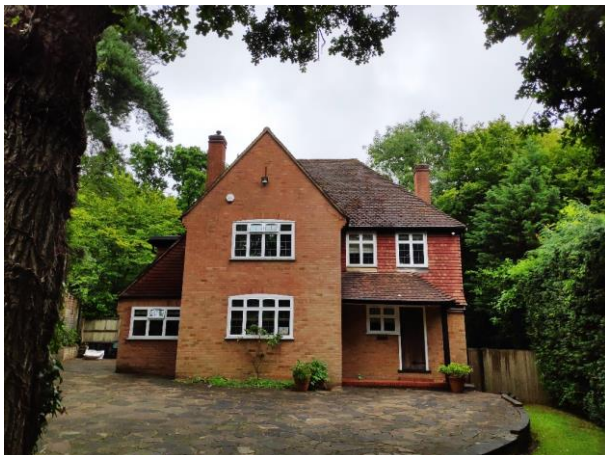
The main building on site was a detached brick built two storey structure with a multi-hipped roof and a smaller pitched gable on the front elevation (Plate 3.1). A sloped roofed single-storey extension with a flat roofed dormer protruded from the northern elevation (Plate 3.2). Two brick chimneys extended from the northern and southern rooflines.

**Plate 3.1: Western Aspect**

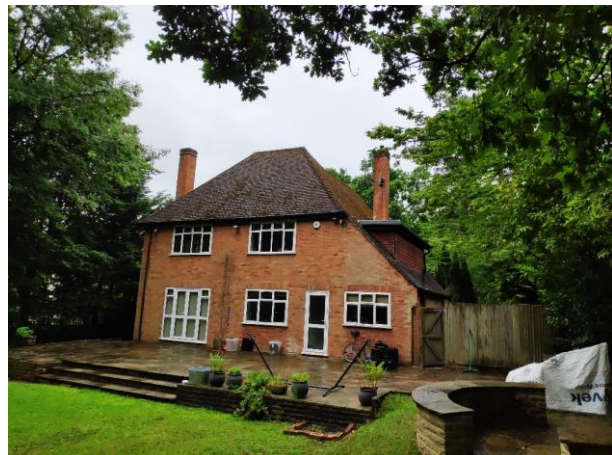
**Plate 3.2: Eastern Aspect**

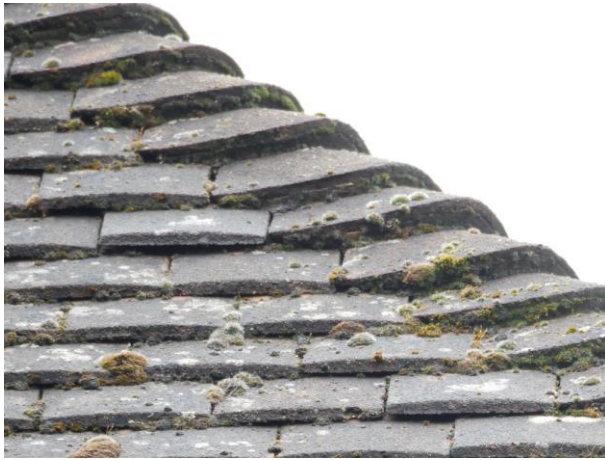
Clay roof tiles and were largely intact on the main structure however, warped tiles were noted along the south-western corner of the hipped roof and more prominently along the pitched gable roof and single storey extension sloped roof (Plates 3.3, 3.4 and 3.5). Damage was also noted to a ridge tile on the pitched gable and slipped tiles were noted on the northern elevation sloped roof and the porch roof (Plate 3.6). Mortar along the edge of the gable end was in poor repair and a near continuous crack was found to lead under the

**Plate 3.3: Lifted Tiles on Main Roof**

The building has been identified as having high potential to support roosting bats. Bat Surveys: Good Practice Guidelines published by the Bat Conservation Trust (Collins, 2016) recommends that for buildings with high bat roosting potential at least three dusk emergence and/or dawn re-entry surveys should be undertaken during the bat emergence/re-entry survey season to determine the presence/absence of roosting bats within the buildings. The bat emergence/re-entry survey season extends from May to September. At least two of the surveys should be undertaken during the peak season for emergence/re-entry surveys between May and August and one of the three surveys should be a dawn re-entry survey. If a roost is discovered during these surveys, a Natural England licence application may be required.

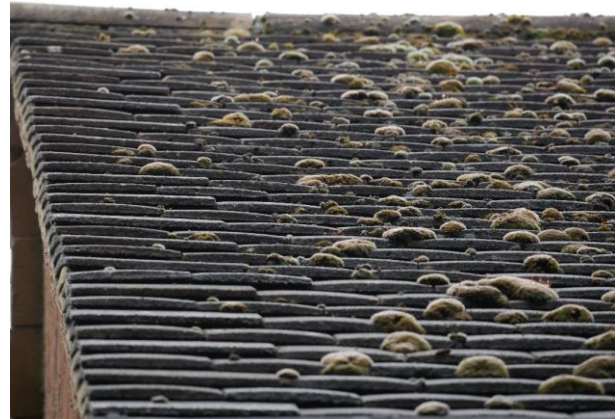
**Plate 3.4: Lifted Tiles on the Pitched Gable and Damaged Ridge Tile**

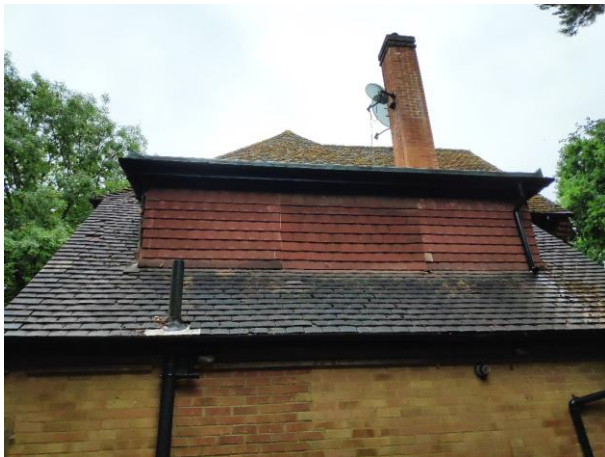
**Plate 3.5: Lifted Tiles on Sloped Roof**

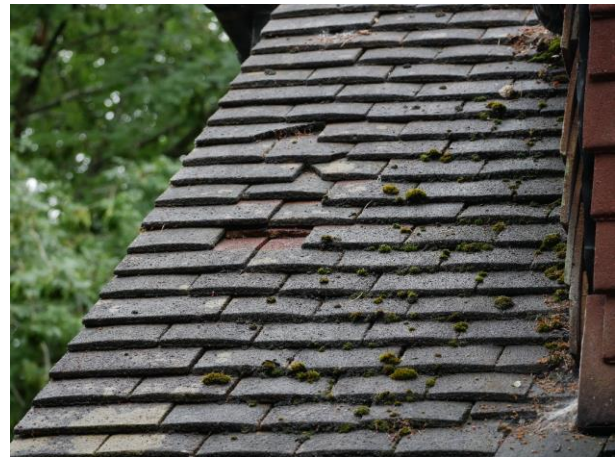
**Plate 3.6: Slipped Tiles**

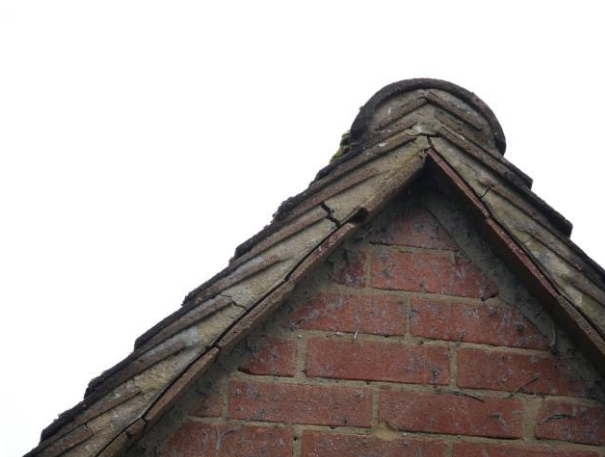
edge tiles of the gable (Plate 3.7). Lead flashing was lifted around the flat roofed dormer and chimneys, presenting gaps beneath for fauna to access crevices between the joints (Plate 3.8).

**Plate 3.7: Damaged Mortar on Gable**

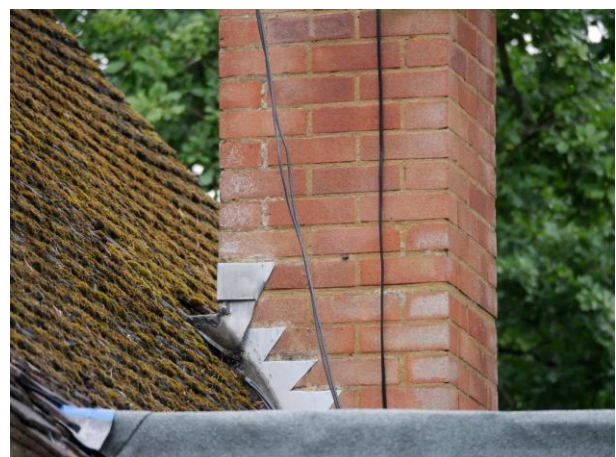
**Plate 3.8: Lifted Flashing around Chimney**

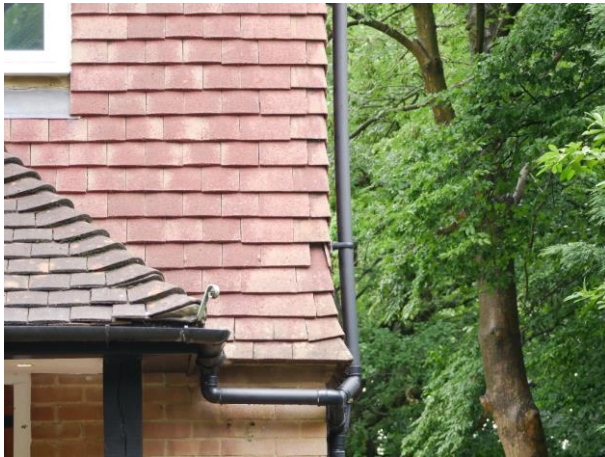
Soffit boxes were generally intact and in good repair throughout. A small area of repaired soffit was noted on the southern elevation which appeared to be well sealed from ground level. Hanging tiles were present on the upper level brickwork of the main structure and around the dormer. Tiles were generally lifted and warped. Slipped tiles were also noted, prominently on the south-west corner of the building (Plate 3.9) and the edge tiles of the dormer were open (Plate 3.10). These features present favourable access points to crevices between tiles and larger areas between tiles and the underlying frame.

Plate 3.9: Damaged Hanging Tile

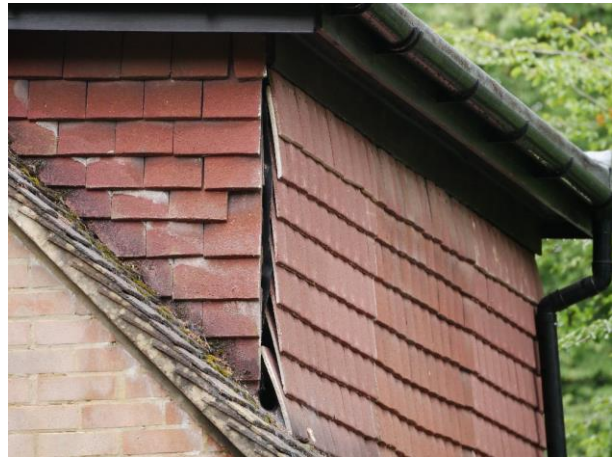
Plate 3.10: Open Hanging Tile Edge

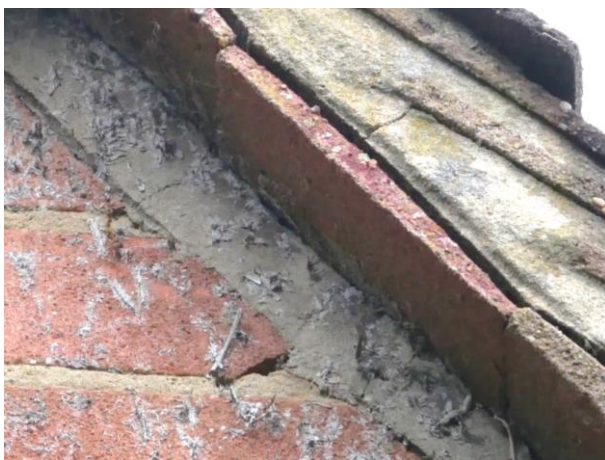
Brickwork was generally in good repair throughout, including on the chimneys and around the windows and doors. A small area of damaged mortar was noted at the top of the western elevation gable, which may provide access into the wall cavity or connect to the loft space (Plate 3.11). Where vents were present, these were too narrow to be used by bats (Plate 3.12).

Plate 3.11: Damaged Mortar on Gable Brickwork

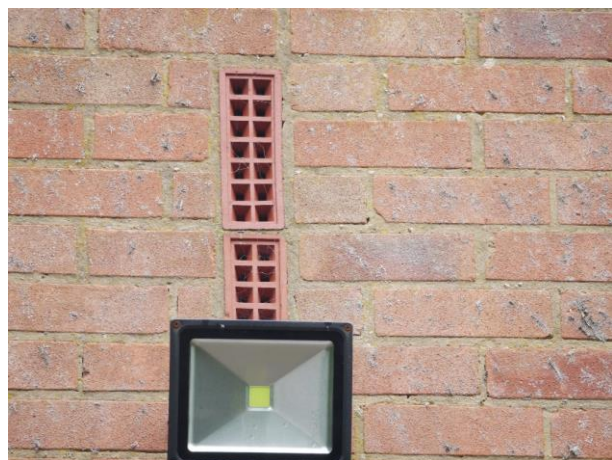
Plate 3.12: Vents – Unsuitable for Bats

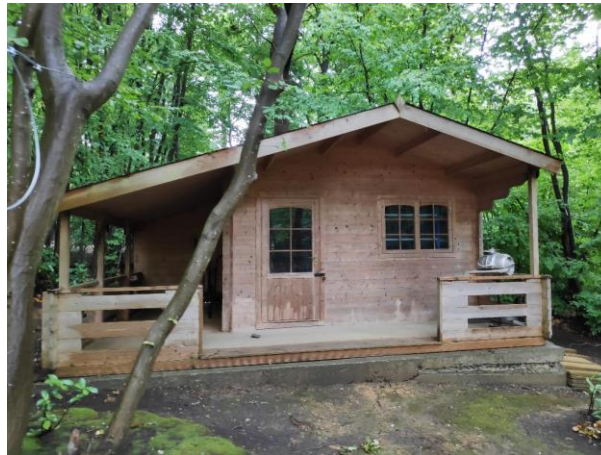
A modern timber summerhouse was located within the rear of the property (Plate 3.13). The structure had a pitched felt shingled roof and timber walls. The structure was in good repair throughout, presenting no potential roosting features of value to bats. The outer porch's smooth timber construction makes it generally unsuitable for use as a feeding perch for bats. No evidence of bats was noted during the external assessment of the structure.

Plate 3.13: Summerhouse

The Summerhouse was fully inspected and no bat roost was identified. The structure had no potential for roosting bats. The survey data obtained for the site is valid for 12 months from the survey date. If development works to the surveyed structure have not commenced within this timeframe it will be essential to update the survey effort to establish if suitable features have developed and if bats have colonised the structure in the interim. In the unlikely event that a bat is found during demolition works all works must immediately cease and a suitably qualified ecologist should be contacted.

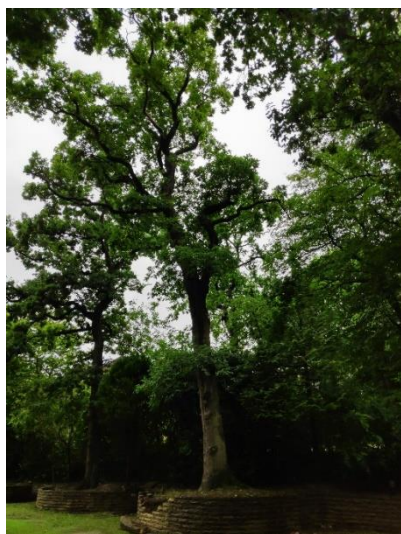
**Plate 3.14: T17**

| Tree No. | Species | Description | BCT Suitability Class | Plate No. |
|---|---|---|---|---|
| T17 | Oak | A mature oak 15 m in height and 1 m Diameter at Breast Height (DBH). Features noted included a snapped limb on the northern aspect at 10 m and snagged limb adjacent. | High | 3.14 and 3.23 |

Bat Survey: Good Practice Guidelines published by the Bat Conservation Trust (Collins, 2016) recommends that for trees with high bat roosting potential at least three dusk emergence and/or dawn re-entry surveys be undertaken during the bat activity season to determine the presence/absence of roosting bats within the trees. The bat activity season extends from May to September. At least one of the surveys should be a dawn re-entry survey, and at least two of the surveys should be undertaken between mid-May and August.

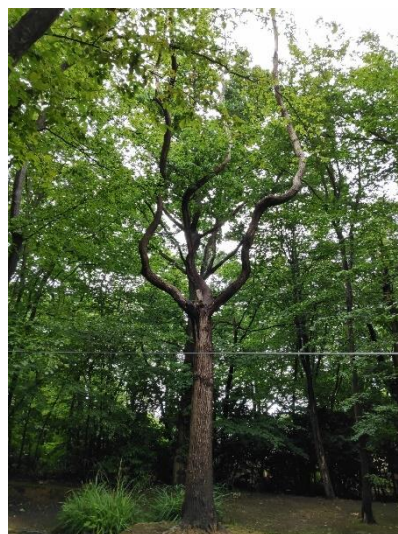
**Plate 3.15: T29**

| Tree No. | Species | Description | BCT Suitability Class | Plate No. |
|---|---|---|---|---|
| T29 | Oak | A mature oak 13 m in height and 0.75 m in DBH. Deadwood noted in upper vertical limbs with fissures that may lead into an internal cavity. | High | 3.15 |

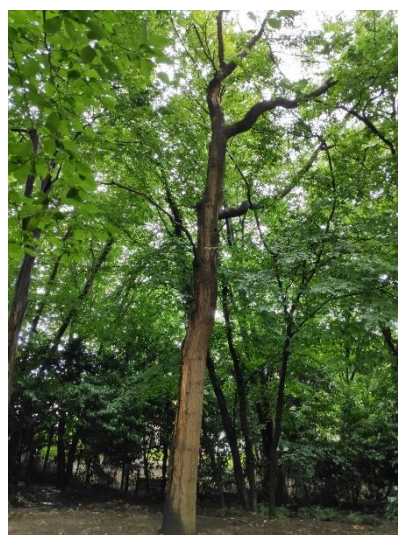
**Plate 3.17: T50**

| Tree No. | Species | Description | BCT Suitability Class | Plate No. |
|---|---|---|---|---|
| T50 | Oak | A mature oak 12 m in height and 0.75 m in DBH. A woodpecker hole was noted at 10 m on the main trunk. | High | 3.17 and 3.21 |

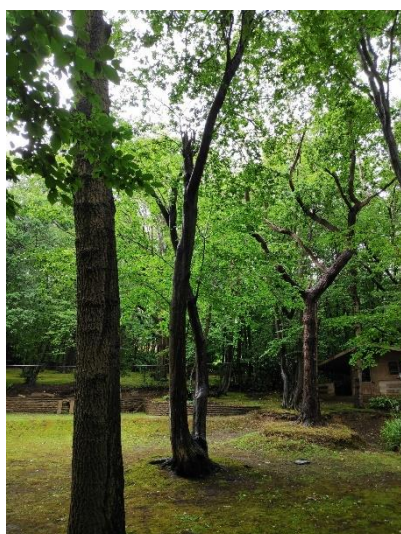
**Plate 3.18: T51**

| Tree No. | Species | Description | BCT Suitability Class | Plate No. |
|---|---|---|---|---|
| T51 | Hornbeam | A mature two stemmed hornbeam 10 m in height and 1 m in DBH. A snapped limb with a wound at the base was noted on a fork point at 6 m. | High | 3.18 and 3.25 |

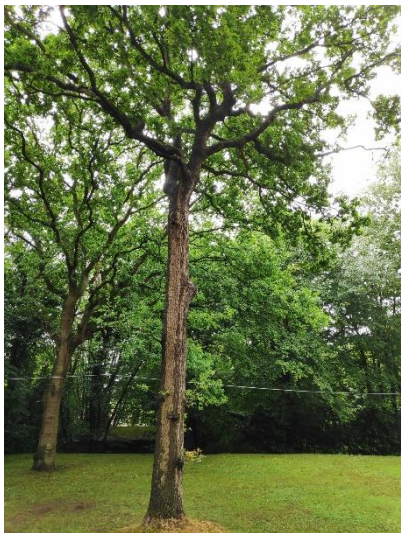
Plate 3.20: T40

| Tree No. | Species | Description | BCT Suitability Class | Plate No. |
|---|---|---|---|---|
| T40 | Oak | A mature oak 12 m in height and 0.75 m in DBH. A woodpecker hole was noted at 6 m on the northern aspect. | High | 3.20 |

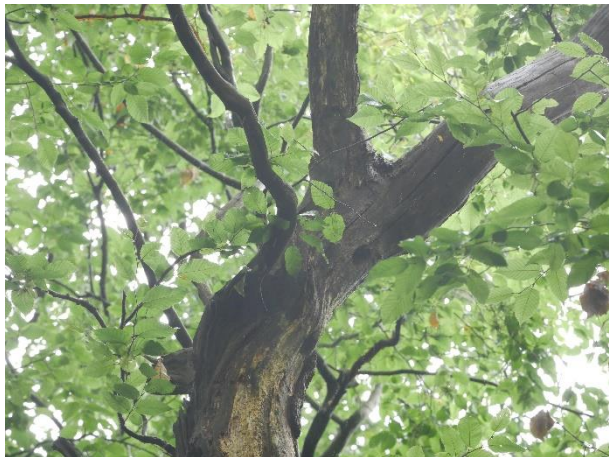
Plate 3.21: Woodpecker Hole

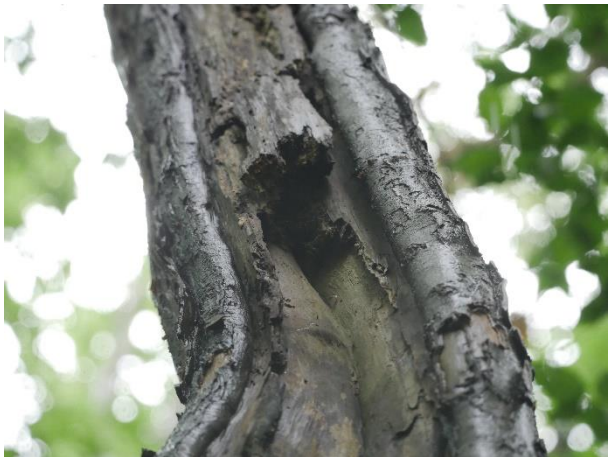
Plate 3.22: Deadwood with Potential Cavity

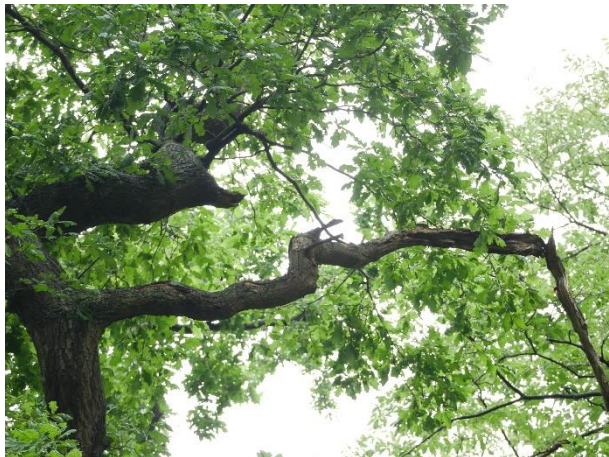
Plate 3.23: Snagged Limbs

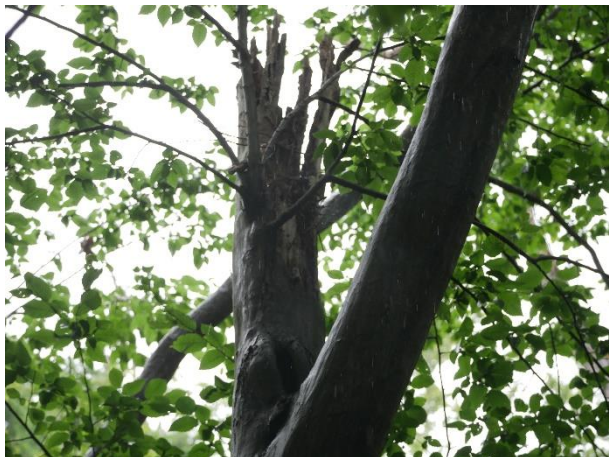
Plate 3.25: Snapped Limb with Wound at Base

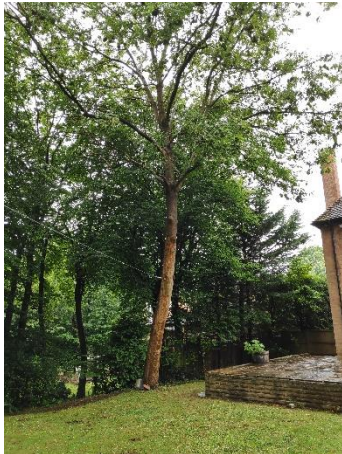
In addition to the trees noted above, 5 no. trees within the rear garden and 2 no within the front garden were considered to be of sufficient size and age to support potential roosting features, but none were recorded from ground level. Remaining trees offered negligible potential to support roosting bats.

**Plate 3.26: T68 – Low Potential Ash with no Visible Features**

It is recommended that a 'soft felling' approach is used for all required works to the above trees. In the unlikely event that a bat is found during works to the trees all works must immediately cease and a suitably qualified ecologist should be contacted.

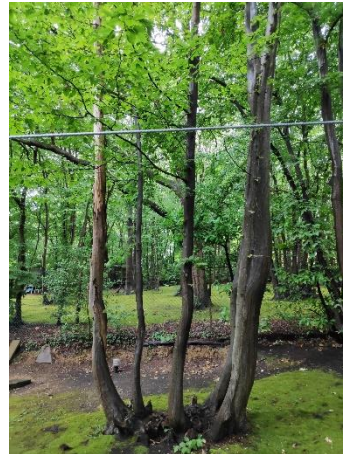
**Plate 3.27: Coppiced Hornbeam – Negligible Bat Roosting Potential**
