VALIDATION REPORT

Site Address:	Junction of Pump Lane & Crown Close, Hayes, Middlesex. UB3 3DN
Report Date:	August 2025
Project No.:	17713
Prepared for:	Higgins Partnership PLC
Planning Application	Hillingdon Council – APPLICATION NUMBER - 76550/APP/2021/4499

VALIDATION REPORT- PHASE 4

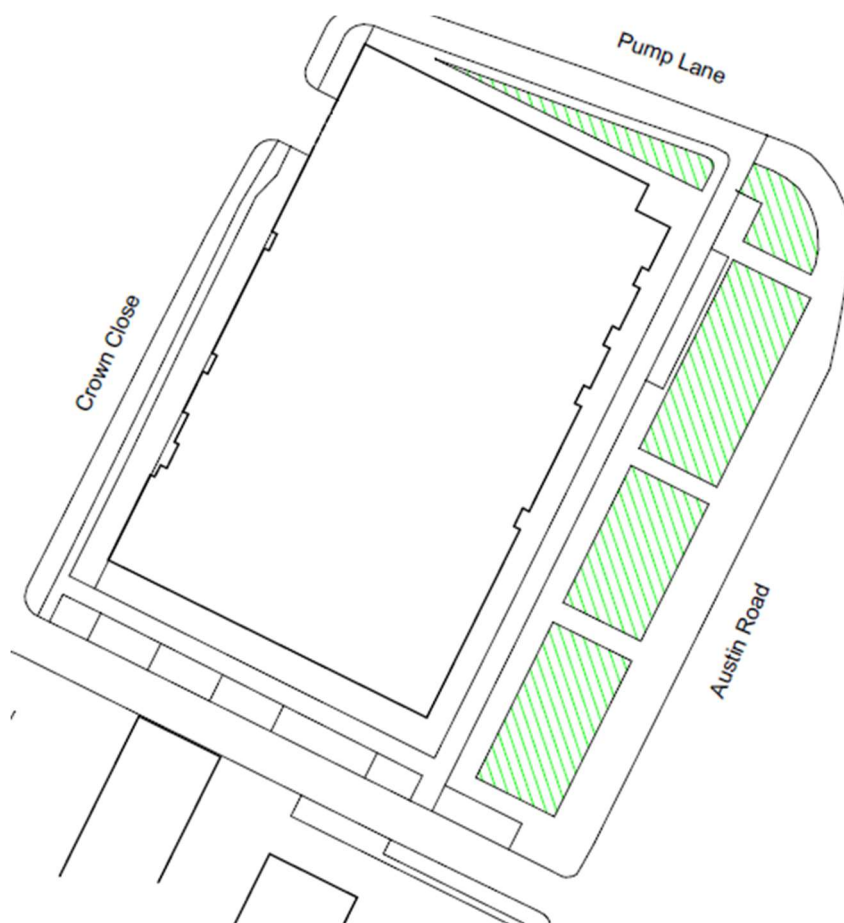
Figure 1 Remediation Plan

This section provides summary of the remediation proposals set out in the Remediation Strategy Report. Remediation will be required where contamination has been identified in place, as detailed in Figure 1.

The strategy adopted for the remediation of the site are defined as follows :-

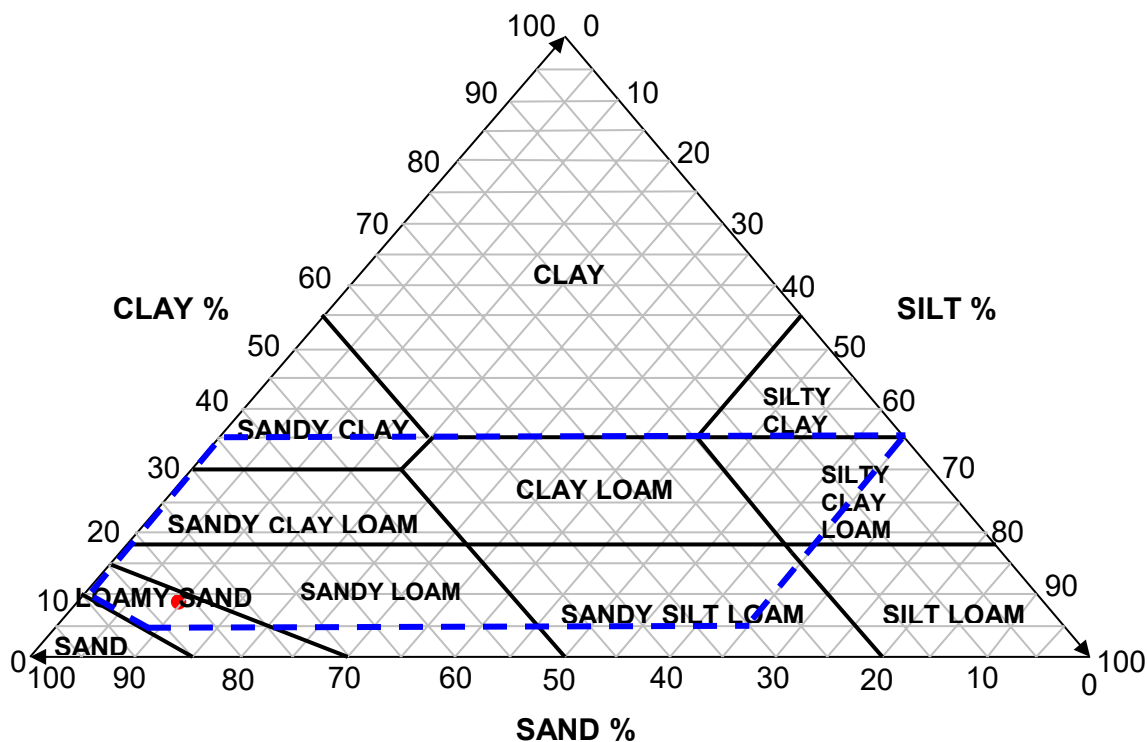
Soil Texture Triangle

Sample Proportion	% dry mass
Sand	82.1
Silt	8.0
Clay	9.9

Texture within acceptable area (Y/N) ☒ Y
