GEO-ENVIRONMENTAL & GEOTECHNICAL ASSESSMENT (GROUND INVESTIGATION) REPORT

**FORMER SITE OF HPH4, HYDE PARK,
1 MILLINGTON ROAD,
HAYES,
LONDON,
UB3 4AZ**

Report Title: Geo-environmental & Geotechnical Assessment Ground Investigation Report for
PHH4, Hyde Park, 1 Millington Road, Hayes, London, UB3 4AZ

Job No: P3284J2275/TE

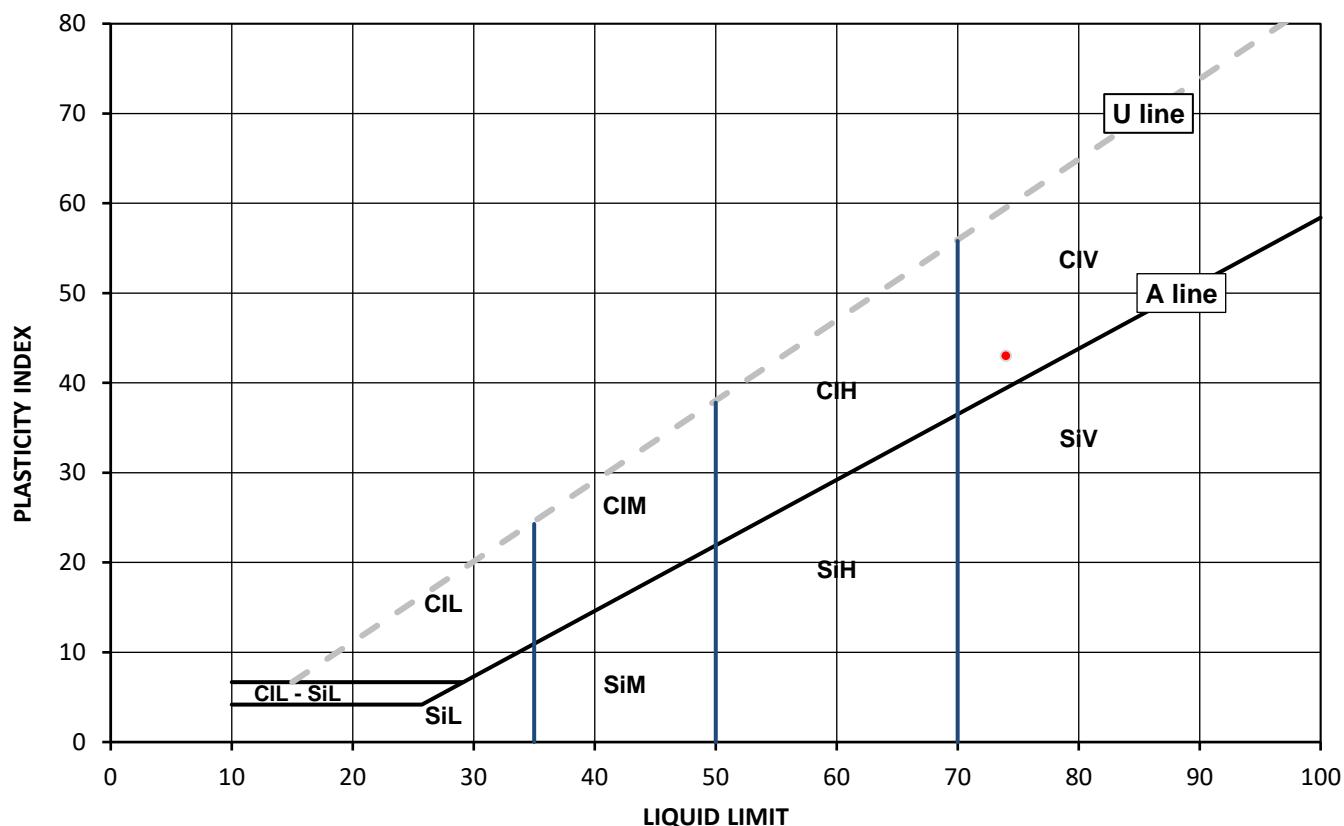
As Received Moisture Content [W] %	Liquid Limit [WL] %	Plastic Limit [Wp] %	Plasticity Index [Ip] %	% Passing 425µm BS Test Sieve
32	74	31	43	100

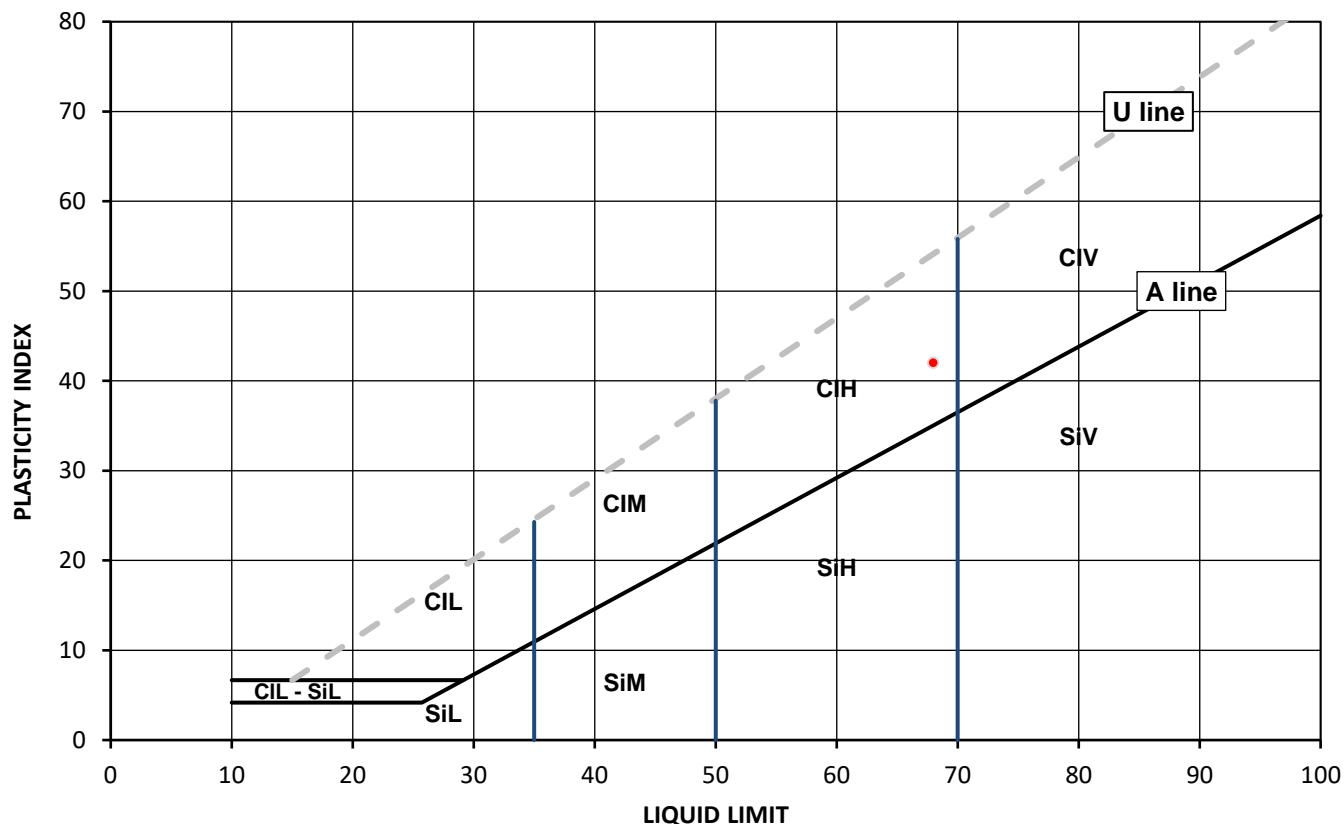
As Received Moisture Content [W] %	Liquid Limit [WL] %	Plastic Limit [Wp] %	Plasticity Index [Ip] %	% Passing 425µm BS Test Sieve
30	68	26	42	99

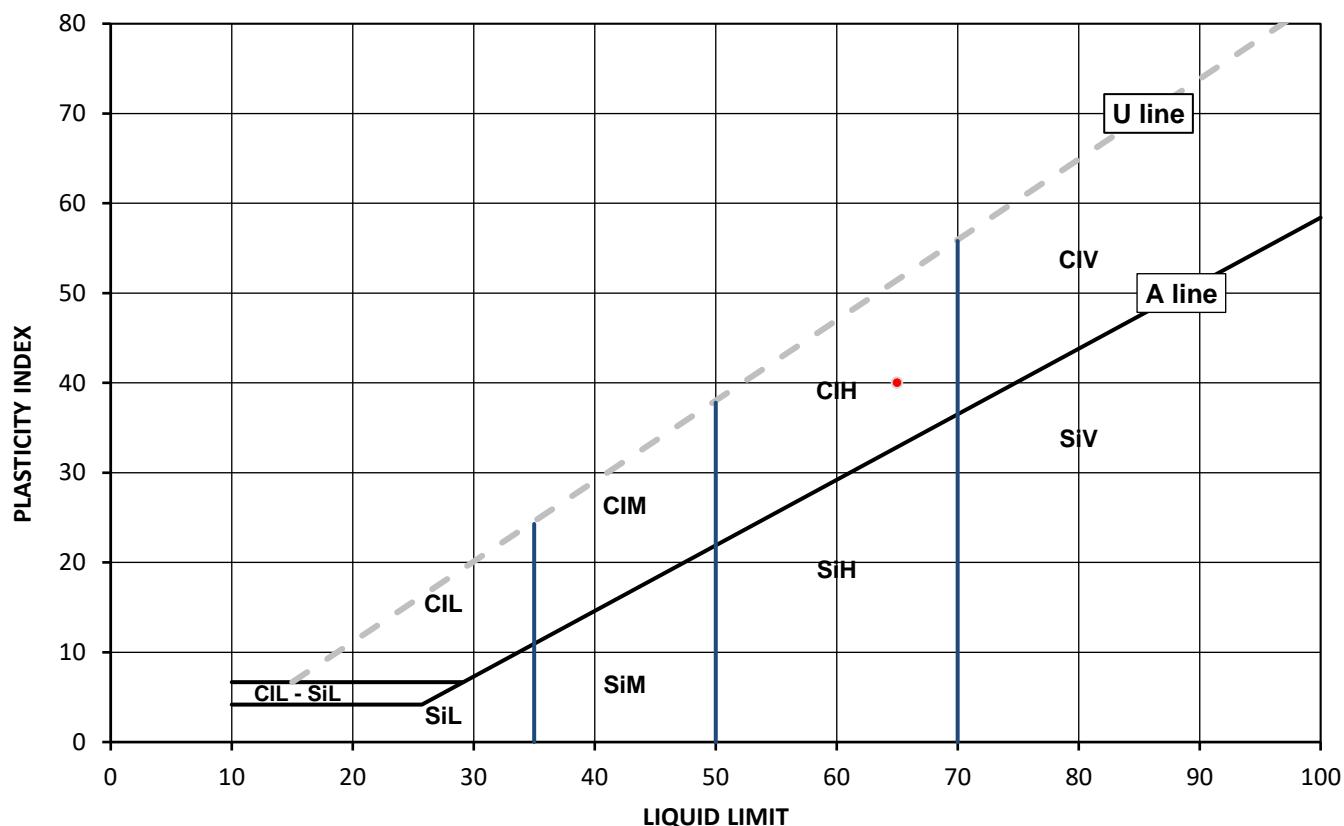
As Received Moisture Content [W] %	Liquid Limit [WL] %	Plastic Limit [Wp] %	Plasticity Index [Ip] %	% Passing 425µm BS Test Sieve
27	65	25	40	98

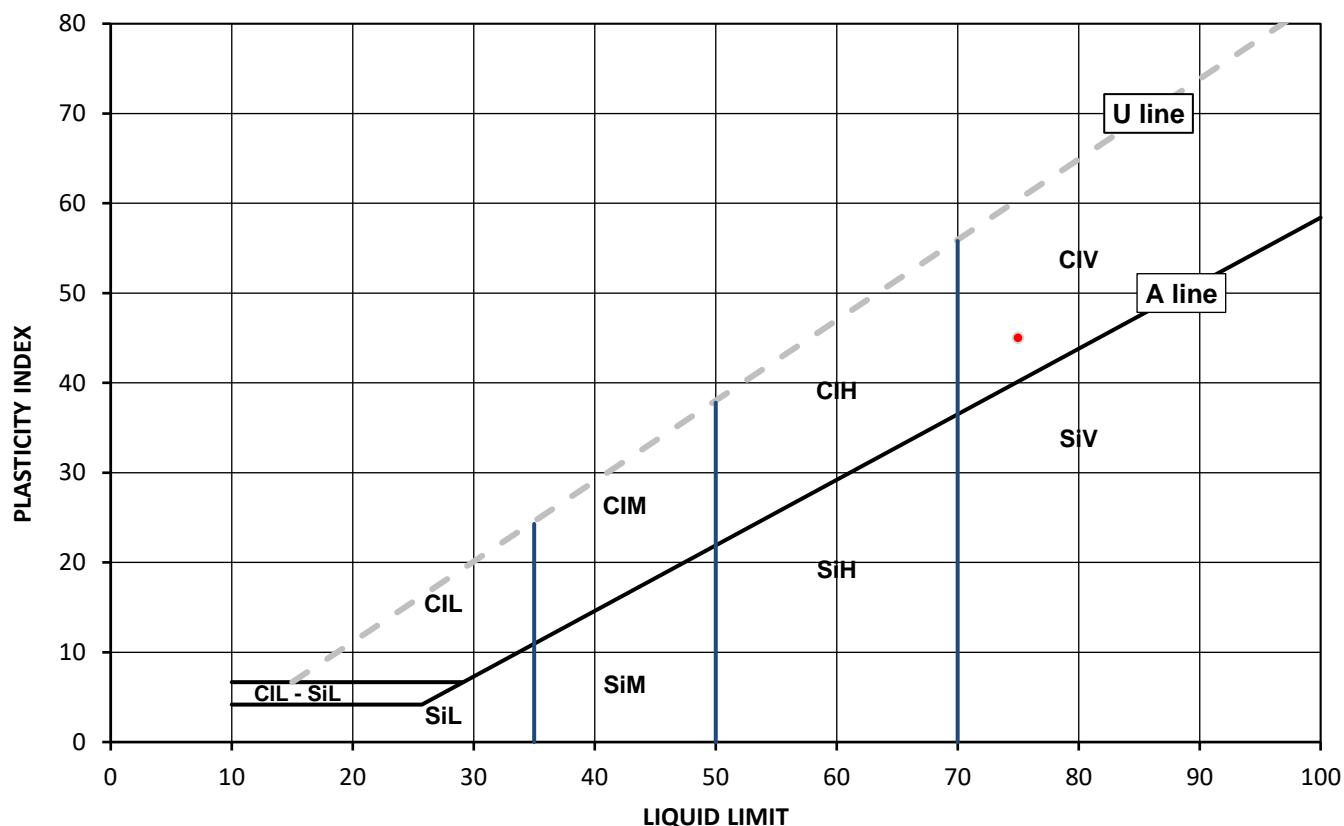
As Received Moisture Content [W] %	Liquid Limit [WL] %	Plastic Limit [Wp] %	Plasticity Index [Ip] %	% Passing 425µm BS Test Sieve
27	75	30	45	100

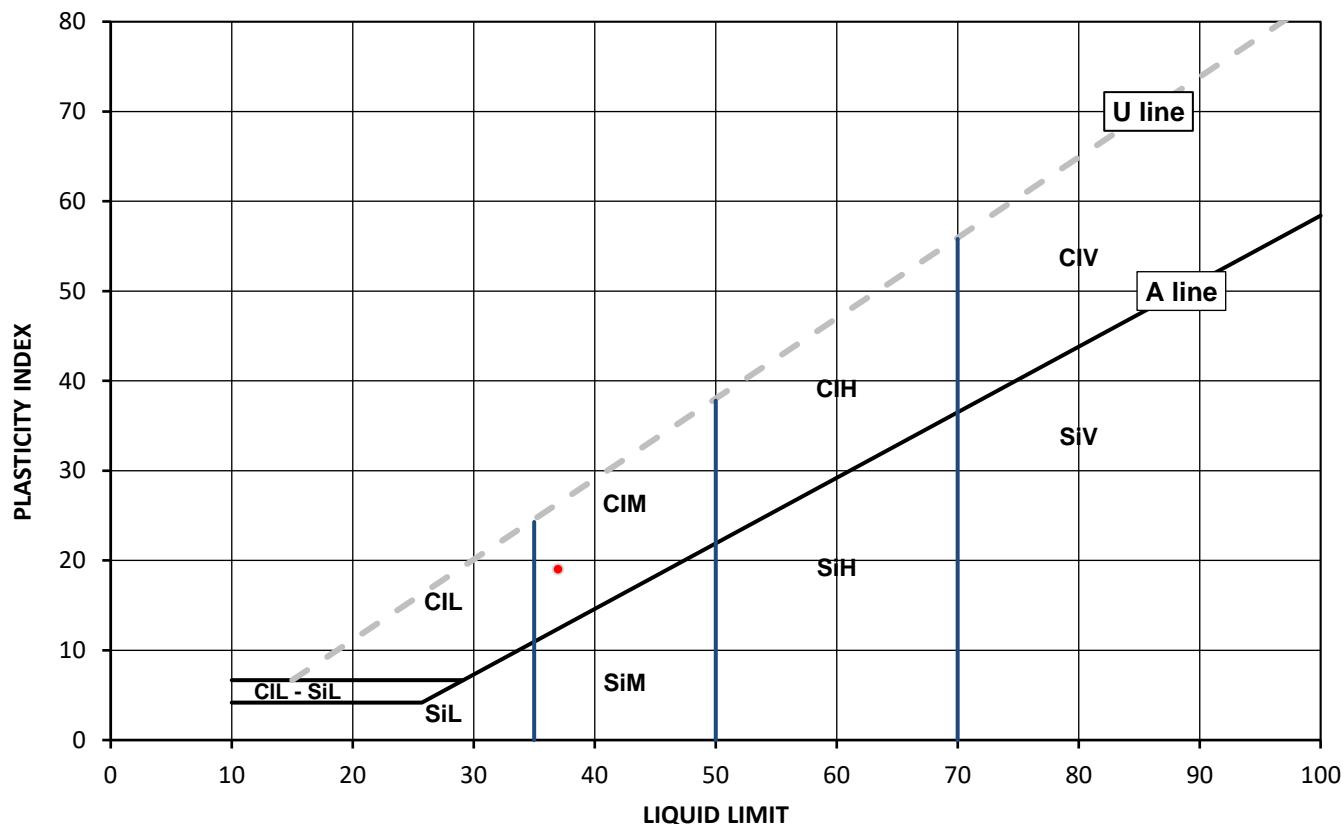
As Received Moisture Content [W] %	Liquid Limit [WL] %	Plastic Limit [Wp] %	Plasticity Index [Ip] %	% Passing 425µm BS Test Sieve
14	37	18	19	36

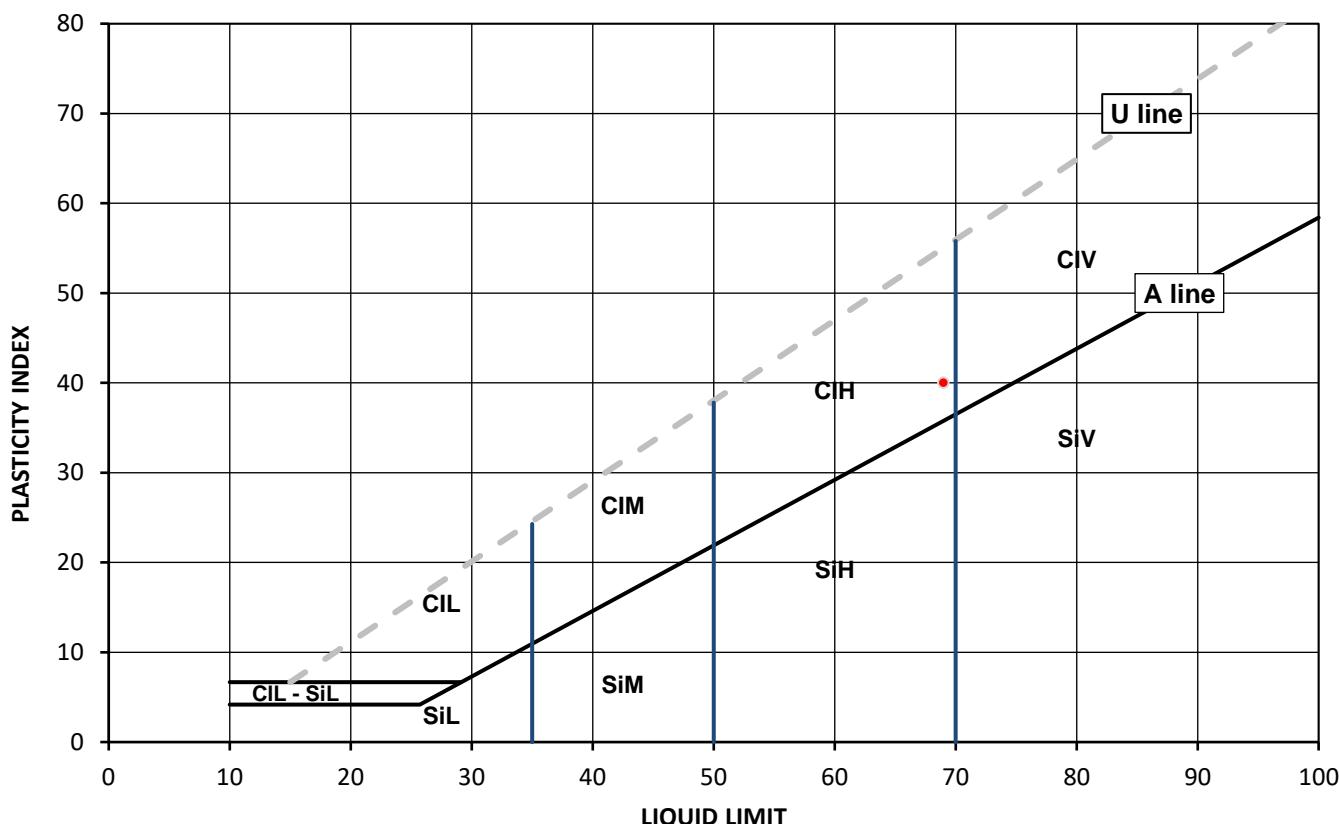
As Received Moisture Content [W] %	Liquid Limit [WL] %	Plastic Limit [Wp] %	Plasticity Index [Ip] %	% Passing 425µm BS Test Sieve
26	69	29	40	100

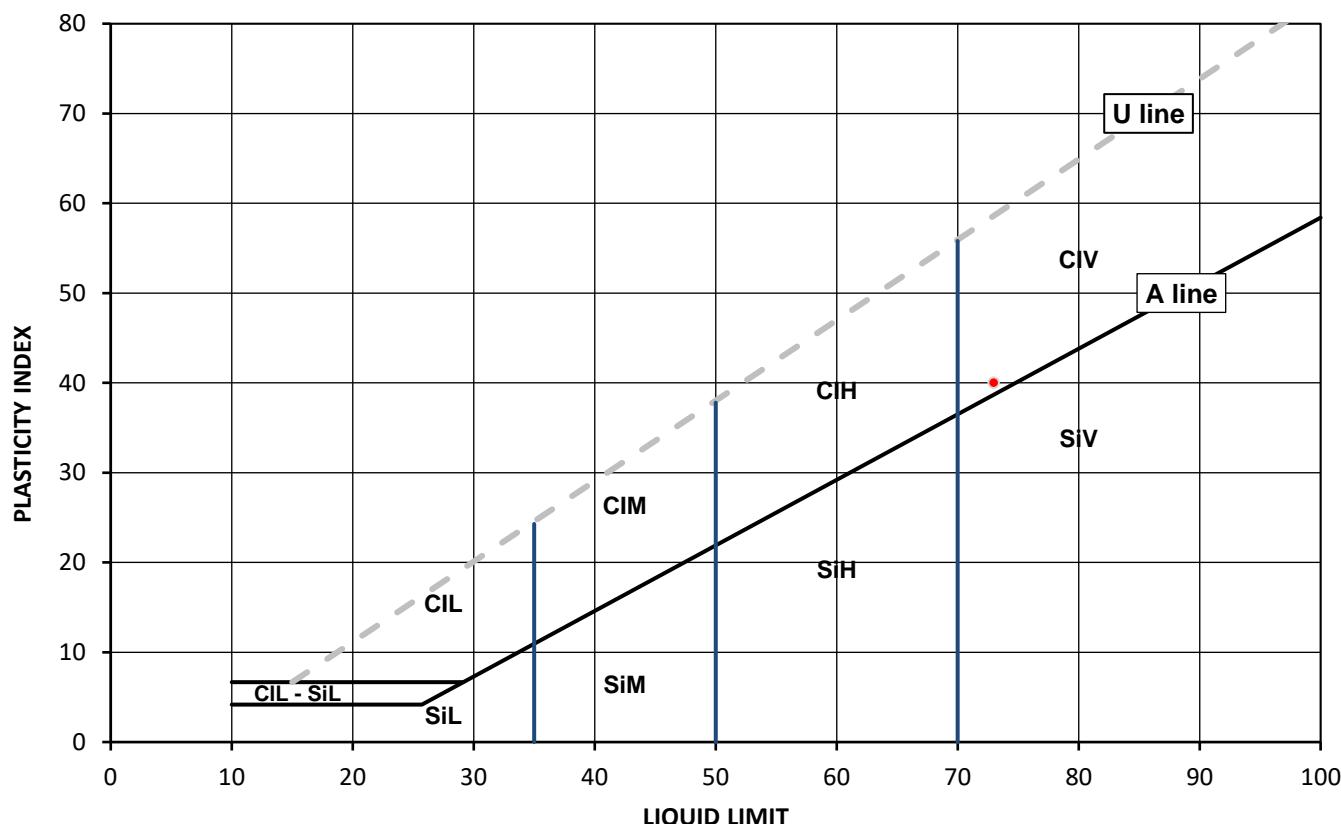
As Received Moisture Content [W] %	Liquid Limit [WL] %	Plastic Limit [Wp] %	Plasticity Index [Ip] %	% Passing 425µm BS Test Sieve
26	73	33	40	100

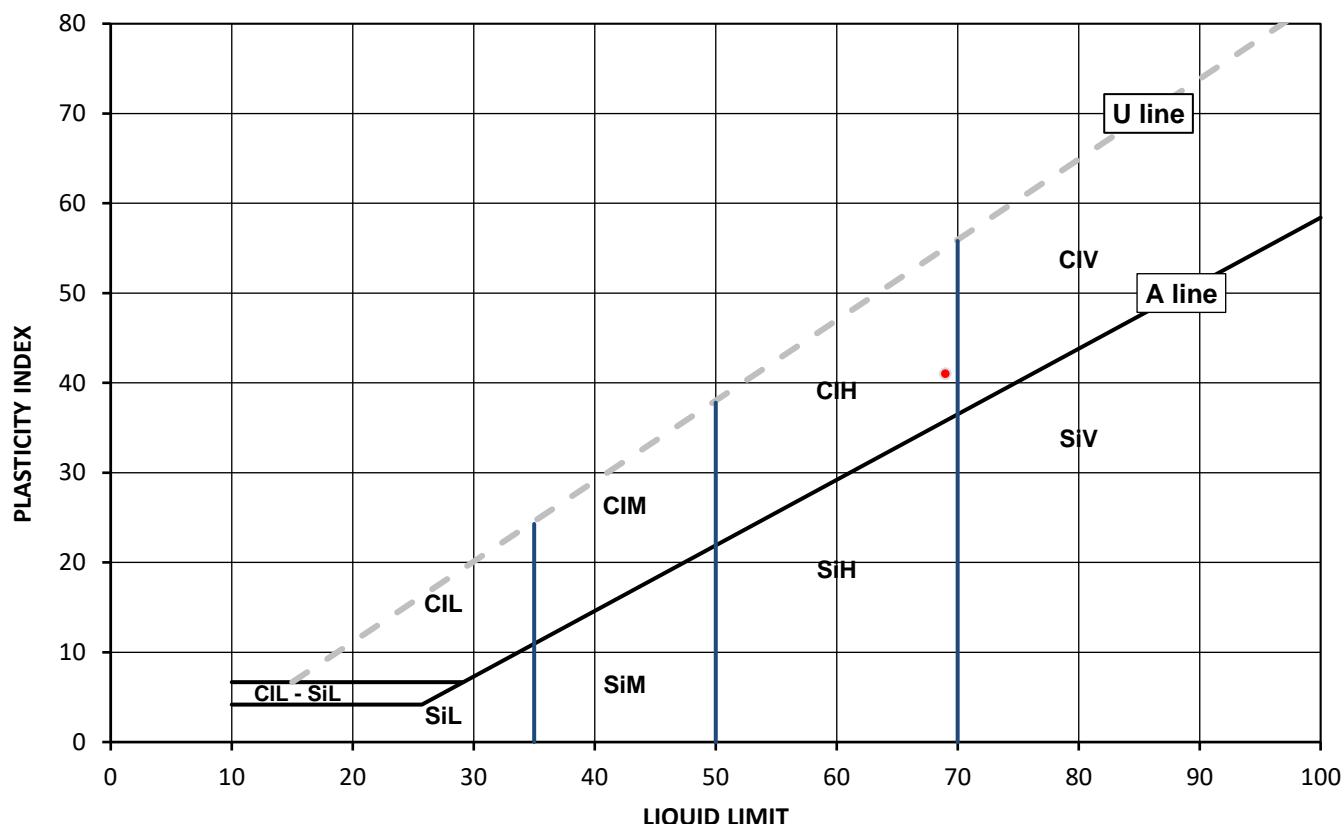
As Received Moisture Content [W] %	Liquid Limit [WL] %	Plastic Limit [Wp] %	Plasticity Index [Ip] %	% Passing 425µm BS Test Sieve
25	69	28	41	100

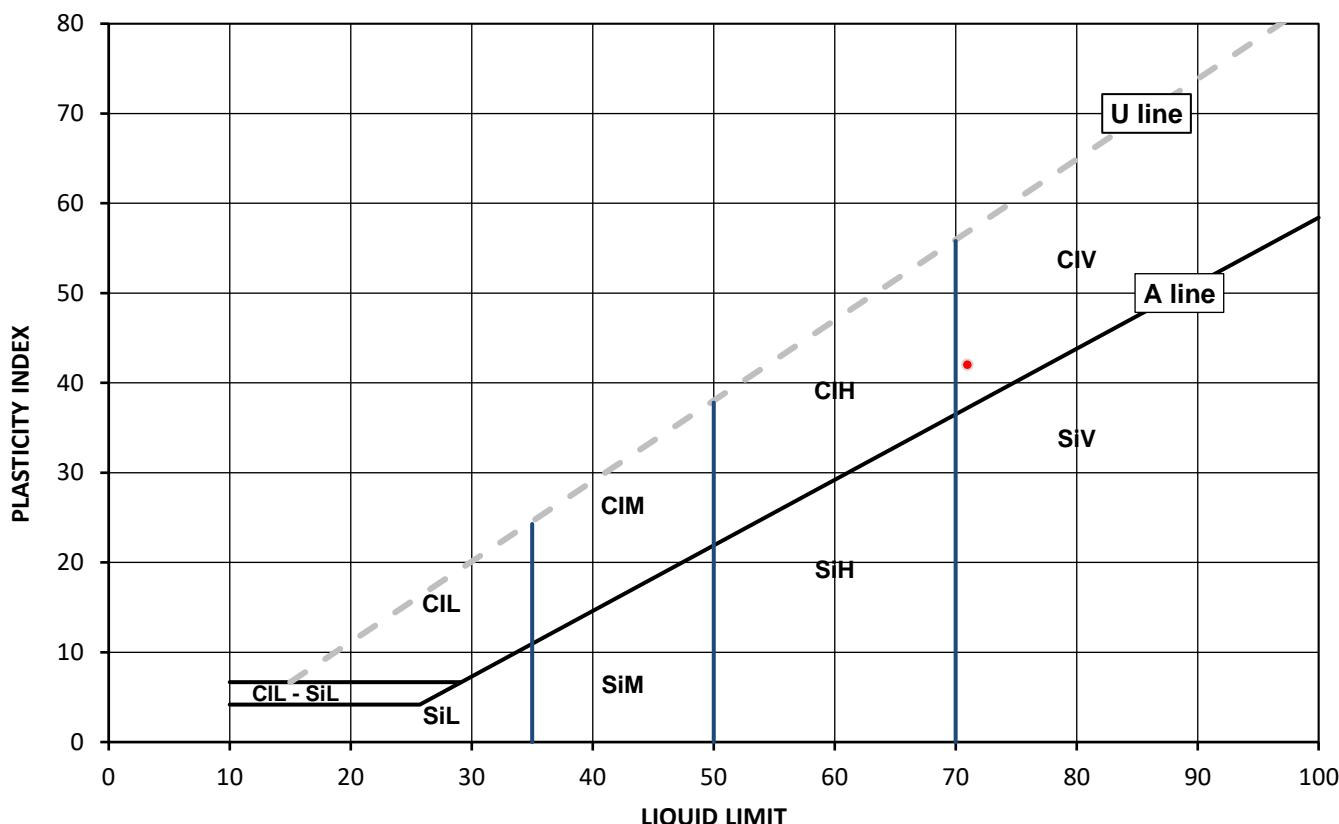
As Received Moisture Content [W] %	Liquid Limit [WL] %	Plastic Limit [Wp] %	Plasticity Index [Ip] %	% Passing 425µm BS Test Sieve
28	71	29	42	100

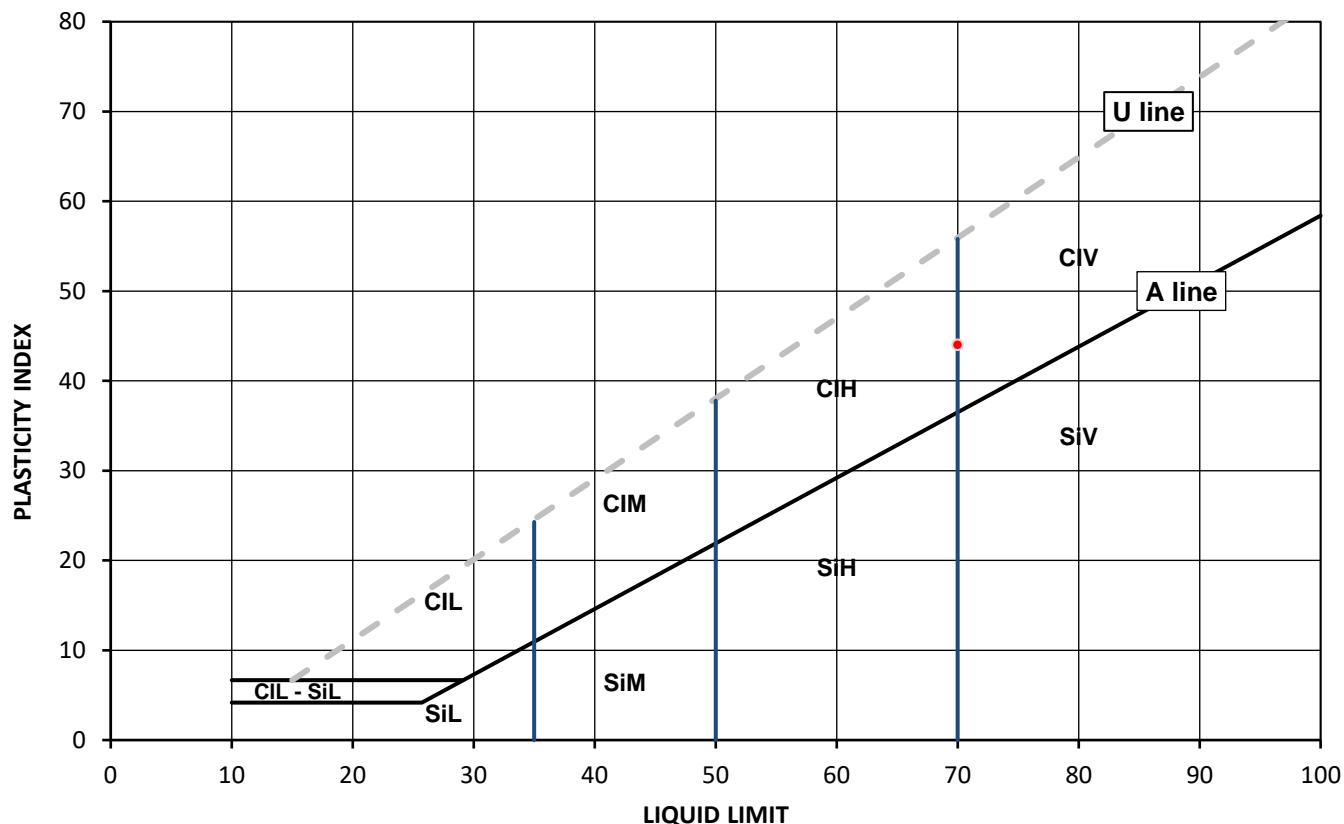
As Received Moisture Content [W] %	Liquid Limit [WL] %	Plastic Limit [Wp] %	Plasticity Index [Ip] %	% Passing 425µm BS Test Sieve
27	70	26	44	100

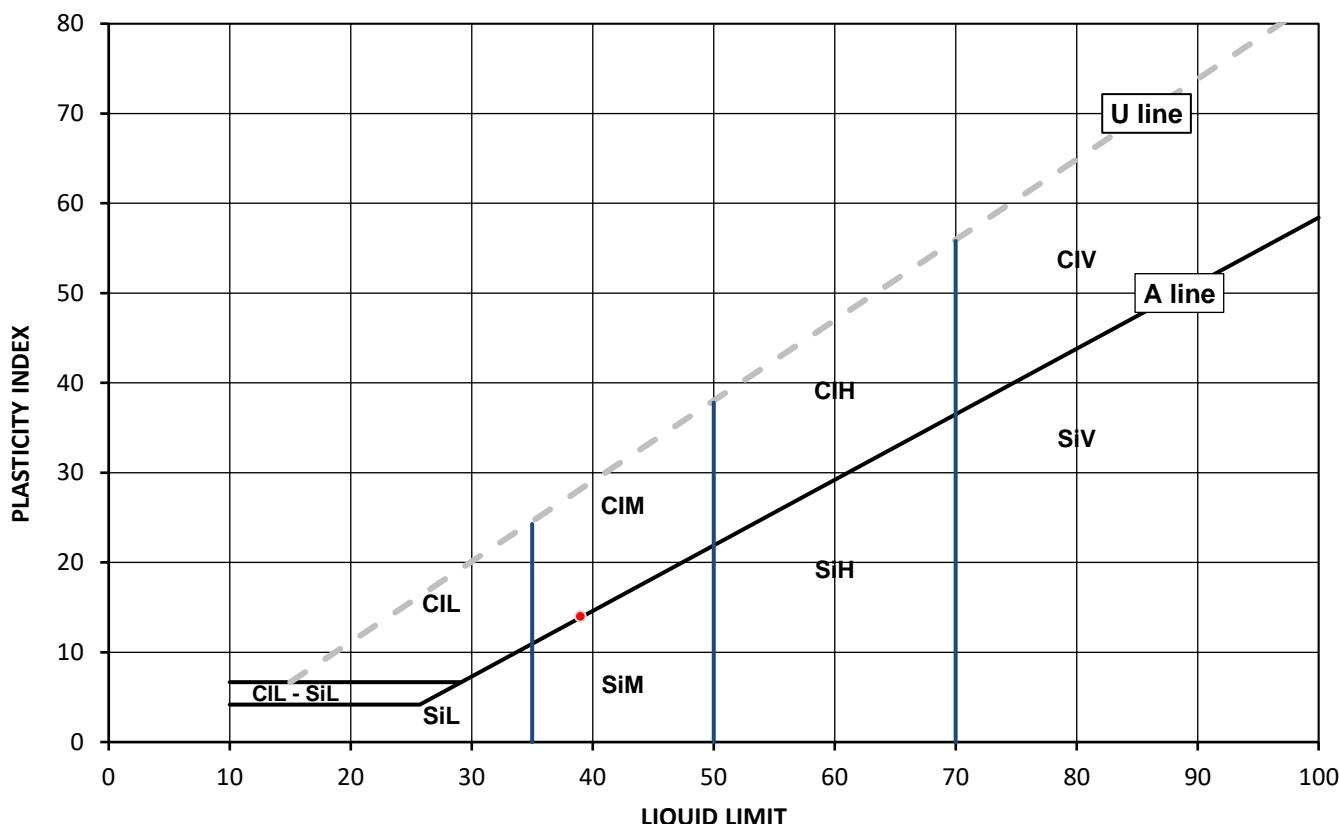
As Received Moisture Content [W] %	Liquid Limit [WL] %	Plastic Limit [Wp] %	Plasticity Index [Ip] %	% Passing 425µm BS Test Sieve
16	39	25	14	100

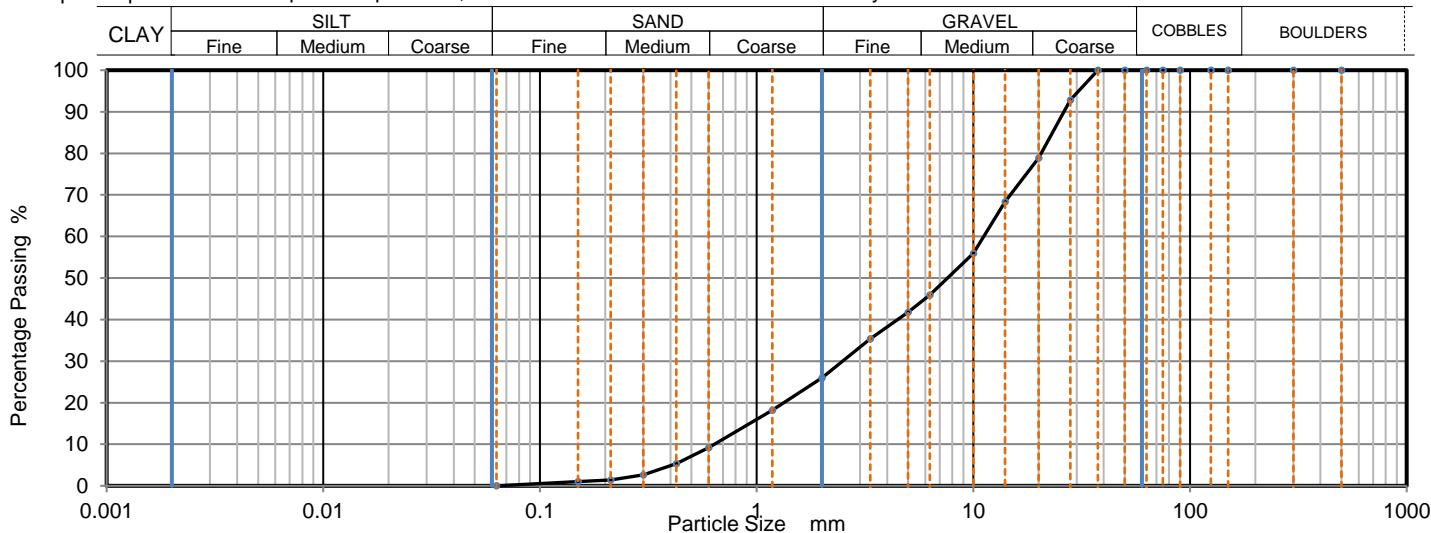
Sample Preparation: Sample was quartered, oven dried at 106.0 °C and broken down by hand.

Sample Proportions	% dry mass
Very coarse	0
Gravel	74
Sand	25
Fines <0.063mm	1
