**REMEDIAL STRATEGY
AND
VERIFICATION PLAN**

FORMER SITE OF HPH4,
HYDE PARK,
MILLINGTON ROAD,
HAYES, LONDON,
UB3 4AZ

Report Title: Remedial Strategy & Verification Plan for Former site of HPH4, Hyde Park, Millington Road, Hayes, London, UB3 4AZ

Job No: P3284J2275/CLP

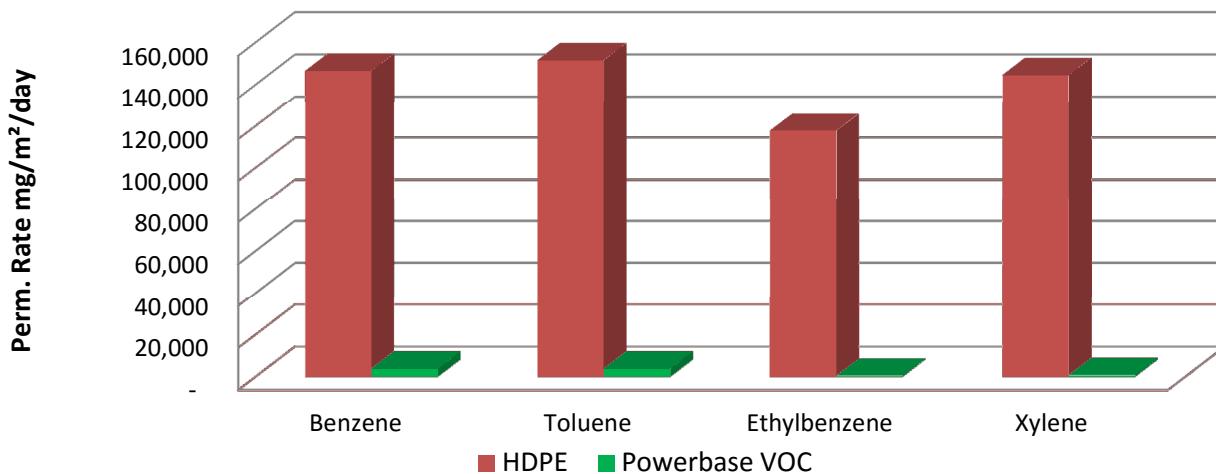
Powerbase VOC vs HDPE ISO 15105-2B test data

PERFORMANCE COMPARISON - POWERBASE VOC vs HDPE

Powerbase VOC significantly outperforms HDPE
