Project Number  
**R1620010949\_01\_PhI**

# **HYDE PARK HAYES BUILDING 3**

## **PHASE I ENVIRONMENTAL ASSESSMENT**

Date **22<sup>nd</sup> October 2020**

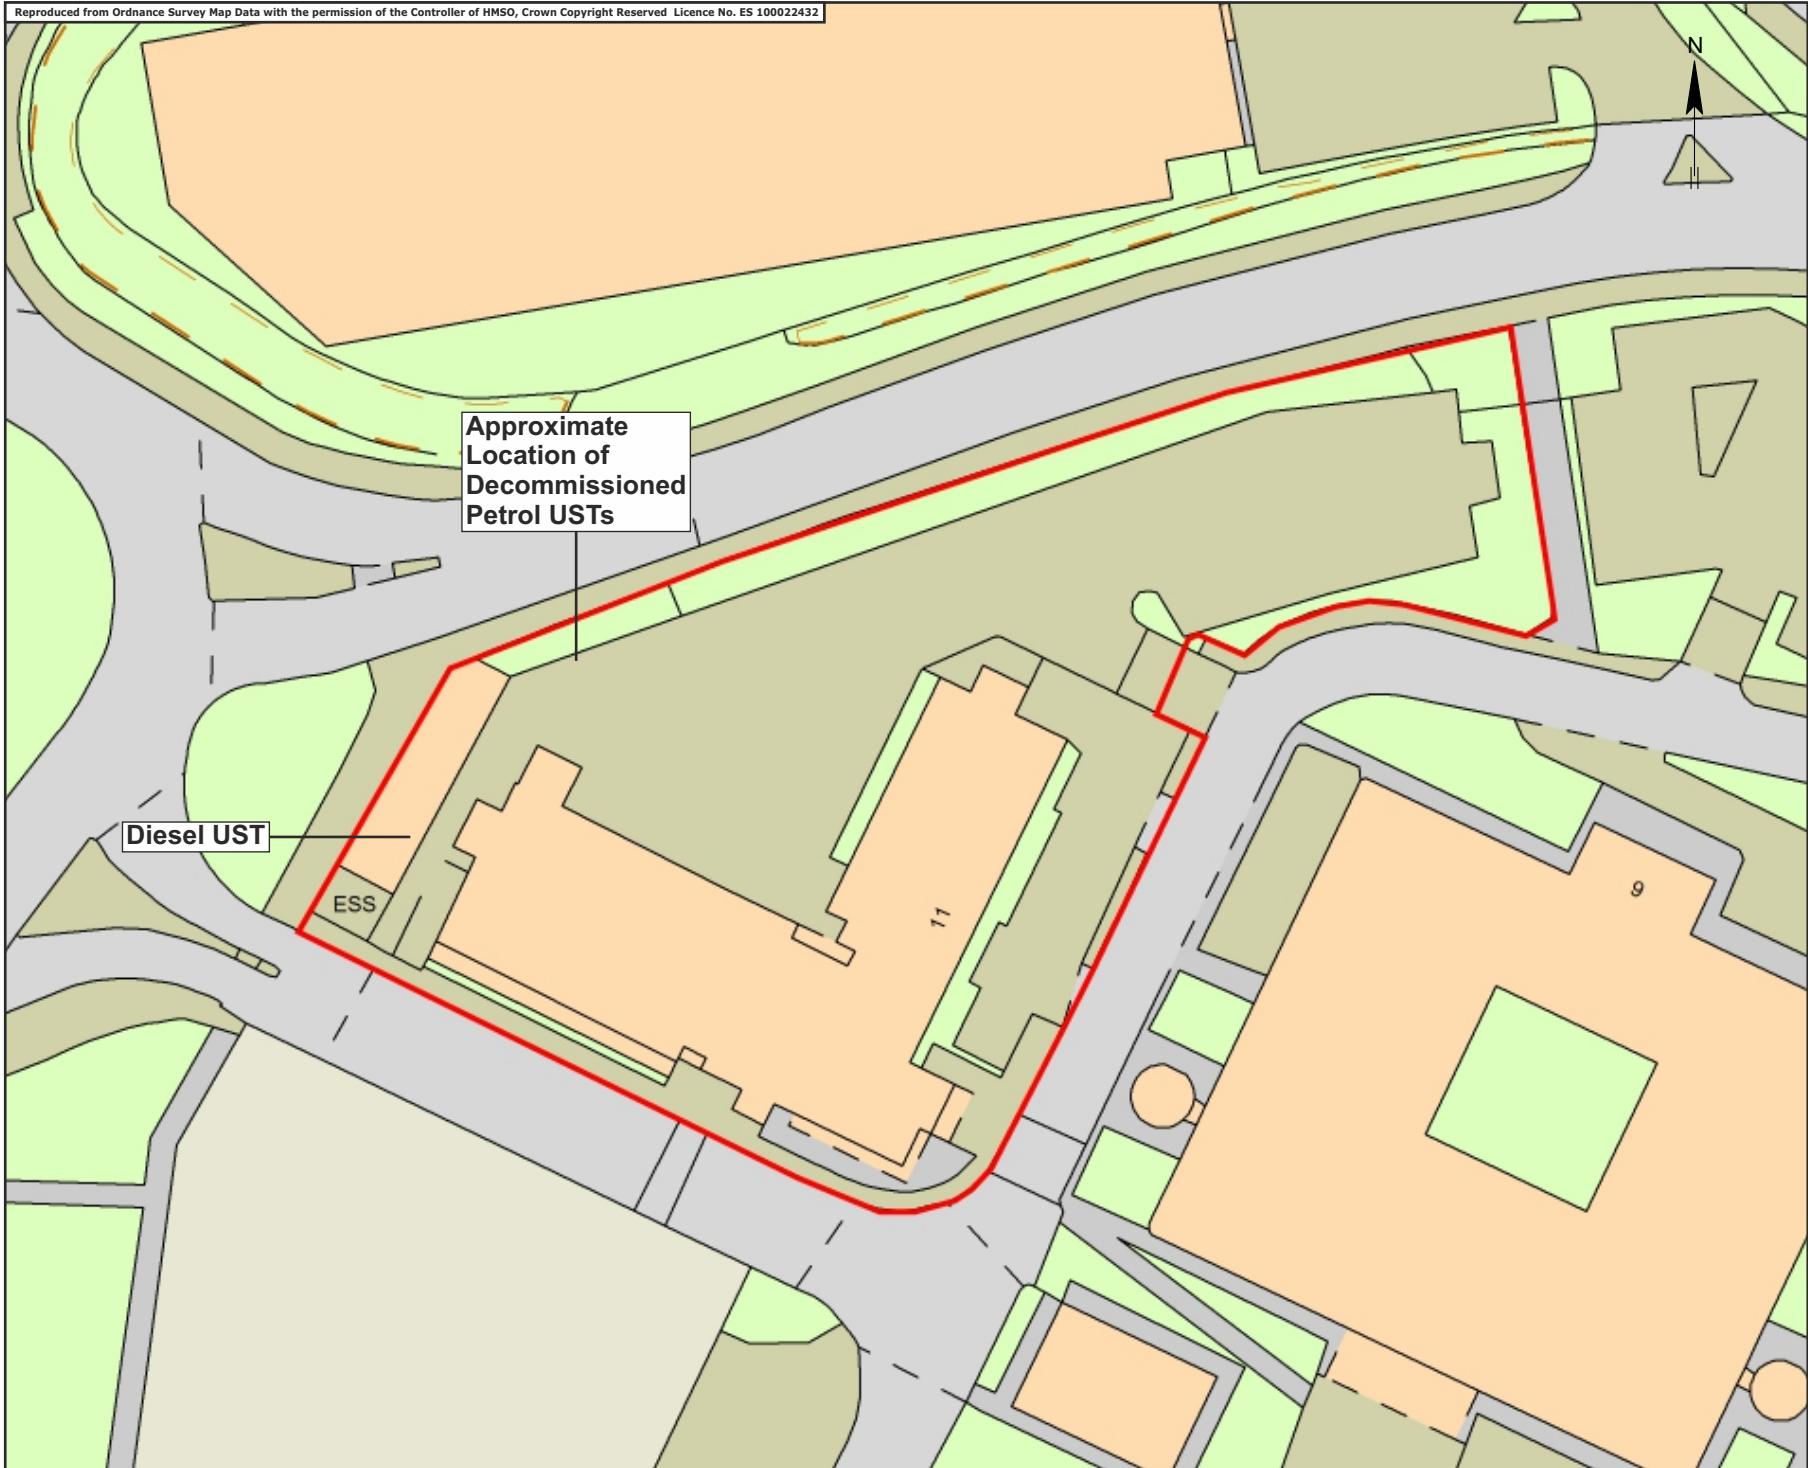
Title Figure 2:  
Site Layout

The hardstanding was observed to be in good condition, with no significant signs of stress, strain or discolouration. A layout of the site is included as Figure 2 (Appendix 1).

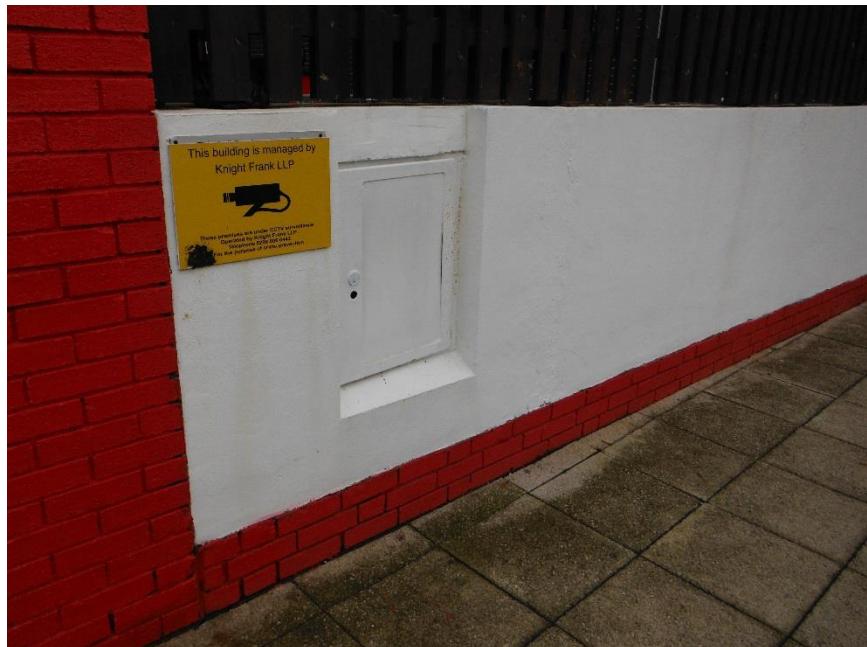
**Photo 2.** UST Offset Fill Point

The tank is filled from an off-set fill point located approximately 5m from the tank; access to the fill point is from the main access road for the site (Photo 2, Appendix 2). The fill point was observed to be freshly painted and in good condition with no signs of spills. Some of the connecting pipework between the tank and the generator was observed to be slightly deteriorated as it emerged from below ground to enter the generator room; however, the site representative informed Ramboll that they have not had reports of leaks or an unexplained loss of fuel in the past 15 years.

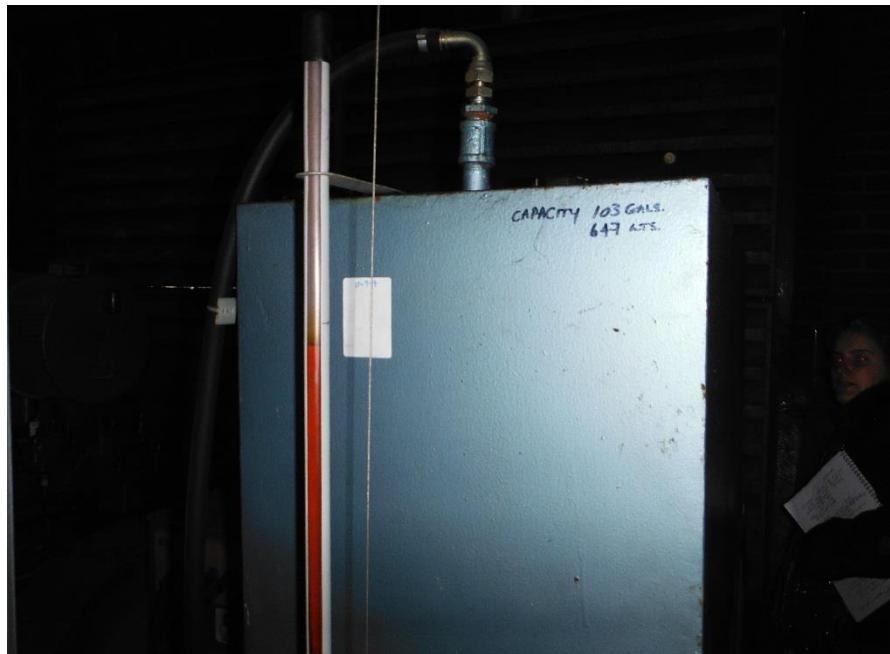
**Photo 5.** 650 Litre Day Tank for Building 3 Generator (fed from UST)

In addition to the operational UST noted above, a 650 litre day tank is attached to the generator located in the single storey building in the south-western corner of the site, which is fed from the UST outlined above (Photo 5, Appendix 2). This was observed to be approximately 80% full during the site inspection and was noted to be a single-skin steel construction with external capillary gauge. The ground surrounding the generator and day tank was observed to be of good condition concrete with no signs of spills, leaks or fatigue. The site representative reported that there have been no fuel leaks associated with this tank. Ramboll understands that as part of the proposed change of use the back-up generator will no longer be required. The proposed refurbishment works would include the removal of the generator and day tank and decommissioning of the UST.
