**Supplementary Site Investigation
and | Residential Development
Generic Quantitative Risk Assessment**

Report prepared at
Yiewsley Library and Car Park
Falling Lane/High Street
Hillingdon
UB7 7BE

On behalf of
Bugler Developments Limited

Report reference
25-154.01
Version 1

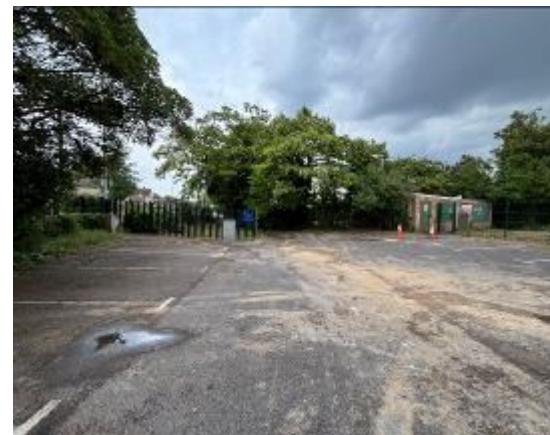
Photo 6

Contaminative Characteristics	
Above or Underground Storage Tanks and Drums	None observed.
Fuel Interceptors	None observed.
Waste Storage and Disposal	None observed.
Hazardous Material Storage and Use	Possible pesticide storage in the small brick building in the east of the site (see photos 6 and 7, Figures 3 and 4).
Asbestos Containing Materials (ACMs)	None observed. An asbestos survey is recommended prior to the redevelopment works.
Boiler Houses	None observed.
Sub-stations	An electricity substation (ESS) is located on site within a brick compound (see photo 9, Figure 4).
Surface Staining	None observed.
Potentially Contaminative Activities	ESS noted in the south-west of the site and possible pesticide storage in the small brick building in the east.

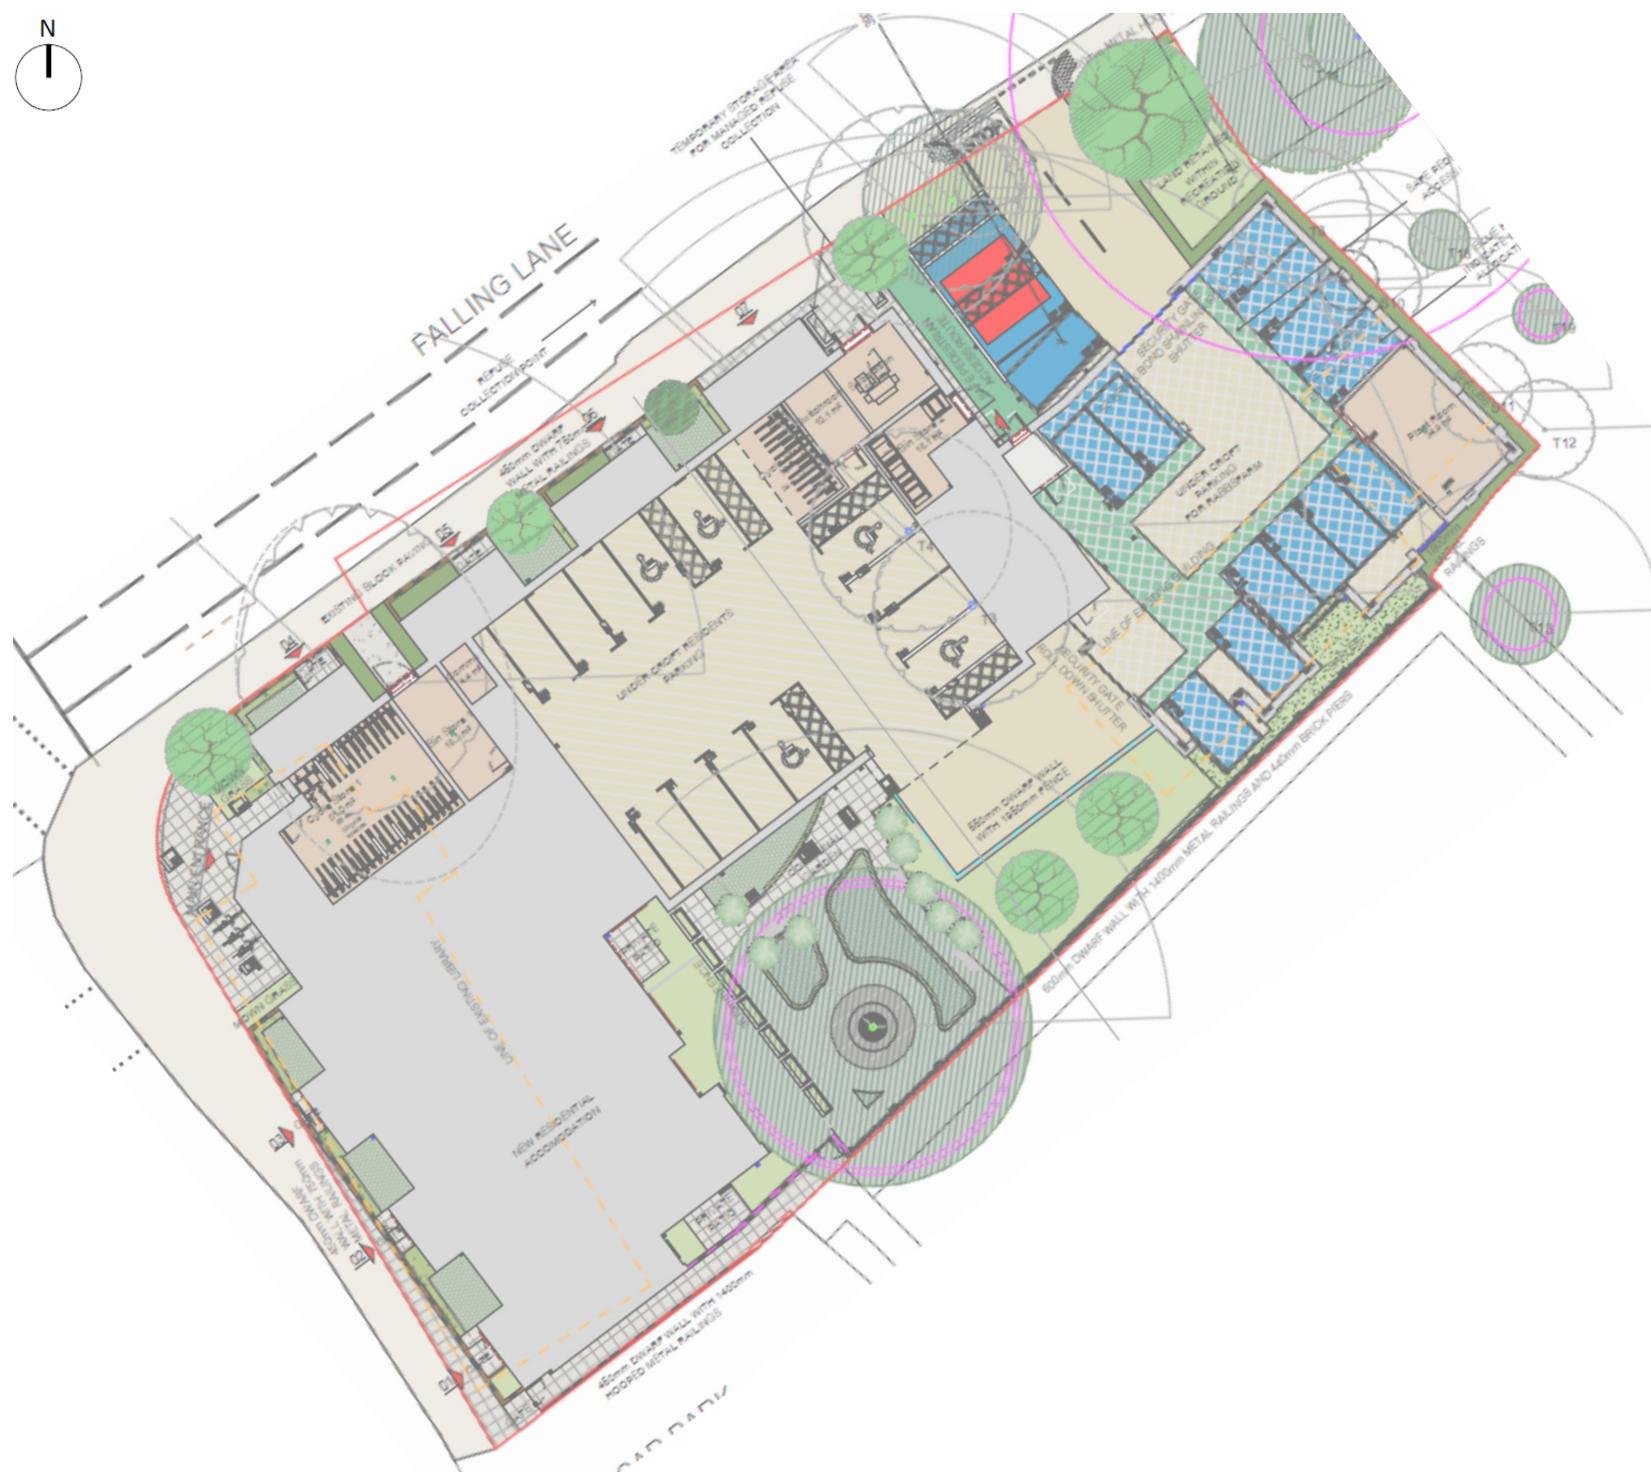
Proposed Land Use	It is understood that the library will be demolished, and the site will be cleared and redeveloped with a four to five storey residential block of apartments with associated undercroft parking at ground floor level, and landscaped areas. Figure 5 presents the Proposed Development Plan.

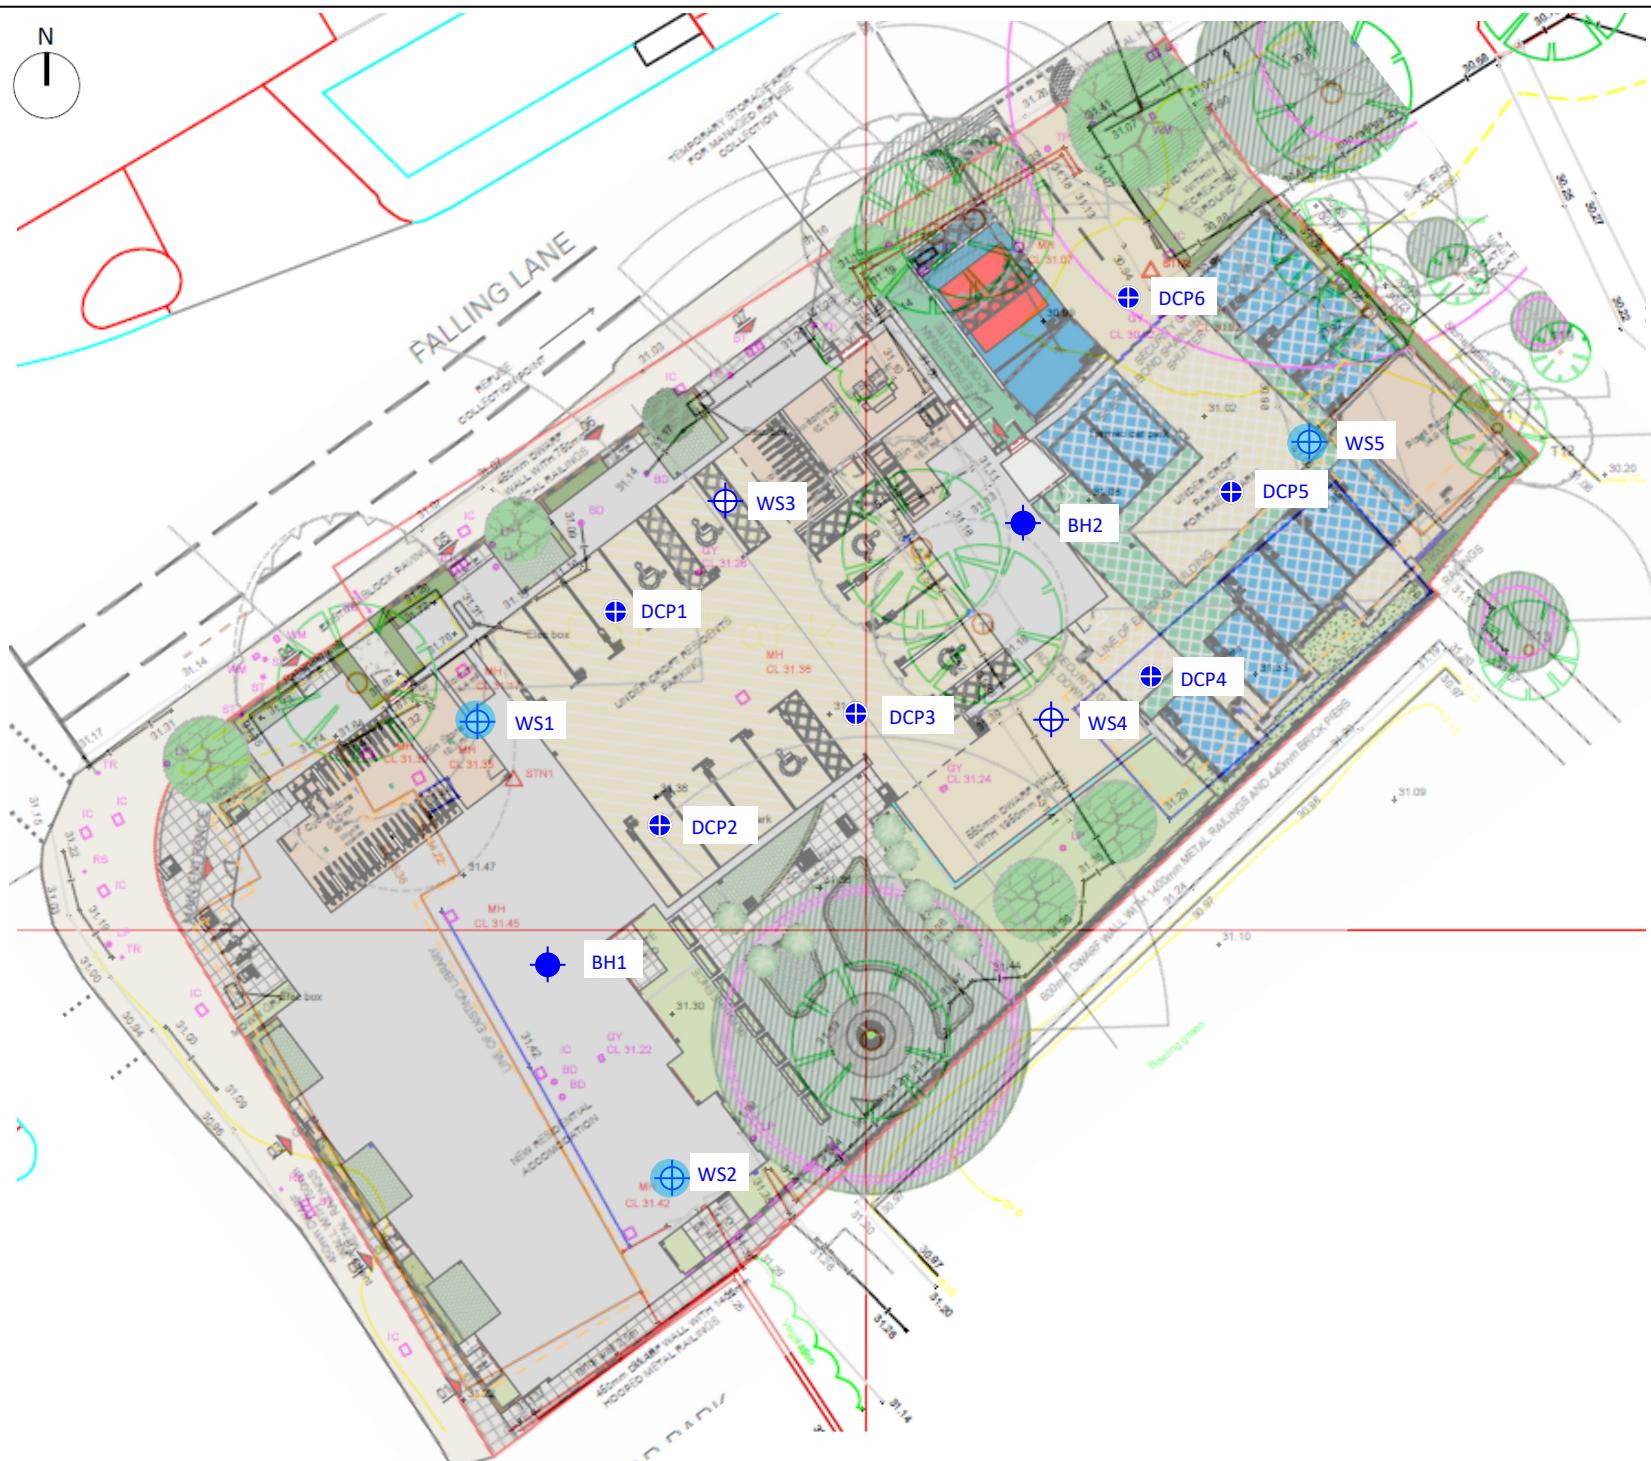
Figure 9

A plan showing the location of the contamination identified is enclosed as **Figure 9**. The plan has been prepared by interpretation of the soil chemical results from the two investigations undertaken.

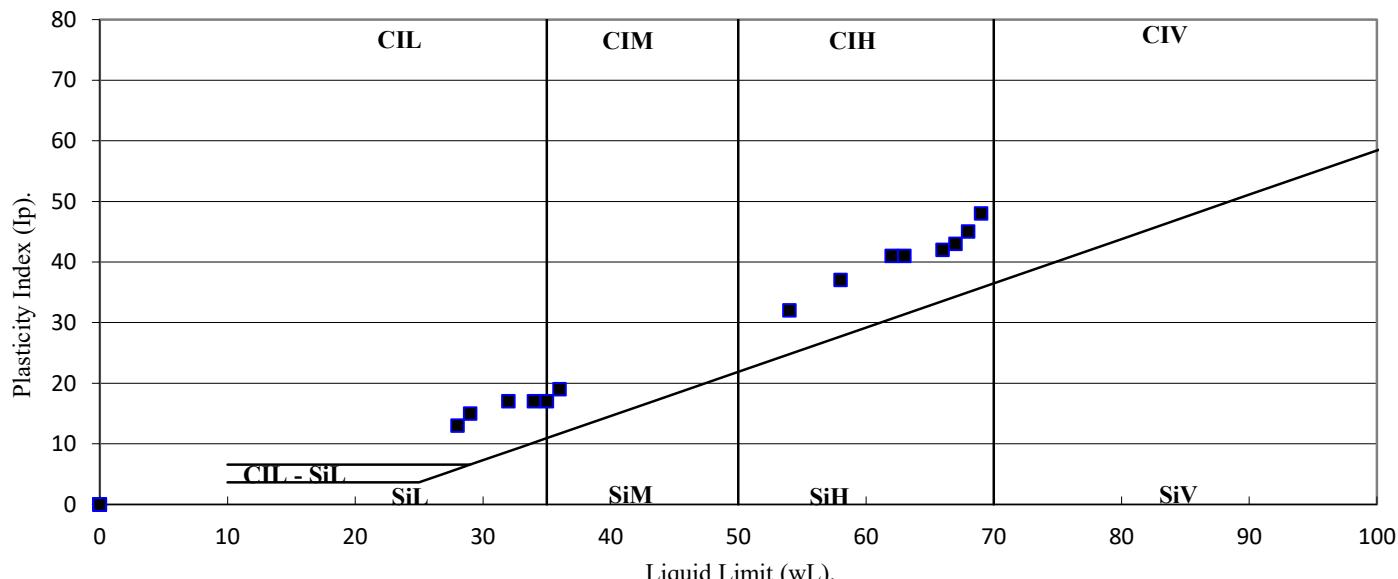
PLASTICITY CHART
BS EN ISO 14688-2:2018 Clause 4.4

NB: All liquid limits are 4 point and wet sieved

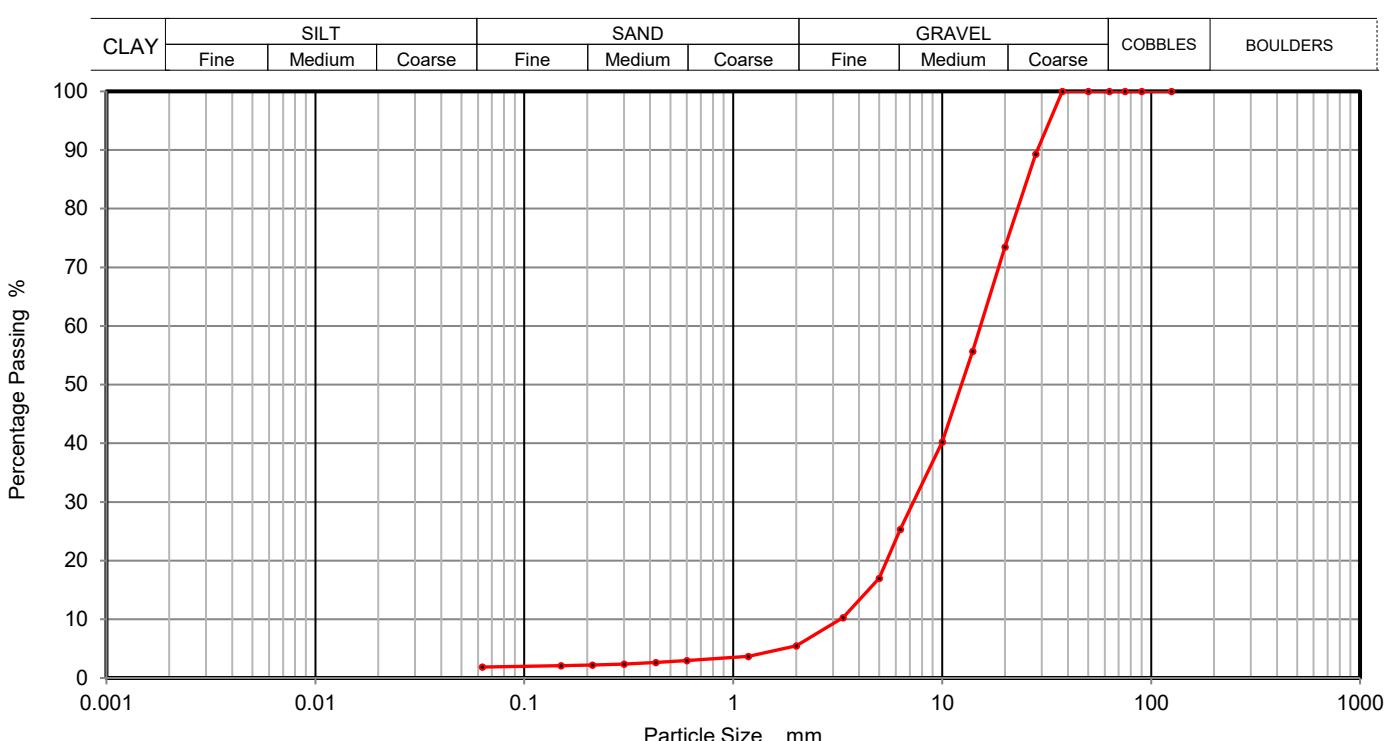
Sieving		Sedimentation	
Particle Size mm	% Passing	Particle Size mm	% Passing
125	100		
90	100		
75	100		
63	100		
50	100		
37.5	100		
28	89		
20	73		
14	56		
10	40		
6.3	25		
5	17		
3.35	10		
2	5		
1.18	4		
0.63	3		
0.425	3		
0.30	2		
0.20	2		
0.15	2		
0.063	2

Sample Proportions	% dry mass
Cobbles	0
Gravel	95
Sand	3
Silt and Clay	2

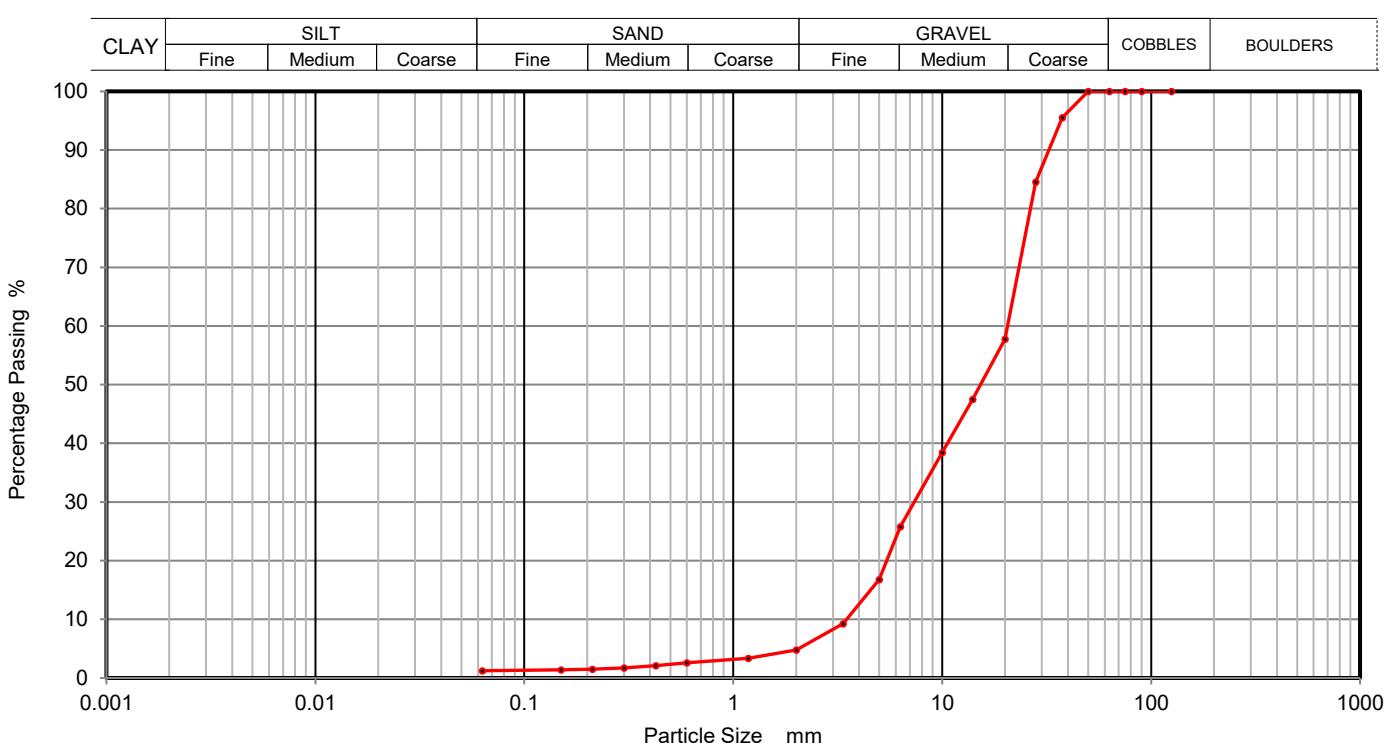
Sieving		Sedimentation	
Particle Size mm	% Passing	Particle Size mm	% Passing
125	100		
90	100		
75	100		
63	100		
50	100		
37.5	96		
28	85		
20	58		
14	48		
10	38		
6.3	26		
5	17		
3.35	9		
2	5		
1.18	3		
0.63	3		
0.425	2		
0.30	2		
0.20	2		
0.15	1		
0.063	1

Sample Proportions	% dry mass
Cobbles	0
Gravel	95
Sand	4
Silt and Clay	1

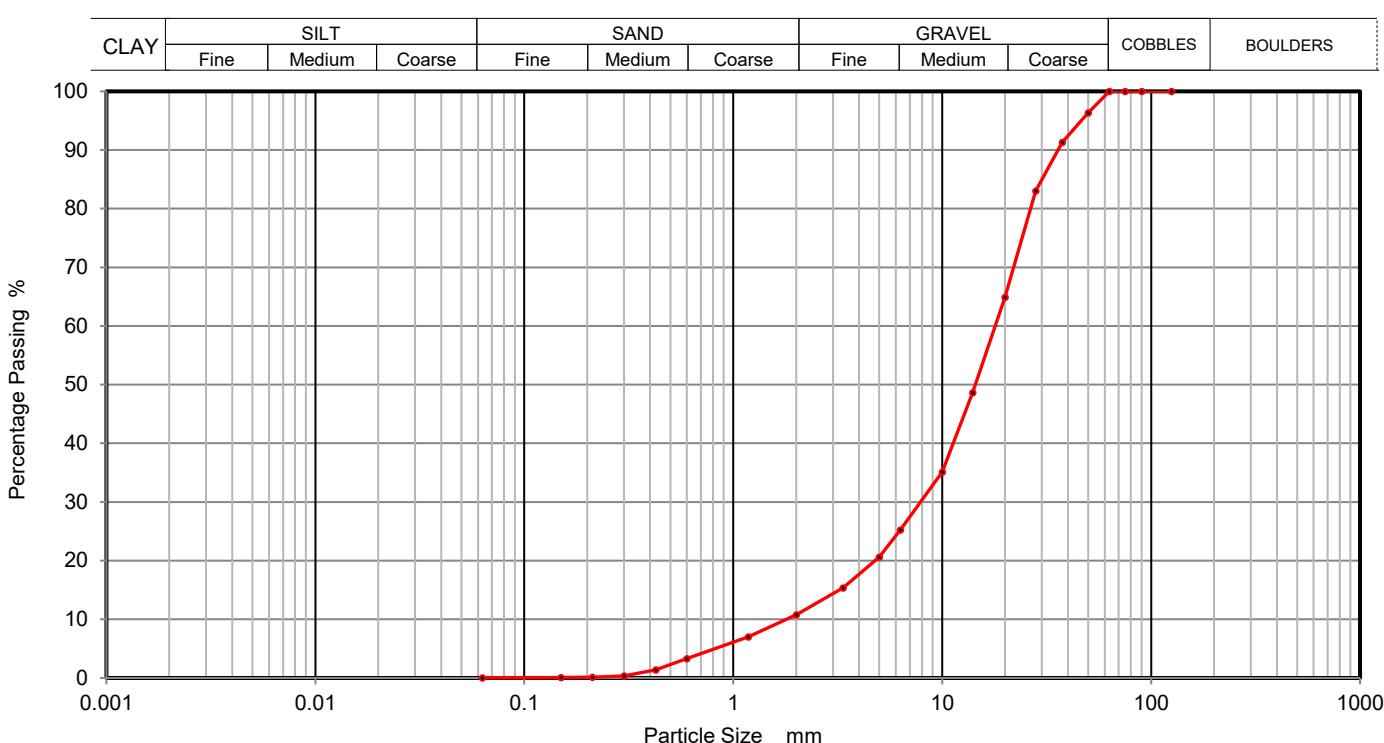
Sieving		Sedimentation	
Particle Size mm	% Passing	Particle Size mm	% Passing
125	100		
90	100		
75	100		
63	100		
50	96		
37.5	91		
28	83		
20	65		
14	49		
10	35		
6.3	25		
5	21		
3.35	15		
2	11		
1.18	7		
0.63	3		
0.425	1		
0.30	0		
0.20	0		
0.15	0		
0.063	0

Sample Proportions	% dry mass
Cobbles	0
Gravel	89
Sand	11
Silt and Clay	0

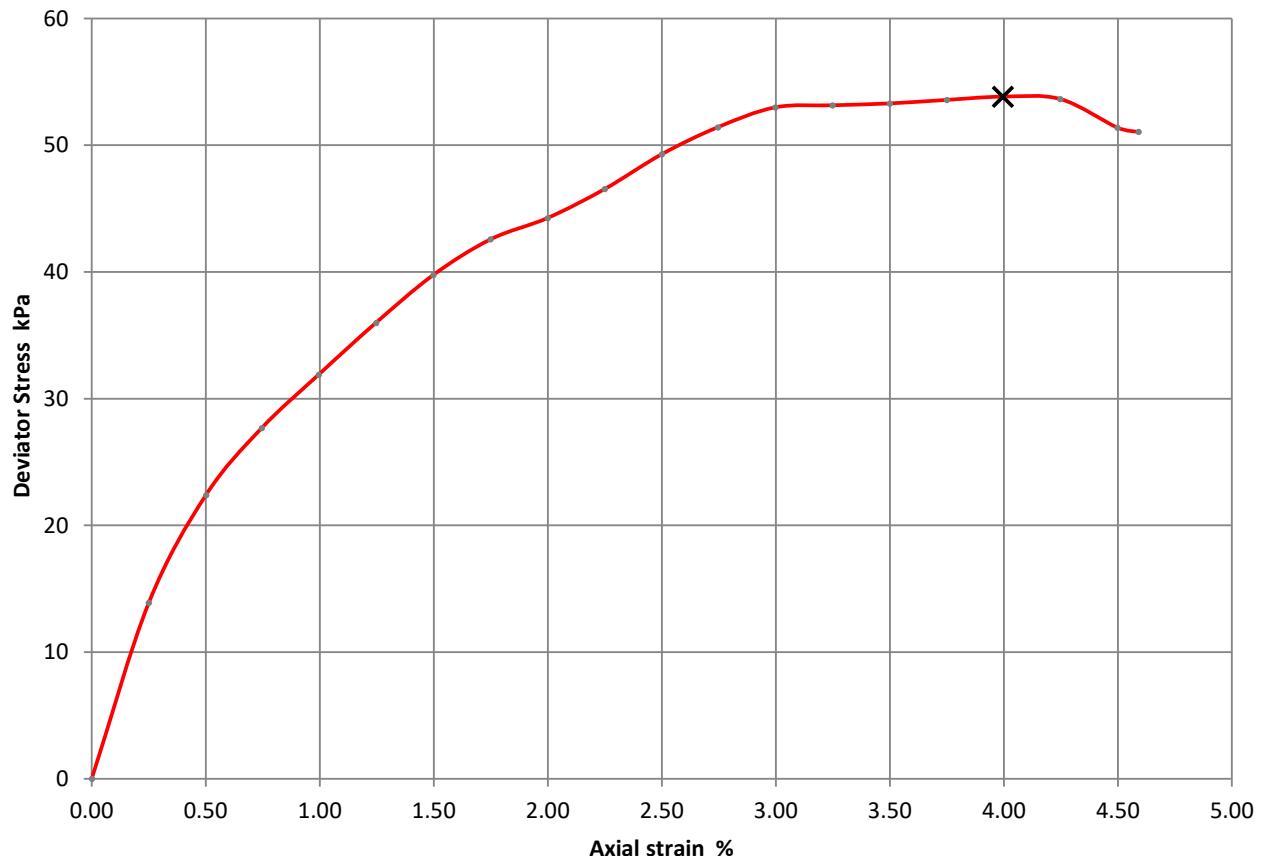
Moisture Content (%)	21
Bulk Density (Mg/m ³)	1.79
Dry Density (Mg/m ³)	1.48
Specimen Length (mm)	200.2
Specimen Diameter (mm)	104.3
Cell Pressure (kPa)	18
Deviator Stress (kPa)	54
Undrained Shear Strength (kPa)	27
Failure Strain (%)	4
Mode Of Failure	Plastic
Membrane Used/Thickness	Rubber/0.4mm
Rate of Strain (%/min)	1.37

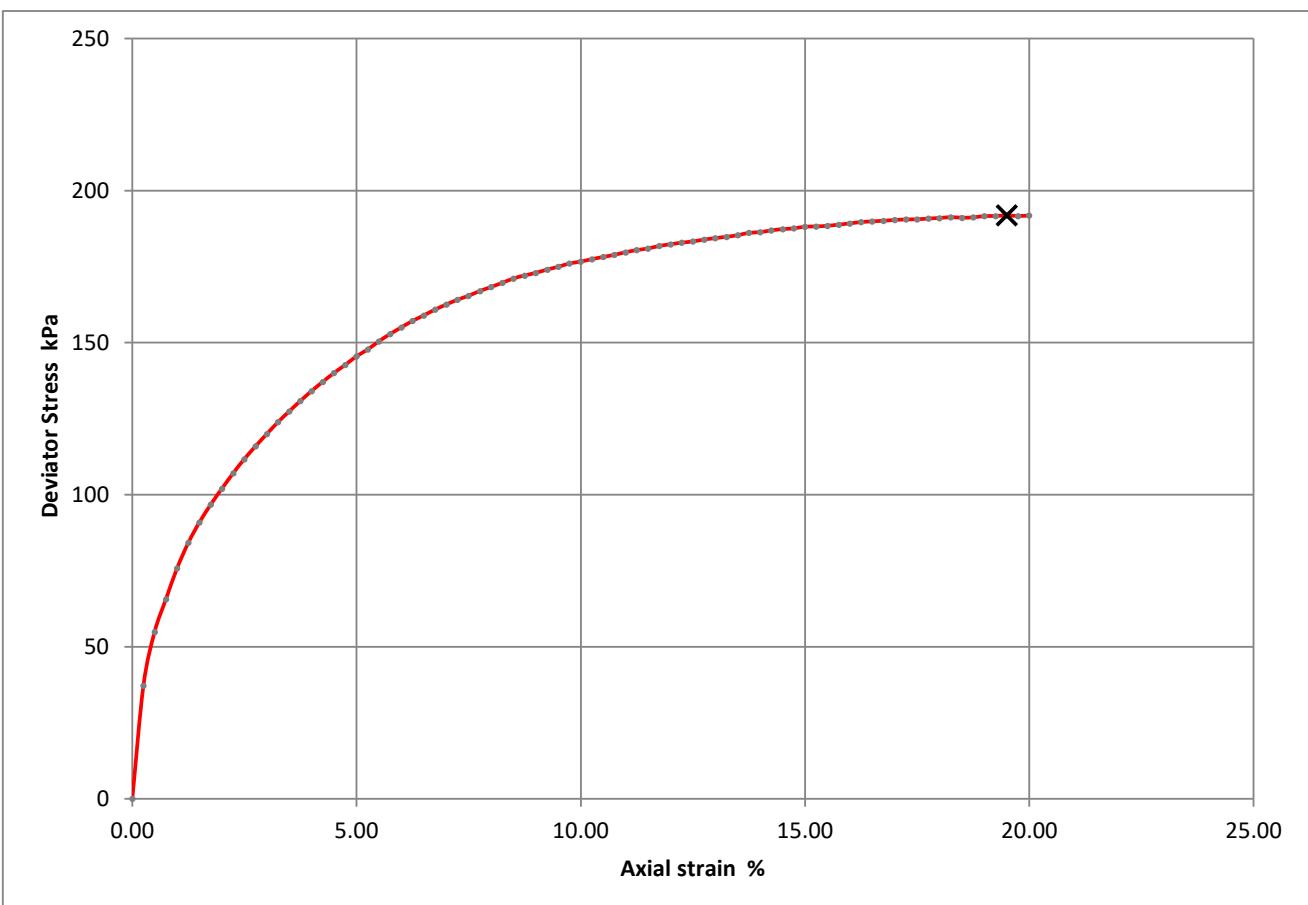
**Single Stage Unconsolidated-Undrained Triaxial Test
BS 1377 : 1990 Part 7 : 8**

Project Name	Newsley Library and Car Park, Falling Lane/High Street, Hillingdon, UB7 7BE	Contract Number	78927
Soil Description	Brown silty CLAY	Borehole/Pit No.	BH1
Date Tested	06/06/2025	Sample No.	
		Depth Top (m)	10.00
		Depth Base (m)	10.45
		Sample Type	U
		Operator	David. E

Moisture Content (%)	26
Bulk Density (Mg/m ³)	1.99
Dry Density (Mg/m ³)	1.59
Specimen Length (mm)	208.4
Specimen Diameter (mm)	104.3
Cell Pressure (kPa)	180
Deviator Stress (kPa)	192
Undrained Shear Strength (kPa)	96
Failure Strain (%)	19
Mode Of Failure	Plastic
Membrane Used/Thickness	Rubber/0.4mm
Rate of Strain (%/min)	1.32

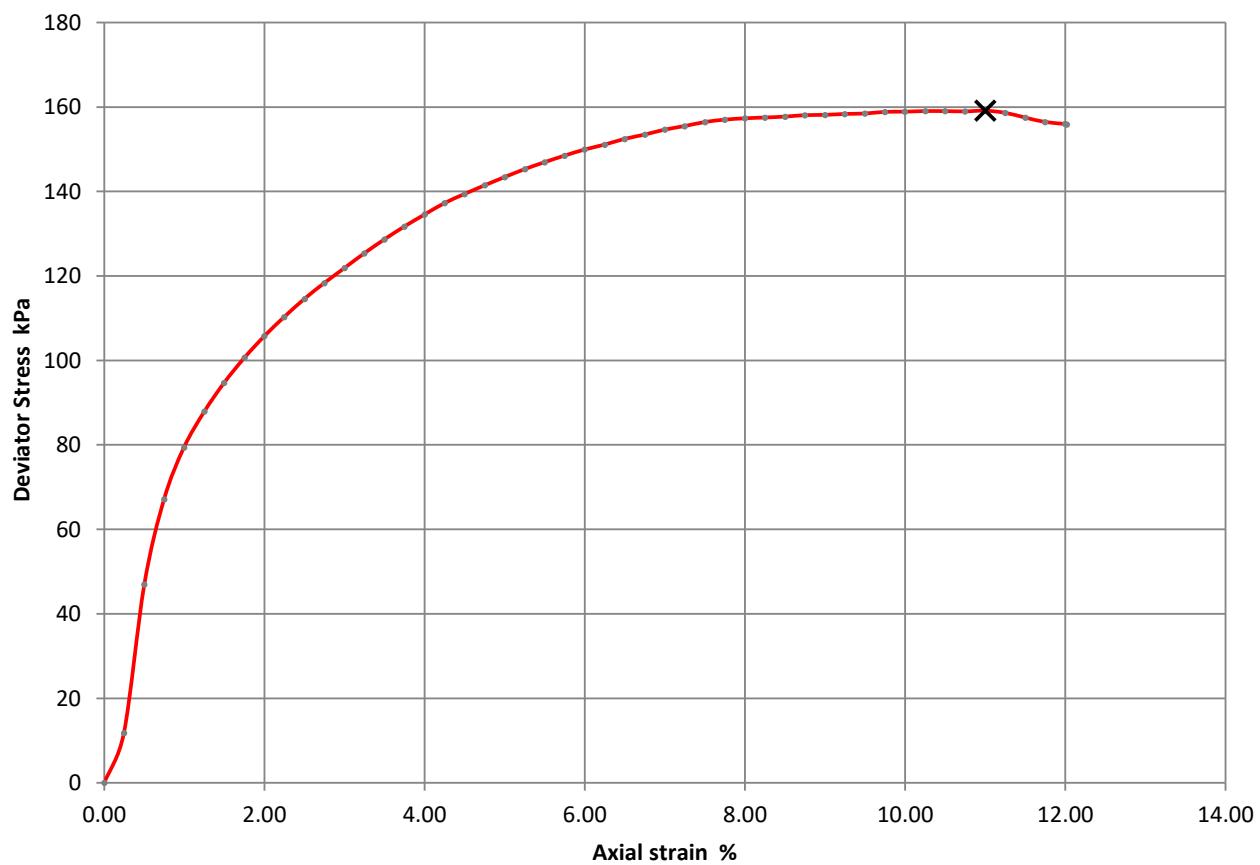
Moisture Content (%)	26
Bulk Density (Mg/m ³)	1.98
Dry Density (Mg/m ³)	1.57
Specimen Length (mm)	208.4
Specimen Diameter (mm)	104.2
Cell Pressure (kPa)	324
Deviator Stress (kPa)	159
Undrained Shear Strength (kPa)	80
Failure Strain (%)	11
Mode Of Failure	Compound
Membrane Used/Thickness	Rubber/0.4mm
Rate of Strain (%/min)	1.32

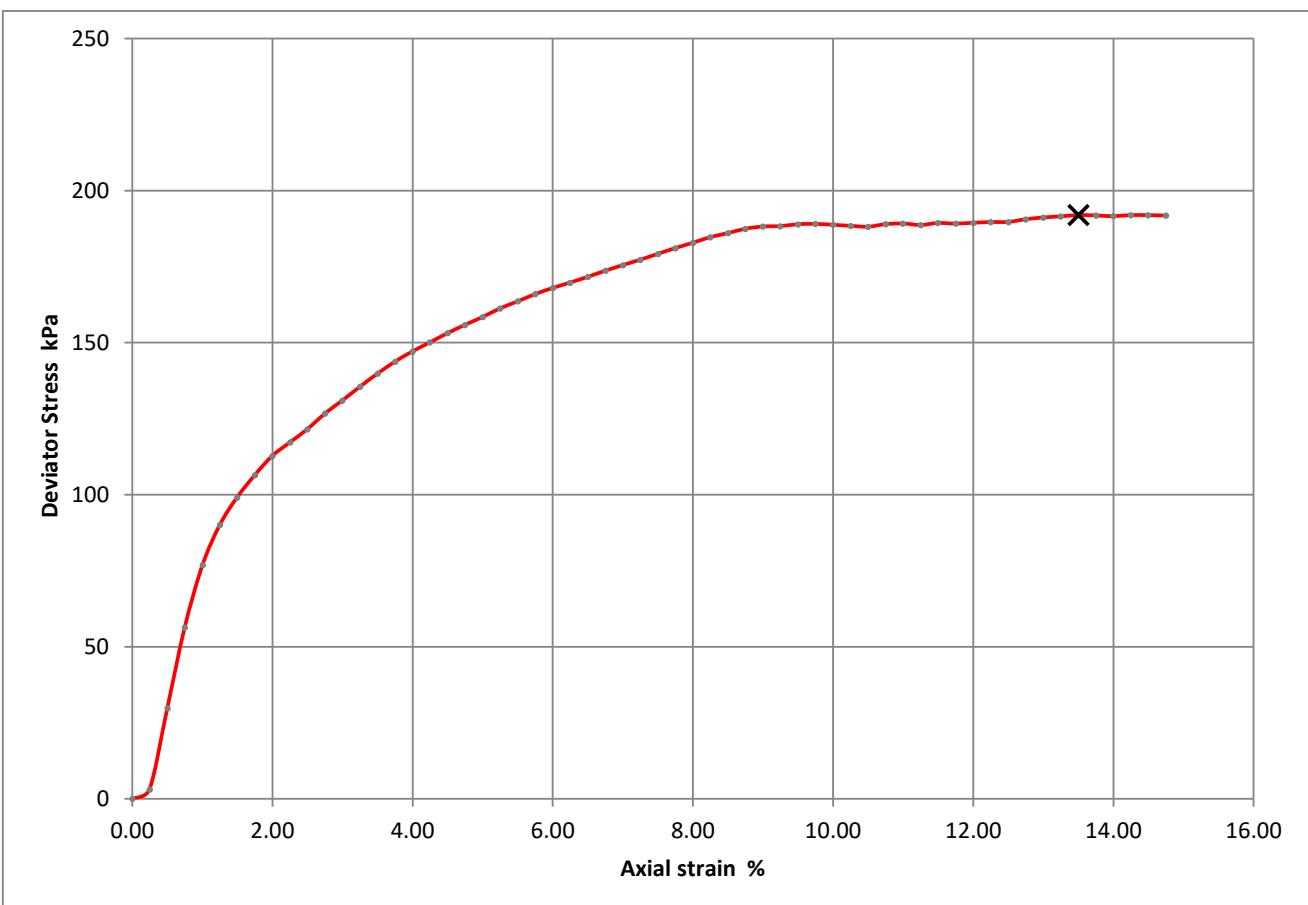
**Single Stage Unconsolidated-Undrained Triaxial Test
BS 1377 : 1990 Part 7 : 8**

Project Name	Newsley Library and Car Park, Falling Lane/High Street, Hillingdon, UB7 7BE	Contract Number	78927
Soil Description	Brown silty sandy CLAY	Borehole/Pit No.	BH2
Date Tested	07/06/2025	Sample No.	
		Depth Top (m)	1.00
		Depth Base (m)	1.45
		Sample Type	U
		Operator	David. E

Moisture Content (%)	20
Bulk Density (Mg/m ³)	1.85
Dry Density (Mg/m ³)	1.54
Specimen Length (mm)	182.3
Specimen Diameter (mm)	104.1
Cell Pressure (kPa)	18
Deviator Stress (kPa)	192
Undrained Shear Strength (kPa)	96
Failure Strain (%)	14
Mode Of Failure	Plastic
Membrane Used/Thickness	Rubber/0.4mm
Rate of Strain (%/min)	1.51

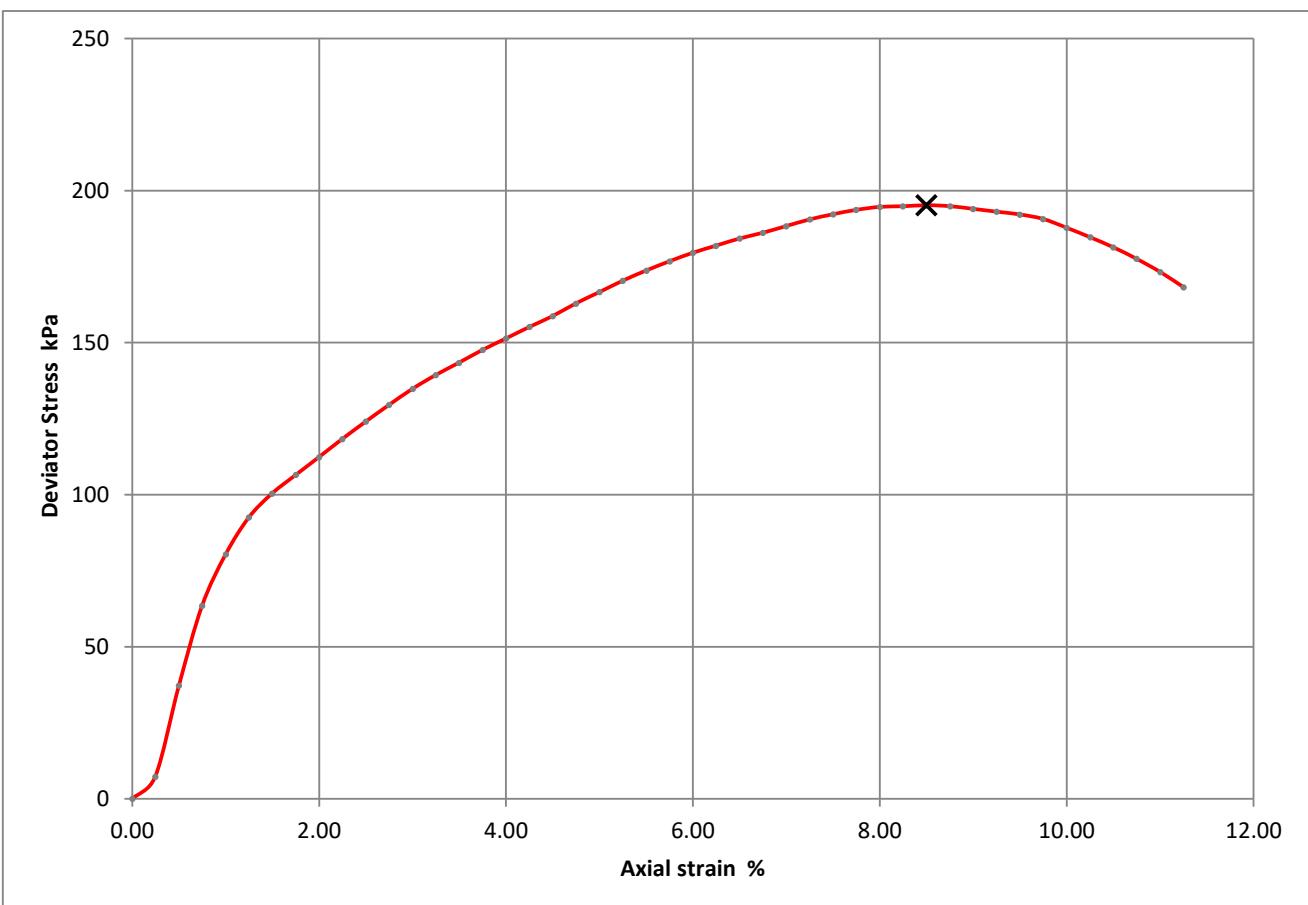
**Single Stage Unconsolidated-Undrained Triaxial Test
BS 1377 : 1990 Part 7 : 8**

Project Name	Newsley Library and Car Park, Falling Lane/High Street, Hillingdon, UB7 7BE	Contract Number	78927
Soil Description	Brown silty CLAY (rootlets)	Borehole/Pit No.	BH2
Date Tested	07/06/2025	Sample Type	U
		Operator	David. E

Moisture Content (%)	26
Bulk Density (Mg/m ³)	1.95
Dry Density (Mg/m ³)	1.55
Specimen Length (mm)	208.3
Specimen Diameter (mm)	104.3
Cell Pressure (kPa)	252
Deviator Stress (kPa)	195
Undrained Shear Strength (kPa)	98
Failure Strain (%)	9
Mode Of Failure	Compound
Membrane Used/Thickness	Rubber/0.4mm
Rate of Strain (%/min)	1.32

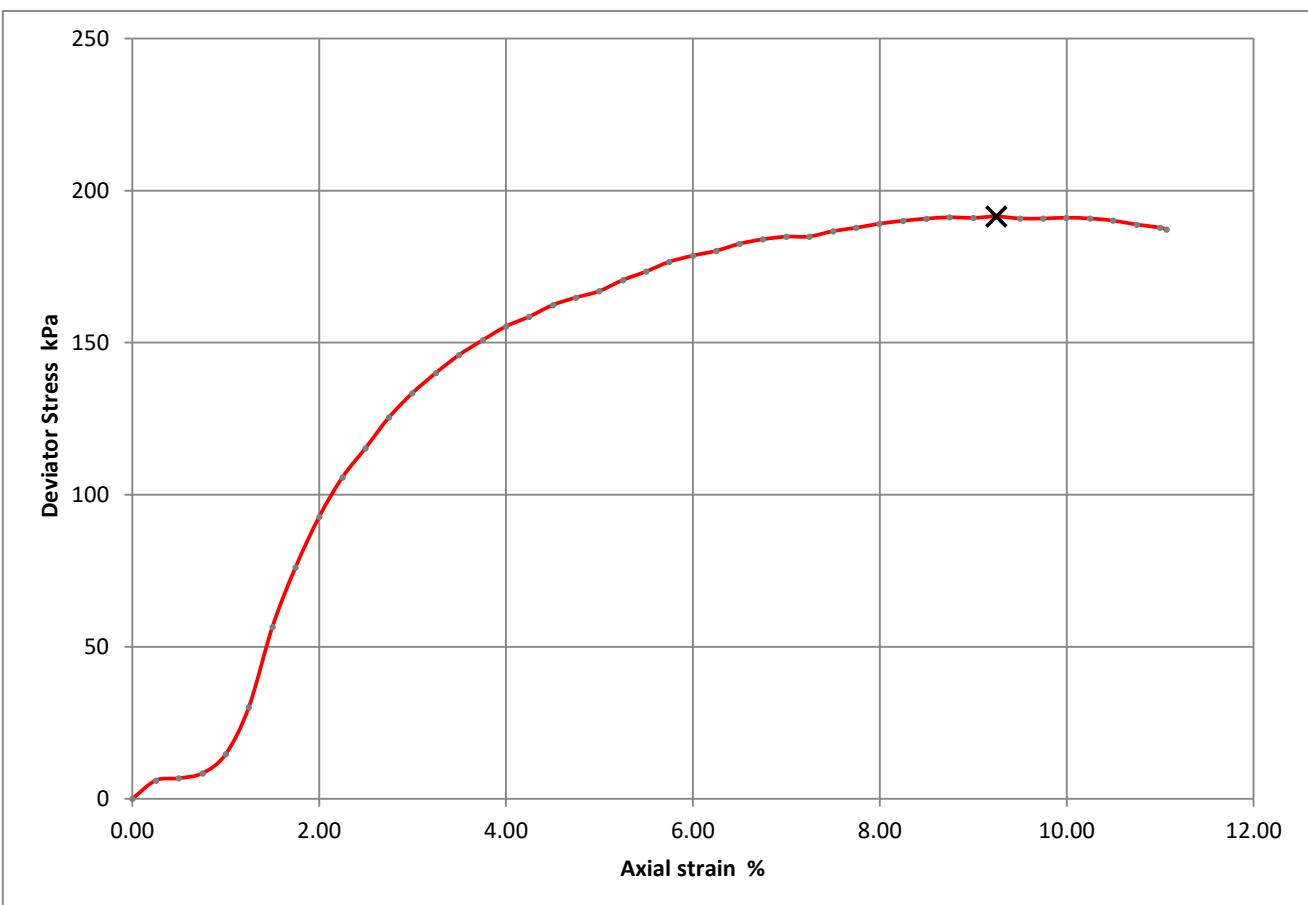
**Single Stage Unconsolidated-Undrained Triaxial Test
BS 1377 : 1990 Part 7 : 8**

Project Name	Newsley Library and Car Park, Falling Lane/High Street, Hillingdon, UB7 7BE	Contract Number	78927
Soil Description	Brown silty CLAY	Borehole/Pit No.	BH2
Date Tested	07/06/2025	Sample No.	
		Depth Top (m)	20.00
		Depth Base (m)	20.45
		Sample Type	U
		Operator	David. E

Moisture Content (%)	26
Bulk Density (Mg/m ³)	1.91
Dry Density (Mg/m ³)	1.51
Specimen Length (mm)	208.3
Specimen Diameter (mm)	104.1
Cell Pressure (kPa)	360
Deviator Stress (kPa)	191
Undrained Shear Strength (kPa)	96
Failure Strain (%)	9
Mode Of Failure	Compound
Membrane Used/Thickness	Rubber/0.4mm
Rate of Strain (%/min)	1.32

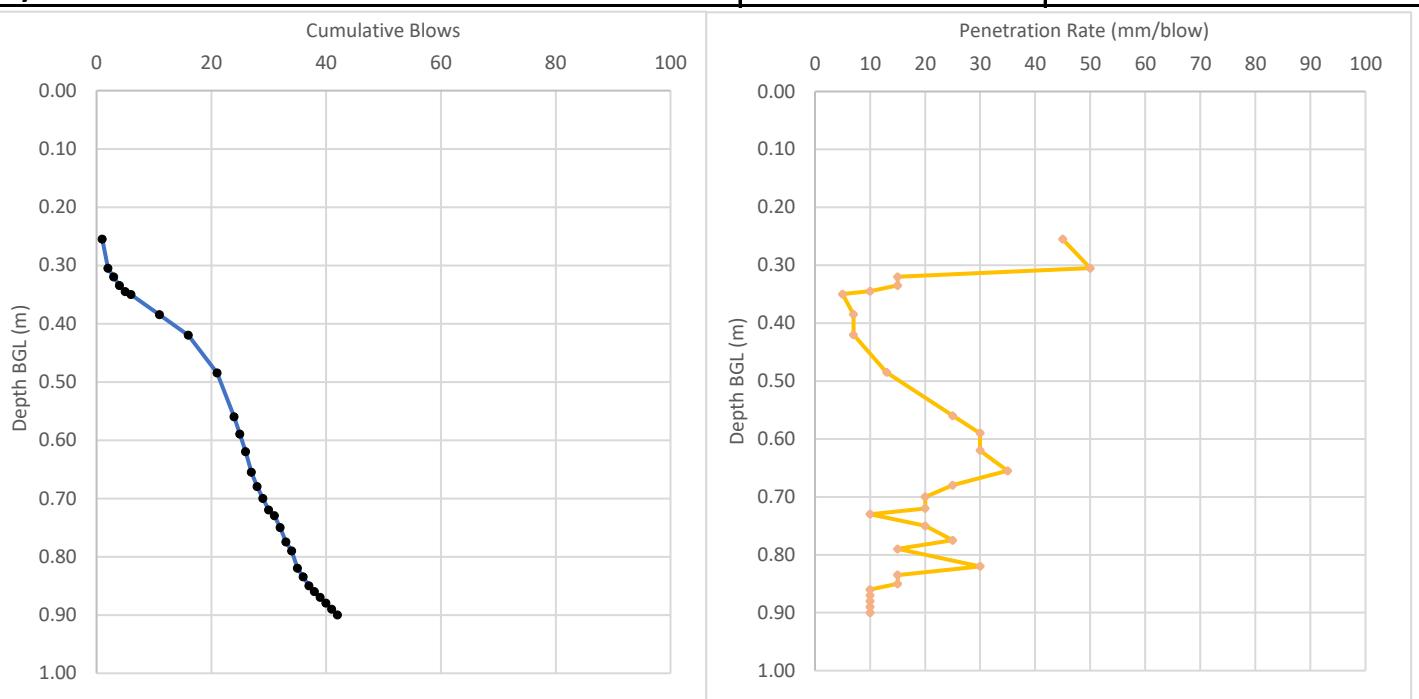
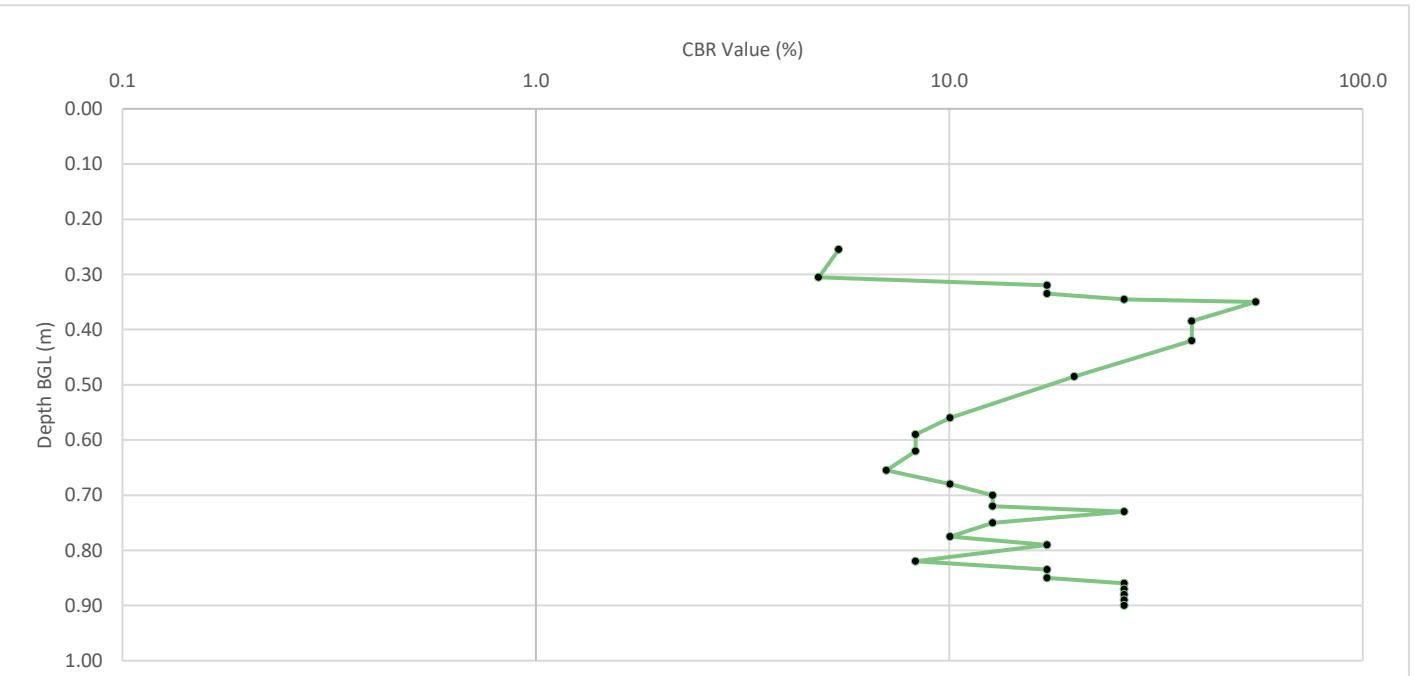
Dynamic Cone Penetrometer

Project:	Yiewsley Library and Car Park, Falling Lane/High Street, Hillingdon, UB7 7BE	Project No:	DCP Location:
		25-154.01	DCP5
Client:	Bugler Developments Limited	Operator:	Date:
		OC	21/05/2025
