**DISCOVERY STRATEGY
REMEDIATION ACTION PLAN
&
VERIFICATION PLAN**

Client	Bugler Developments Limited
Works	Discovery Strategy, Remediation Action Plan and Verification Plan
Site	Land at Otterfield Road, Yiewsley, UB7 9PE

Project	Version	Date
25-205.01	1	1 July 2025

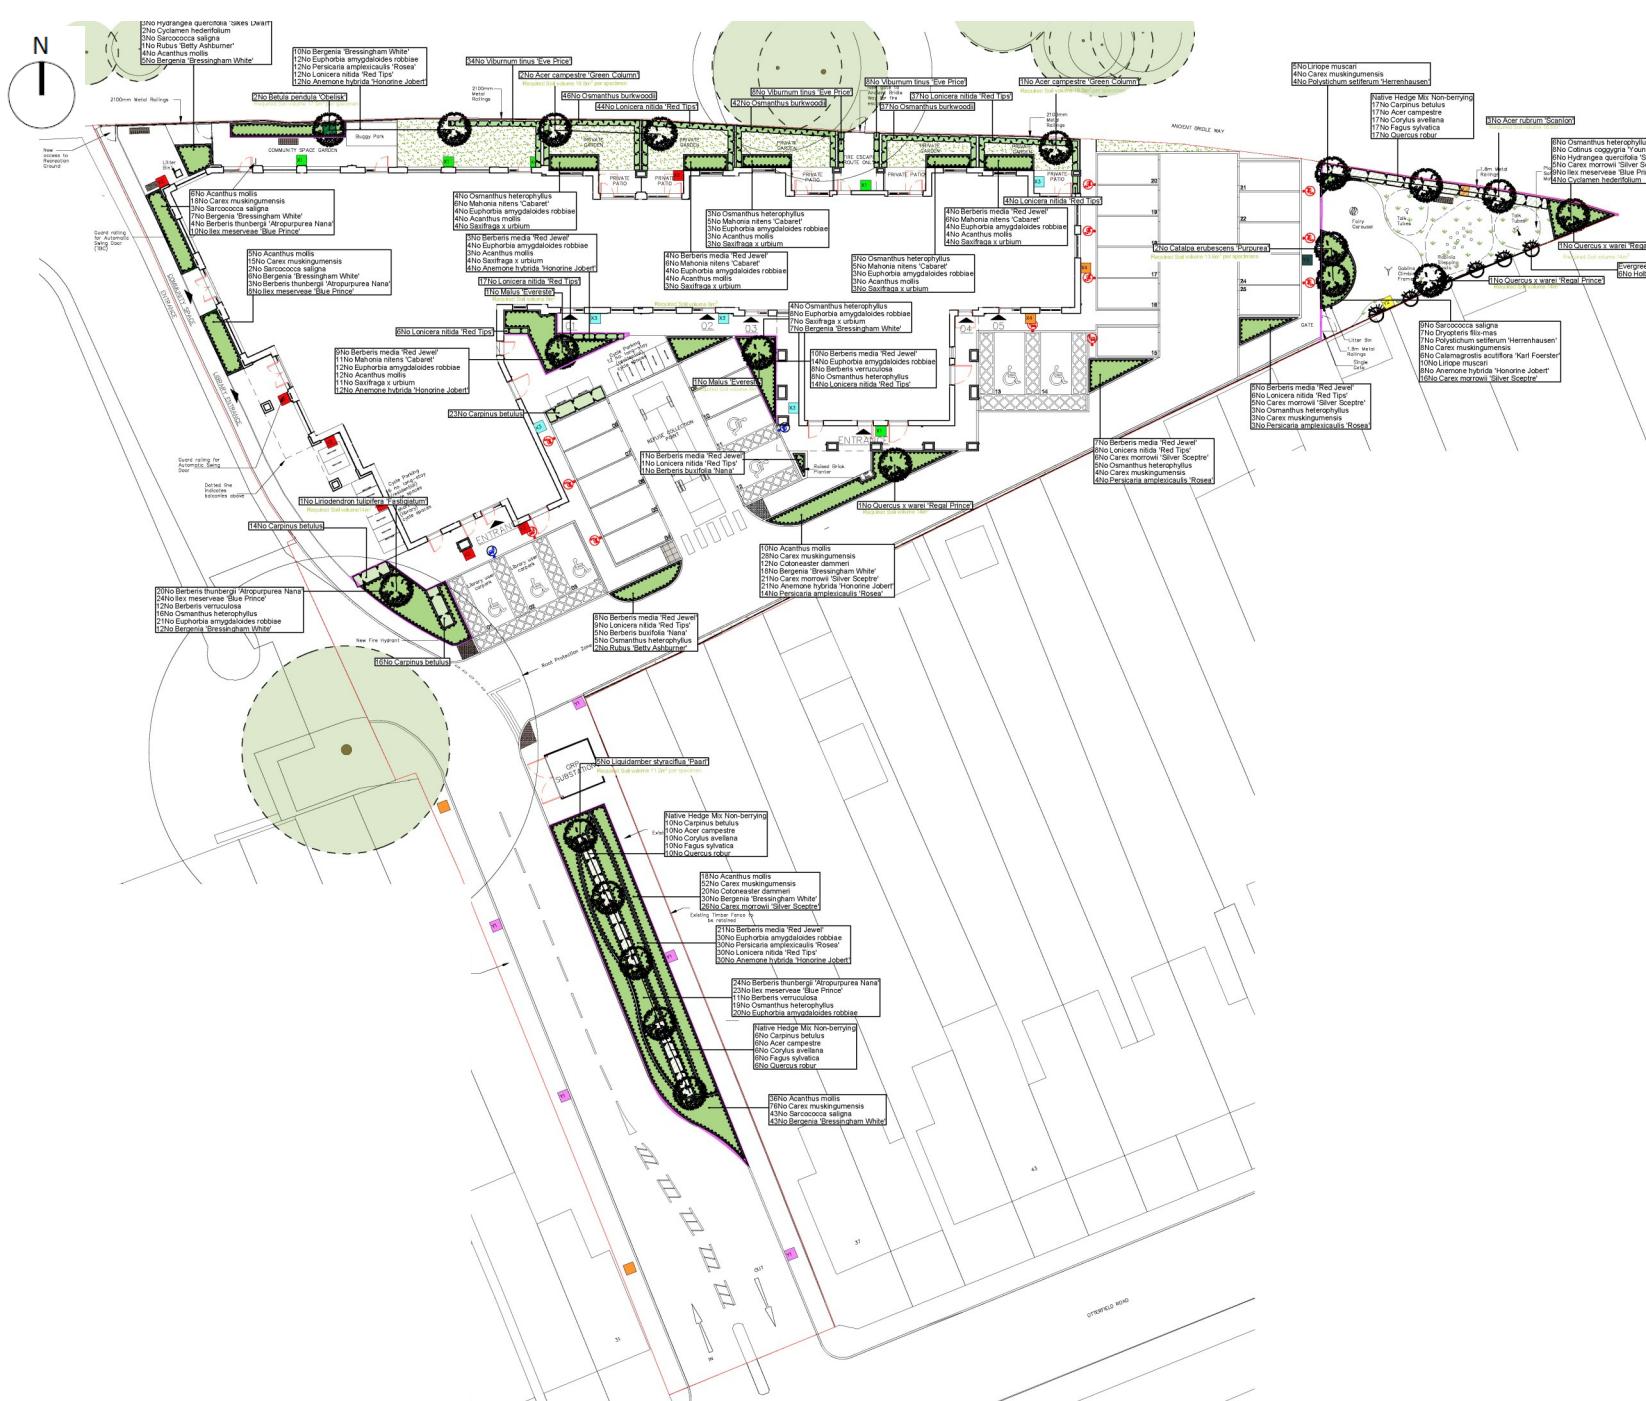
Figure 1 – Proposed Development Plan

New homes have gardens and amenity areas which are demarcated upon **Figure 1** by green soft landscaping. To the frontage and around the parking bays of the new homes/development is soft landscaped public open space.

Proposed Development Plan

1. **Figure 1** – Proposed Development Plan
2. **Figure 2** – Cover System Remediation and Verification Plan

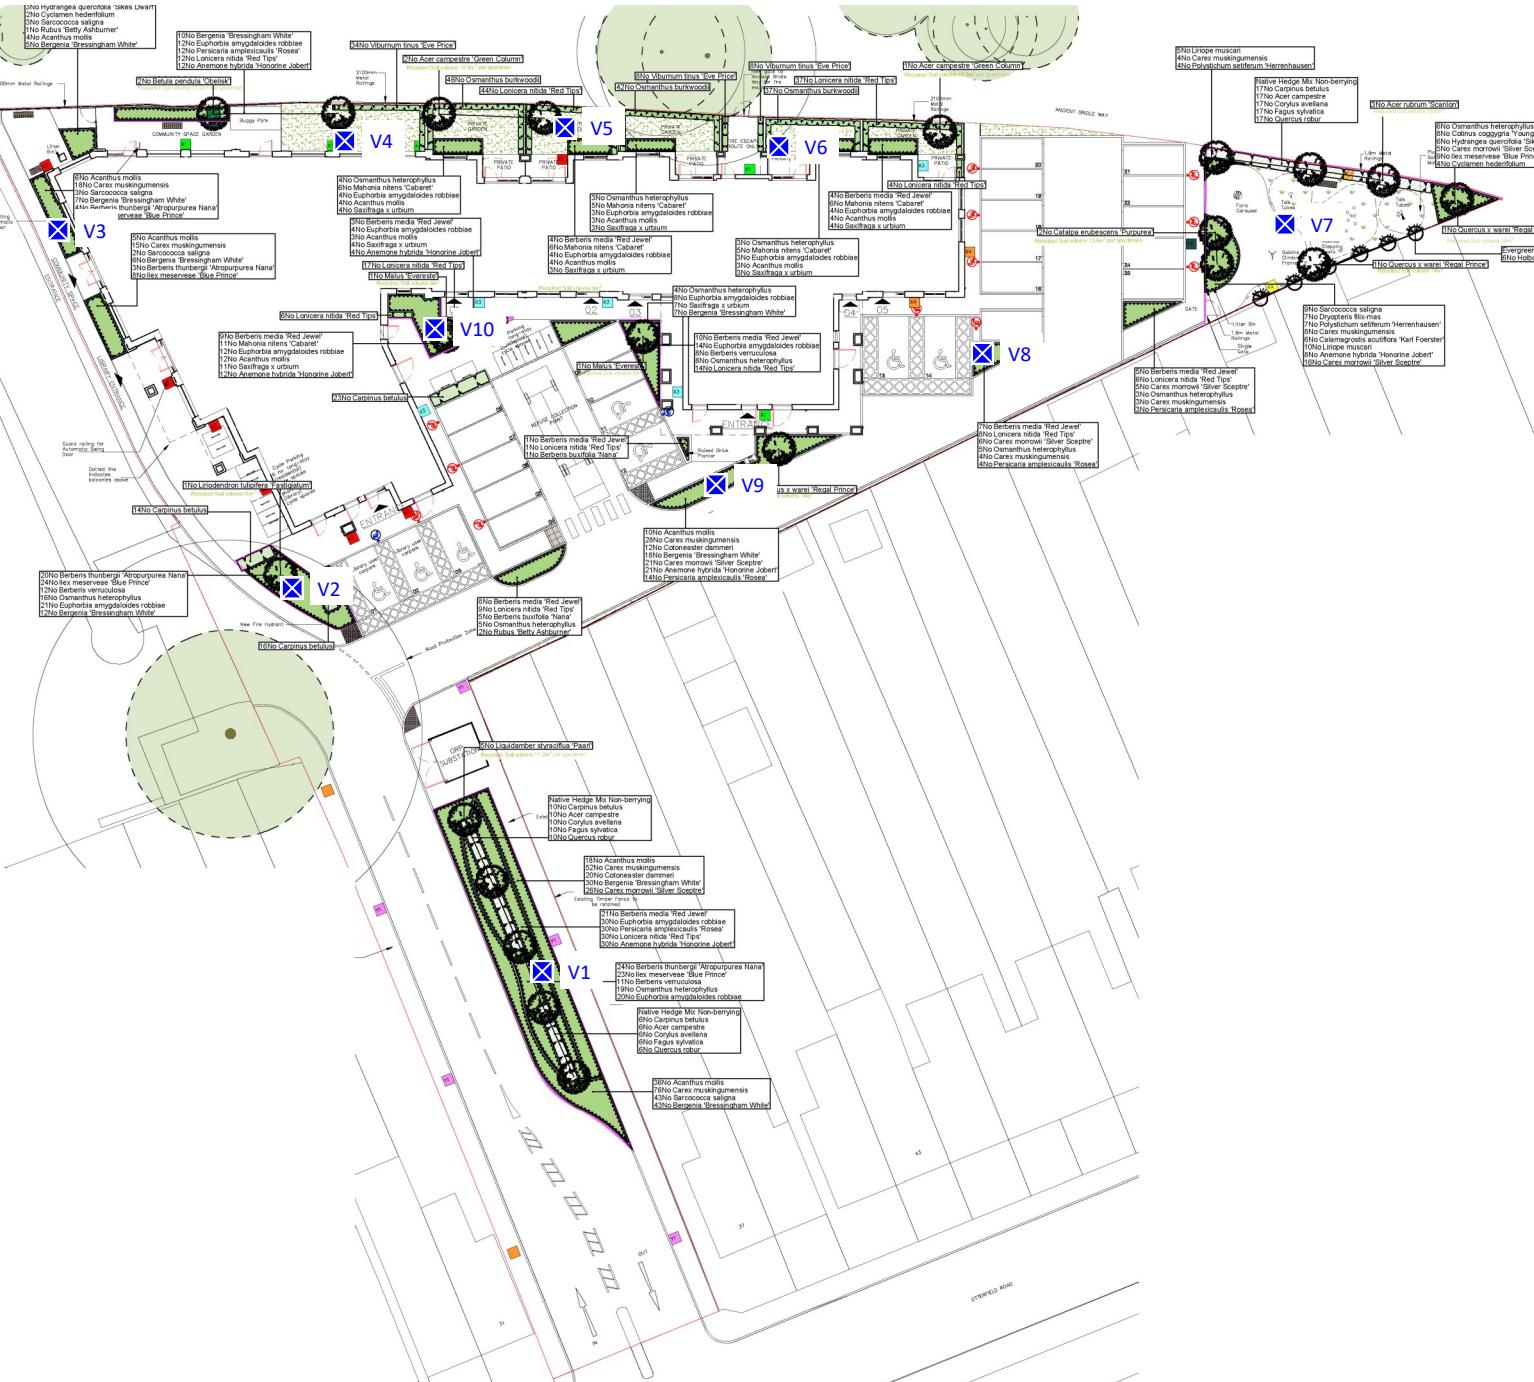
Figure 2 – Remediation and Verification Plan

Figure 2 provides suggestion of verification positions to confirm cover system thickness/construction providing spatial arrangement across the soft landscaped areas of the site.

Verification Trial Hole

Figure 2 is enclosed within **Appendix I**, which presents a Remediation and Verification Plan.

The following method statement is presented to construct and verify a 'clean cover' system to soft landscaped areas identified in **Figure 2**.

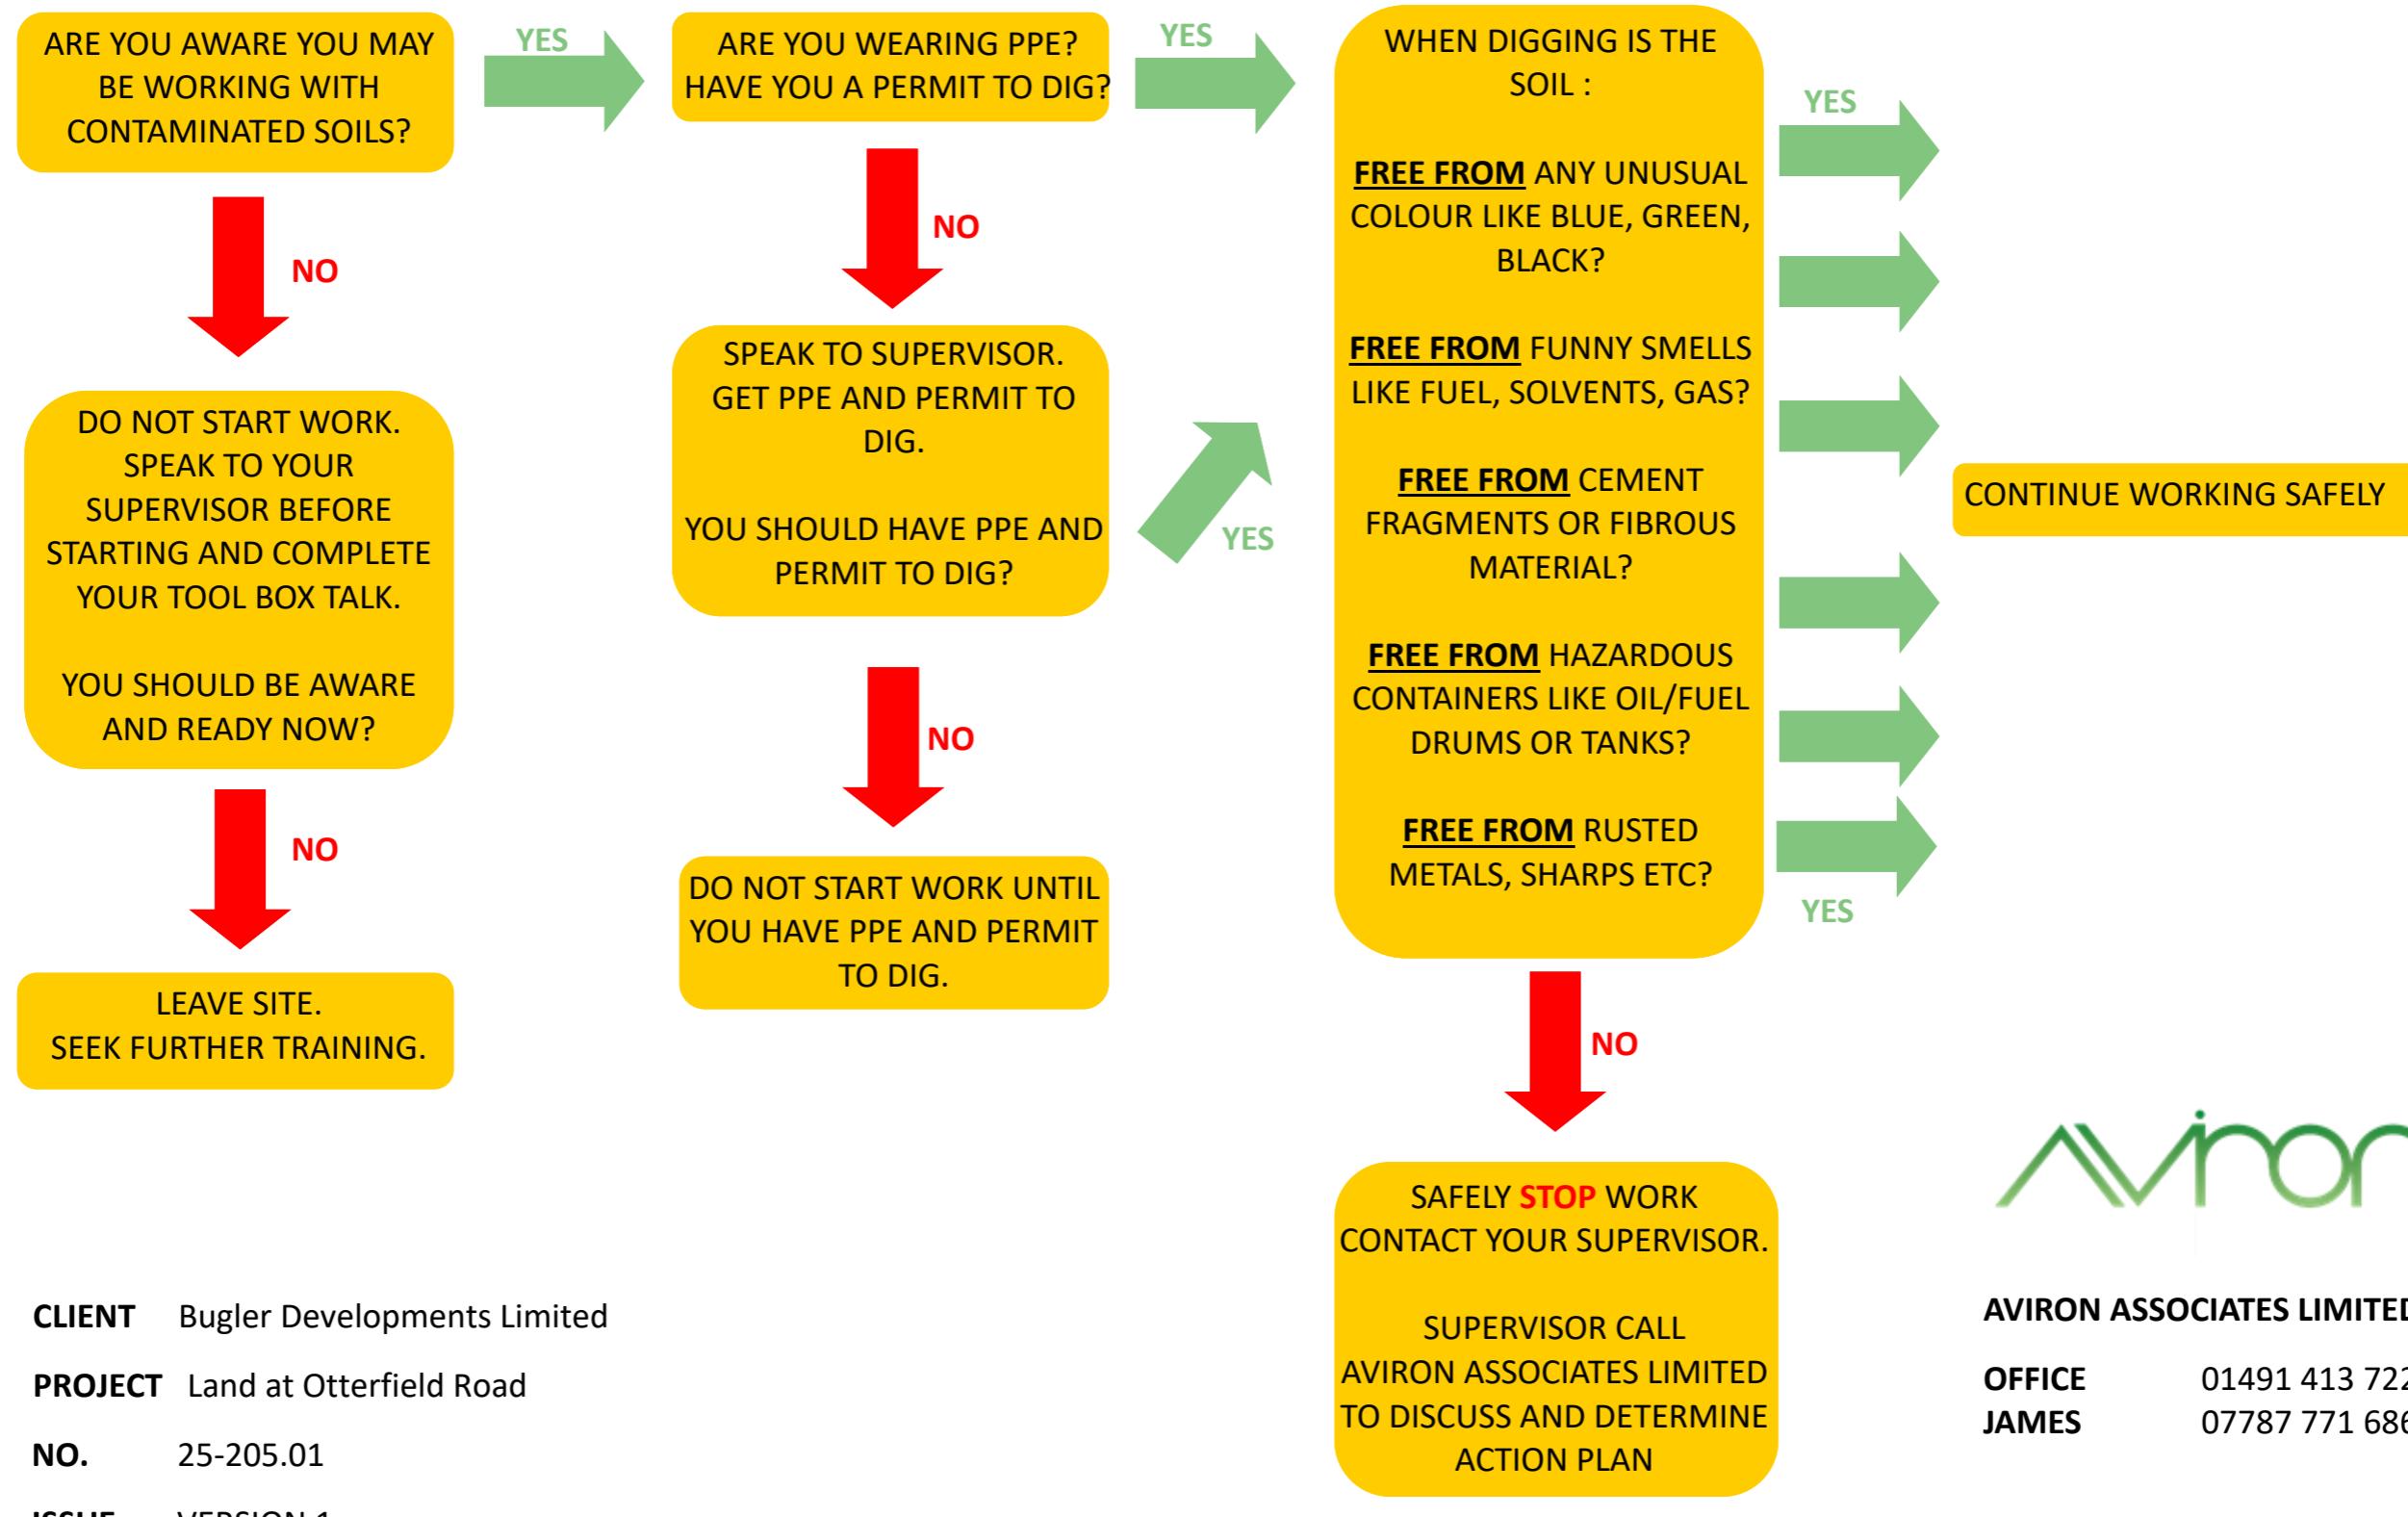
Appendix II**Discovery Strategy Flow Chart**

HOW TO IDENTIFY CONTAMINATED SOILS AND WHAT TO DO?

The Discovery Strategy flow chart is presented as **Appendix II**. This should be printed and laminated.
