Our Ref: 2105014.002.01
Your Ref:

ENDEAVOUR SEA SCOUT GROUP, COWLEY – SUPPLEMENTARY GEOTECHNICAL INVESTIGATION

Figure 1 – Exploratory Hole Location Plan
Appendix A – Exploratory Hole Logs
Appendix B – Site Photographs
Appendix C – Geotechnical Laboratory Results (K4 Report No. 30569 and ELAB Report No. 21-35452)

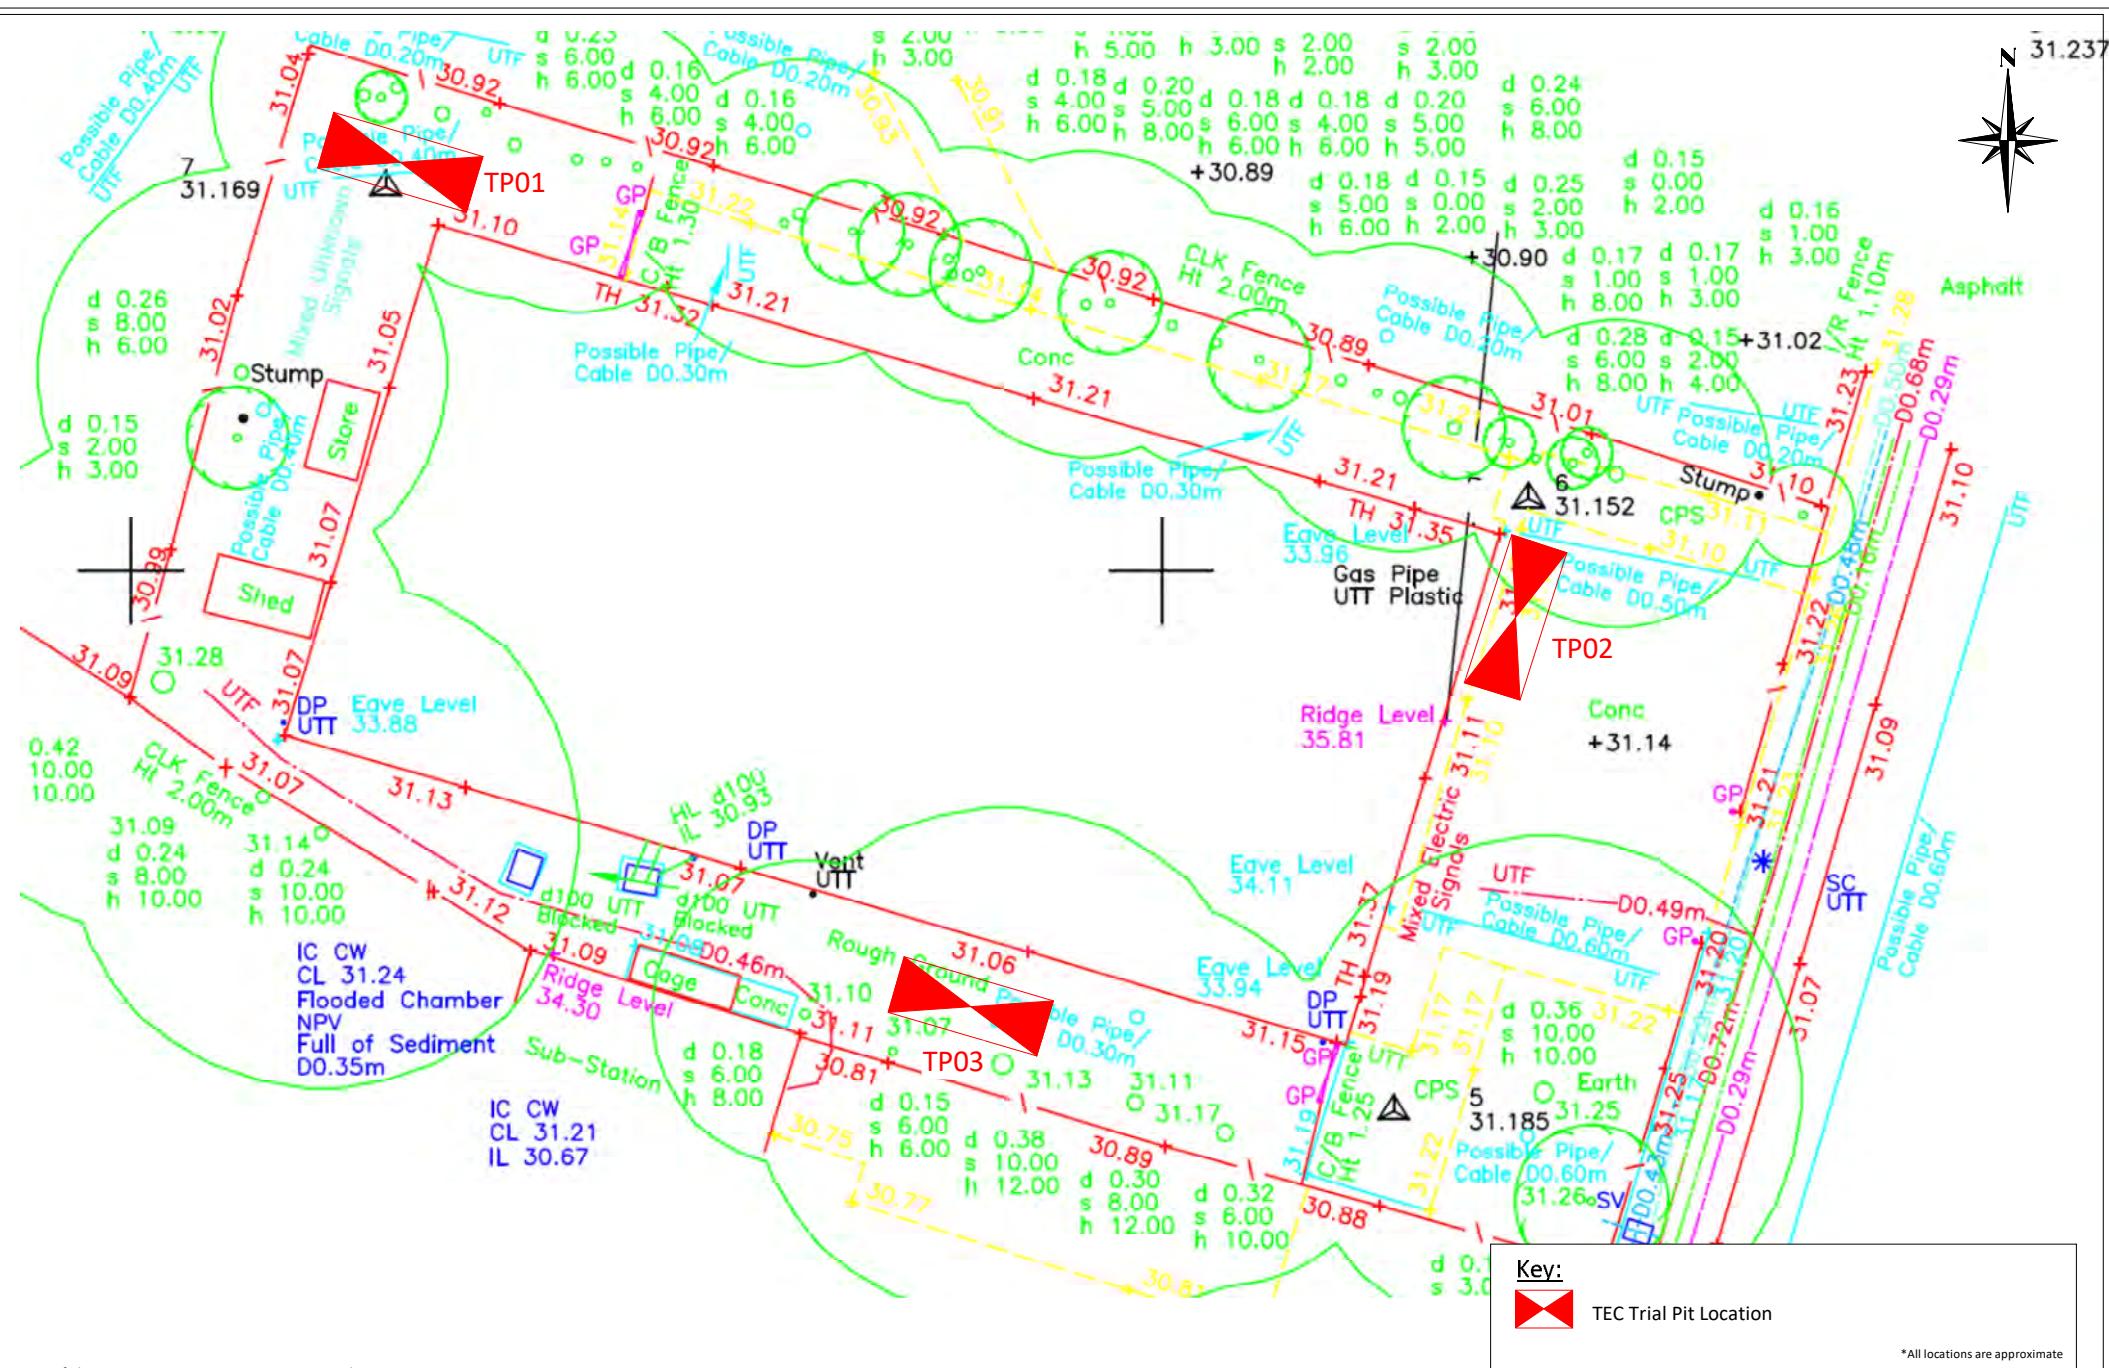
Extract of Client Drawing L10397-1-ENDEAVOUR, Dated May 2021

*All locations are approximate

Exploratory hole locations are presented in Figure 1, with exploratory hole logs presented in Appendix A. Photographs of the materials encountered are presented in Appendix B. A summary of the encountered ground conditions is provided in Table 2, below:

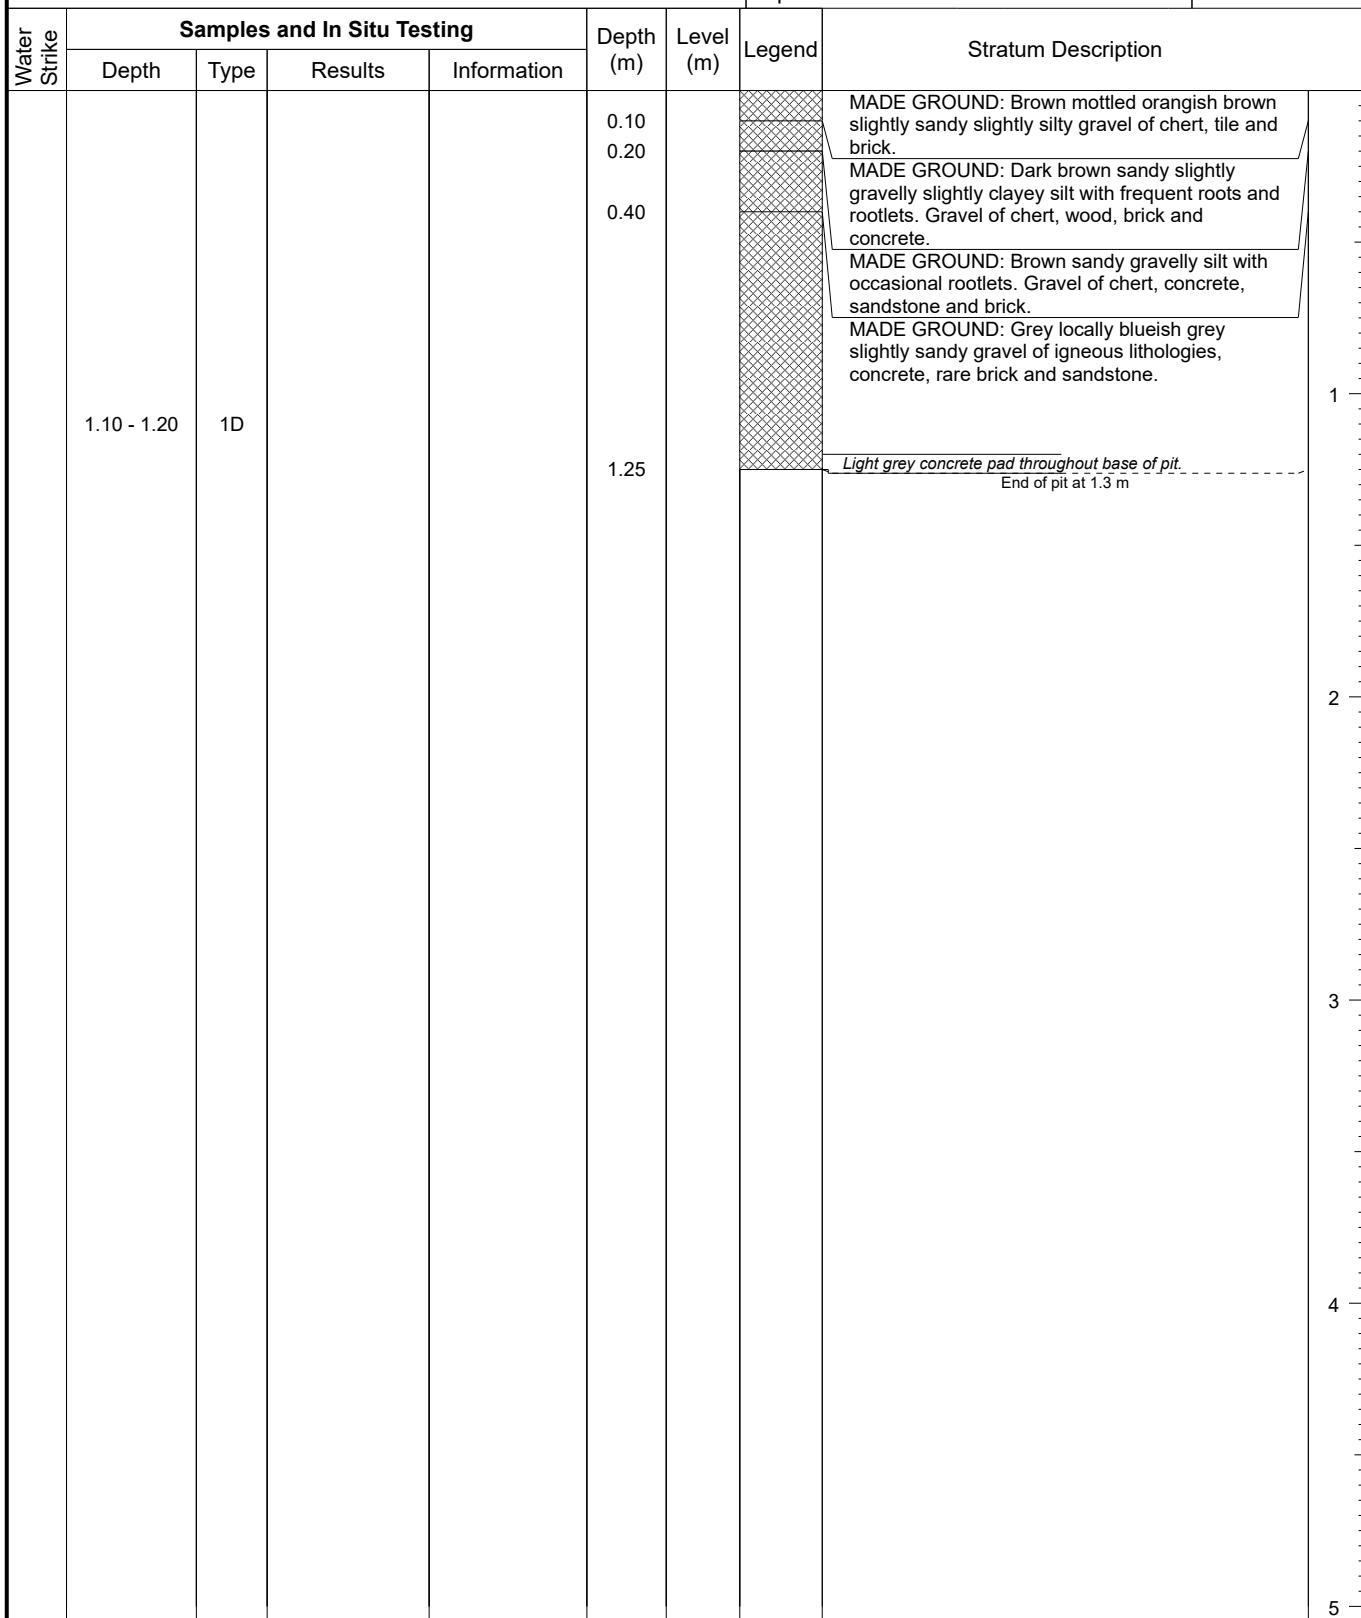
Trialpit No
TP03
FINAL
Sheet 1 of 1

Project Name:	Endeavour Sea Scout Group, Cowley	Project No.	Co-ords: - Level: mbgl	Date 10/08/2021
Location:	Cowley	Dimensions:	1.89m	Scale 1:25
Client:	London Borough of Hillingdon Council	Inclination:	1.00m	Orientation: ° Depth: 1.3m Logged JN

Remarks:	Terminated on concrete slab within base of pit. Groundwater not encountered.	
Stability:	Stable

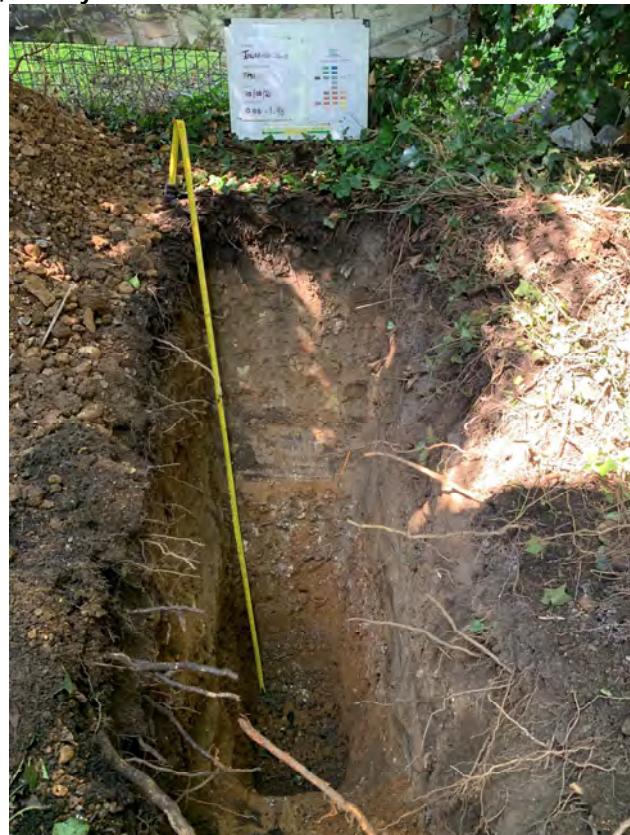
Photograph 1: Encountered ground materials, TP01. 0.0 - 1.9mbgl

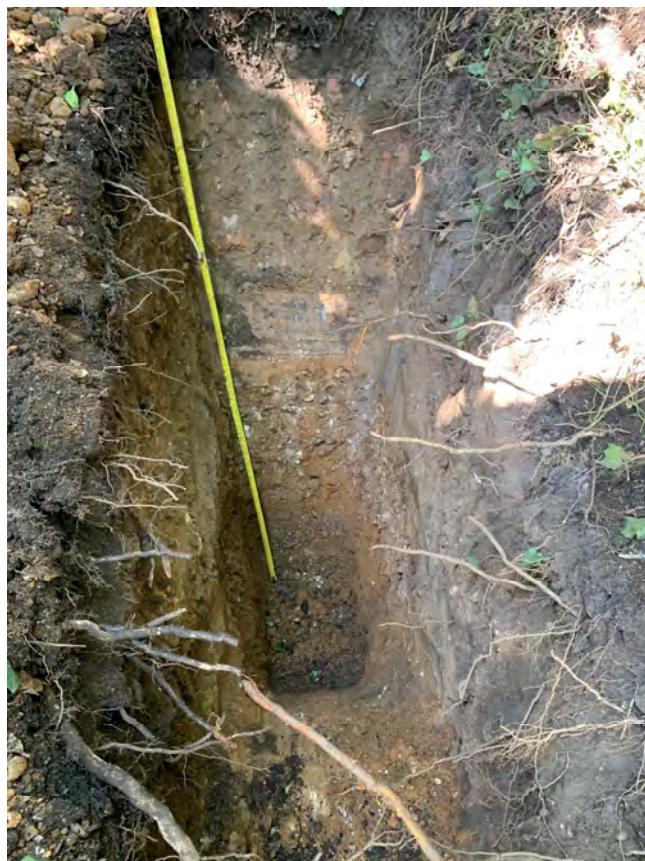
Photograph 2: Encountered ground materials. Base of TP01 1.5 – 1.9mbgl.

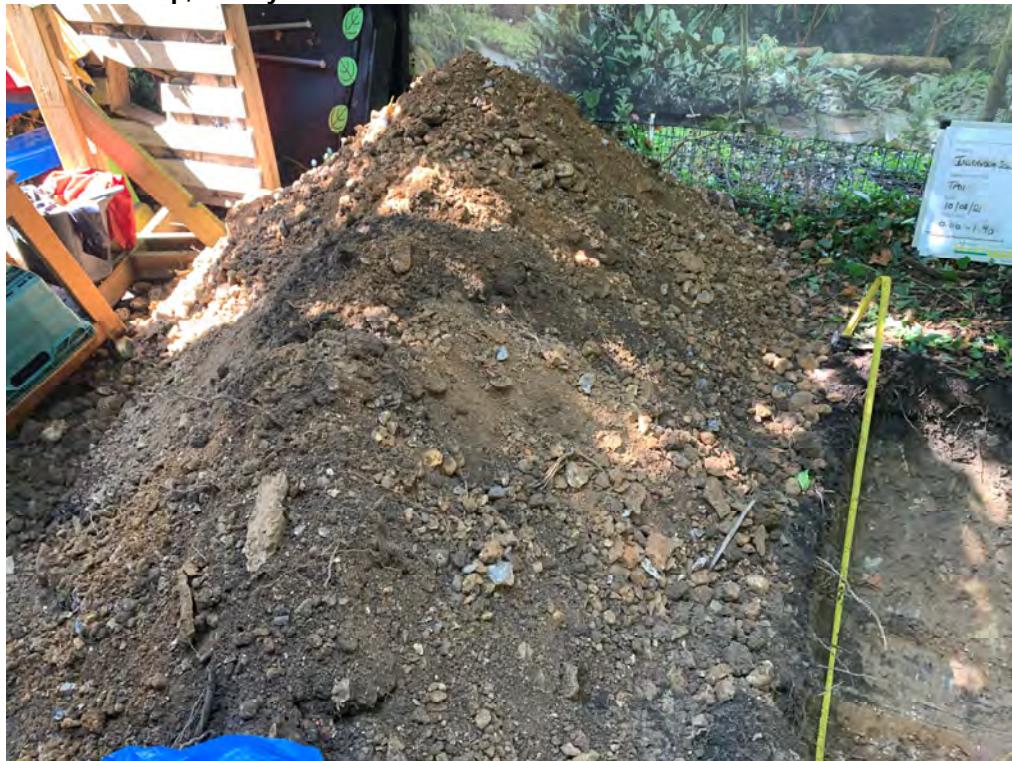
Photograph 3: Encountered spoil materials. TP01 0.0 – 1.9mbgl.

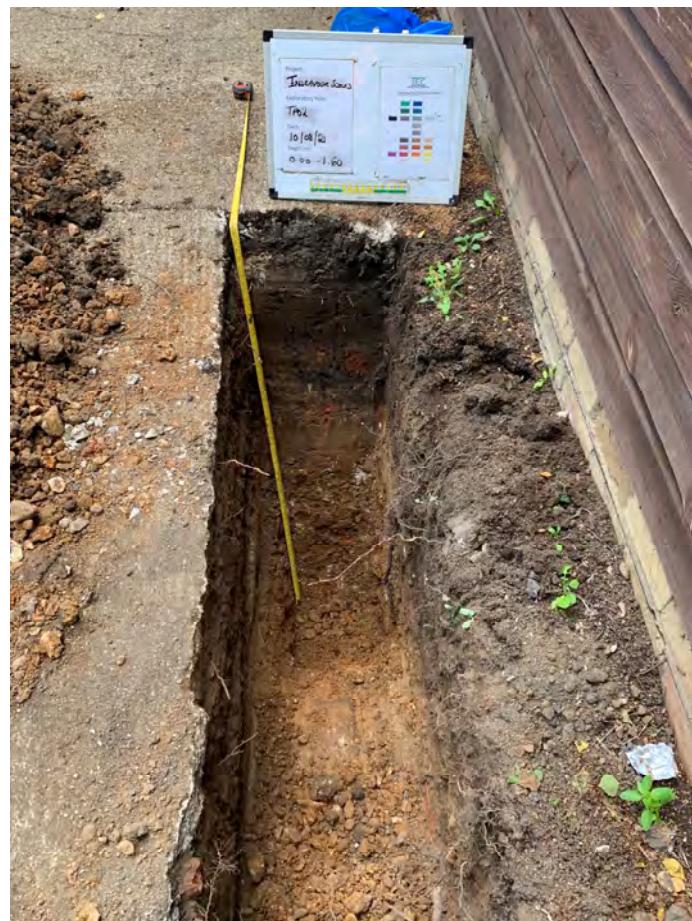
Photograph 4: Encountered ground materials. TP02 0.0 – 1.6mbgl.

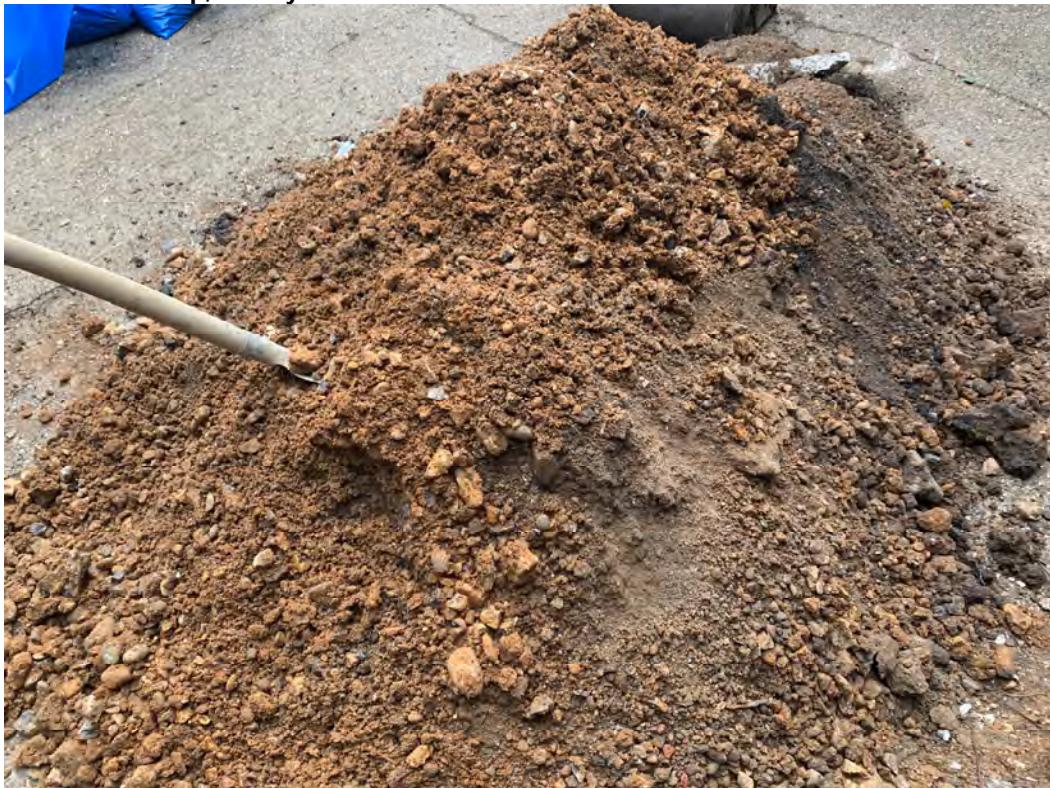
Photograph 5: Encountered spoil materials. TP02 0.0 – 1.6mbgl.

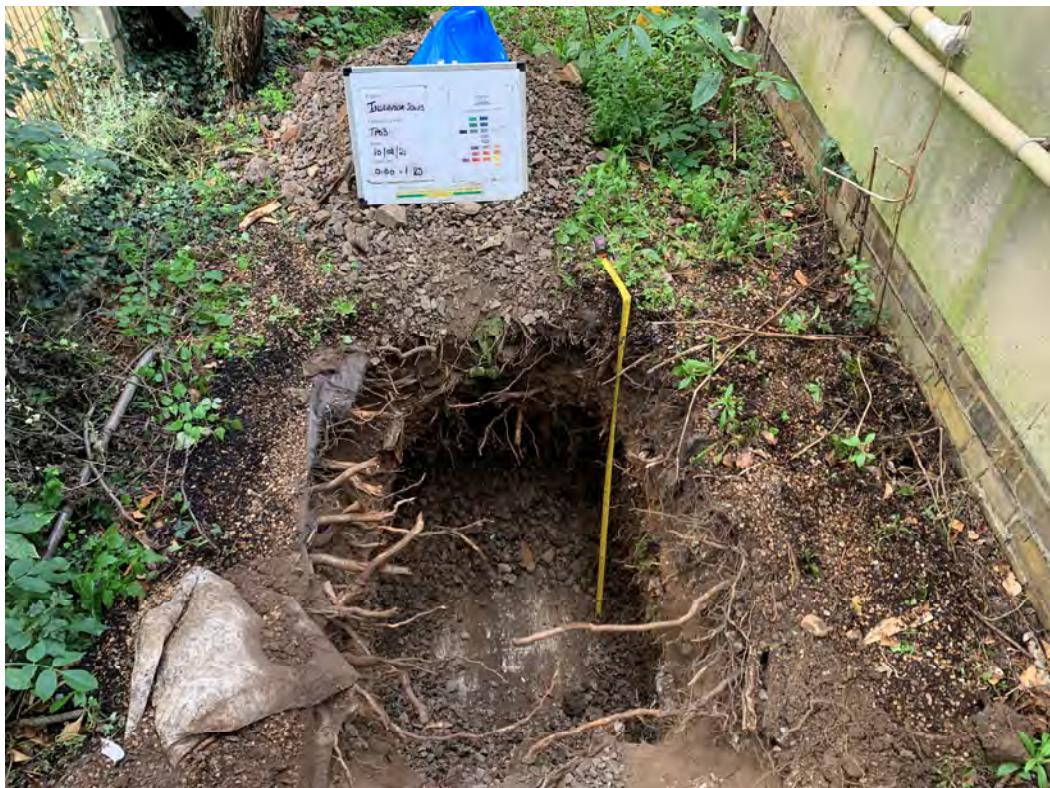
Photograph 6: Encountered ground materials. TP03 0.0 – 1.3mbgl.

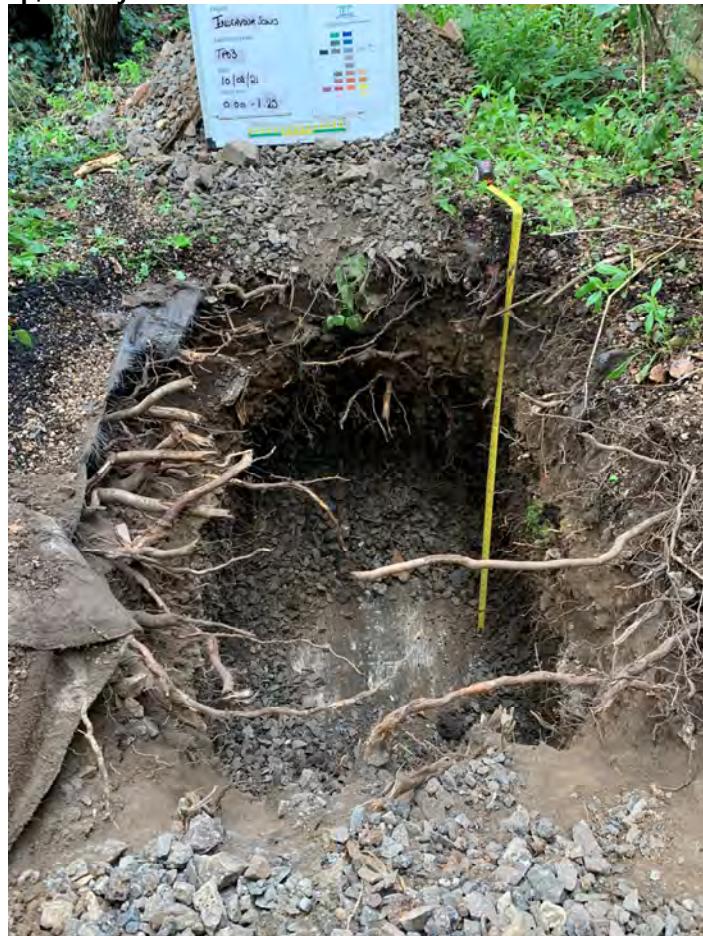
Photograph 7: Close view of concrete within base of TP03. 1.25mbgl.

Excavations at the site for conventional foundations may be achievable using conventional equipment, although it is anticipated that breakers may be required at relatively shallow depth where the existing concrete slab is encountered or excavation within the very dense sand and gravel at depth be required.

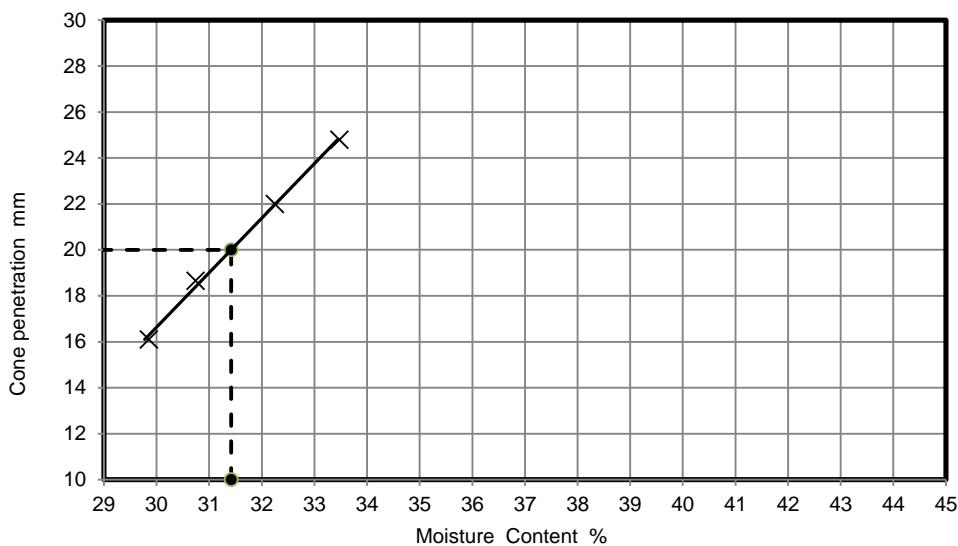
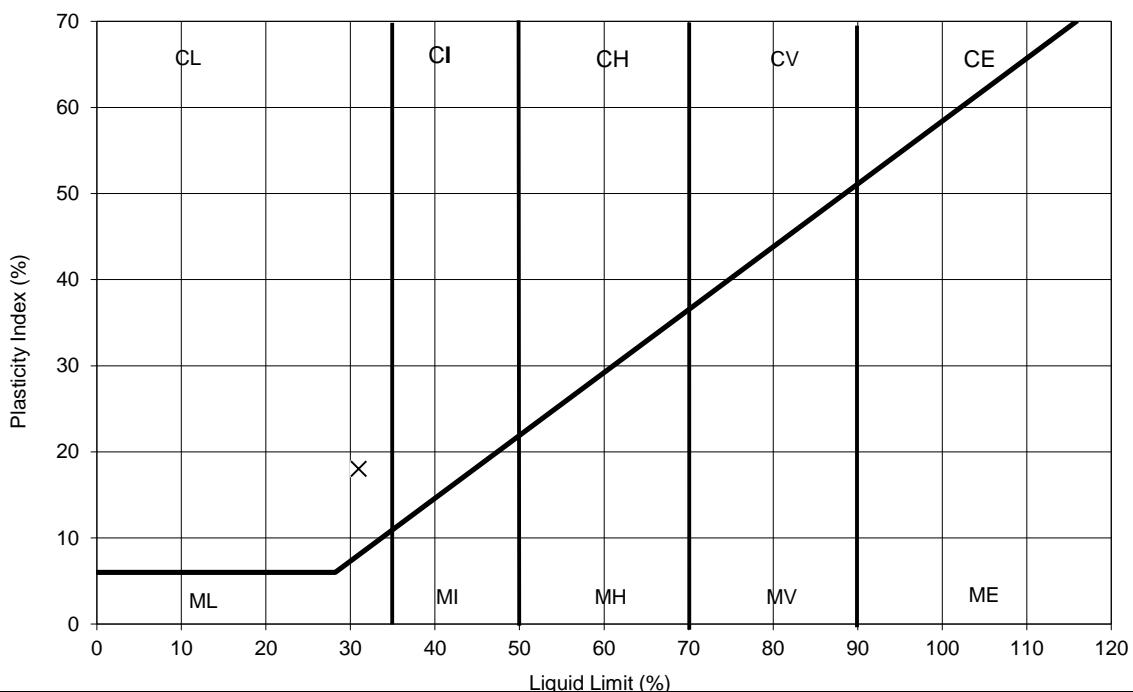
LIQUID LIMIT, PLASTIC LIMIT AND PLASTICITY INDEX

Job No.	30569
		Borehole/Pit No.	TP01
Site Name	Endeavour Sea Scout Group, Hillingdon	Sample No.	-
Project No.	2105014.002	Client	TEC
Soil Description	Brown sandy silty clayey GRAVEL (gravel is fmc and angular to rounded)	Depth Top	1.80 m
		Depth Base	1.90 m
		Sample Type	B
		Samples received	13/08/2021
		Schedules received	16/08/2021
		Project Started	16/08/2021
		Date Tested	25/08/2021

NATURAL MOISTURE CONTENT	9.3	%
% PASSING 425µm SIEVE	39	%
LIQUID LIMIT	31	%
PLASTIC LIMIT	13	%
PLASTICITY INDEX	18	%

Moisture Content (%)	Plasticity Index (%)	% passing 425µm sieve	Modified Plasticity Index ⁽¹⁾ (%)	Volume Change Potential ⁽¹⁾
7.5 – 9.3	18 – 27	24 – 39	6.48 – 7.02	Non-plastic

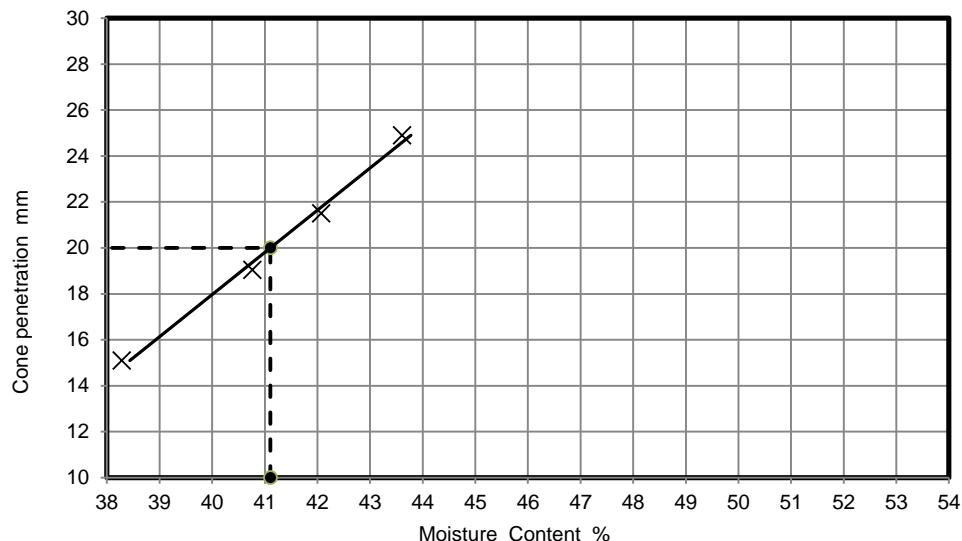
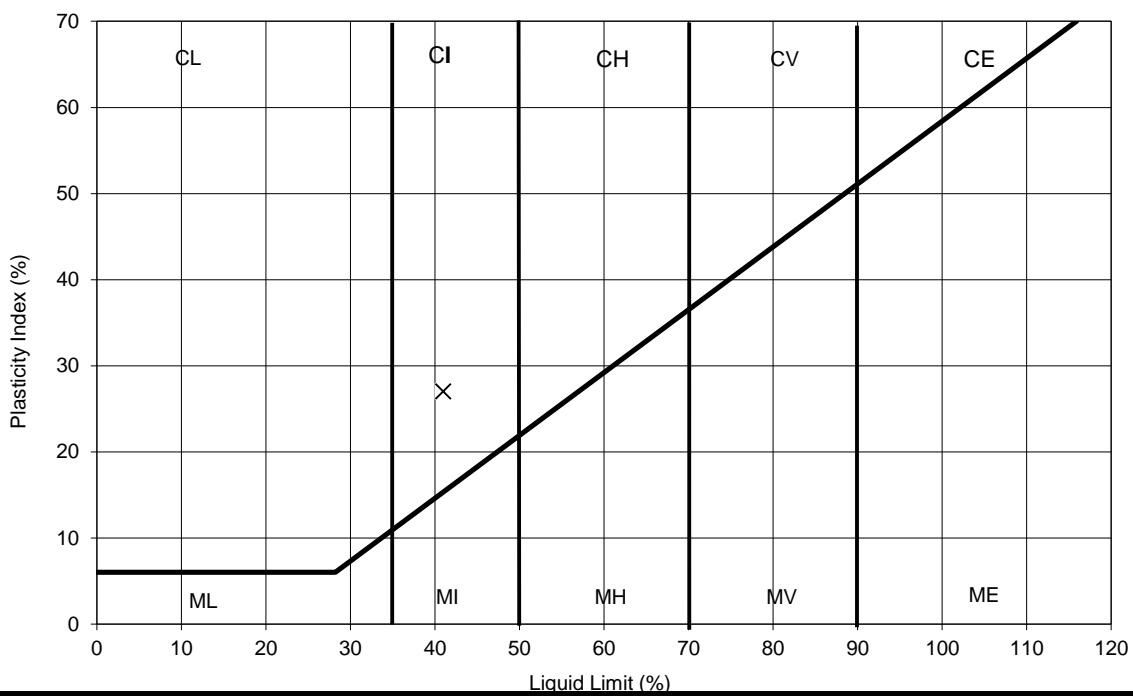
LIQUID LIMIT, PLASTIC LIMIT AND PLASTICITY INDEX

Job No.	30569	
				Borehole/Pit No.	TP02	
Site Name	Endeavour Sea Scout Group, Hillingdon			Sample No.	-	
Project No.	2105014.002	Client	TEC	Depth Top	1.00	m
Soil Description	Brown sandy silty clayey GRAVEL (gravel is fmc and angular to rounded)			Depth Base	1.10	m
				Sample Type	B	
				Samples received	13/08/2021	
				Schedules received	16/08/2021	
				Project Started	16/08/2021	
				Date Tested	25/08/2021

NATURAL MOISTURE CONTENT	7.5	%
% PASSING 425µm SIEVE	24	%
LIQUID LIMIT	41	%
PLASTIC LIMIT	14	%
PLASTICITY INDEX	27	%

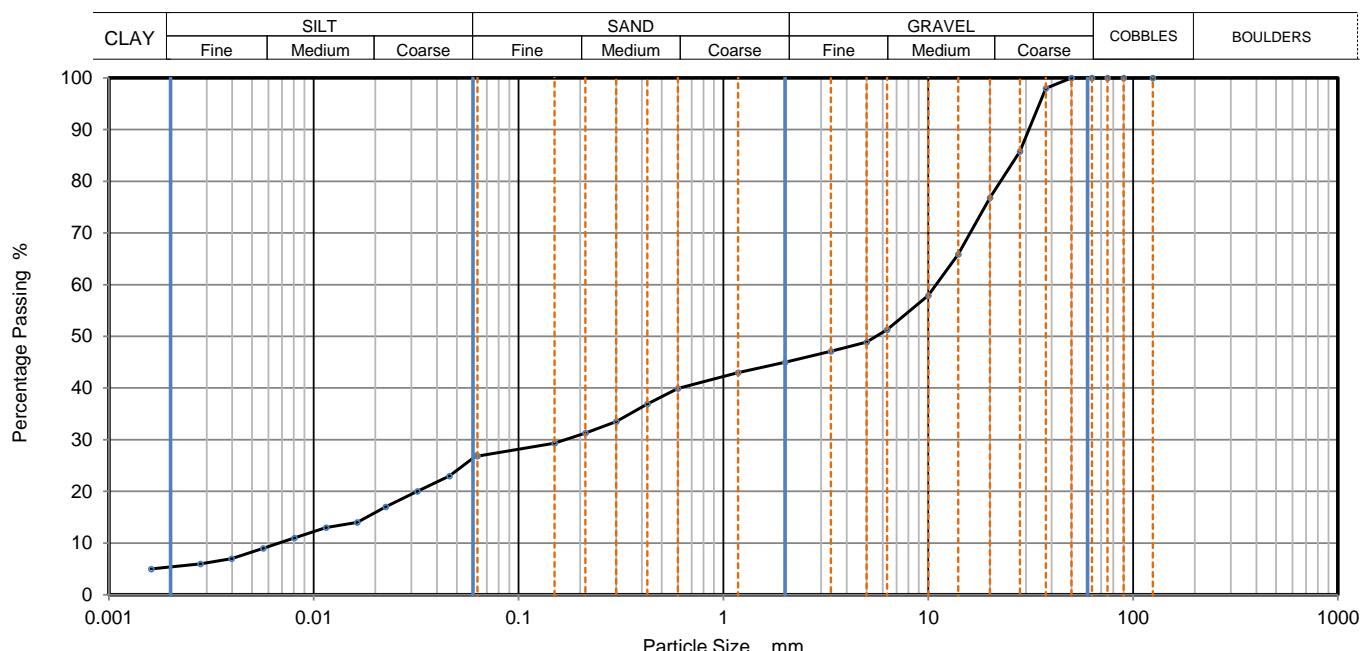
PARTICLE SIZE DISTRIBUTION				Job Ref	30569			
					Borehole/Pit No.	TP01			
Site Name	Endeavour Sea Scout Group, Hillingdon				Sample No.	-			
Project No.	2105014.002	Client	TEC		Depth Top	1.10	m		
Soil Description	Brown clayey sandy very silty GRAVEL (gravel is fmc and sub-angular to sub-rounded)				Depth Base	1.20	m		
					Sample Type	B			
					Samples received	13/08/2021			
					Schedules received	16/08/2021			
Test Method	BS1377:Part 2: 1990, clause 9.0				Project started	16/08/2021			
These results only apply to the items tested					Date tested	27/08/2021

Sample Proportions	% dry mass
Very coarse	0.0
Gravel	55.0
Sand	18.2
Silt	21.3
Clay	5.5

Clay (%)	Silt (%)	Sand (%)	Gravel (%)	Cobbles and Boulders (%)
4.0 – 5.5	4.3 – 21.3	17.6 – 18.2	55.0 – 74.1	-

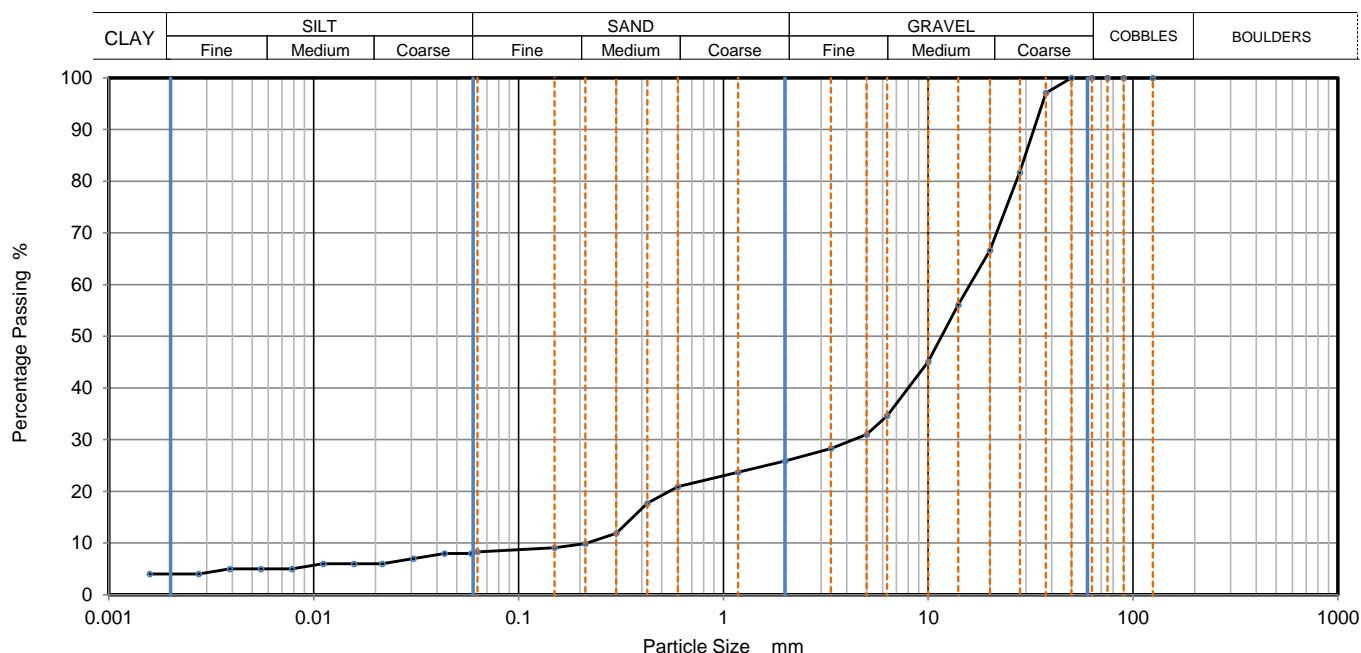
PARTICLE SIZE DISTRIBUTION				Job Ref	30569					
					Borehole/Pit No.	TP02					
Site Name	Endeavour Sea Scout Group, Hillingdon				Sample No.	-					
Project No.	2105014.002	Client	TEC		Depth Top	1.50	m				
Soil Description	Reddish brown slightly clayey slightly silty sandy GRAVEL (gravel is fmc and sub-angular to sub-rounded)				Depth Base	1.60	m				
Test Method	BS1377:Part 2: 1990, clause 9.0				Sample Type	B					
These results only apply to the items tested					Samples received	13/08/2021					
					Schedules received	16/08/2021					
					Project started	16/08/2021					
					Date tested	27/08/2021

Sample Proportions	% dry mass
Very coarse	0.0
Gravel	74.1
Sand	17.6
Silt	4.3
Clay	4.0
