ENDEAVOUR SEA SCOUTS GROUP, COWLEY

TEC have been instructed by B & X Construction Ltd on behalf of London Borough of Hillingdon Council to detail the remediation works undertaken at the abovementioned site. The report below was undertaken in general accordance with our proposal email dated 29 January 2024 and subsequent telecommunications and emails.

Remediation Works

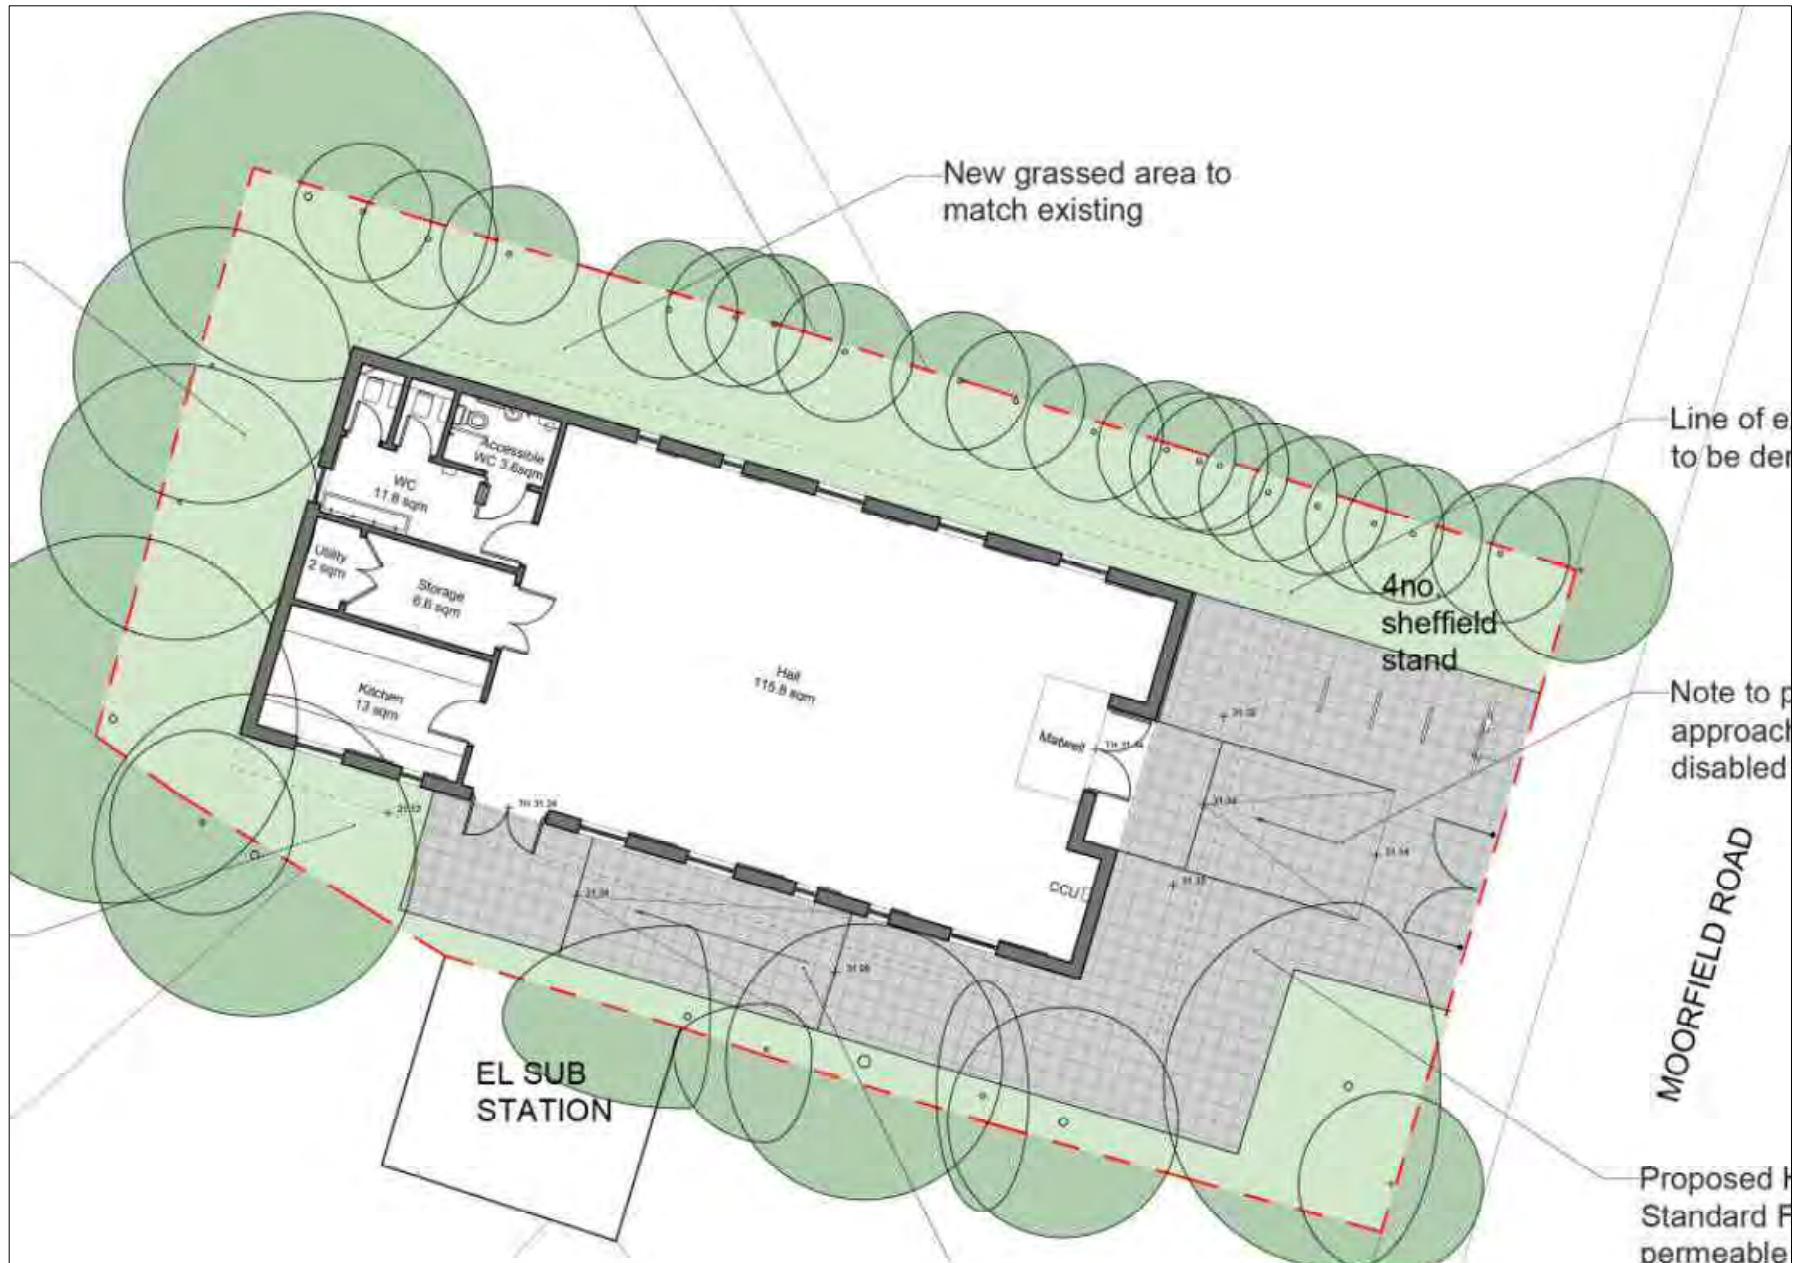
Figure No:
2

Extract of Inter Urban Studios 'Endeavour Sea Scout Group - Proposed Site Plan'. Dwg No.: PL-03 A, 29.03.22.

Drawing Name:
Proposed Development Plan

The proposed development is understood to comprise the demolition of the existing scout hut and construction of a new scout hut with areas of soft landscaping and hard infrastructure (Figure 2).

- Based on the concentrations of contaminants recorded within the made ground materials on site, a simple cover system in accordance with Building Research Establishment (BRE) guidance (BRE 465) titled "*Cover Systems for Land Regeneration – Thickness of Cover Systems for Contaminated Land*" may be appropriate in the proposed soft landscaped areas to mitigate against the potential risk to site end users. Further, based upon site specific data and BRE465 calculations, to ensure contaminant levels remain below relevant screening values, a minimum depth of 460mm of clean cover should be provided within proposed soft landscaped areas (Figure 2), where made ground remains.

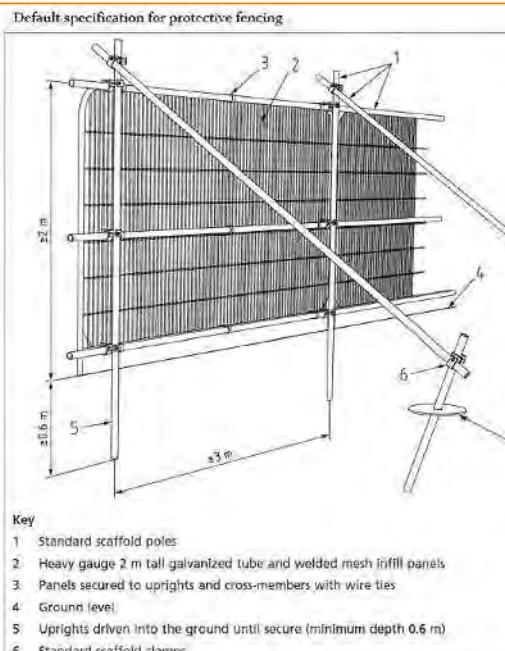
Client: L B Hillingdon
Drawing No: TH/A3/3066/TPP

At this site, operations are to occur in the following sequence:

1. Carry out tree work operations highlighted yellow in the tree data schedule (Appendix 2). All tree works are to be carried out by a competent and experienced arborist to current British Standards (see Appendix 5.9 for assistance finding a suitable arborist).

2. Erect protective fencing along the position(s) shown by the dashed red line/s on the TPP.
3. Lay ground protection and/or retain suitably hard-wearing existing hard surfaces within the area(s) shown by the diagonal blue lines on the TPP.

4. Provide a photographic record of all tree protection to arboricultural consultant - this will be forwarded to and approved by the Council's Arboricultural Officer and must demonstrate that all aspects of tree and ground protection measures have been implemented in accordance with this Arboricultural Report. The tree protection measures shall be retained until completion of all works hereby permitted.

5. Demolish existing building, leaving any suitable hard surfaces in situ (as ground protection).
6. Working from on top of existing hard surfaces and/or suitable ground protection, excavate traditional strip foundation trenches.

7. Commence construction.
8. Remove tree protection when all construction activity has ended.
9. Carry out landscaping works.

TEC can confirm that during the course of construction at the site, it was not possible to install the recommended 460mm depth simple cover system within the limited areas of communal soft landscaping. Therefore a layer of clean imported topsoil has been provided across areas of soft landscaping, placed directly over the existing soils, as detailed within TECs November 2024 Verification letter. The reason that 460mm clean cover system could not be installed, is due to the presence of numerous existing trees present at the site, both around the site boundaries, and within some pf the proposed soft landscaped areas. These trees have extensive root protection zones identified within the Arboricultural Method Statement ref. TH 3066 dated 17th September 2021 prepared by Trevor Heaps Arboricultural Consultancy Ltd. These root protection zones extend across the proposed areas of communal soft landscaping. The extent of the trees in relation to the proposed soft landscaping is shown on Figure 2, and the root protection zones are shown on Drawing Ref. Tree Protection Plan No. TH/A3/3066/TPP prepared by Trevor Heaps Consultancy Ltd also attached to this letter.

Although a 460mm depth of clean cover system is not viable for the limited areas of communal soft landscaping at the site (turfed areas and minimal planted borders), an alternative cover system is proposed given the on site restrictions. As noted within NCLOGs 'A regulator's Guide to Cover Systems and their Verification' 2024, where existing (or proposed) root systems are present, it is not possible to construct a substantial soil cover system over larger portions of the root system, as this will compress the ground, starve the roots of oxygen, suppress growth, and ultimately lead to the death of the tree.

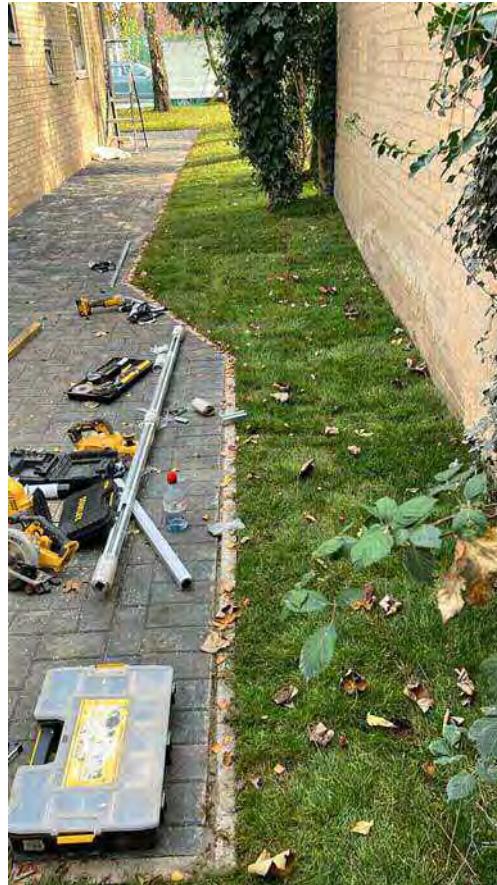
Photograph 1: B & X Construction Ltd Supplied Photograph – Soft Landscaped Area and Block Paving, photograph supplied to TEC on 04.11.2024.

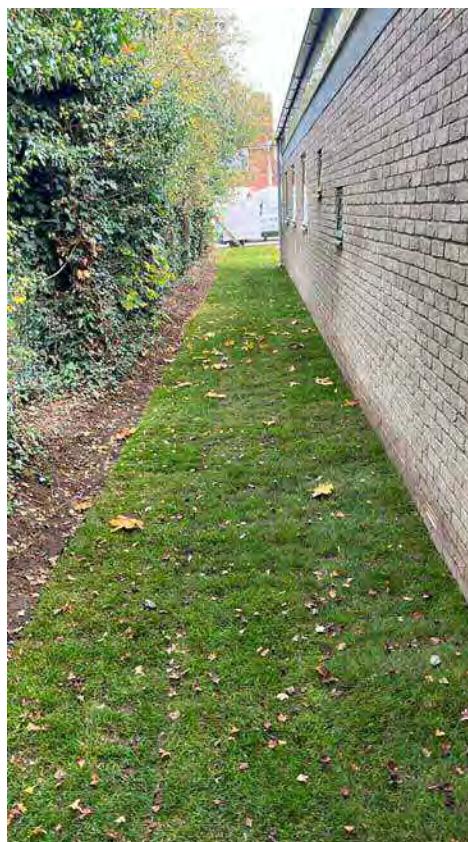
Photograph 2: B & X Construction Ltd Supplied Photograph – Soft Landscaped Area, photograph supplied to TEC on 04.11.2024.

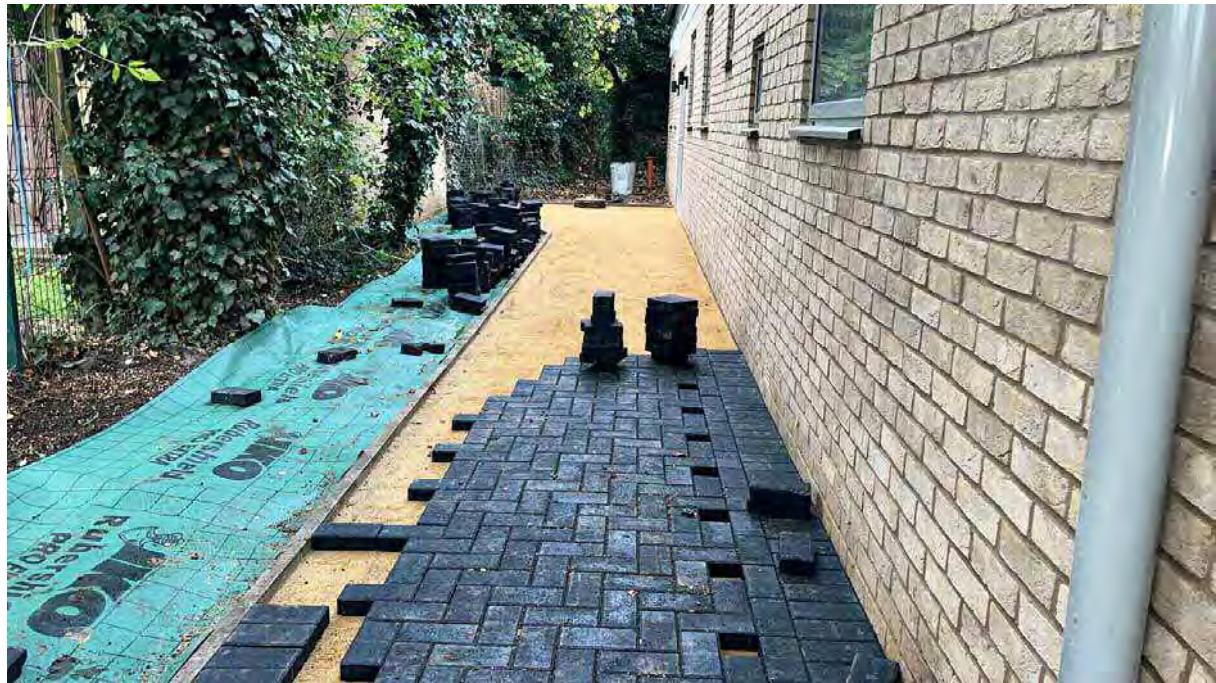
Photograph 3: B & X Construction Ltd Supplied Photograph – Block Paving and membrane covering soft landscaped area, photograph supplied to TEC on 04.11.2024.

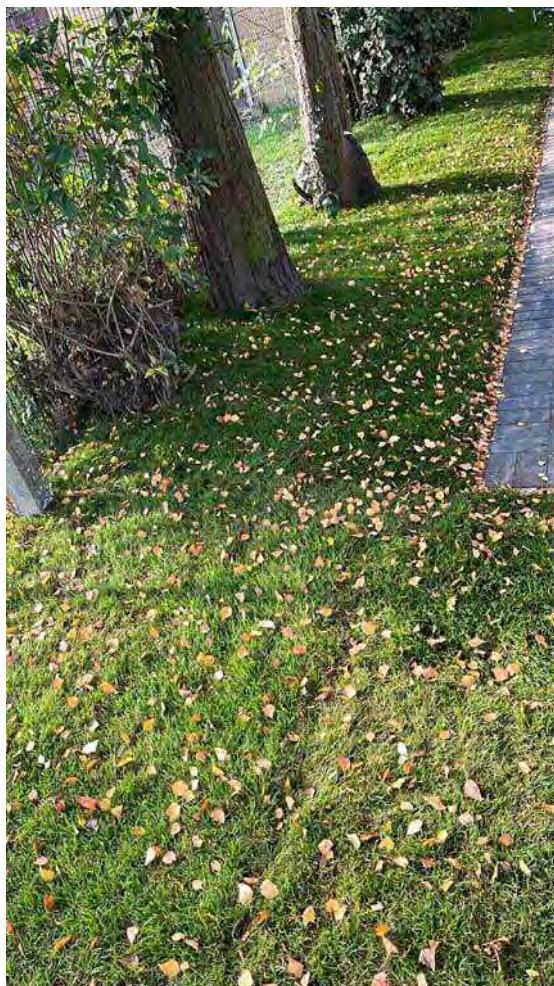
Photograph 4: B & X Construction Ltd Supplied Photograph – Soft Landscaped Area and Block Paving, photograph supplied to TEC on 04.11.2024.

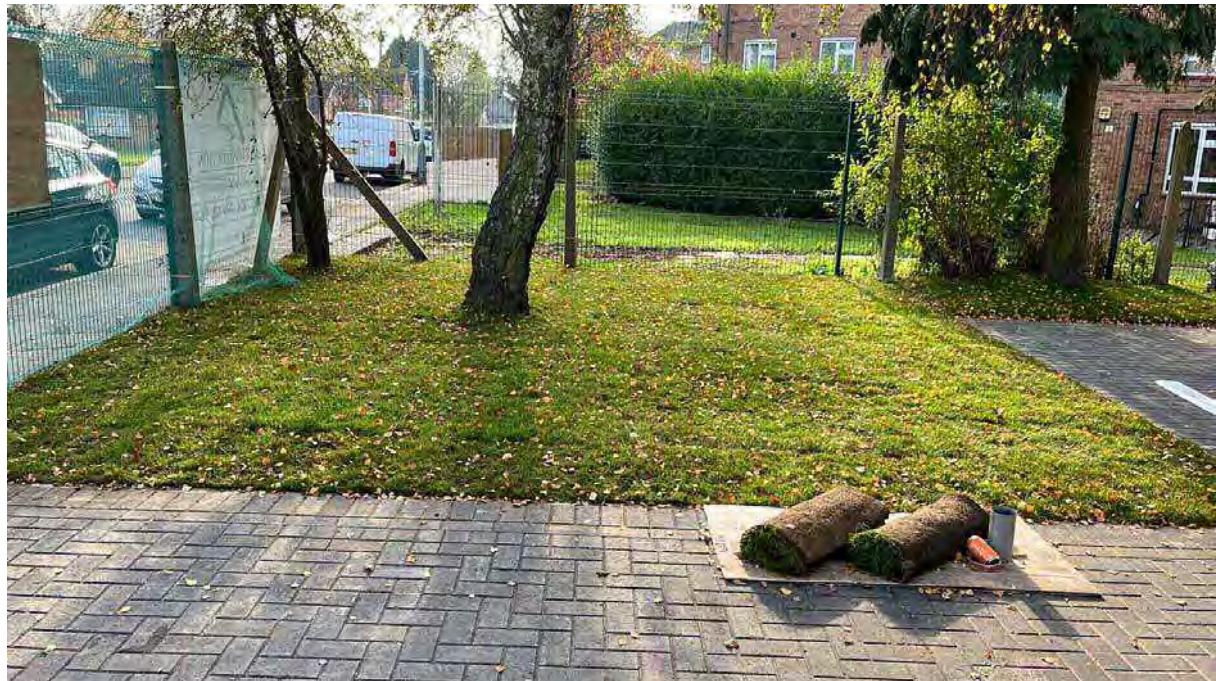
Photograph 5: B & X Construction Ltd Supplied Photograph – Soft Landscaped Area and Block Paving, photograph supplied to TEC on 04.11.2024.

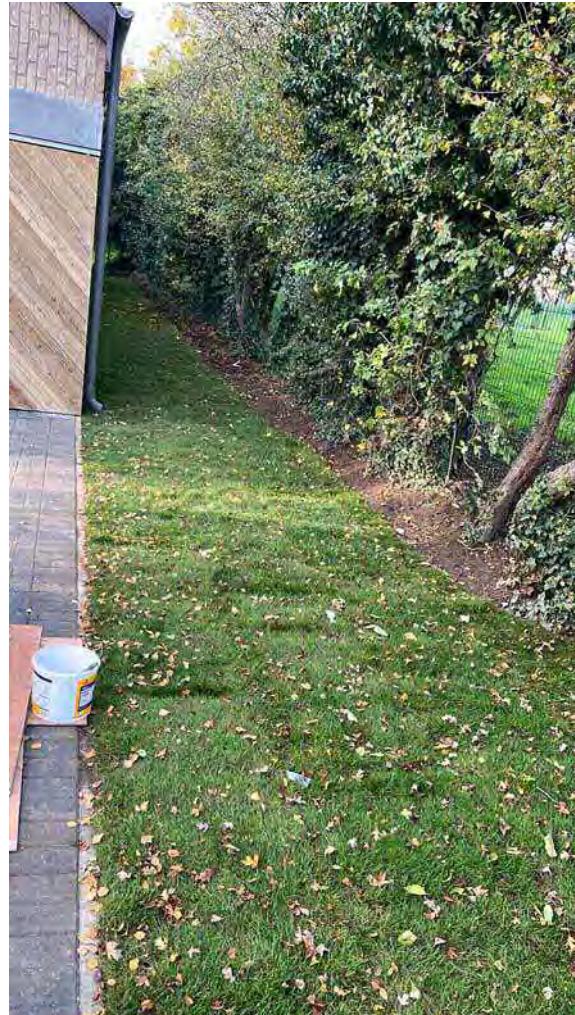
Photograph 6: B & X Construction Ltd Supplied Photograph – Soft Landscaped Area and Block Paving, photograph supplied to TEC on 04.11.2024.

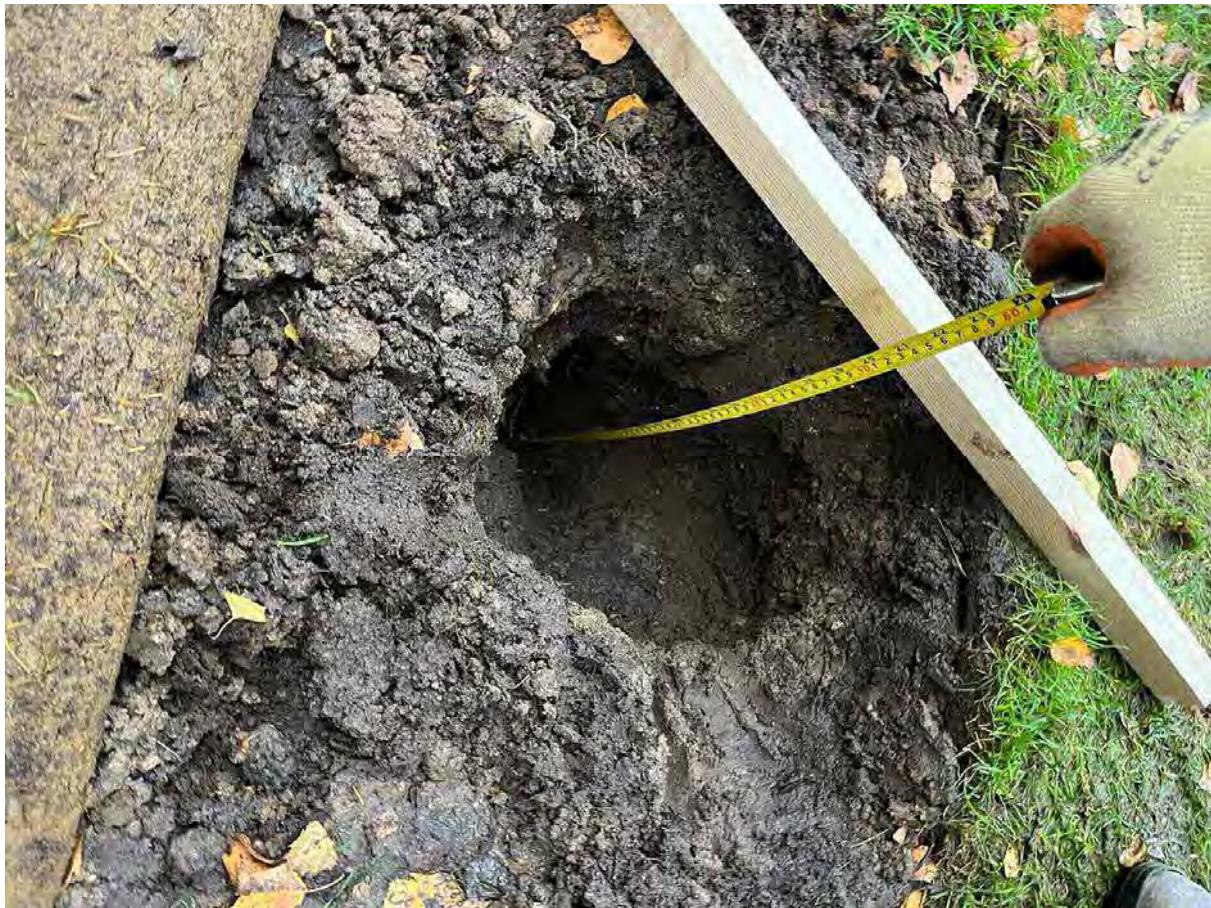
Photograph 7: B & X Construction Ltd Supplied Photograph – validation pit, photograph supplied to TEC on 07.11.2024.

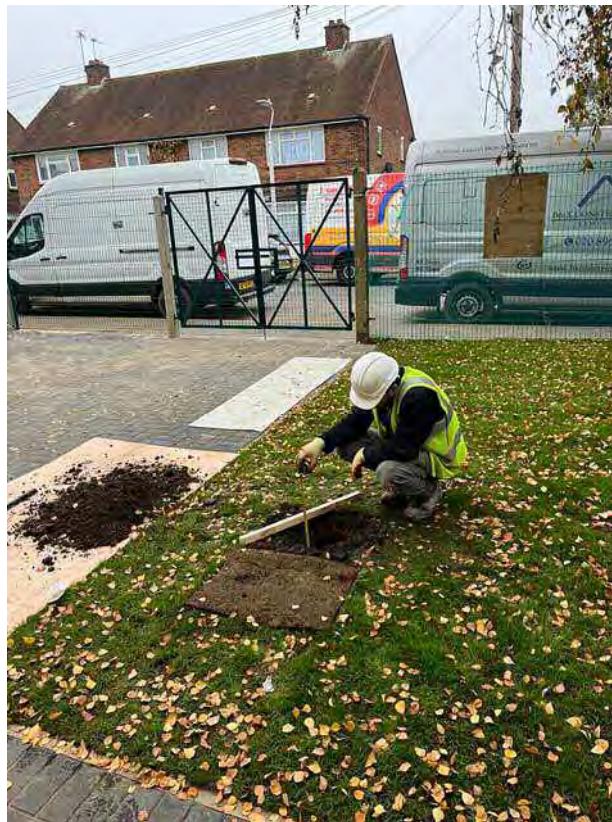
Photograph 8: B & X Construction Ltd Supplied Photograph – validation pit, photograph supplied to TEC on 07.11.2024.

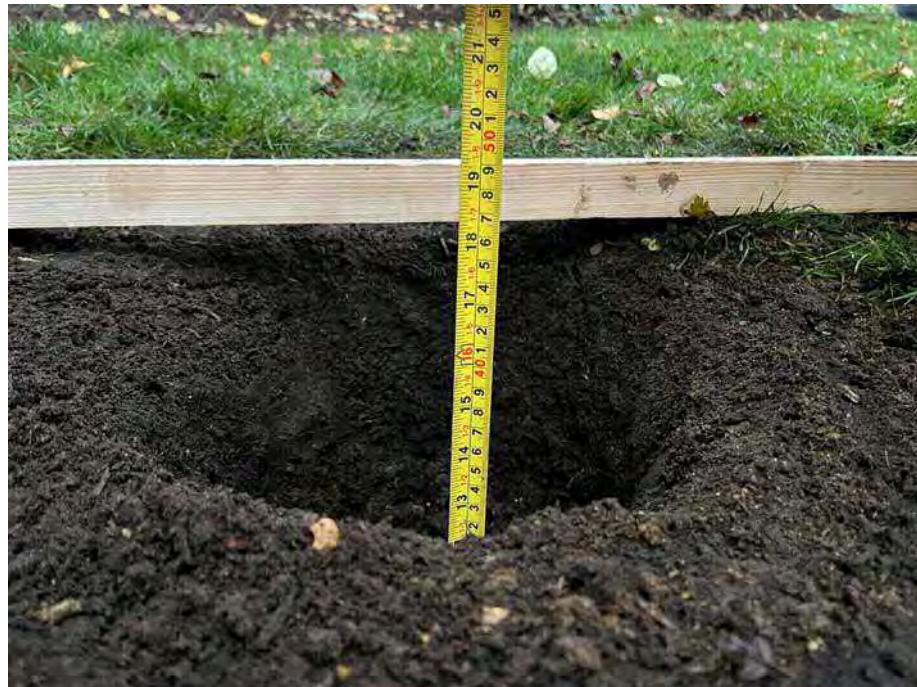
Photograph 9: B & X Construction Ltd Supplied Photograph – validation pit, photograph supplied to TEC on 07.11.2024.

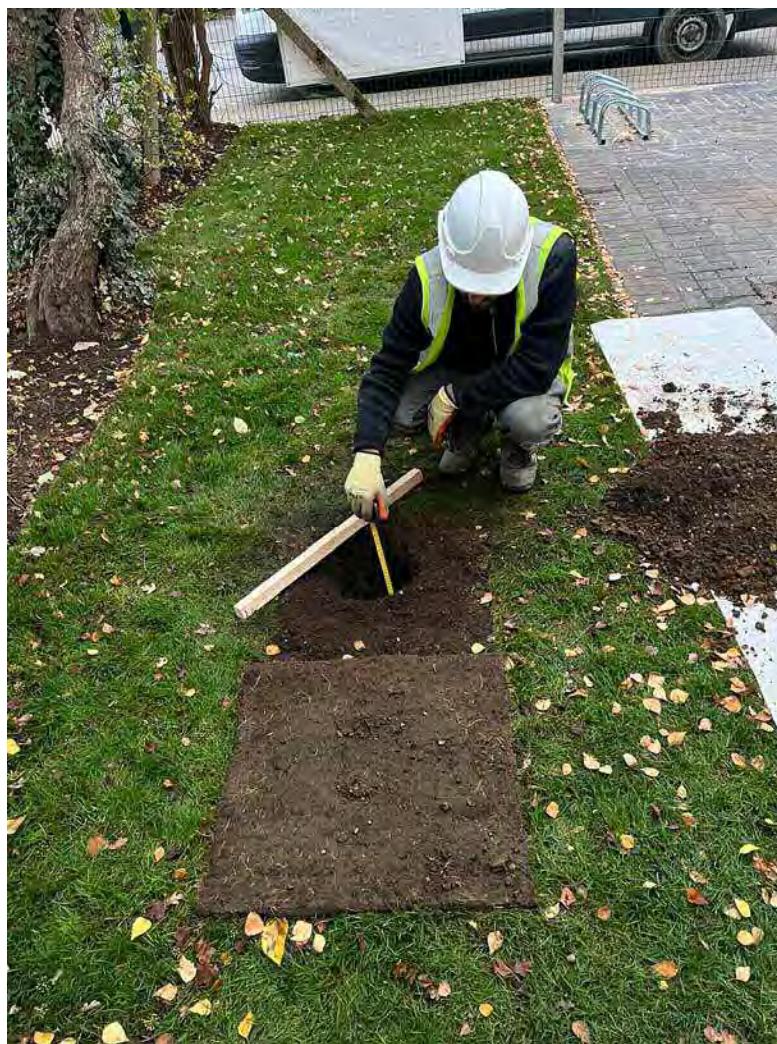
Photograph 10: B & X Construction Ltd Supplied Photograph – validation pit, photograph supplied to TEC on 07.11.2024.

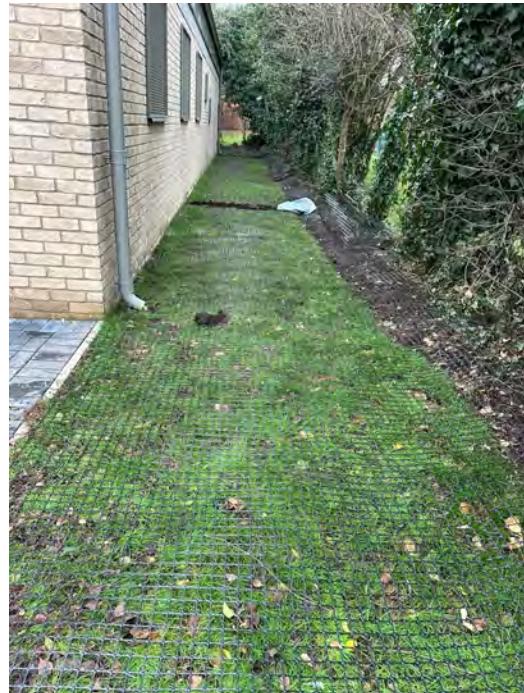
Photograph 11: B & X Construction Ltd Supplied Photograph – Tensar SS20 placement to side of building, photograph taken on 01.02.2025.

Therefore, it has been recommended that an alternative capping solution is adopted, which will prevent exposure to any underlying potentially contaminated soils by preventing end users from digging into the soil within proposed communal soft landscaping at the site and will also be suitably protective of the existing trees. As the soft landscaping at the site is a managed communal area, exposure to soils within the root protection zones (and across all soft landscaped areas can be prevented by the provision of a geogrid system (in this case Tensar SS20), infilled and overlain with a nominal thickness of clean free draining topsoil as a top dressing. The Tensar technical note for the selected SS20 geogrid has been included as Appendix D.

Although TEC have been unable to visit the site, based upon correspondence and photographs from B & X Construction Ltd, it is understood that the proposed development is near completion. It is further understood that areas of proposed soft landscaping and hardstanding cover (outwith the building footprint) have now been completed (see Appendix A – B & X Construction Ltd supplied photographs). The photographs provided to TEC by B & X Construction Ltd show areas of soft landscaping, as well as areas of block paving (hardstanding). It should be noted that Photographs 1. to 10. show the works undertaken in 2024 to install a geotextile marker membrane and imported topsoil over the existing soils at the site, whilst photographs 11 to 16 show the recent works undertaken to install the Tensar SS20 geotextile over the completed soft

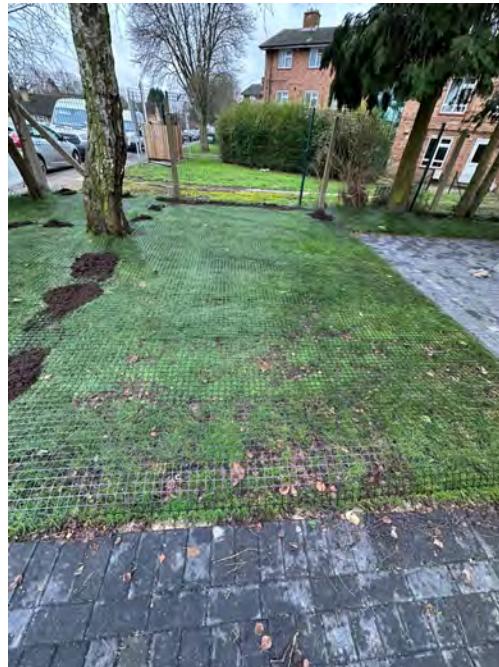
Photograph 13: B & X Construction Ltd Supplied Photograph – Tensar SS20 covering soft landscaped area to front of building, photograph taken on 01.02.2025.

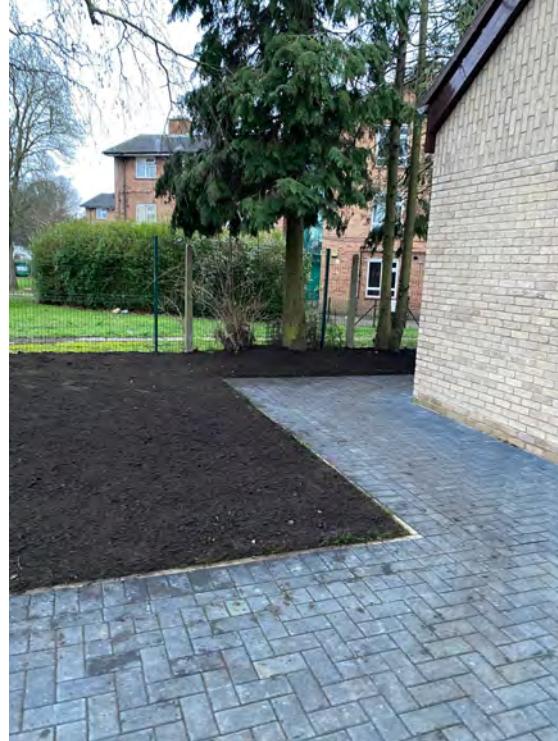
Photograph 14: B & X Construction Ltd Supplied Photograph – Topsoil finishing to Soft Landscaped Area at front of the building and Block Paving, photograph taken on 04.02.2025.

landscaped areas, which has then been 'top dressed' with an additional layer of Rolawn 'Hallstone Blend' topsoil supplied by Selco Building supplies.

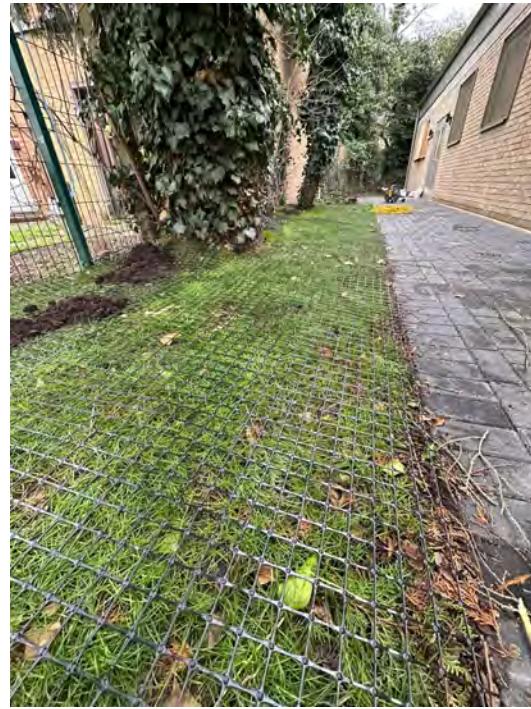
Photograph 15: B & X Construction Ltd Supplied Photograph – Tensar SS20 placement to Soft Landscaped Area to side of the building and Block Paving, photograph taken on 01.02.2024.

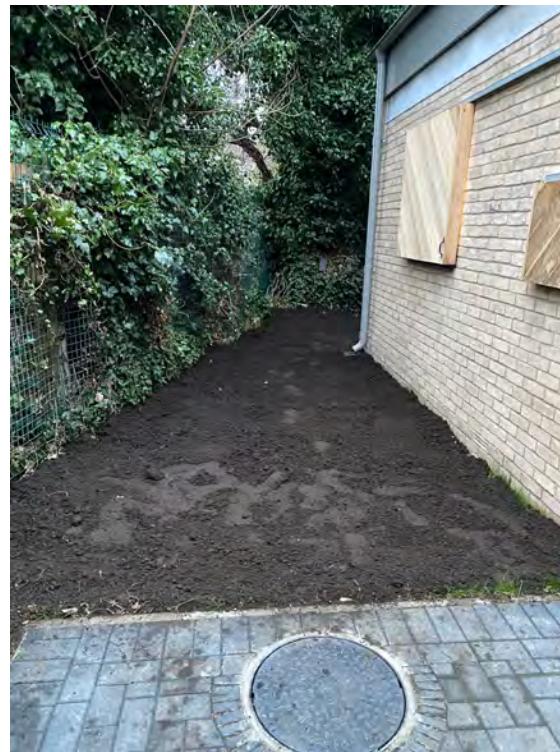
Photograph 16: B & X Construction Ltd Supplied Photograph – Soft Landscaped Area and Block Paving to rear of the building following topsoil dressing, photograph taken on 04.02.2024.

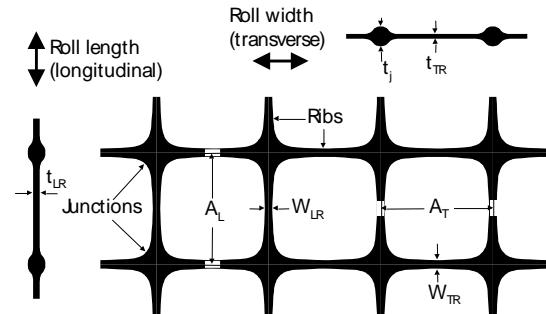
Tensar SS geogrids are used for the reinforcement of soils and aggregates in construction of structures such as road pavements, working platforms and reinforced foundations.

Tensar SS geogrids are stiff monolithic geogrids with integral junctions. They are orientated in two directions such that the resulting ribs have a high degree of molecular orientation which continues through the area of the integral node. The ribs have a rectangular cross section with square edges.
