**1 & 1A Old School House  
Uxbridge UB10 0AA**

Desk Study Report

Aujila Property Limited

J22046  
Rev 2

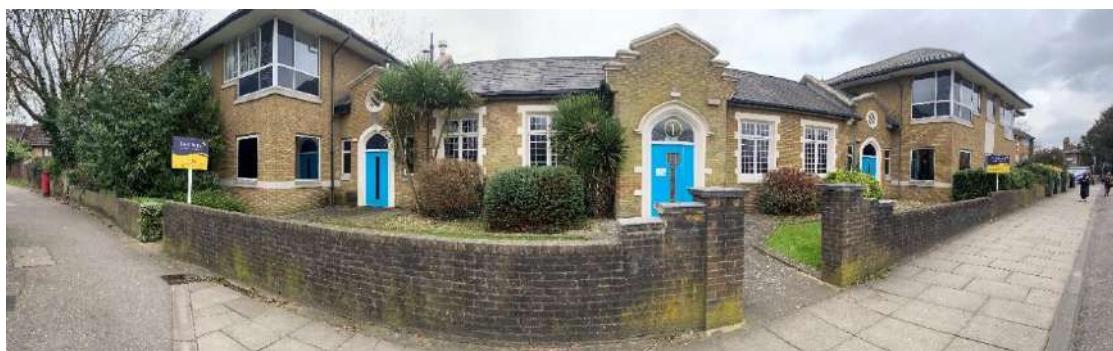
*Image looking towards the southwest at the north-eastern elevation of the building. Note the small areas of soft landscaping present at the front of the site.*

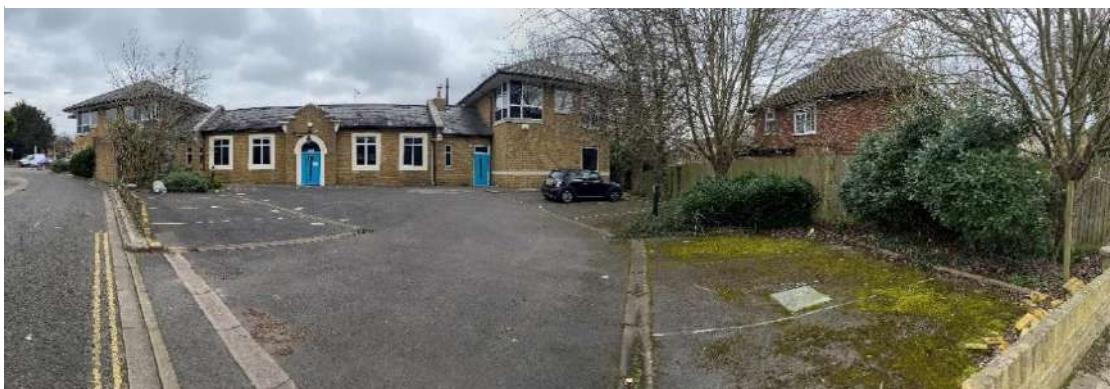
*Photograph 2: Image looking towards the northeast at the south-western elevation of the building along with the asphaltic concrete surfaced car park.*
