Phase 2 Land Contamination Risk Assessment

**Proposed Conversion of
Commercial Floorspace
(Charitable Services Offices) to
Residential Use (Class MA)**

**Unit No.28, Hawthorne Court,
Ryefield Crescent, Northwood
HA6 1LJ**

Reference: 3284P P2 Hamways Ltd - Northwood

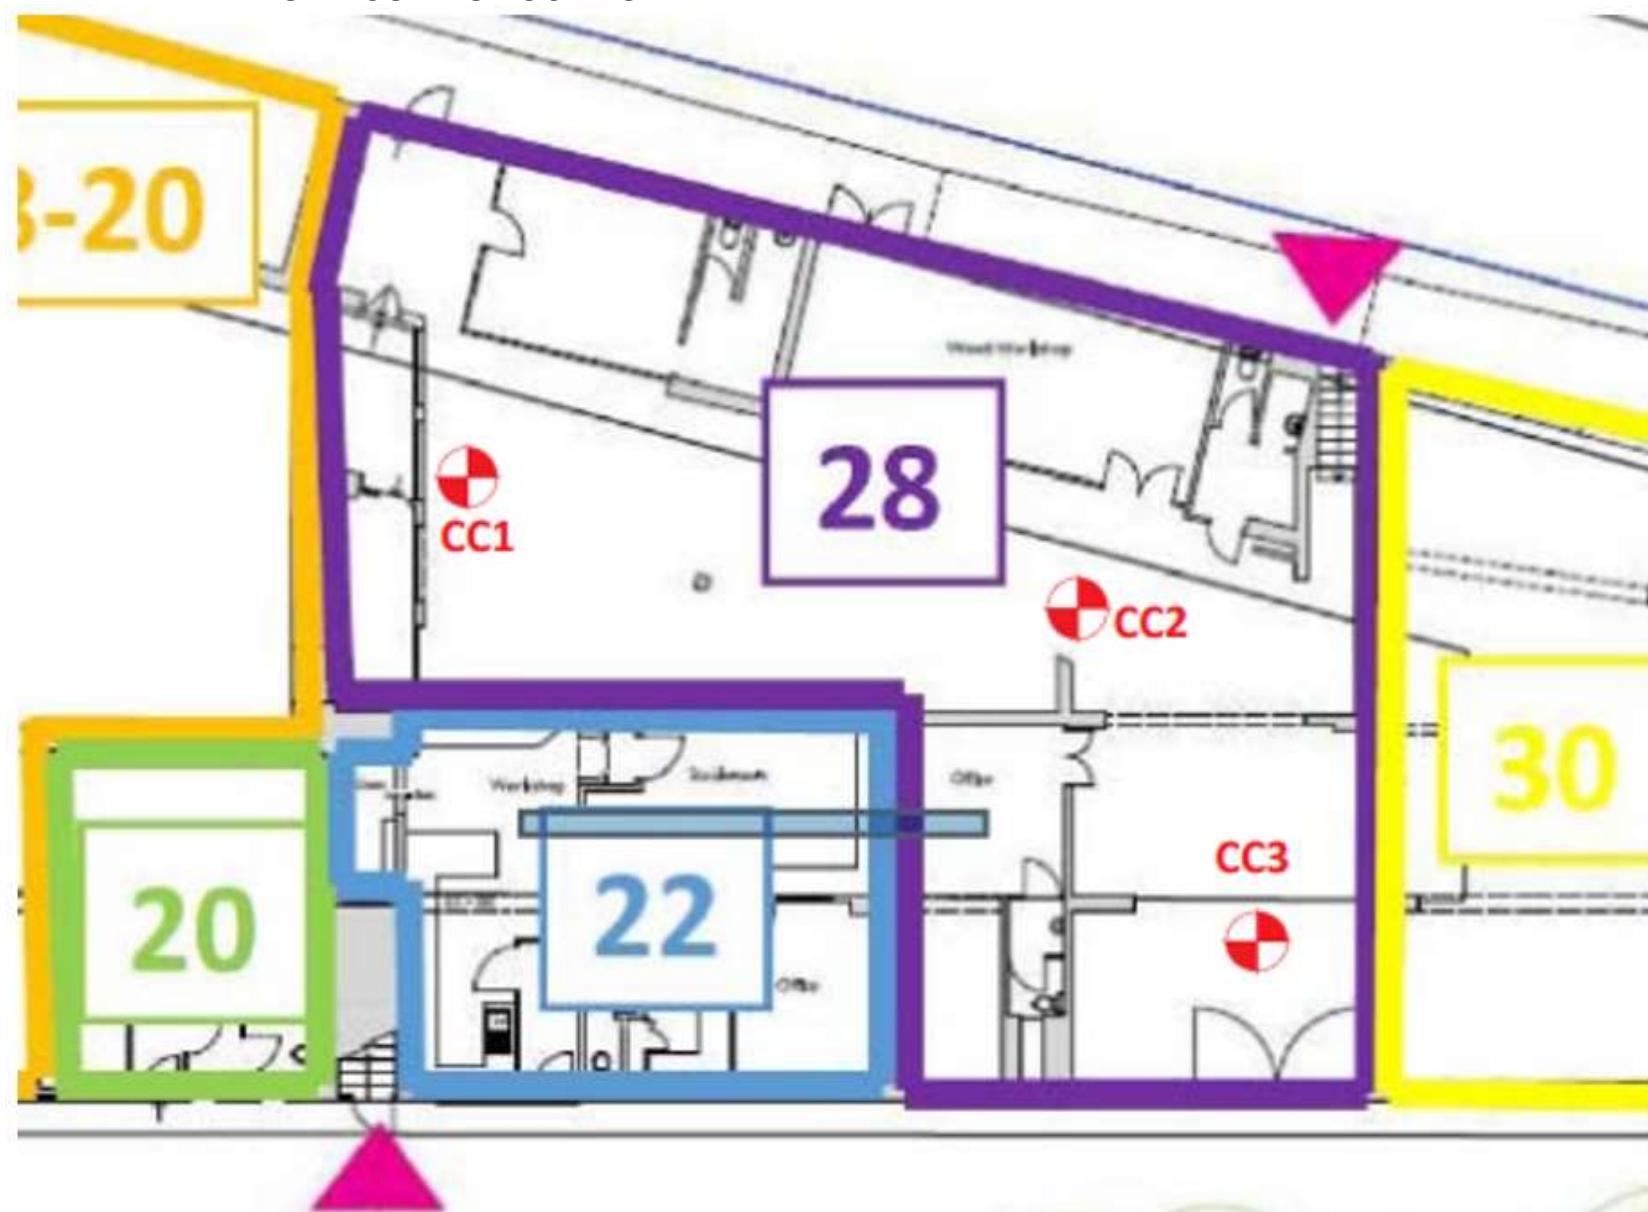
SITE CORING LOCATION PLAN

Castledine Environmental attended site on the 25th April 2022 with the intention of taking samples for VOC laboratory analysis. The site works consisted of 3 No. locations (designated CC1 to CC3) which were cored through the existing concrete flooring, with the underlying strata encountered then logged and sampled.
