Preliminary Risk Assessment

Site Investigation and Generic Quantitative Risk Assessment

**Report prepared at**  
Land to rear of 162-188 Cranford Drive  
Hayes  
UB3 4LG

**Report reference**  
24-221.01

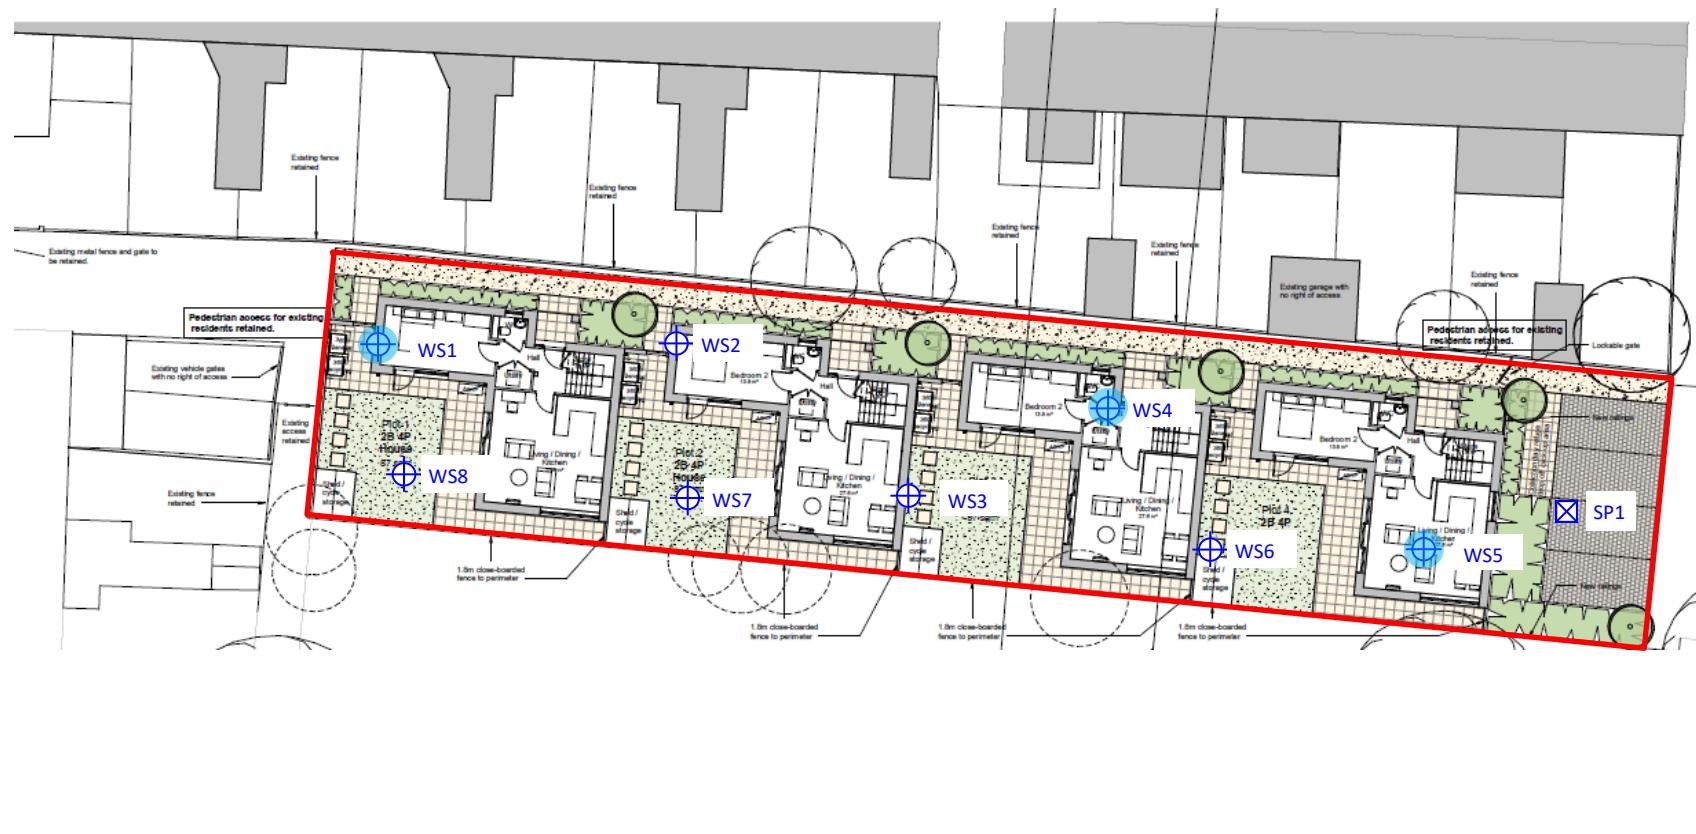
- Window Sample Location
- Monitoring Well
- Mechanical Trial Pit BRE 365

Location	Rationale	Monitoring Well
	<b>Window Sample (WS) Boreholes</b>	
WS1	West of the site to determine ground conditions beneath the proposed building in Plot 1 and enable soil sampling and to target the three-chambered interceptor.	Gas and groundwater monitoring well installed to 1.5m.
WS2	North-west of the site to determine ground conditions beneath the proposed building in Plot 2 and enable soil sampling. Positioned for spatial coverage.	Not installed.
WS3	Centre-south of the site beneath the proposed building in Plot 2 and the previous garage buildings to determine ground conditions and enable soil sampling.	Gas and groundwater monitoring well installed to 1.6m.
WS4	North-east of the site beneath the proposed building in Plot 3 to determine ground conditions and enable soil sampling. Positioned for spatial coverage.	Not installed.
WS5	South-east of the site beneath the proposed building in Plot 4 and the previous garage buildings to determine ground conditions and enable soil sampling.	Gas and groundwater monitoring well installed to 4.0m.

WS6	West of the site to determine shallow ground conditions and enable soil sampling beneath the previous garage buildings.	Not installed.

WS7	Centre-south-west of the site to determine shallow ground conditions and enable soil sampling beneath the previous garage buildings.	Not installed.
WS8	Centre-south-east of the site to determine shallow ground conditions and enable soil sampling beneath the previous garage buildings.	Not installed.
<b>Machine Trial Pits (SP)</b>		
SP1	East of the site to determine shallow ground conditions and enable soil infiltration testing for soakaway design.	Not installed.

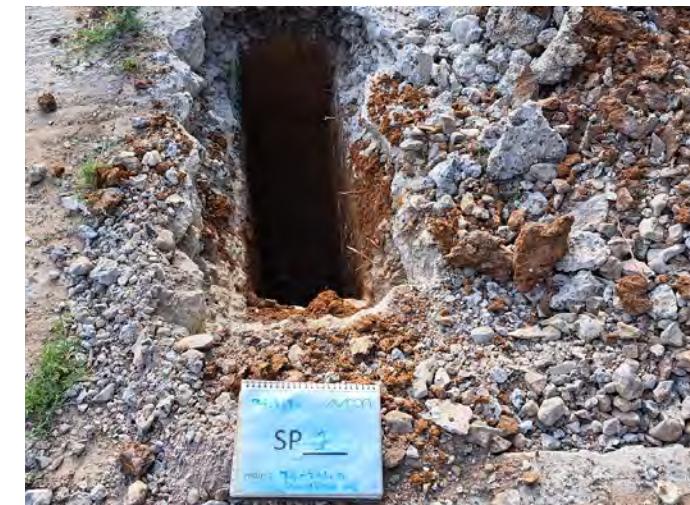
Table 5.4.1: Groundwater During Investigation		
Location	Depth – bgl (during GI)	Comments
WS1	Dry to 1.5m	The wet strata noted in the base of trial pit SP1 at 2.1m bgl is expected to represent the principal aquifer of the Taplow Gravel Member.
WS2	Dry to 1.0m	
WS3	Dry to 2.0m	
WS4	Dry to 4.0m	
WS5	Dry to 1.0m	
WS6	Dry to 0.9m	
WS7	Dry to 0.9m	
WS8	Dry to 0.9m	
SP1	Wet at the base of the trial pit at 2.1m

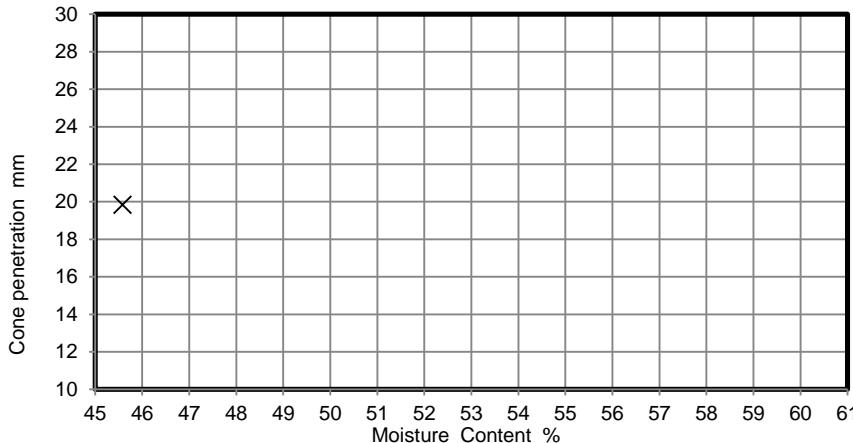
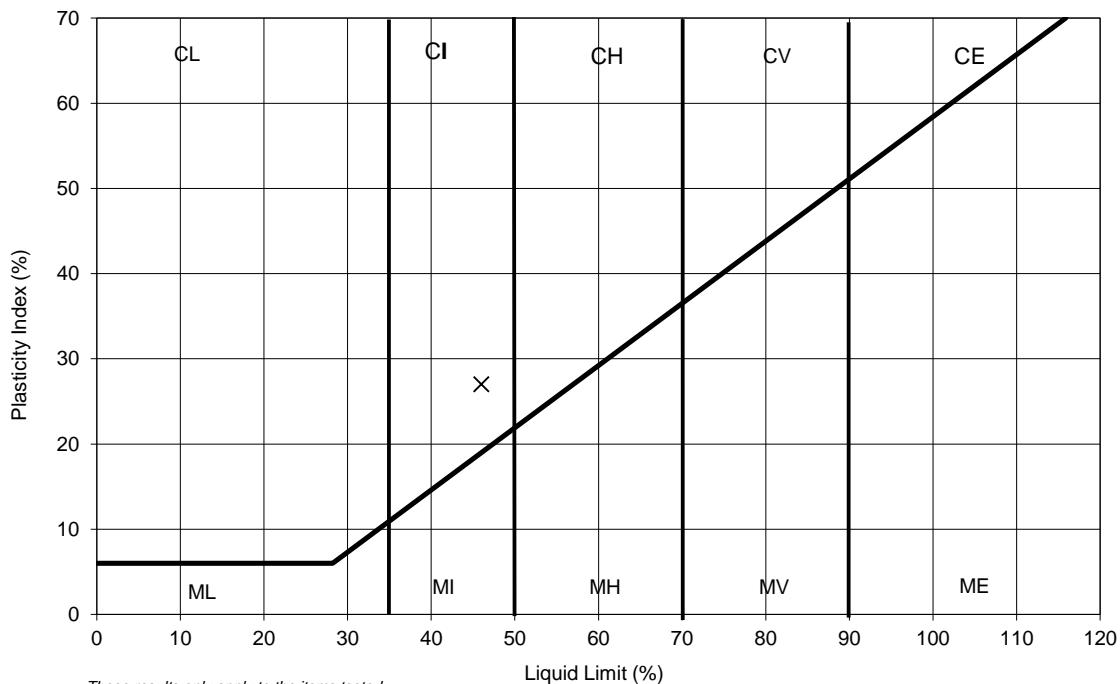
### LIQUID LIMIT, PLASTIC LIMIT AND PLASTICITY INDEX

Job No.	35782
Borehole/Pit No.	WS1
Site Name	Land to the rear of 162-188 Cranford Drive, Hayes, UB3 4LG
Project No.	24-221.01
Client	Aviron
Depth Top m	1.00
Soil Description	Orangish brown slightly mottled grey slightly gravelly silty CLAY (gravel is fm and sub-angular to rounded)
Depth Base m	-
Sample Type	D
Samples received	30/07/2024
Schedules received	28/07/2024
Project Started	30/07/2024
Date Tested	09/08/2024

NATURAL MOISTURE CONTENT	20	%
% PASSING 425µm SIEVE	96	%
LIQUID LIMIT	46	%
PLASTIC LIMIT	19	%
PLASTICITY INDEX	27	%

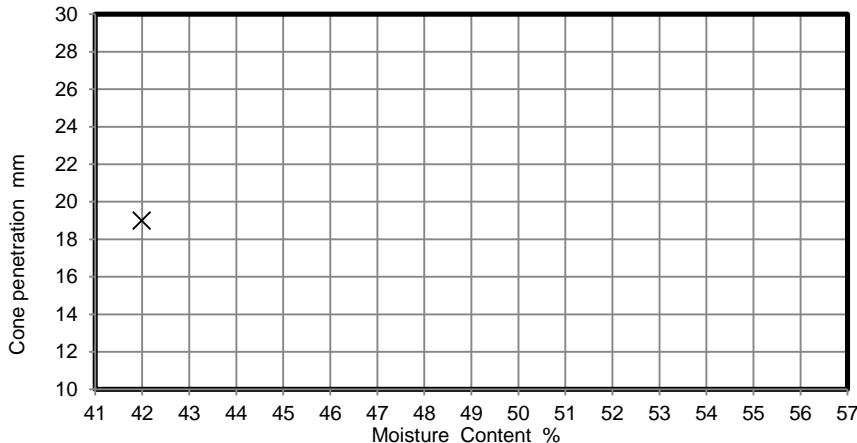
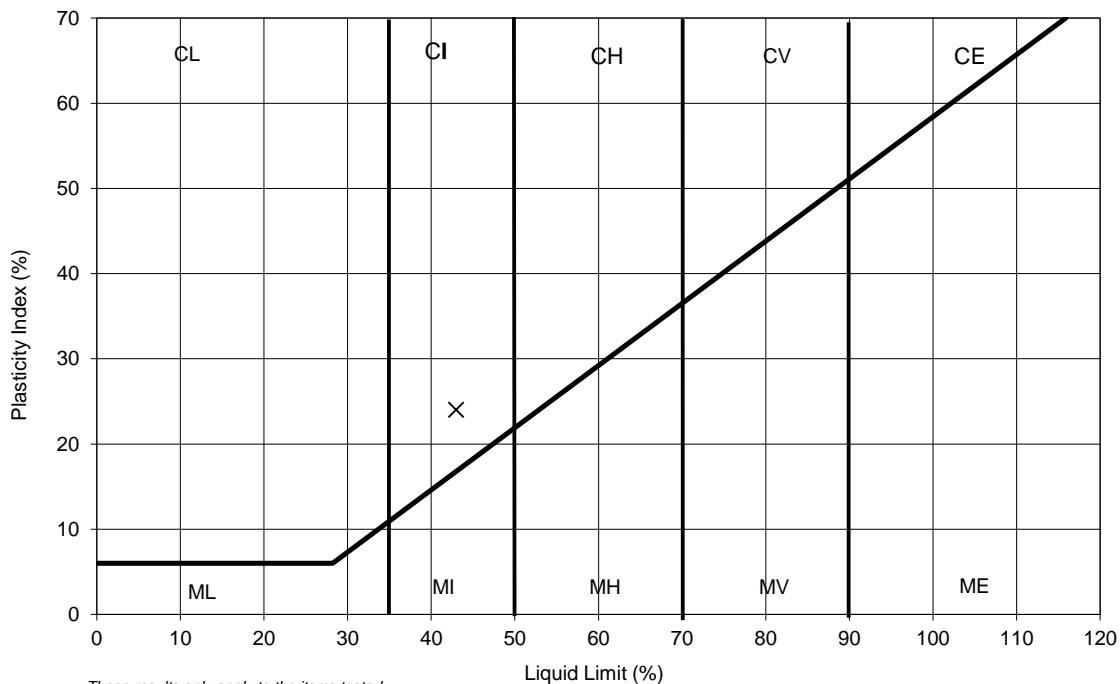
### LIQUID LIMIT, PLASTIC LIMIT AND PLASTICITY INDEX

Job No.	35782
Borehole/Pit No.	WS3
Site Name	Land to the rear of 162-188 Cranford Drive, Hayes, UB3 4LG
Project No.	24-221.01
Client	Aviron
Depth Top m	1.00
Soil Description	Brown slightly mottled grey slightly gravelly silty CLAY (gravel is fm and sub-angular to rounded)
Depth Base m	-
Sample Type	D
Samples received	30/07/2024
Schedules received	28/07/2024
Project Started	30/07/2024
Date Tested	09/08/2024

NATURAL MOISTURE CONTENT	20	%
% PASSING 425µm SIEVE	95	%
LIQUID LIMIT	43	%
PLASTIC LIMIT	19	%
PLASTICITY INDEX	24	%

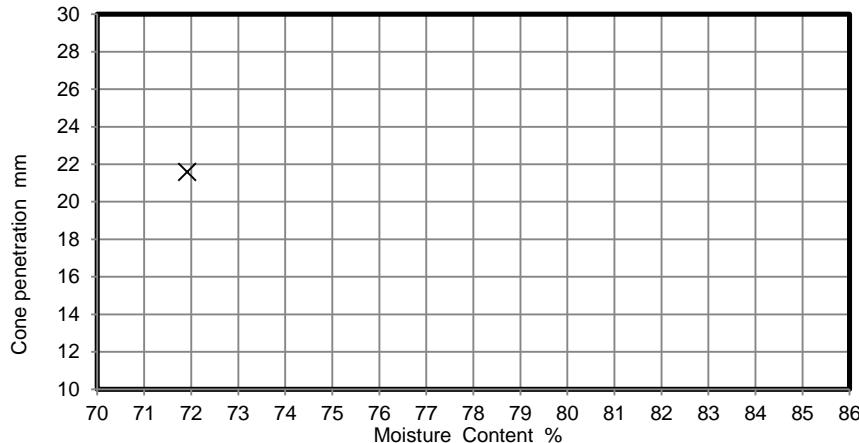
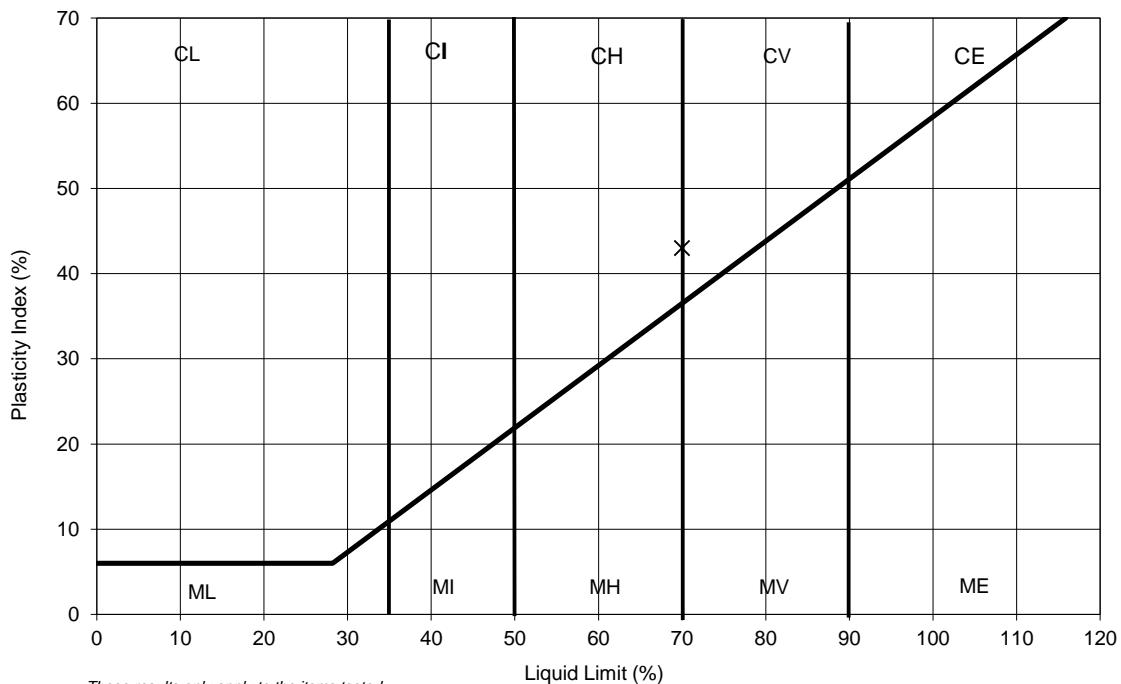
### LIQUID LIMIT, PLASTIC LIMIT AND PLASTICITY INDEX

Job No.	35782
Borehole/Pit No.	WS4
Site Name	Land to the rear of 162-188 Cranford Drive, Hayes, UB3 4LG
Project No.	24-221.01
Client	Aviron
Depth Top m	3.00
Soil Description	Brown slightly mottled bluish grey silty CLAY
Depth Base m	-
Sample Type	D
Samples received	30/07/2024
Schedules received	28/07/2024
Project Started	30/07/2024
Date Tested	09/08/2024

NATURAL MOISTURE CONTENT	21	%
% PASSING 425µm SIEVE	100	%
LIQUID LIMIT	70	%
PLASTIC LIMIT	27	%
PLASTICITY INDEX	43	%

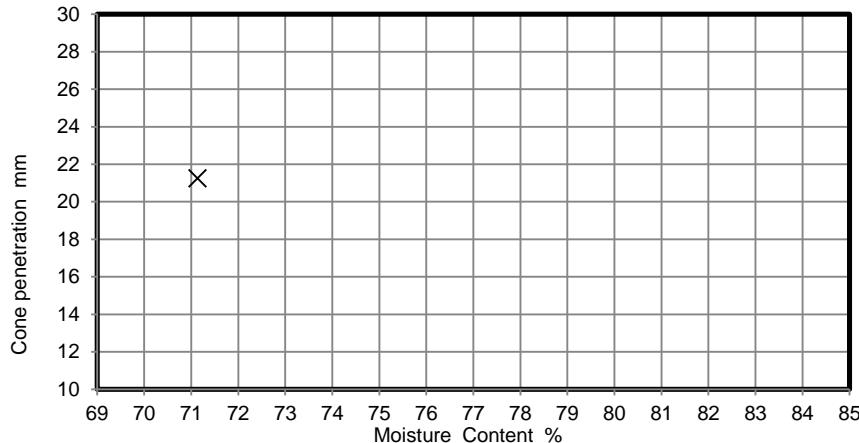
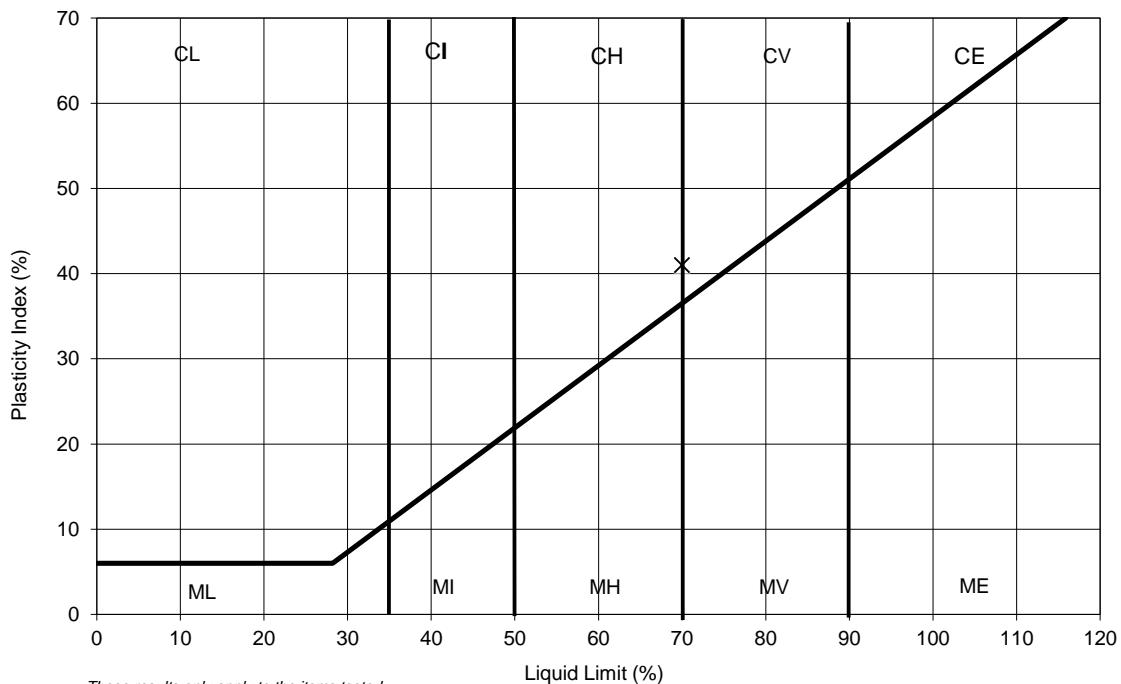
### LIQUID LIMIT, PLASTIC LIMIT AND PLASTICITY INDEX

Job No.	35782
Borehole/Pit No.	WS4
Site Name	Land to the rear of 162-188 Cranford Drive, Hayes, UB3 4LG
Project No.	24-221.01
Client	Aviron
Depth Top m	4.00
Soil Description	Dark grey silty CLAY
Depth Base m	-
Sample Type	D
Samples received	30/07/2024
Schedules received	28/07/2024
Project Started	30/07/2024
Date Tested	09/08/2024

NATURAL MOISTURE CONTENT	26	%
% PASSING 425µm SIEVE	100	%
LIQUID LIMIT	70	%
PLASTIC LIMIT	29	%
PLASTICITY INDEX	41	%

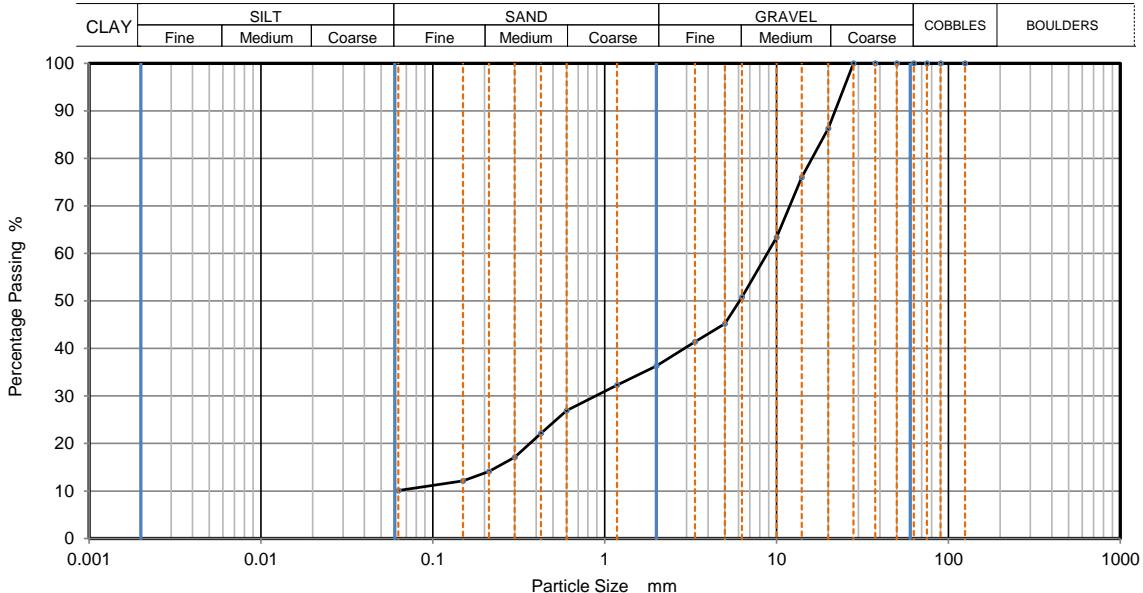
Site Name	Land to the rear of 162-188 Cranford Drive, Hayes, UB3 4LG			Job Ref	35782
Project No.	24-221.01			Borehole/Pit No.	WS4
Soil Description	Orangish brown clayey very sandy GRAVEL (gravel is fmc and sub-angular)	Client	Aviron	Depth Top	2.00 m
Test Method	BS1377:Part 2: 1990, clause 9.0			Depth Base	- m
				Sample Type	D
				Samples received	30/07/2024
				Schedules received	28/07/2024
				Project started	30/07/2024
				Date tested	07/08/2024

Sieving		Sedimentation	
Particle Size mm	% Passing	Particle Size mm	% Passing
125	100		
90	100		
75	100		
63	100		
50	100		
37.5	100		
28	100		
20	86		
14	76		
10	63		
6.3	51		
5	45		
3.35	41		
2	36		
1.18	32		
0.6	27		
0.425	22		
0.3	17		
0.212	14		
0.15	12		
0.063	10

Sample Proportions	% dry mass
Very coarse	0
Gravel	64
Sand	26
Fines <0.063mm	10

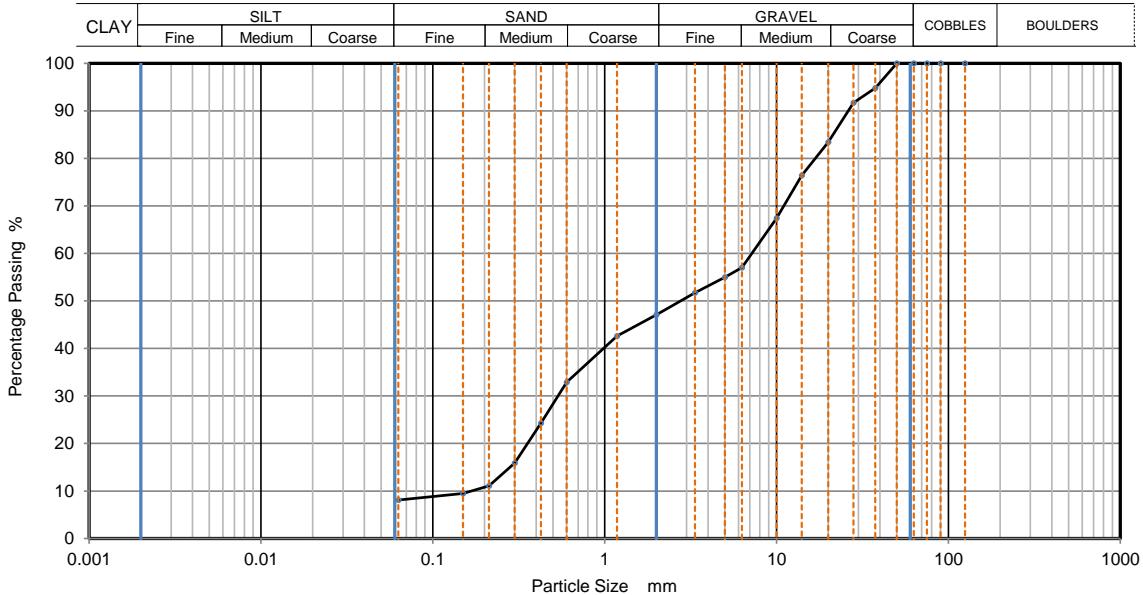
Site Name	Land to the rear of 162-188 Cranford Drive, Hayes, UB3 4LG			Job Ref	35782
Project No.	24-221.01	Client	Aviron	Borehole/Pit No.	SP1
Soil Description	Orangish brown clayey very sandy GRAVEL (gravel is fmc and sub-angular to sub-rounded)			Depth Top	2.00 m
Test Method	BS1377:Part 2: 1990, clause 9.0			Depth Base	- m
				Sample Type	B
				Samples received	30/07/2024
				Schedules received	28/07/2024
				Project started	30/07/2024
				Date tested	07/08/2024

Sieving		Sedimentation	
Particle Size mm	% Passing	Particle Size mm	% Passing
125	100		
90	100		
75	100		
63	100		
50	100		
37.5	95		
28	92		
20	83		
14	76		
10	67		
6.3	57		
5	55		
3.35	52		
2	47		
1.18	43		
0.6	33		
0.425	24		
0.3	16		
0.212	11		
0.15	10		
0.063	8

Sample Proportions	% dry mass
Very coarse	0
Gravel	53
Sand	39
Fines <0.063mm	8

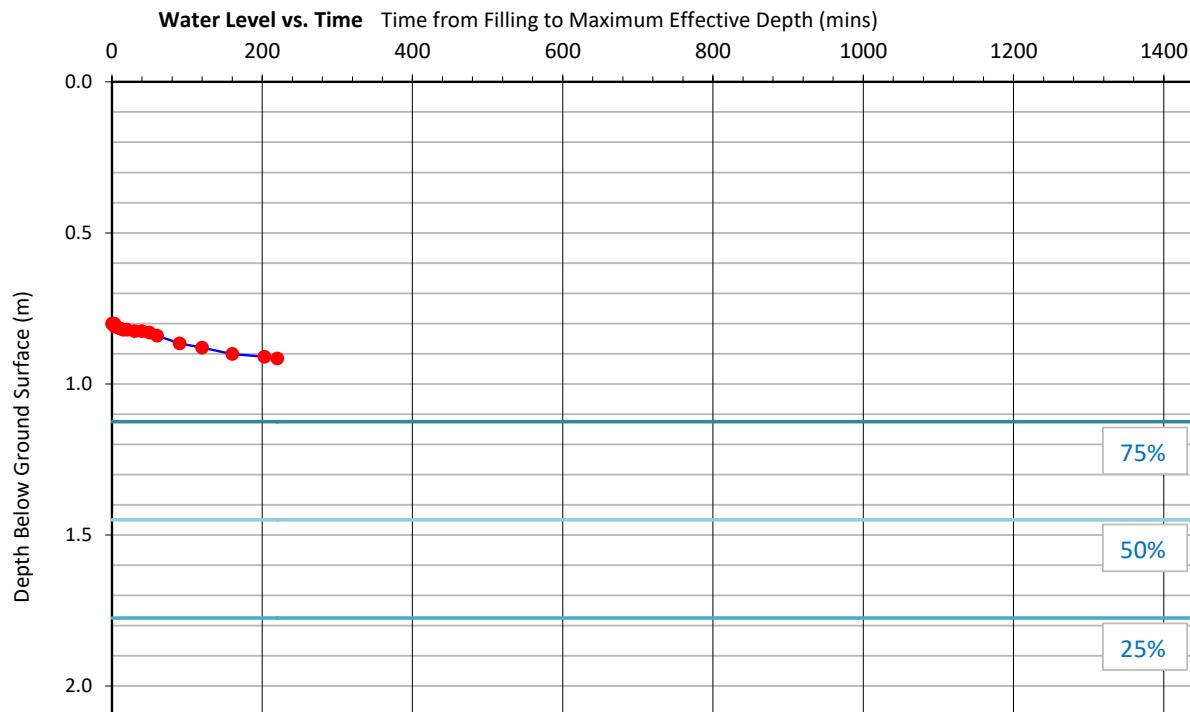
Soil infiltration rate,  $f$  : 0.43875/(3.21 x 0)  
 $f$  : ms<sup>-1</sup>

No rate determined
