PHASE ONE ENVIRONMENTAL ASSESSMENT REPORT (PRELIMINARY RISK ASSESSMENT)

Phase I Environmental Assessment – Summary

Client: Polaris Property Developments Limited	Phase One Environmental Desk Study Report	Report	IN22732 CL 001
		Date	April 2022
		Page	2

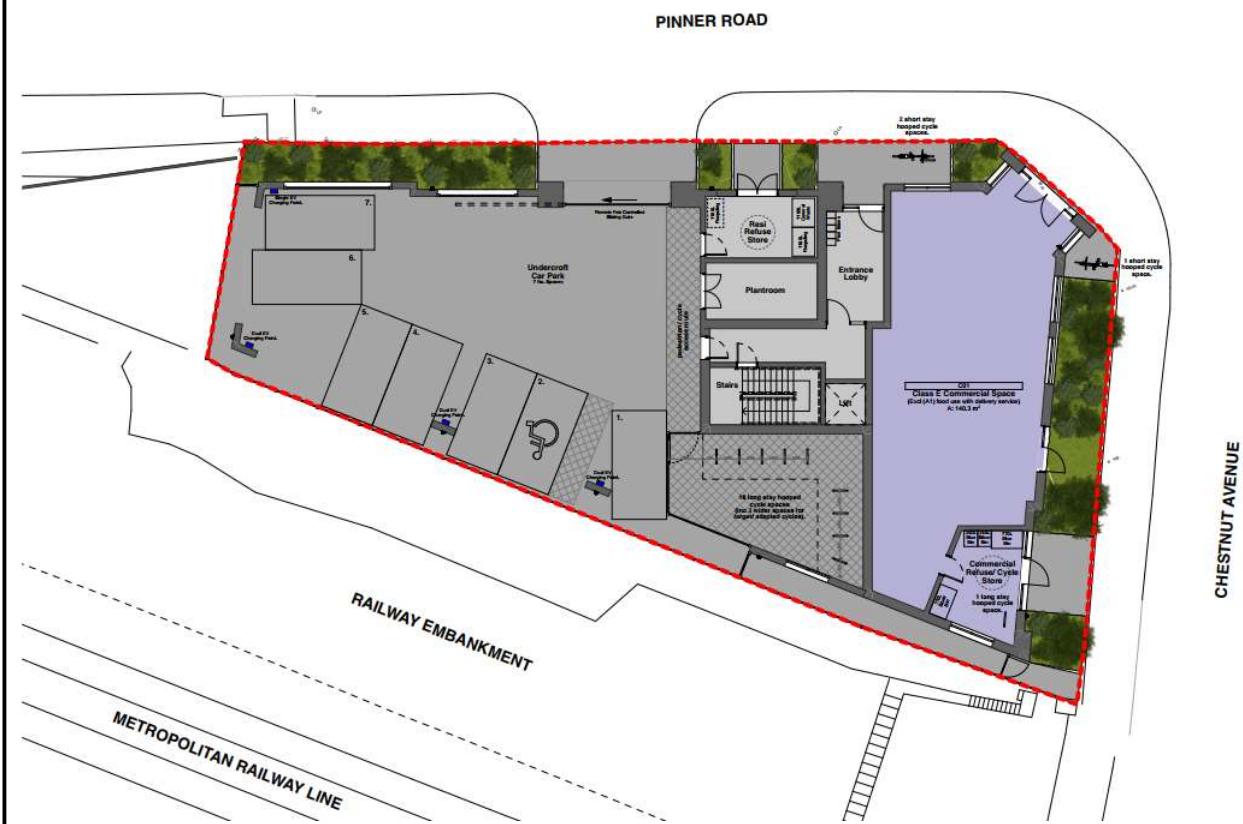
Table Three: Proposed Development Plans

Proposed Developments	<p>We understand that Polaris proposes to redevelop the site with a mixed commercial and residential building. The commercial units and parking will form ground level with the upper two levels populated with nine flats. There will be a communal landscaped area within the development.</p> <p>A site plan showing the proposed development plan is provided below.</p>
Notes	<p>We understand that this report is to be submitted in support of a planning application for the site's redevelopment, as detailed above. Whilst our assessment has not been compiled to directly satisfy any specific planning conditions the information contained in this report may assist in satisfying any such requirements (although further works may be required).</p>
