## GEO-ENVIRONMENTAL INVESTIGATION REPORT

Client: Polaris Property  
Developments LimitedGeo-Environmental  
Investigation Report

Report	IN22732 CL 002
Date	July 2022
Page	IN22732 CL 002

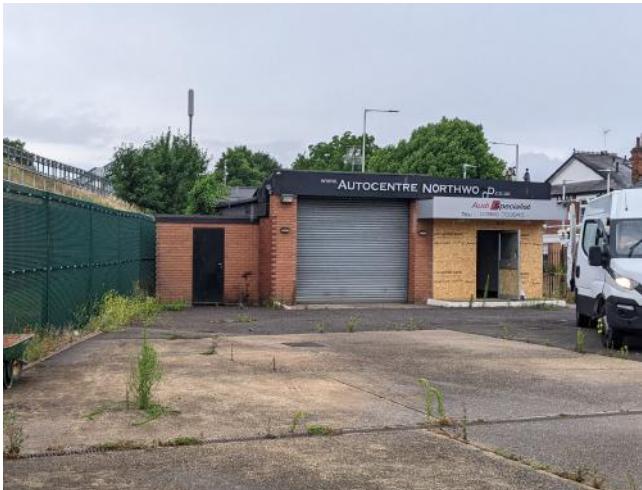
Photograph One: Site building (disused) - office and former vehicle maintenance workshop

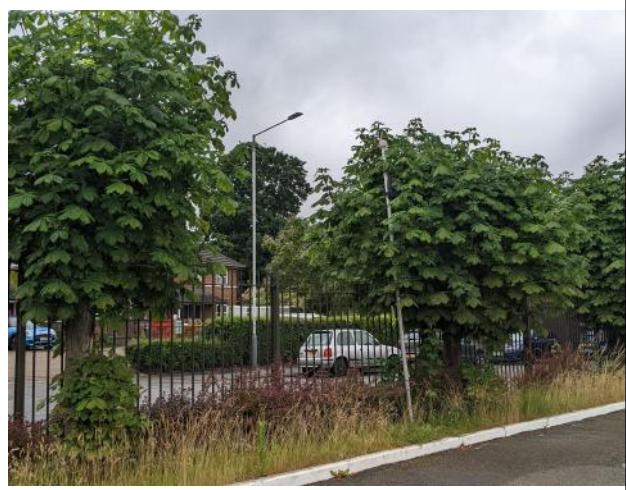
Photograph Two: trees along eastern boundary

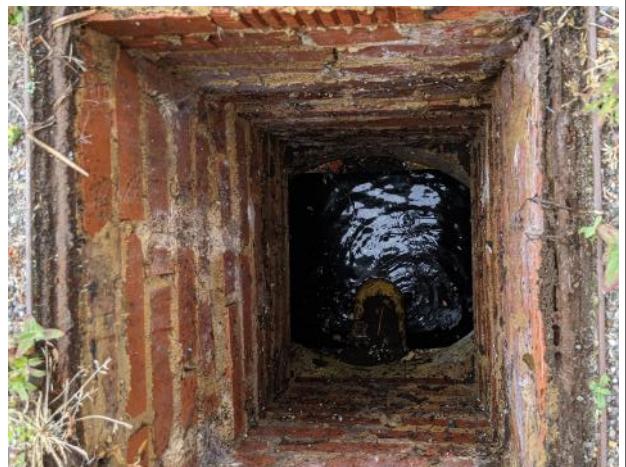
- Chestnut Avenue forms the eastern boundary. There are several semi-mature trees along this boundary.
- There is a three-chambered drainage interceptor (presumably the former forecourt interceptor) located in the south-eastern corner of the site. This is constructed from three brick chambers with metal lids. There is standing water present within all three chambers, with a hydrocarbon sheen in chambers 1 and 3.

Photograph Four: Middle chamber of drainage interceptor.
