Report prepared at
Garage Court
r/o 66-74 Farmlands
Joel Street
Pinner
HA5 2LN

On behalf of
Kearns Developments Limited

Report reference
25-262.01
Version 1

Report Quality Management			
Project Name	Garage Court, r/o 66-74 Farmlands, Joel Street, Pinner, HA5 2LN		
Project Title	Preliminary Risk Assessment and Site Investigation		
Client	Kearns Developments Limited		
Project Number	25-262.01		
Version	1		Date
Prepared by	Vanessa Bell BSc (Hons), MSc	Environmental Consultant	30/01/2026
Prepared by	Orlando Blackwell BEng (Hons) MSc (Eng)	Principal Engineer	16/03/2026
Approved by	James Burkitt BEng (Hons) CEnv MRICS	Managing Director	16/03/2026

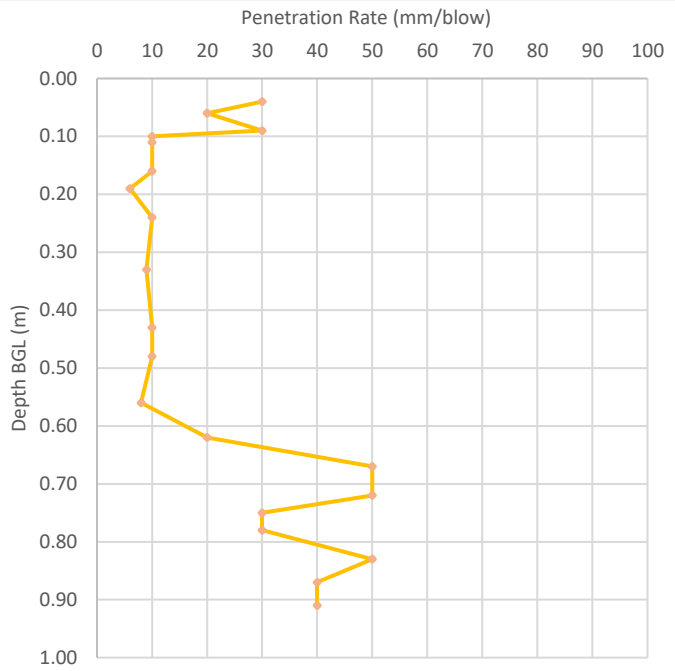
Dynamic Cone Penetrometer

Project: Garage Court, r/o 66-74 Farmlands, Joel Street, Pinner, HA5 2LN	Project No: 25-262.01	DCP Location: DCP1
Client: Kearns Developments Limited	Operator: OC	Date: 19/02/2206
Surface Conditions & Observations: Slightly wet, harder MG	Zero Error (mm): 20	Approx AOD (m):

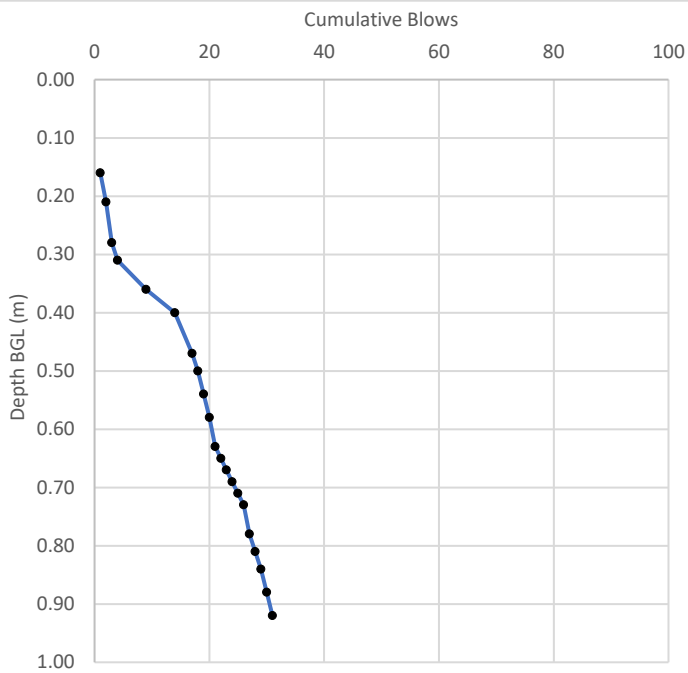
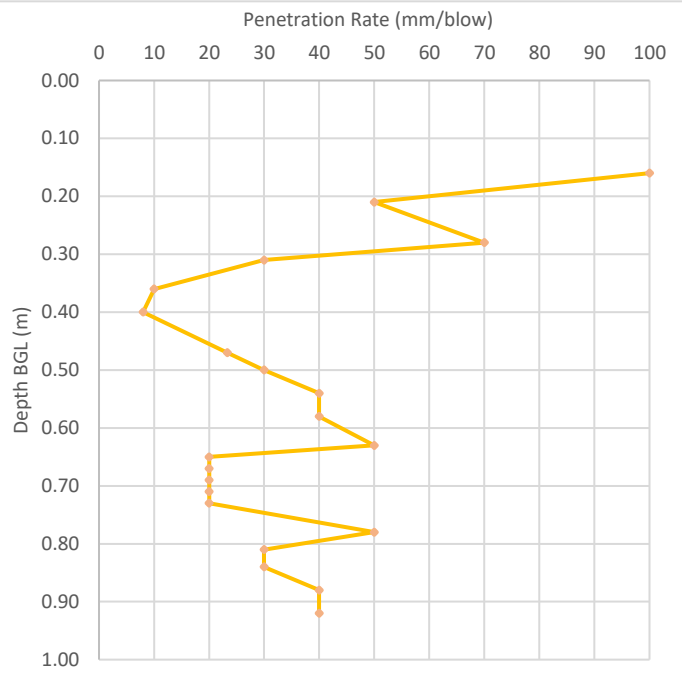
Dynamic Cone Penetrometer

Project: Garage Court, r/o 66-74 Farmlands, Joel Street, Pinner, HA5 2LN	Project No: 25-262.01	DCP Location: DCP4
Client: Kearns Developments Limited	Operator: OC	Date: 19/02/2206
Surface Conditions & Observations: Slightly wet	Zero Error (mm): 20	Approx AOD (m):
