**WINSTON CHURCHILL HALL,
PINN WAY, RUISLIP HA4 7QL**

An Archaeological Watching Brief

Planning reference	78327/APP/2023/2901		
Local planning authority	London Borough of Hillingdon		
PCA report no.	R16355	Site Code	PIW24
PCA project no	K8746	Date	June 2024

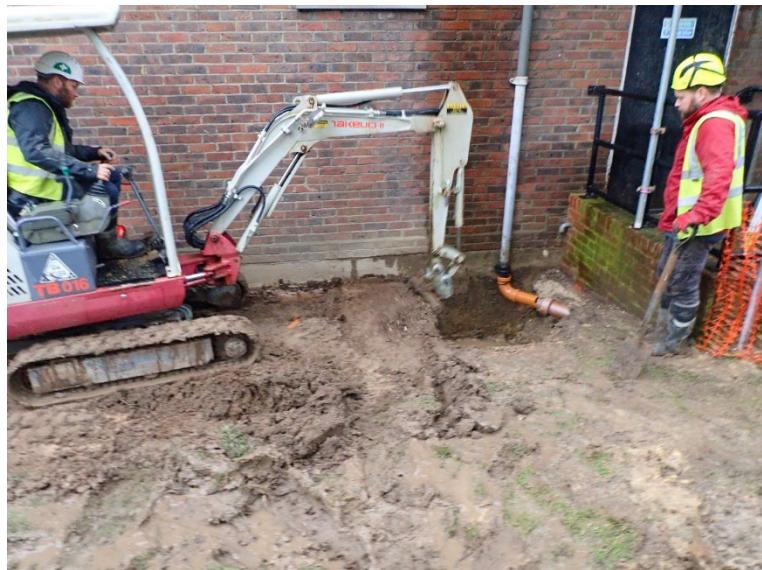
6.2.2 The pit measured 1.5m by 2m and reached a maximum depth of 1.2m below ground level. This was excavated using a tracked mini digger with a flat bucket on 19th February 2024 (plate 1).

Plate 1: excavation of pit in progress, view looking north.

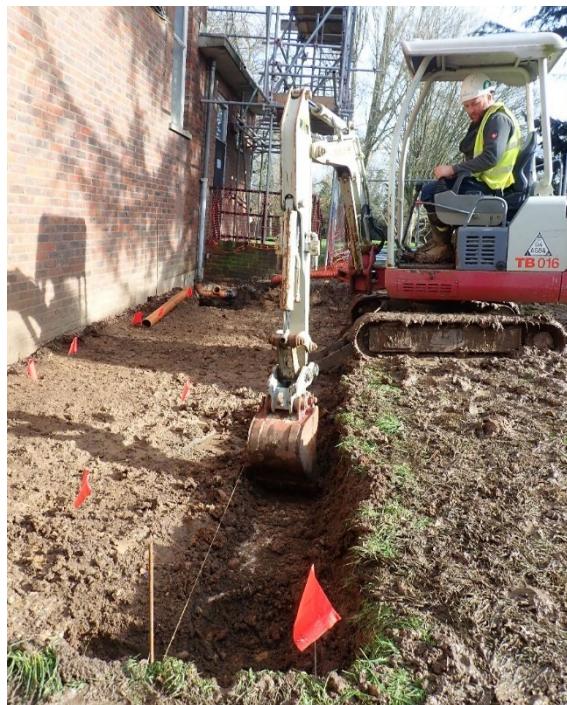
6.2.3 The foundation trench was immediately to the west of the pit, measuring 7.5m by 3.5m and reached a depth of approximately 300mm below ground level. Around the outer perimeter of the main trench, a deeper trench for footings was dug, 200mm wide and up to 500mm deep, to allow for footings for fencing around the air pumps. The excavation of the foundation trench was undertaken by a tracked mini digger with a flat bucket on consecutive days, 22nd and 23rd February 2024 (plate 2).

Plate 2: excavation of trench in progress, view looking east.

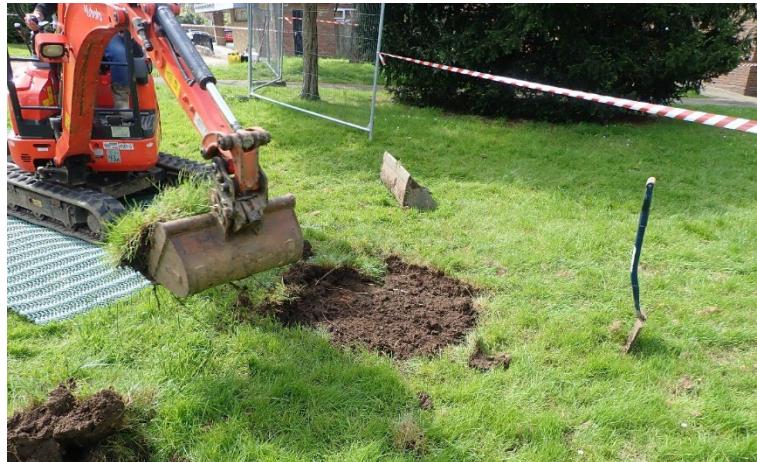
6.2.4 The tree pits were to the south (pits 1 and 2) and east (pits 3 and 4) of the building, measuring 1.2m by 1.2m and reaching a depth of approximately 900mm below ground level (Plate 3). Shrub pits were also observed but these were only dug to a depth of ca. 400mm and did not go below the topsoil. These works took place between 29th April and 30th April 2024.

Plate 3: excavating a tree pit (pit 3, looking west)

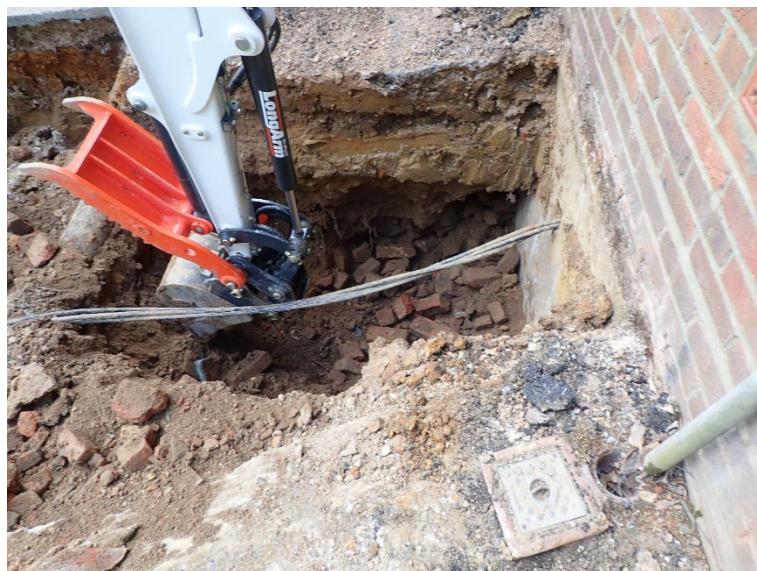
6.2.5 The service trench consisted of a narrow shuttered trench 1.6m wide dug up to the building across the tarmac pathway alongside it, approximately 3.5m across, and reached a depth of approximately 2m, plus a wider rectangular area extending across the grass beyond the pathway, approximately 3.6m by 2.6m, which reached a depth of 0.7m below ground level. (plate 4). This work took place on 30th April and 1st May 2024.

Plate 4: excavating the service trench, view looking south

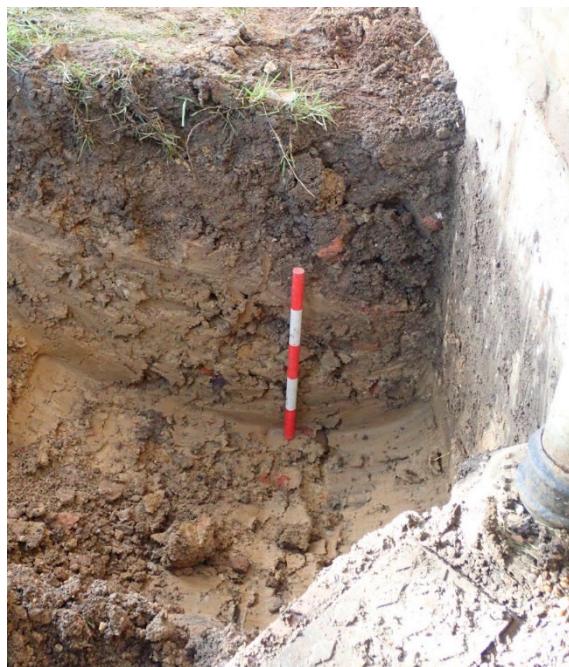
Size	1.5m X 2m
Location	Adjacent to southeastern wall of building
Ground height	ca. 41m OD
Maximum depth	1.2m
Stratigraphy (depths given are below ground level against wall)	[+] Topsoil 0.0m – 0.15m. Layer sloped downwards from south to north, dropping approximately 0.3m over width of pit. [+] Made ground, up to 300mm thick, containing a range of what appeared to be discarded building material, including a length of scaffolding pipe, a broken and flattened galvanised bucket and very frequent bricks and brick fragments 0.15m – 0.40m. Layer sloped downwards from south to north, dropping approximately 0.2m over width of pit. [1] Reworked clay, occasional fragments of CBM 0.40m – 0.70m. Layer sloped downwards from south to north, dropping approximately 0.15m over width of pit. [2] Stiff brown clay, no inclusions, 0.70m to base (NFE)
Notes	Clay [2] interpreted as natural. Pit recorded as section S1.

Plate 5: Pit looking west showing reworked clay [1] and natural clay [2] at base.

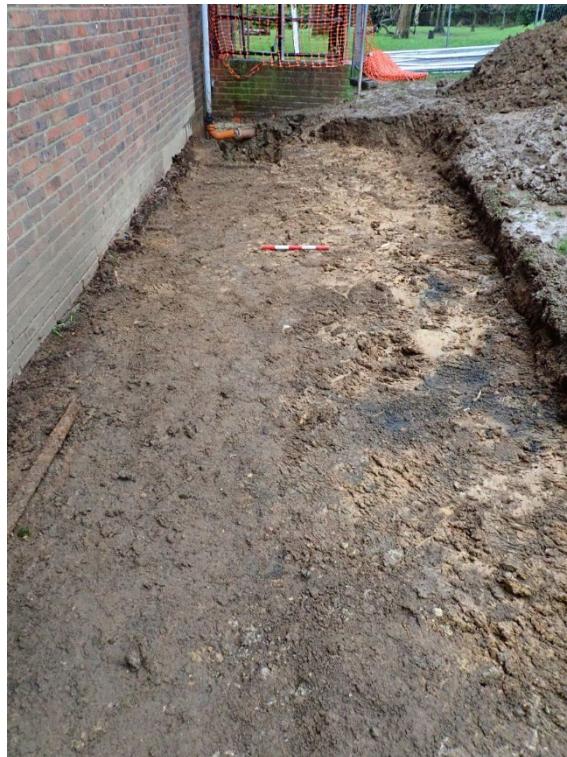
Size	7.5m x 3.5m
Location	Adjacent to southeastern wall of building to west of pit
Ground height	ca. 41m OD
Maximum depth	0.5m
Stratigraphy (depths given are below ground level against wall)	[+] Topsoil 0.0m – 0.15m. Layer sloped downwards from south to north, dropping approximately 0.3m over width of trench. [+] Made ground, continuous with layer observed in pit, lenses of yellow sand in some areas. 0.15m – 0.4m. Slope downwards to north observed. [1] Reworked clay, continuous with layer observed in pit; occasional fragments of CBM 0.40m – base (NFE). Slope downwards to north observed.
Notes	[1] was just visible in places below made ground in main trench, more clearly within footing trench on perimeter of main trench. Separate section not drawn.

Plate 6: Foundation trench looking north showing transition to reworked clay [1] below modern made ground.

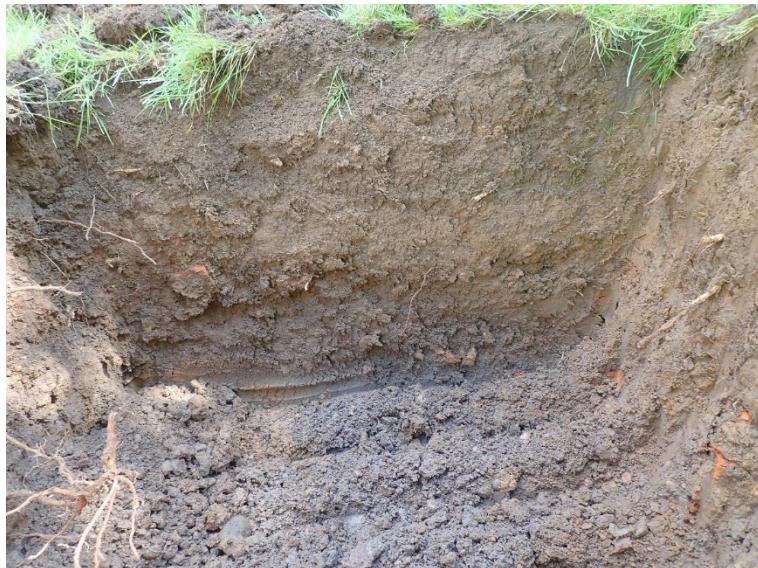
Size	1.2m x 1.2m
Location	Four pits excavated; Pits 1 and 2 to south of building, Pits 3 and 4 to east of building
Ground height	ca. 42m OD (to south) ca. 40m OD (to east)
Maximum depth	0.9m
Stratigraphy (depths given are below ground level against wall)	[4] Topsoil 0.0m – 0.6 to 0.8m. [3] Made ground / dump dk grey brown silty clay with frequent broken roof tile. Observed to base of pit at ca. 0.9m
Notes	Separate sections not drawn.

Plate 7: Tree pit 2, looking southeast. Broken roof tile can be seen at base of layer [4] at start of layer [3] below.

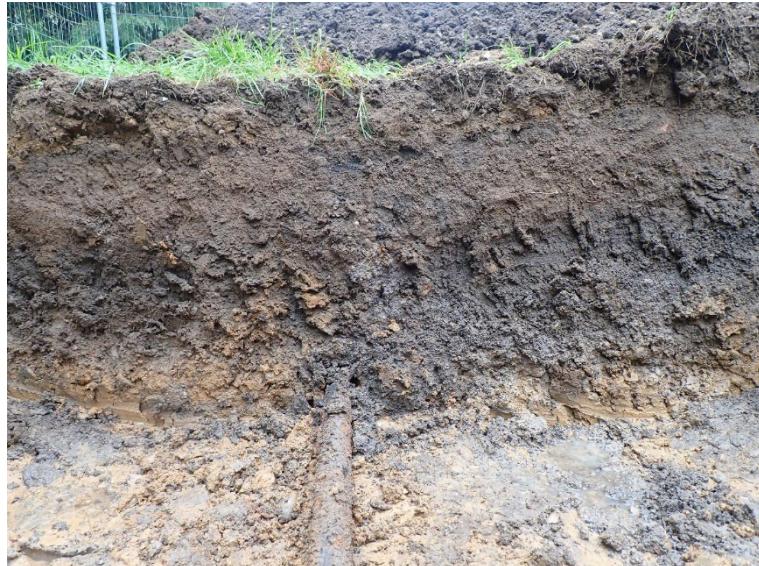
Size	1.6m x 13.5m deep trench plus shallower rectangular area ca. 3.6m x 2.6m
Location	Near NE corner of building. Deep trench against building's eastern wall was 1.6m wide and 3.5m across the tarmac path alongside the building. Beyond this a roughly rectangular area situated on the grassed area to the east of the pathway.
Ground height	ca. 40m OD
Maximum depth	ca. 2m in narrow trench, 0.7m in rectangular trench
Stratigraphy (depths given are below ground level against wall)	In the area of the narrow trench, and extending to approximately 4m to the east of the building, below the tarmac was brick rubble in a silty clay matrix to the base of the excavation. In the rectangular trench on the grassed area to the east, the sequence was [4] Topsoil 0.0m – 0.2m. [6] Made ground / dump dk grey brown silty clay with frequent CBM, modern glass fragments (including whole spirits bottle) metal and plastic fragments 0.2m – 0.45m [7] Disturbed (trampled?) clay layer 0.45m – 0.6m

[8] Natural clay. Observed to base of pit at ca. 0.75m
Notes	Clay [8] interpreted as natural (= [2]) Rectangular trench recorded as section S2.

Plate 8: west facing section of rectangular trench showing layers [4], [6], [7] with natural clay [8] at base. Construction cut for electrical cable is not clear in section but was visible in plan from below topsoil [4].
