# BS5837 Arboricultural Impact Assessment & Method Statement

**1A Clifford Gardens, Hayes, UB3 1NX**

**Client:** Multi Creation

**Job Reference:** 05005R

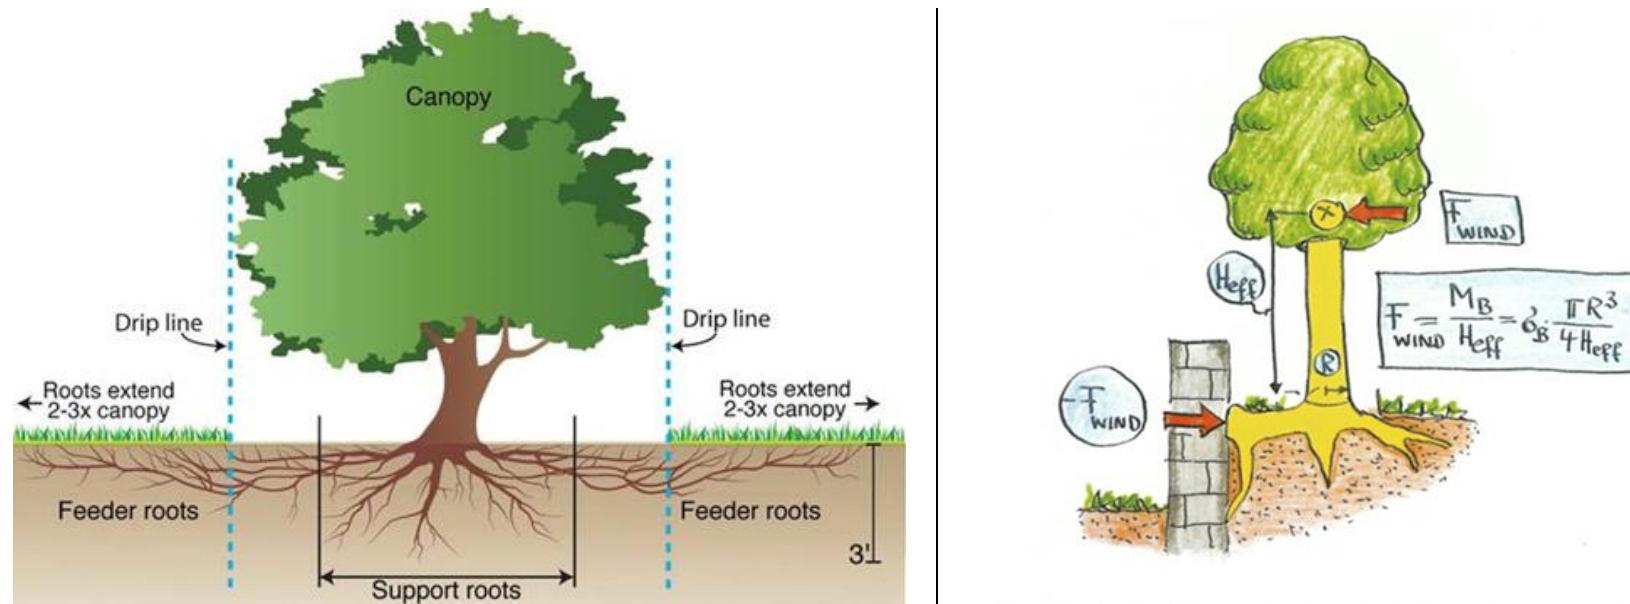
**Fig 2 – Open grown trees or those with minimal obstructions close to their stems will have a network of structural roots supporting feeder/ fine root growth beyond (above left). In certain situations root morphology can be affected by structures close to the main stem (above right: Mattheck).**

5.1.7 Within around 3 to 4m of the base of mature trees there will generally be a structural root system providing both support and the main structure/ root architecture for smaller roots to originate. These larger roots have the very real capacity to be influence by any significant structures (footings, roads to adoptable standard construction etc) where there may be a physical obstruction close to them and this can affect root morphology in such locations. In addition to this there will generally be a noticeable increase in structural rooting to the southwest of mature trees in the UK to reflect the prevailing wind direction, particularly where a tree may be isolated/ open grown increasing its wind exposure. Root growth and location will also be influenced by the presence of other trees, structures sheltering trees etc all of which can combine to affect the shape and location of a structural root system.

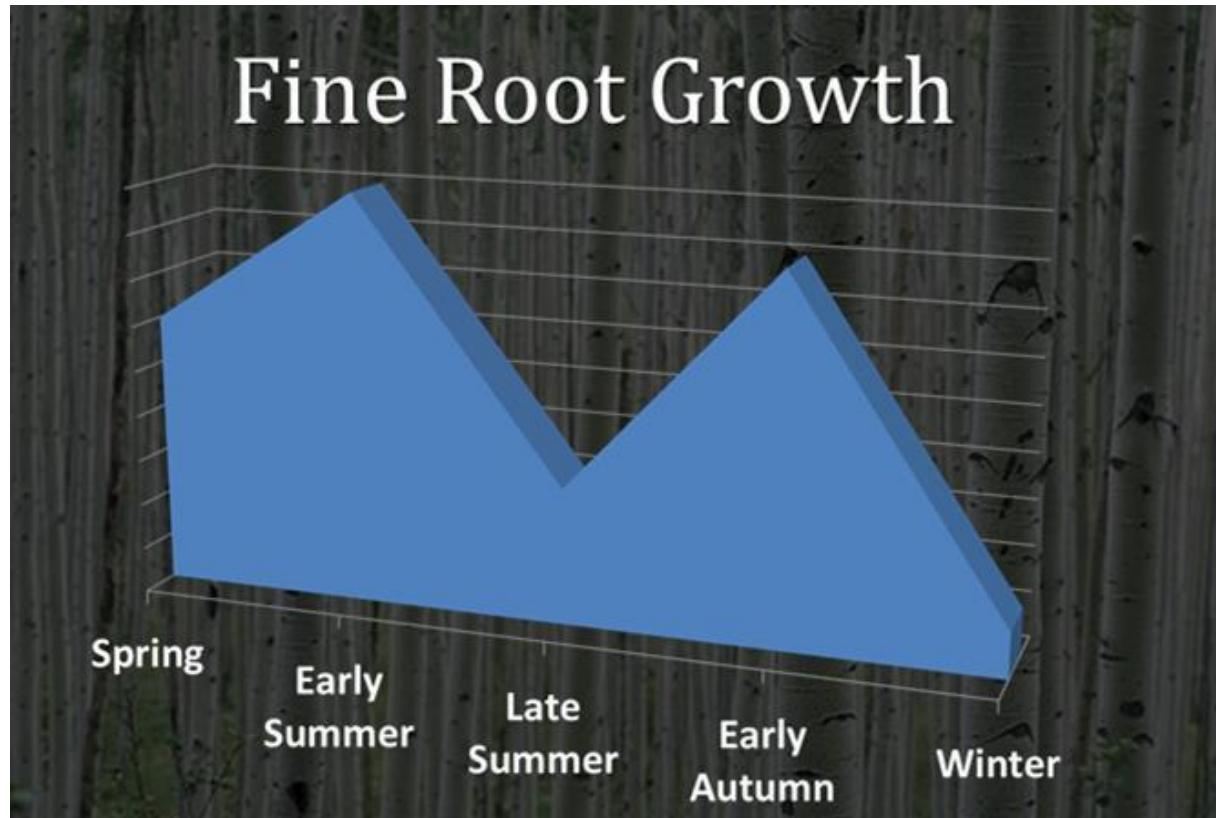
**Fig 3 – Fine root growth is (generally) seasonal peaking in late spring and again in early autumn but dying back in winter dormant periods when photosynthetic production ceases. This is an important part of the soil nutrient cycle and demonstrates that a static RPA as calculated by BS5837 is a ‘simplistic’ view of the tree rooting dynamic. (Image Source: Tamla Trees)**

5.1.8 Beyond the structural (and generally permanent) root system will be a network of smaller roots which in turn subdivide to fine roots. Fine roots will also be found throughout the root system (i.e. both close to and distant from a tree) to maximise soil resource uptake and reflect underlying soil conditions. Some larger roots (>25mm and sometimes much larger) can extend away from this area and remain permanent particularly where there may be a constant supply of water (such as a broken downpipe on a building some distance away) which encourages a roots development. Generally the smaller roots (<10mm and particularly fibrous roots) outside of the immediate structural root plate can be considered to be in a state of constant change. They will grow seasonally and tree roots generally grow at night. Small fibrous roots are also mostly short lived (ranging from anything

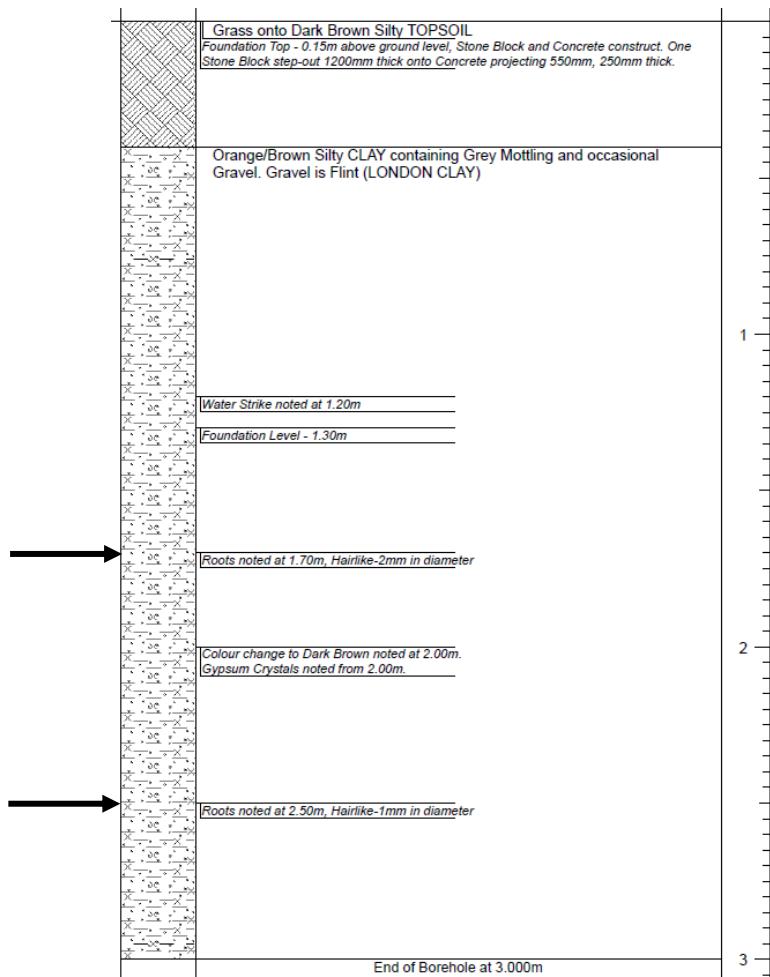
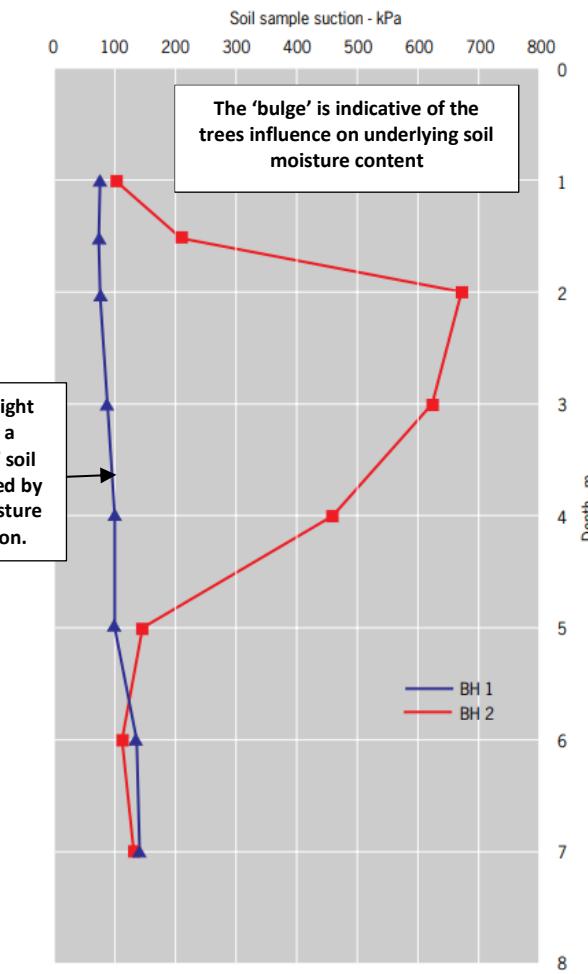
Fig 4 – Borehole log 10m from mature Oak tree on clay soil detailing fine roots to depths of 2.5m indicated with arrows (Source: Tamla Trees project) and annotated soil moisture depletion by trees showing a peak influence at 2m and extending to 5m (above right)

5.1.9 The fine root system shows species variation and will also vary in depth (depending on species dynamics and underlying soil conditions). Adopted highways generally have a footing that extends < 0.5m and most UK residential properties have footings in the range of 0.5-1.5m depth. Trees will easily root below these depths and this is evidenced by the fact that every year in the UK there are thousands of tree related subsidence cases.

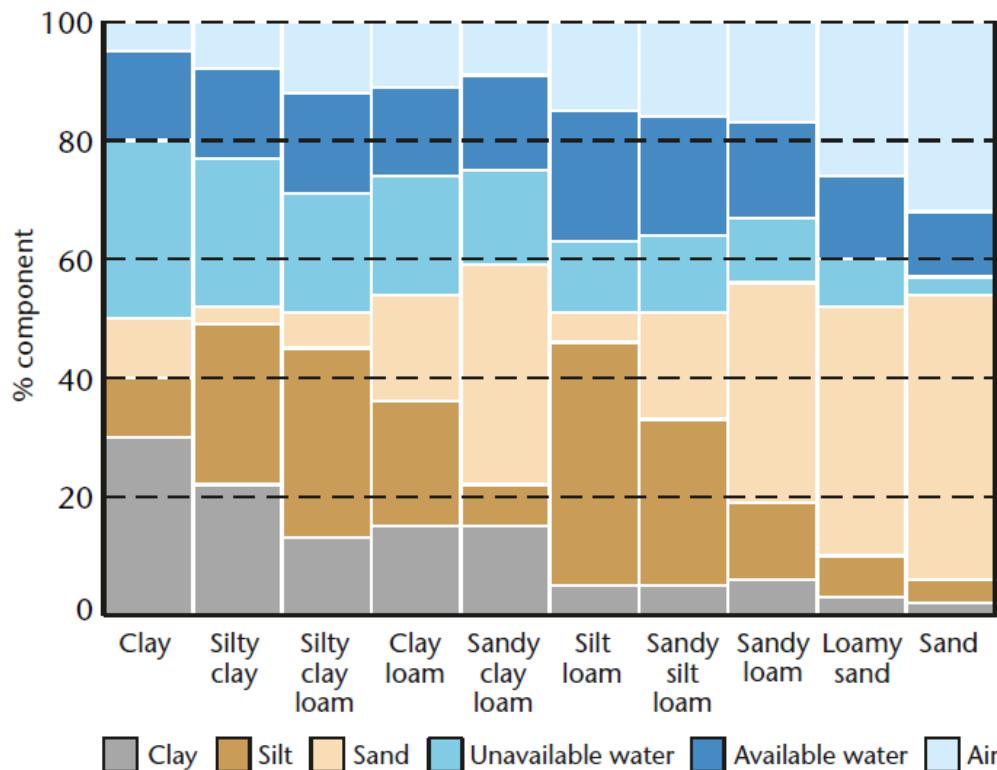
**Fig 6 – Diagram showing the typical particulate composition and air/ water content at field capacity for mineral soil types<sup>5</sup>** The variation in soil type has a direct bearing on the potential impact of adverse construction techniques (such as soil compaction) as well as overall root system morphology & development. Clay soils tend to have shallower rooting as moisture remains readily available while soils containing free draining gravel and sand can encourage deeper rooting based on reduce soil bulk density and greater seasonal variations in moisture availability.

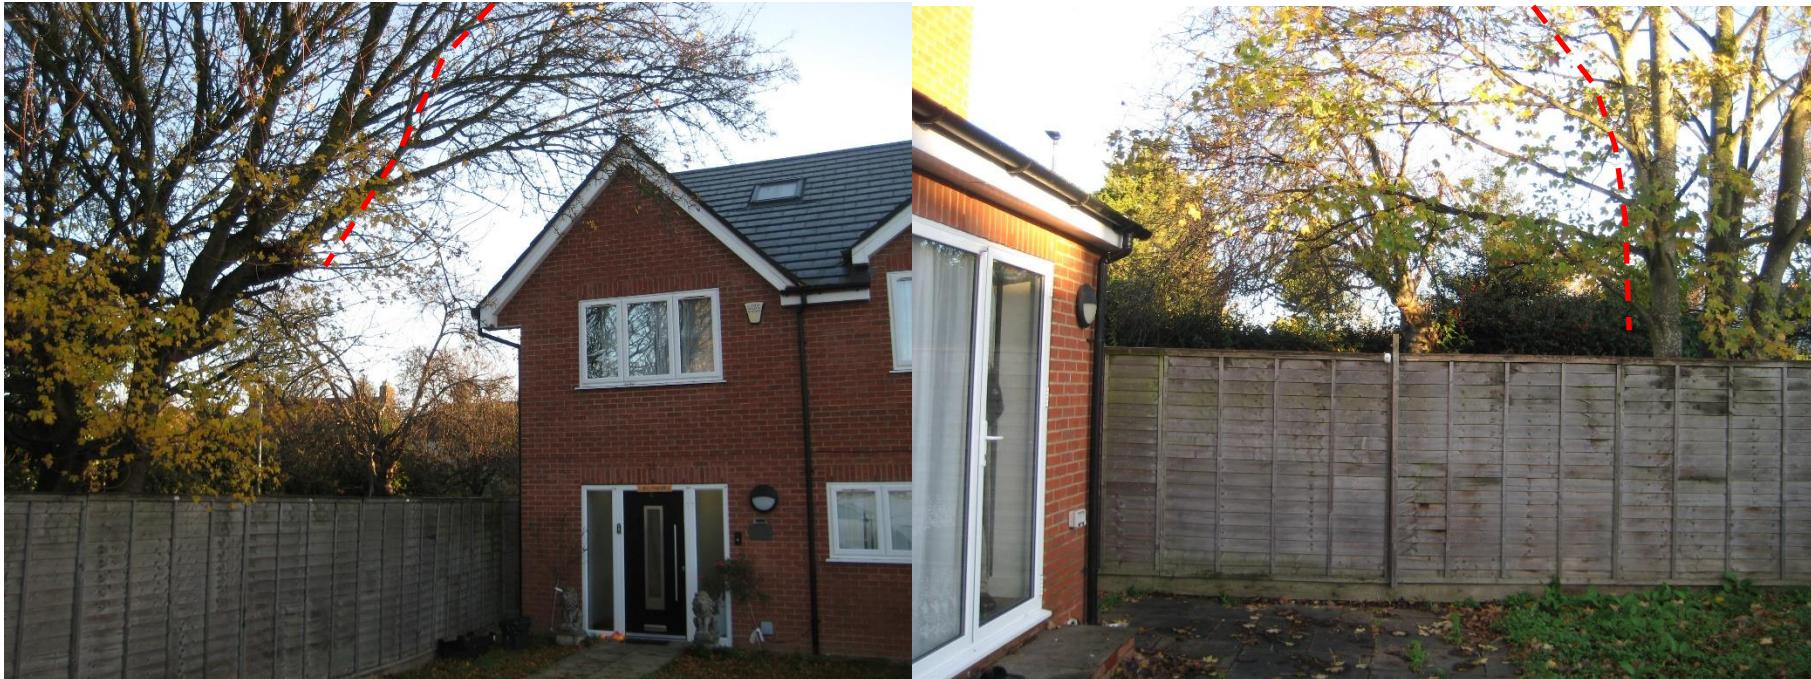
Fig 7 – T1 (Left) and T2 (right) will be crown lifted and the overhang towards the property sensitively reduced as indicated above.

5.3.1 No trees are proposed for removal. Some minor crown lifting and reduction of overhanging branches is proposed. This approach establishes repeat pruning points for any future works to maintain a balance between the retained trees and extended property.

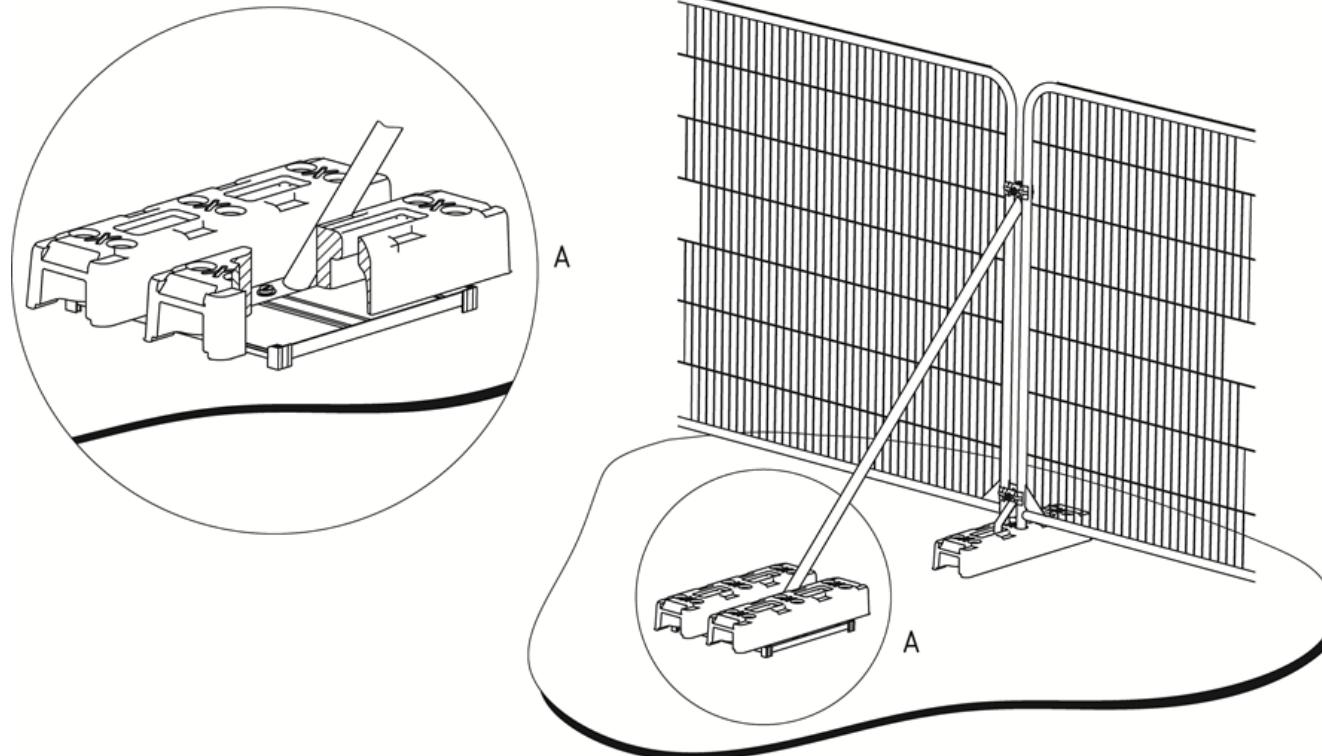
- *Braced feet fence spec (left).*
- *Note: To be marked with signs (inset) and purpose to be briefed to all ground workers.*
- *Maintained for duration of the build.*

5.4.2 High quality BS5837 compliant fencing will be installed prior to on-site works for T2 (to the rear).

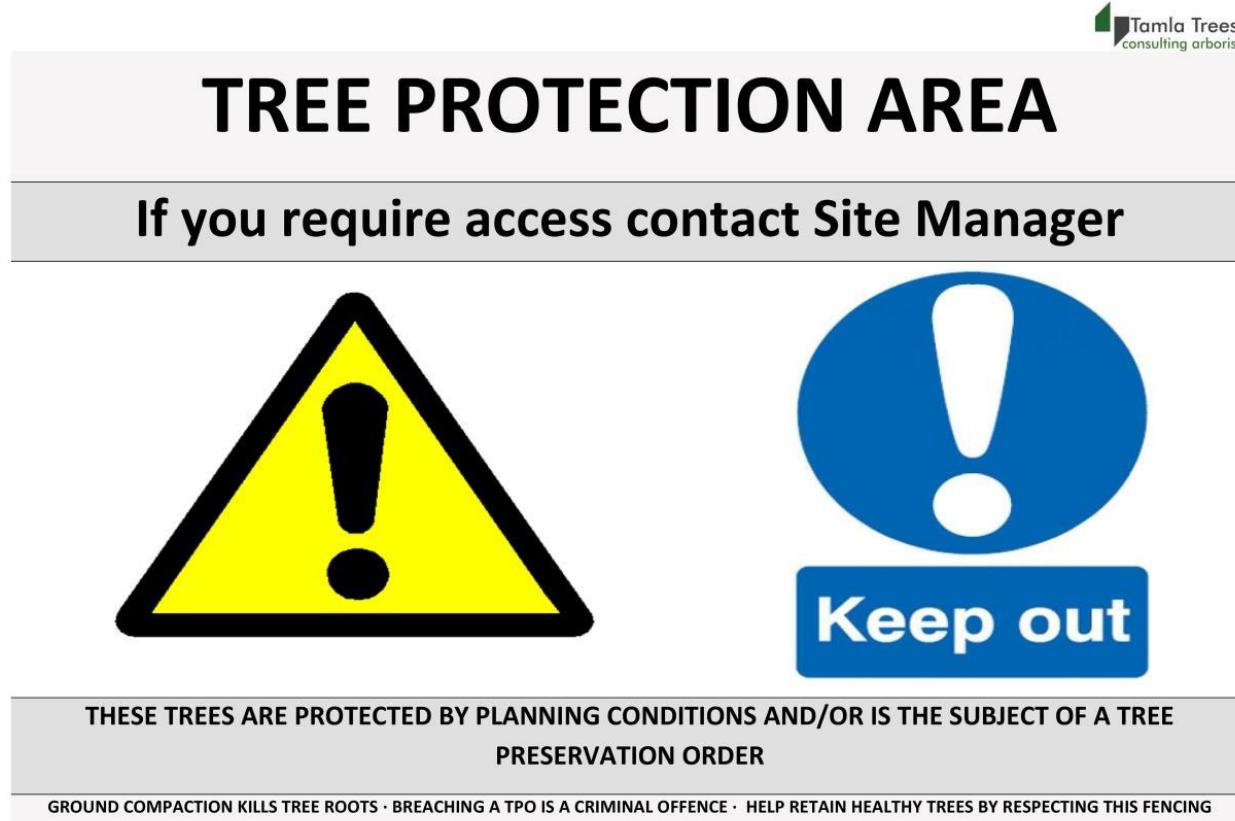
**Fig 8 – Professional grade weatherproof tree protection signs no smaller than 297 x 420 mm (A3) should be installed.**

5.4.3 All internal tree protection must be appropriately signed to ensure that all site operatives know its purpose.

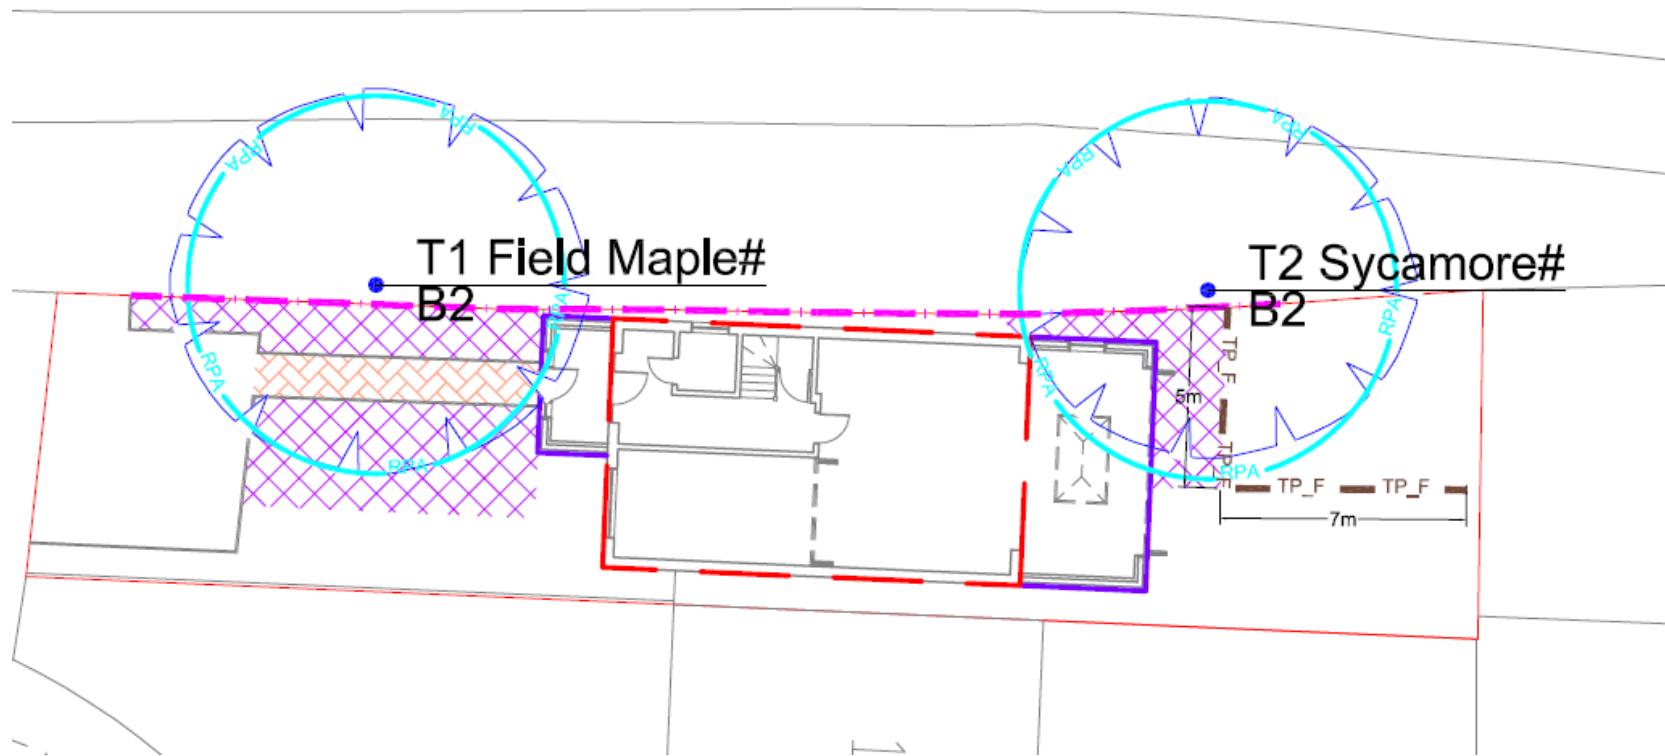
**Fig 9 – Temporary ground protection will be used to work around the proposal area (hatch).**

5.4.4 Temporary ground protection is required to allow safe movement around the proposal. It should be installed prior to any site activity and maintained for the duration of the works.

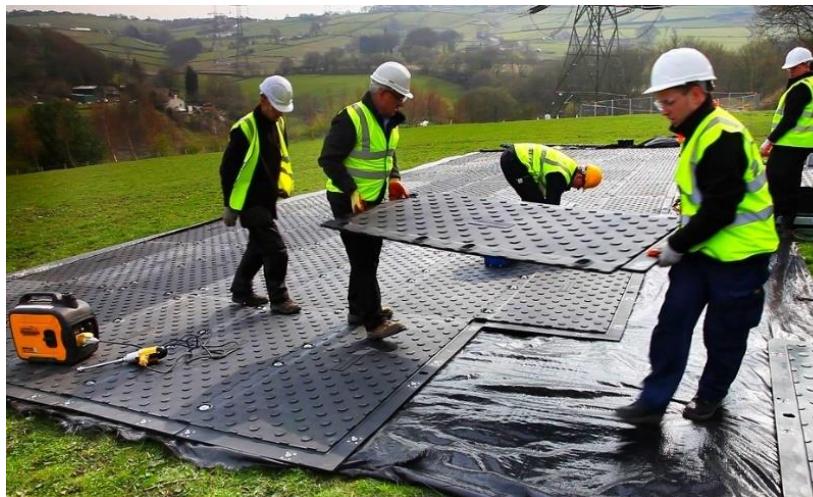
Fig 10 – Overview of ground protection. The contractor must ensure the specification is suitable for the works (overview of this above right)

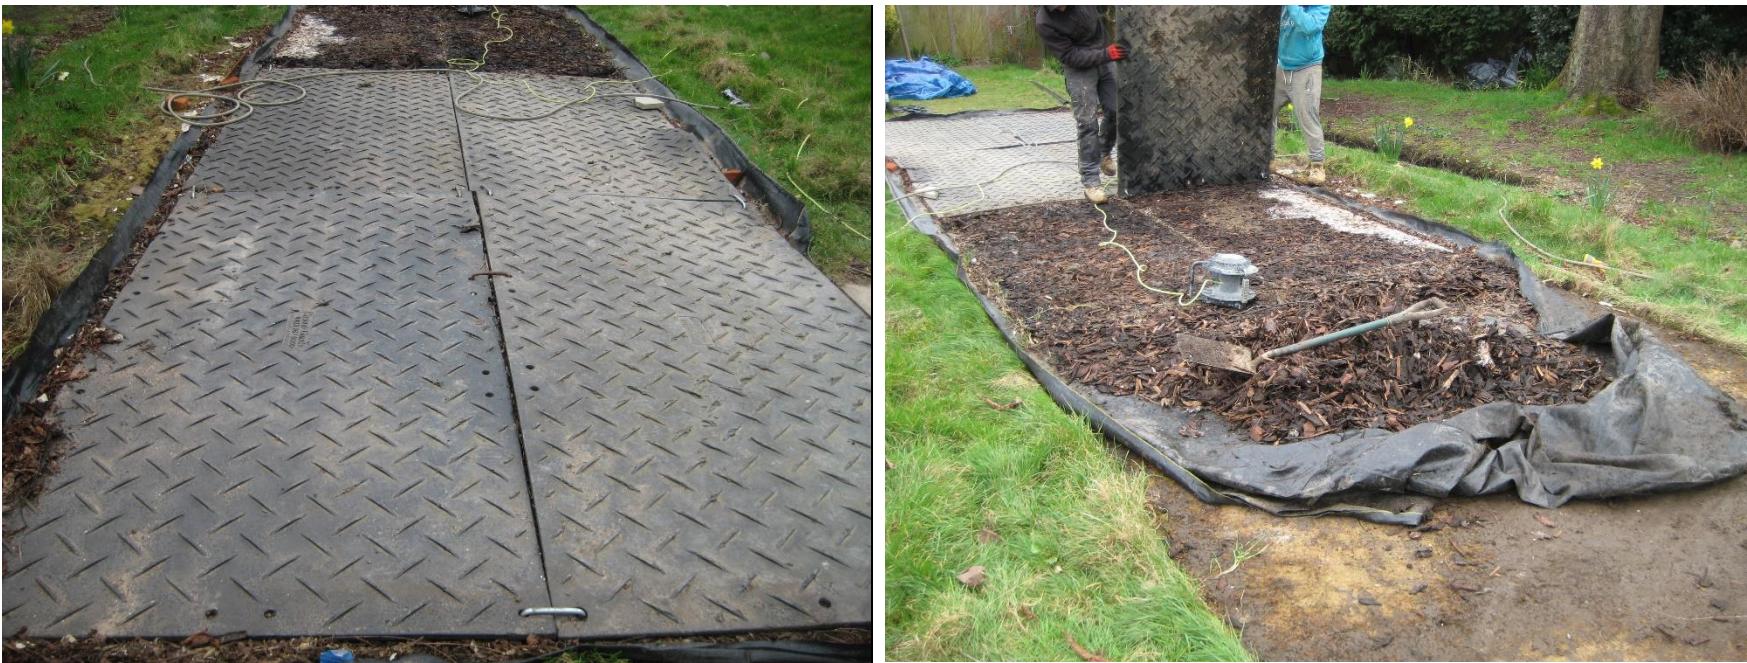
**Fig 11 – Temporary ground protection is an effective way of allowing access through the RPA of retained trees. It must be installed prior to any on site activity and maintained for the duration of all works to be effective. Above left Tamla Trees project ground protection in place and above right being removed following the completion of site works. (Note: depending on the length of time it is in place it will adversely affect underlying grass ground cover which will need reseeded/ turfed accordingly)**

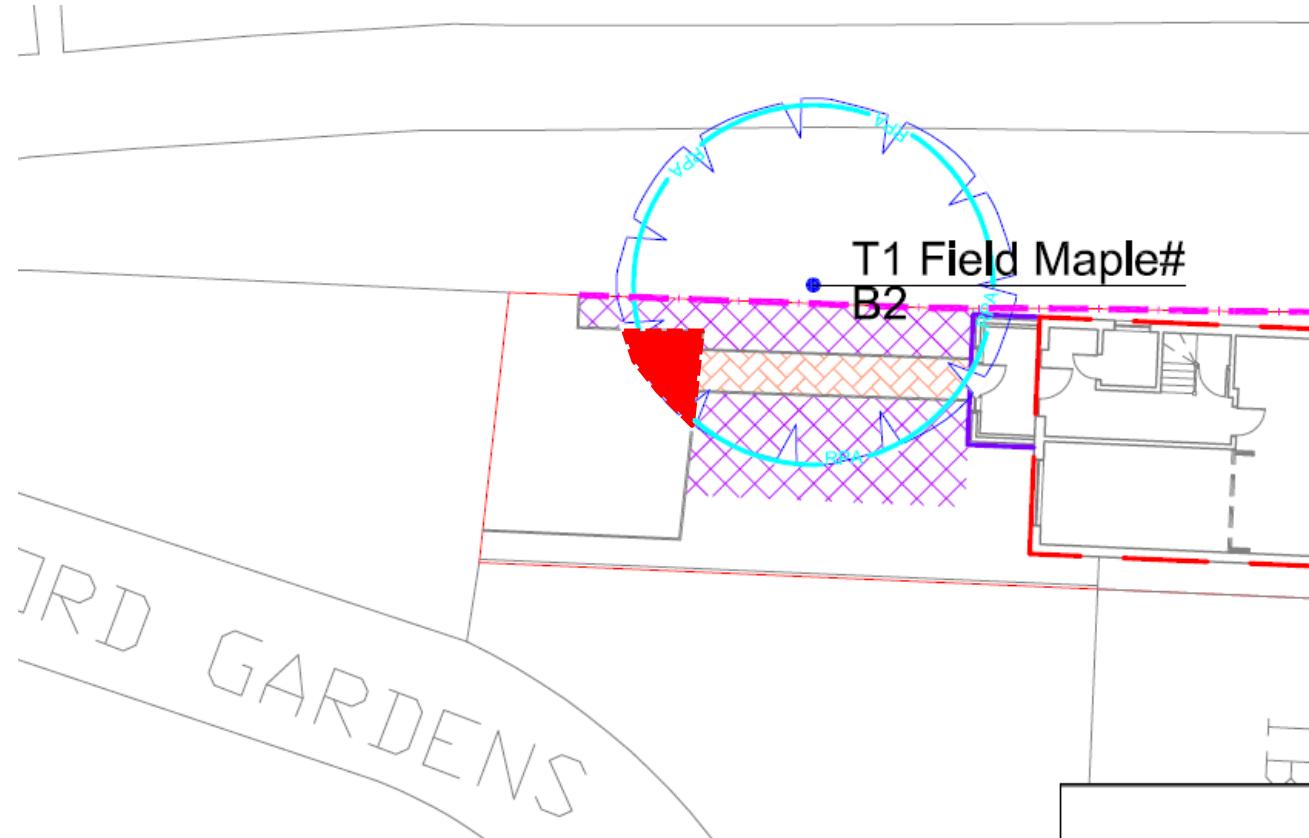
**Fig 12 – Visualisation of the minimal parking encroachment into the RPA of T1. At this level and distance a no dig surface is not proposed.**

5.5.1 The parking area is extended to the western end of the site but this encroachment within the RPA of T1 is so minimal and issues with levels are such that a no dig surface is not proposed. A no dig surface (to achieve consistency of levels) would need to extend over the whole parking area and this is not considered proportionate to the potential impact from such a small incursion.

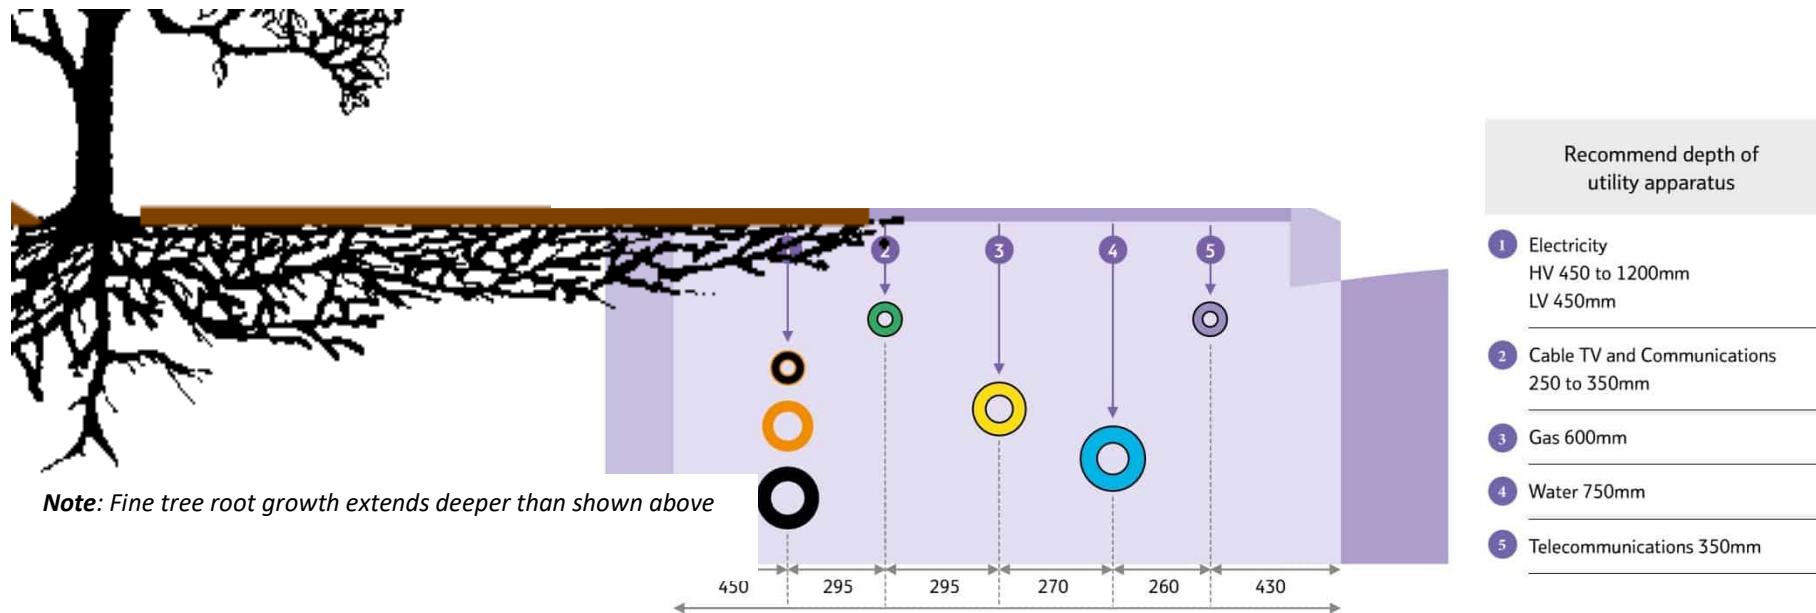
**Fig 13 – Annotated service installation depth drawing (source: Thorne & Derrick). Service installations occupy the same soil volume/ depth where the greatest level of tree roots will likely be found. It is envisaged that services will connect with existing ones present on site serving the existing property with ample space for installations outside the RPA.**

5.6.1 All services should be designed outside the RPA where possible and no manhole/ chambers should be located within the retained tree RPA. Where further excavations are required, these will be undertaken by hand if within the RPA of retained trees.

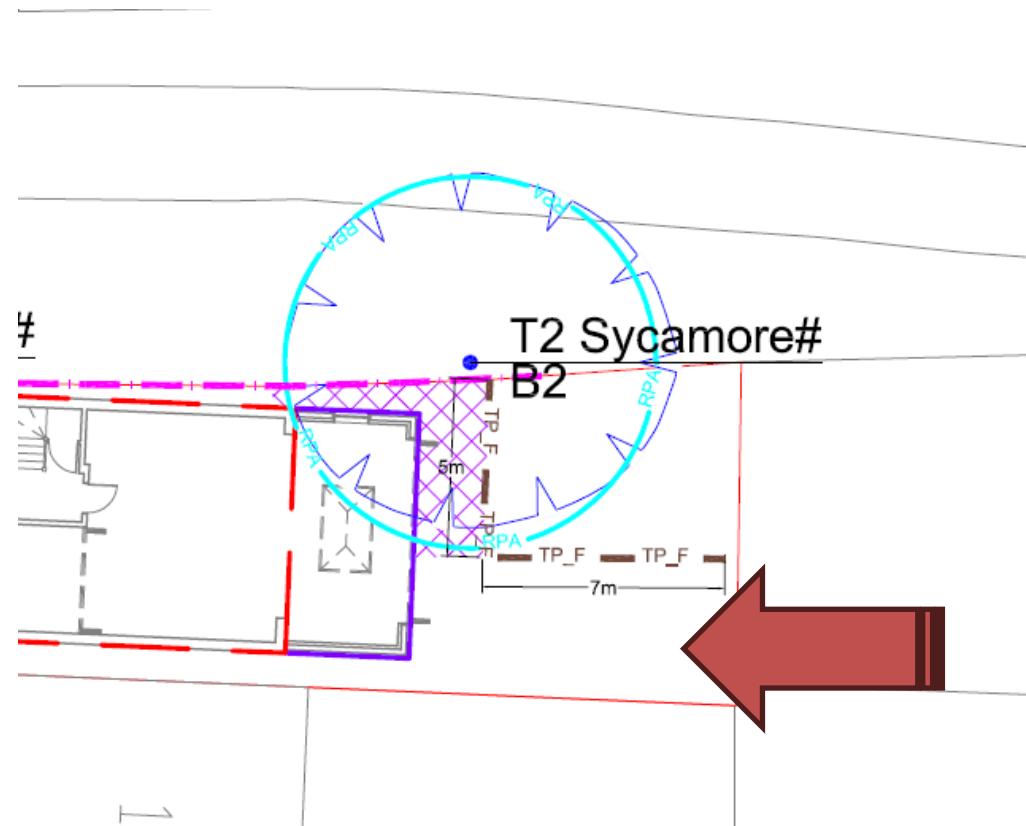
**Fig 14 – Should a new soak away be required it should be located in the area indicated as this will keep it outside the RPA of T2.**

5.6.2 **Services** - If a soakaway is to be installed it should be located within the rear garden space available outside the RPA's. It seems unlikely given the underlying clay soil.

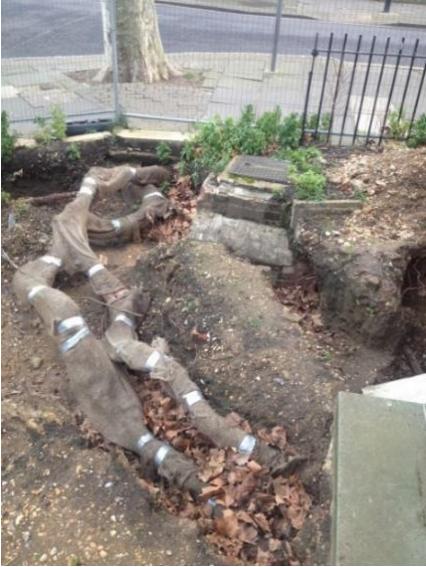
Root Wrapping

<p><b>Overview</b></p> <ul style="list-style-type: none"> <li>• <i>Any exposed roots &gt;25mm should be wrapped in hessian (example left) if exposed overnight or for any 4-hour period.</i></li> <li>• <i>Spot marking with spray paint to highlight locations also advised.</i></li> <li>• <i>Alternatively roots can be covered over with topsoil to maintain moisture retention.</i></li> <li>• <i>Example Tamla Trees project on London Plane (left).</i></li> </ul>
<b>Threat Level to Retained Trees</b>		<b>HIGH</b>

5.6.7 **Root Wrapping/ Protection:** In the event the footing works expose any roots >25mm in diameter these must be wrapped or protected with a covering of soil if left exposed overnight or for longer than any single 4-hour period before backfilling following service install.

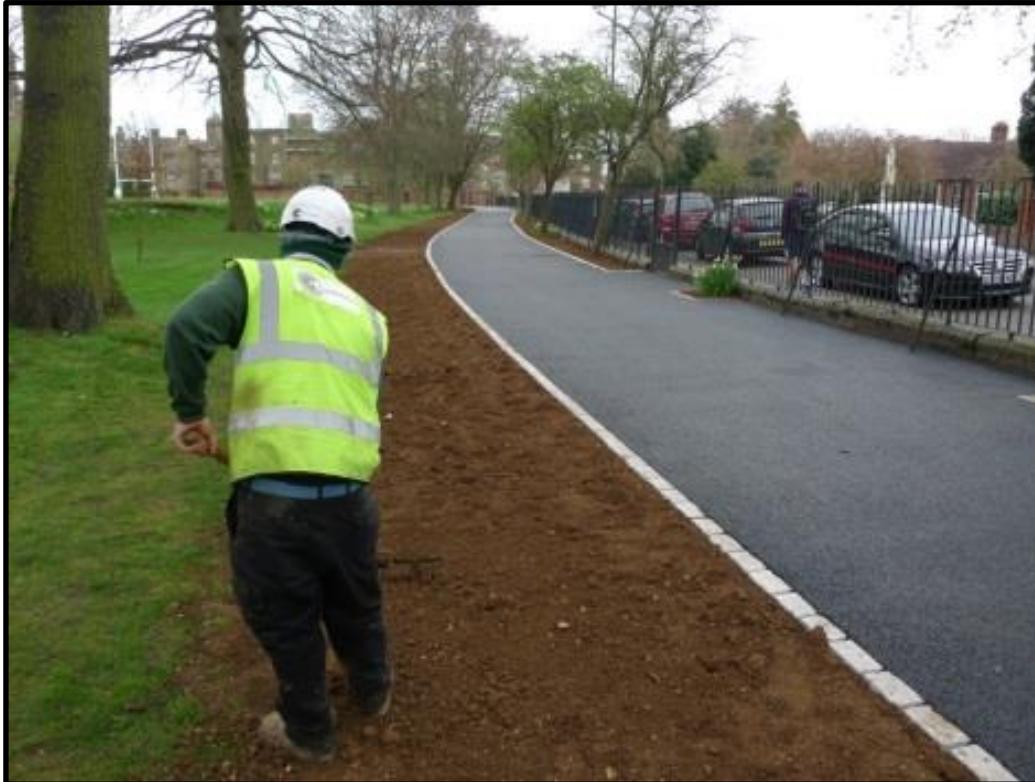
**Fig 16 – All 'making good' topsoil will be BS3882 compliant and raked out by hand to no greater depth than 100mm.**

5.7.1 All 'making good' will be with BS3882 compliant topsoil raked out by hand (to no more than 100mm depth within any tree RPA) and then seeded/planted as appropriate. Further comment on full landscaping details is outside the scope of this report.

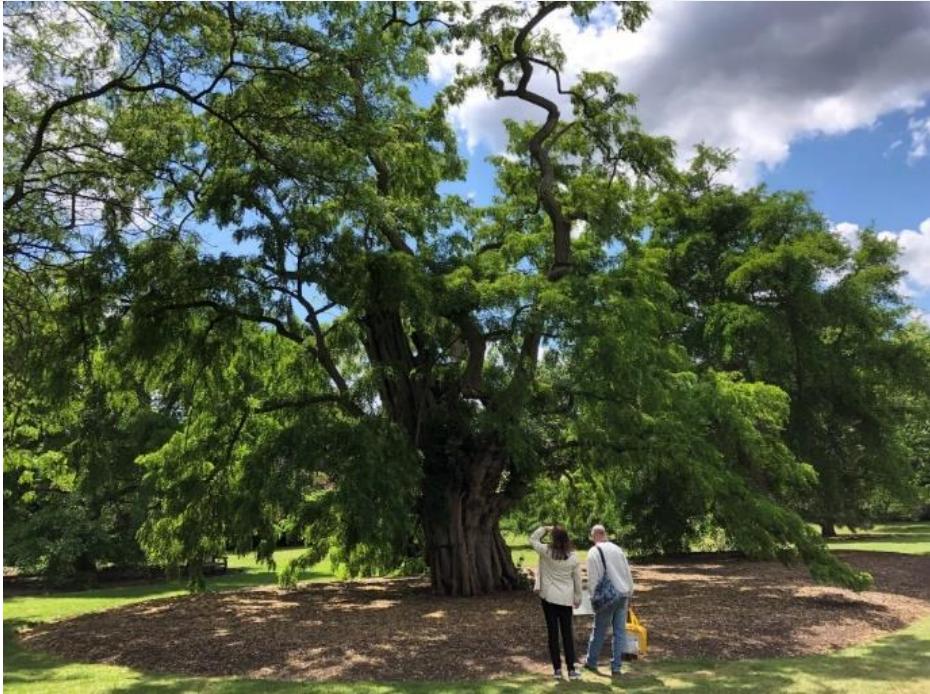
## Mulching

- *Circular area edged to 50-100mm depth to stop mulch from 'creeping' on to surround lawn.*
- *Composted mulch then spread around below tree by hand – no need to lift or remove underlying grass.*
- *Mulch topped up annually/ as required.*
- *Positive benefits for mulched trees*

5.7.2 We encourage the use of composted bark mulch below tree canopies where possible to aid water retention and increase soil microbial activity. This is particularly relevant to mature retained trees.

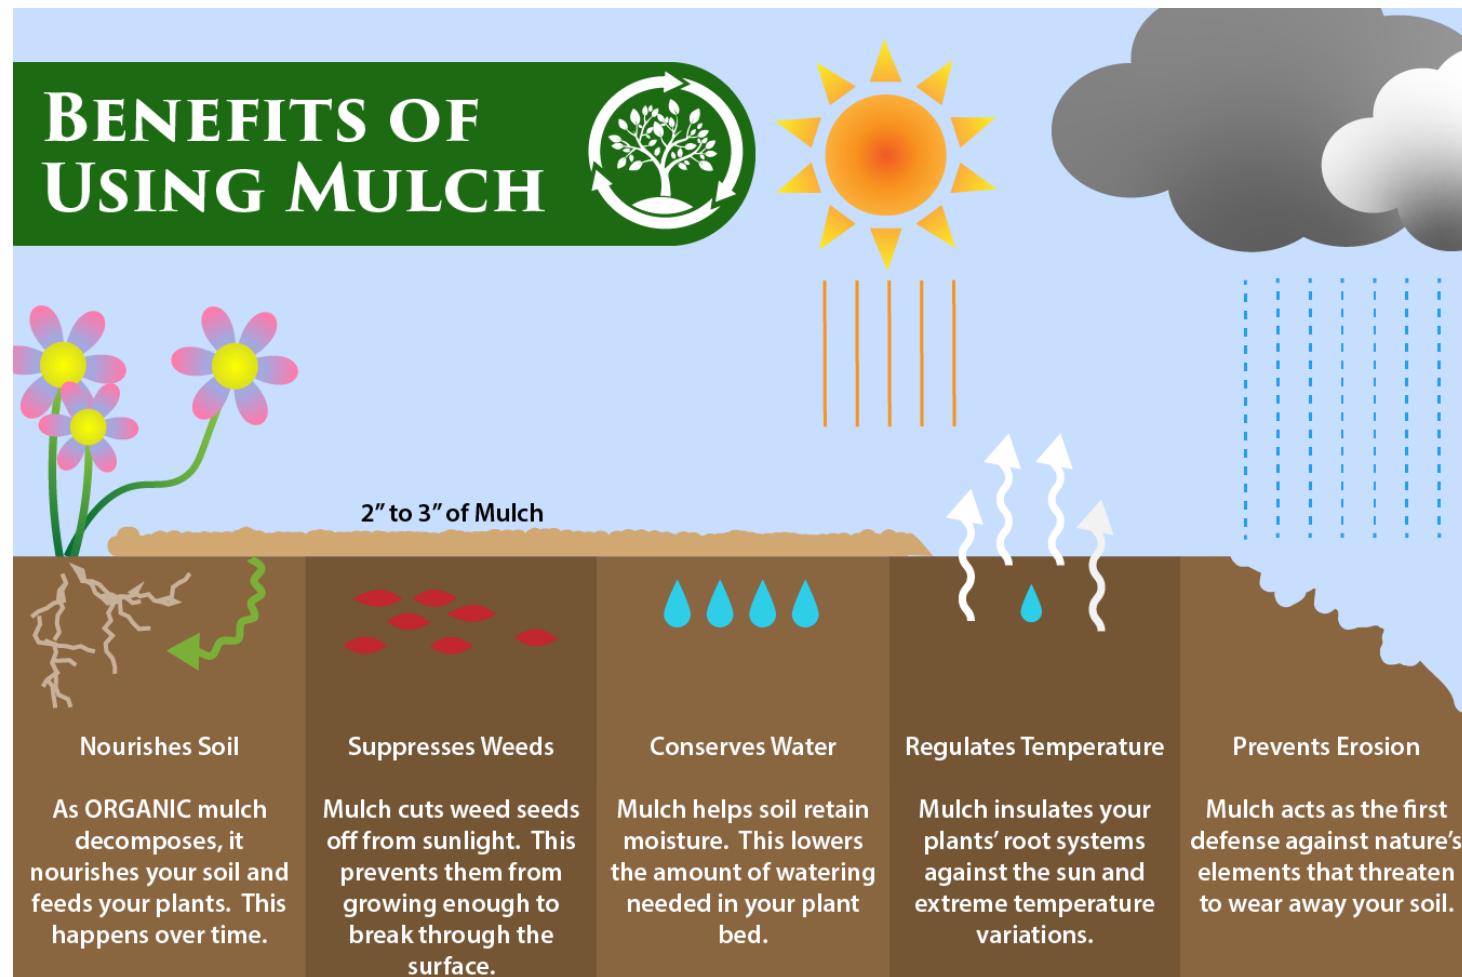
Fig 17 – Benefits of Mulch (Image Source 1<sup>st</sup> Stop Landscape Supply (US)

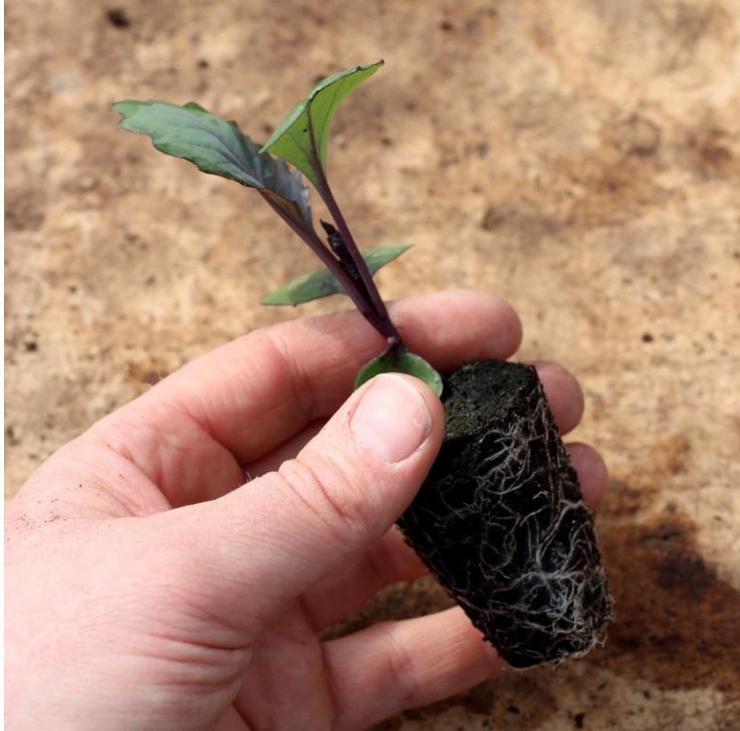
<h2>Plug and Pot Planting</h2>

<p><b>Overview</b></p> <ul style="list-style-type: none"> <li>• <i>Within 1.5m of retained trees planting should be with plug stock (left)</i></li> <li>• <i>Small plant pot sizes &lt;3l utilised for new planting in further areas.</i></li> <li>• <i>Hand dug planting holes.</i></li> <li>• <i>Top dressed in compacted bark mulch/ soil as appropriate.</i></li> <li>• <i>Watered weekly May – September during season 1 &amp; 2.</i></li> </ul>
<p><b>Threat Level to Retained Trees</b></p>	<p><b>LOW</b></p>

5.7.3 Where soft landscape planting occurs within the RPA of retained trees, we advise the use of small pot sizes and plug planting where possible to minimize the risk of root disturbance.

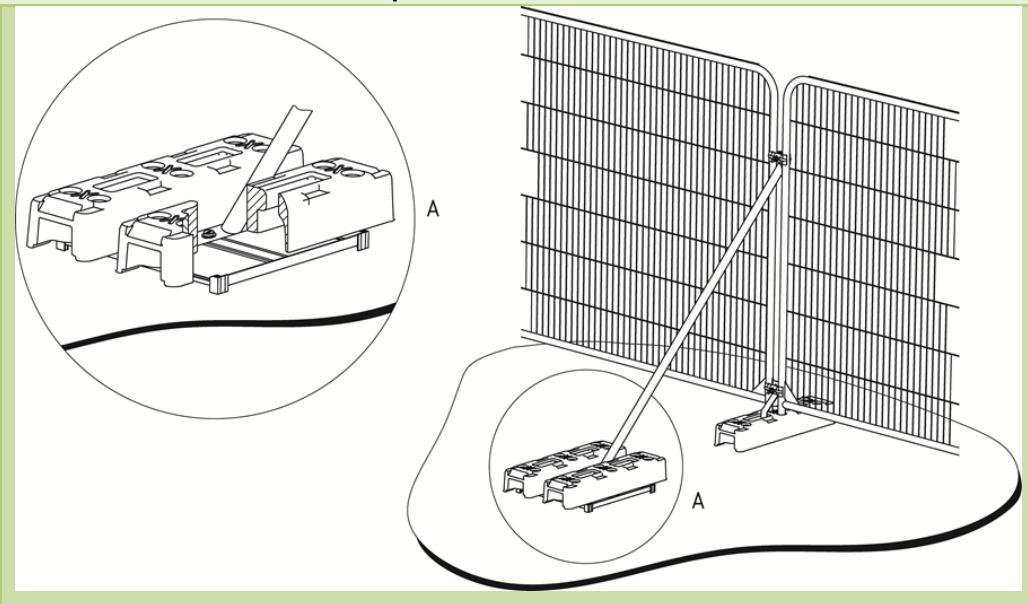
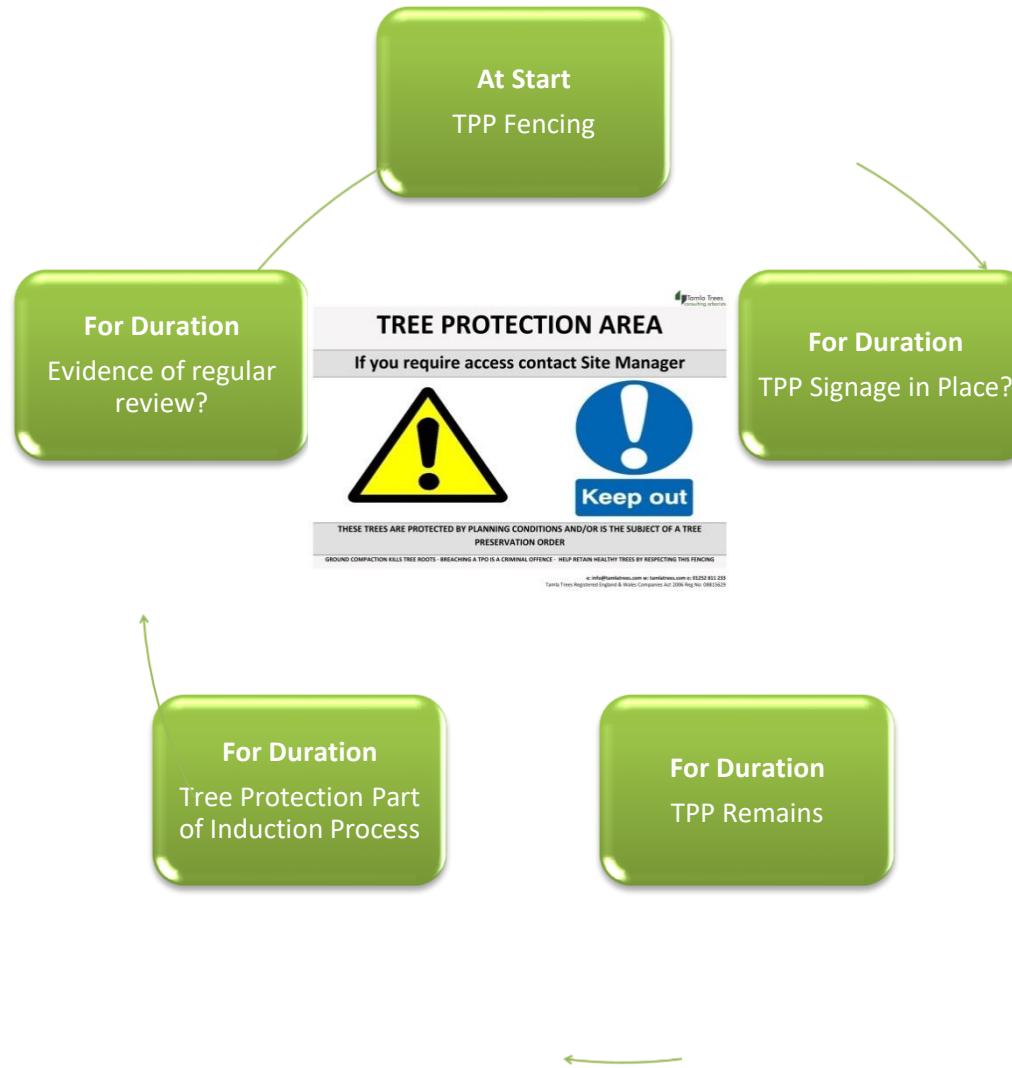
# Appendix 6 - Tree Protection Plan

**Tree protection is essential to successfully integrate the proposal into the surrounding trees. It is designed to manage the impact on the underlying soil and rooting environment. It must therefore be installed prior to any further site activity. Even apparently minimal tracking of the soil near trees has the capacity to irretrievably modify the soil environment to the detriment of tree health and stability.**

- All tree protection must be in place prior to any site activities. It is recommended that this fencing is installed prior to any site works (including demolition).
- To be effective Tree Protection must remain in place for the duration of the development and form part of the site induction process.
- Fencing spec (right) to be installed following pruning but prior to any on site construction activity. To be combined with temporary ground protection (not shown right).

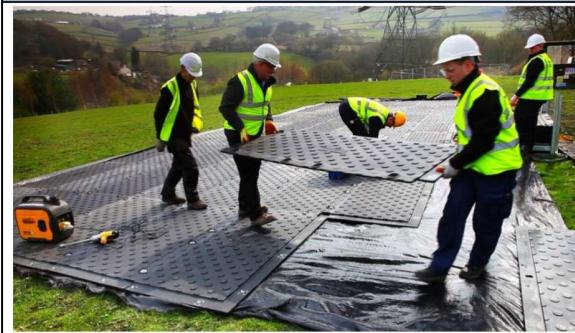
**Temporary Ground Protection Specification**

To be installed prior to any on site activity (demolition or construction)

- Retain existing on site hard standing if present for as long as possible.
- If indicated new temporary ground protection should be installed as part of the tree protection measures prior to work starting on site.
- For exposed unmade ground within Root Protection Area.
- To be laid on non-permeable membrane
- We recommend 3m x 1m x 20mm mats manufactured from recycled HMPE plastic, with carrying handles and an engraved grid pattern with minimum 150mm overlap to join together.

To cover all exposed unmade ground for tree Root Protection Area outside of Tree Protective Fencing

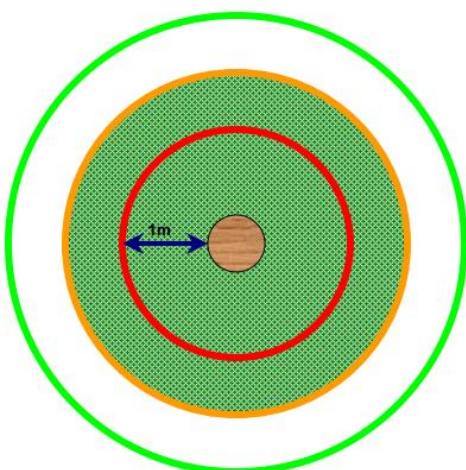
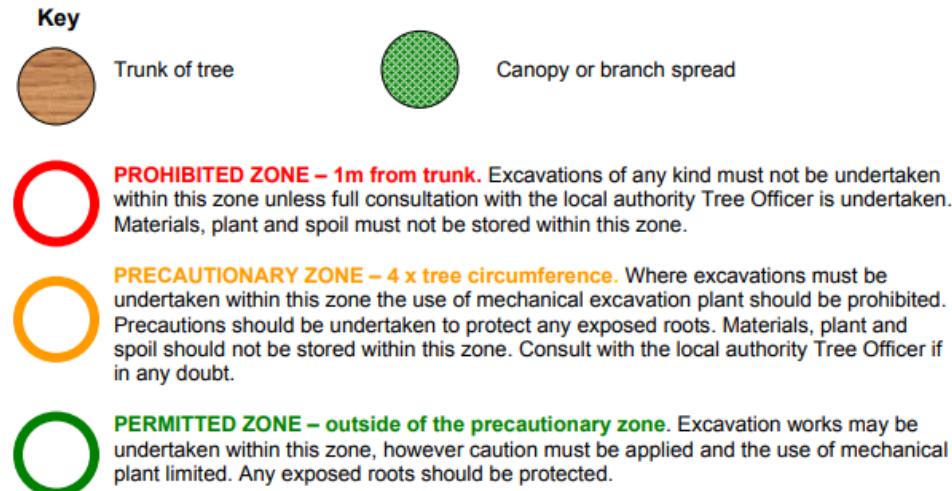
*Extract from National Joint Utilities Group “Guidelines for the planning, installation and maintenance of utility apparatus in proximity to trees. Volume 4, issue 2. London: NJUG 2007”*
