# BS5837 Arboricultural Impact Assessment & Method Statement

**1A Clifford Gardens, Hayes, UB3 1NX**

**Client:** Multi Creation

**Job Reference:** 05005R

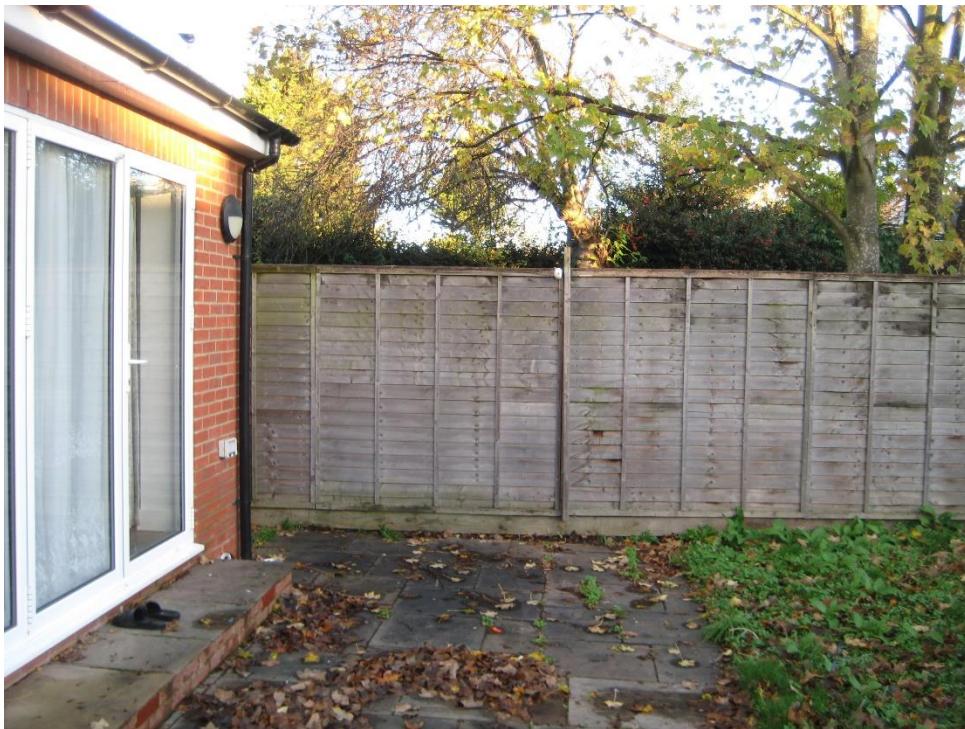
**Image 2 – Existing boundary fencing prevents movement towards the trees.**
