28<sup>th</sup> August 2025

### **Bat Survey at 82-84 High Street, Ruislip**

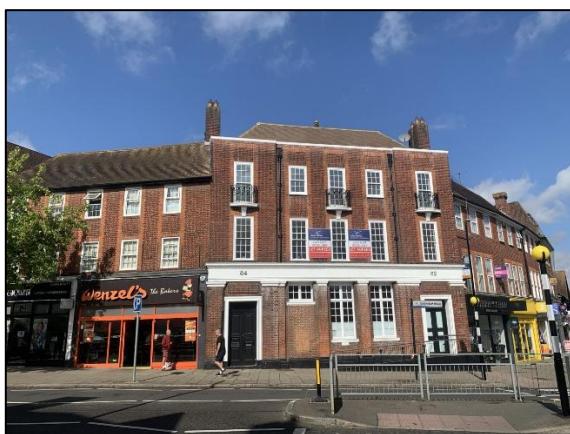
Photo 1 Front elevation

3.3 There are very few suitable features for bats, limited to minor gaps in lead flashing, tiles and stone capping. All features are of very low suitability for bats. The loft void is partially naturally lit (photo 6), with no apparent gaps for bats. No evidence of bats was found.
