Project: 69 The Green, West Drayton, UB7 7PW

Title: Proposed Repair

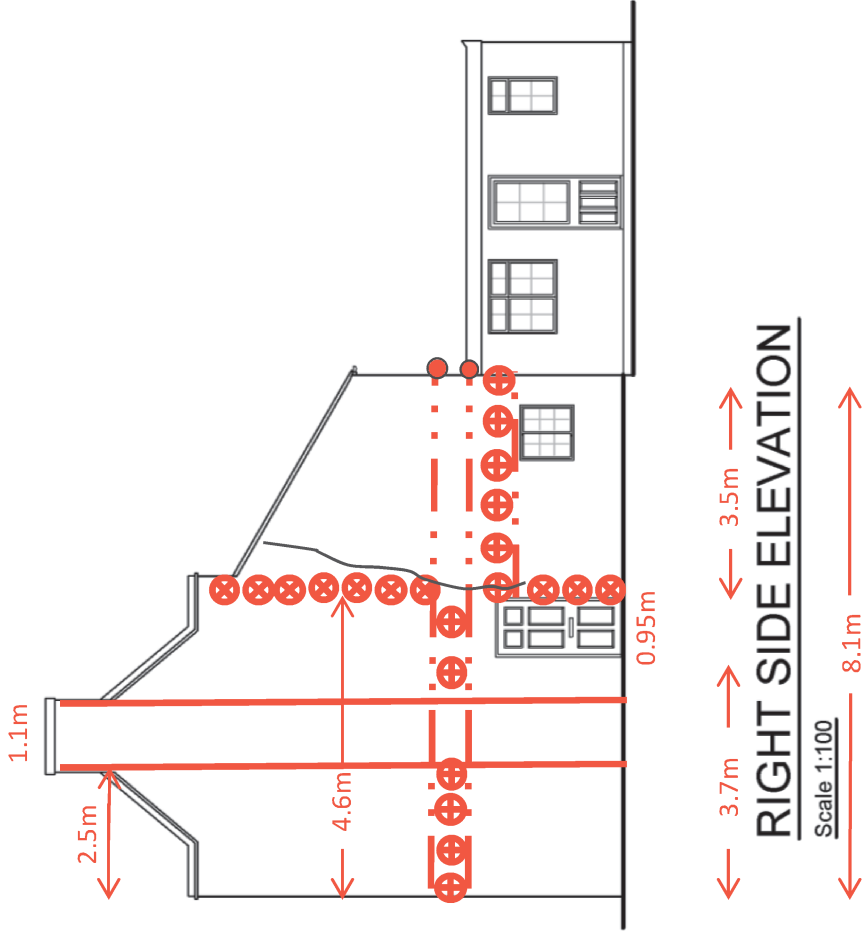
Helibeam at floor levels, wrapped around rear elevation.  
BowTie HD's into floors.  
CemTies into spine walls.  
Localised rebuild and crack stitching of the 50mm crack required.  
Cracked bricks to be repaired / replaced.
