**Arboricultural Method Statement**

**Whitbread Group PLC**

**Premier inn London Uxbridge**  
**Phase 500 Riverside Way**  
**Uxbridge**  
**UB8 2YF**

**02 September 2024**

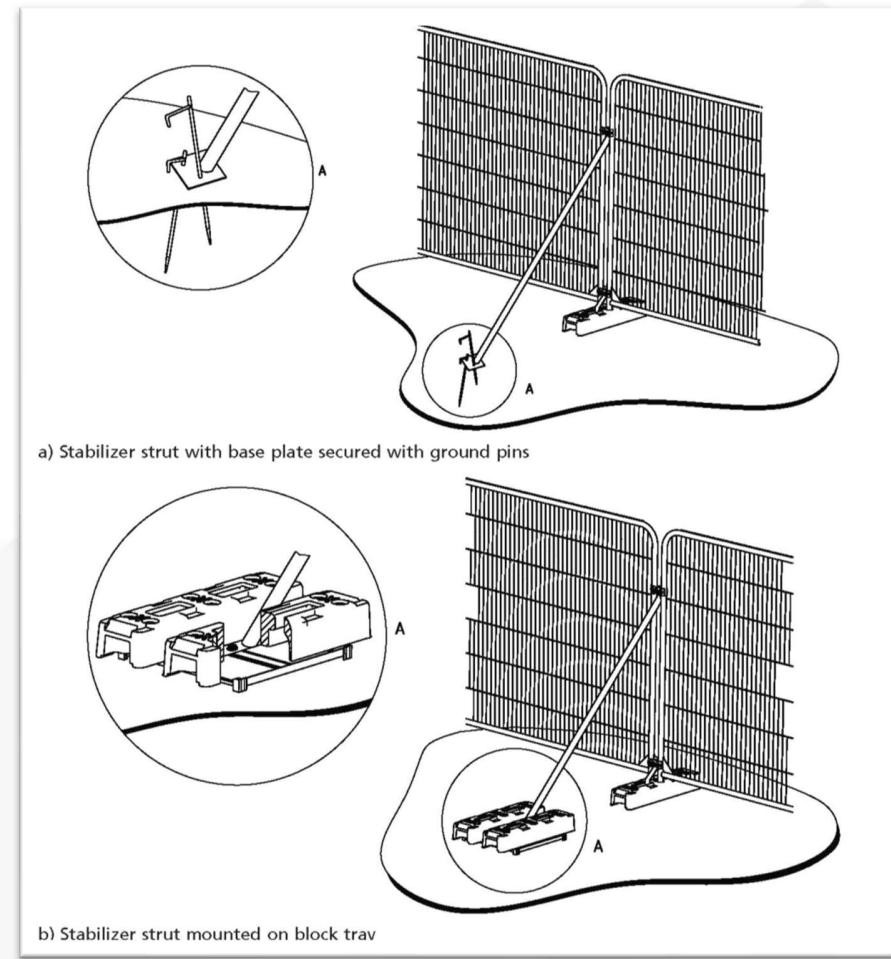
To comprise either 2.4m wooden site hoarding or of 2m tall welded mesh panels on rubber or concrete feet. Panels are to be joined together using a minimum of two anti-tamper couplers, installed so that they can only be removed from inside the fence. The panels will be supported on the inner side by stabiliser struts, which will be attached to a base plate and secured with ground pins.

**Figure 3:** Examples of protective barrier fencing with above-ground stabilising systems (BS5837).

Protective barrier fencing should be appropriate for the intensity and proximity of the development to protect trees where development activity is nearby.

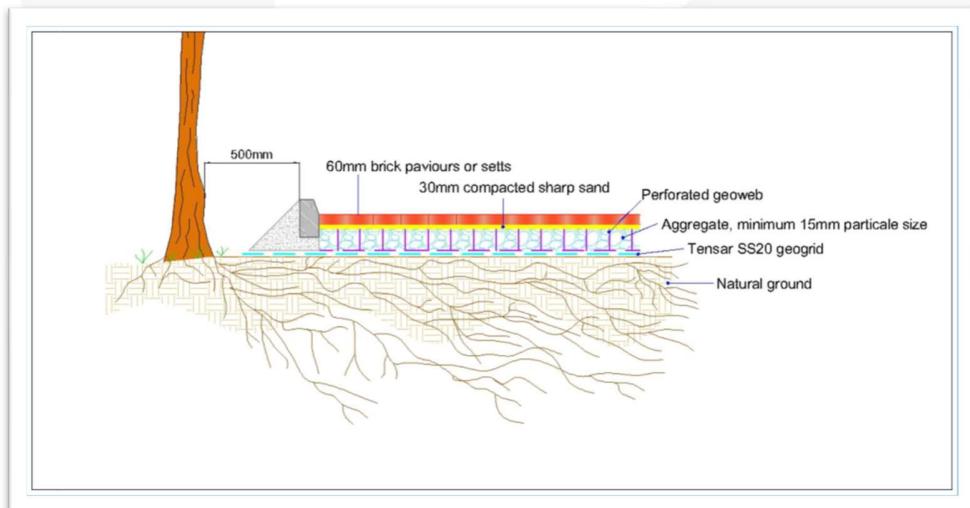
**Figure 4:** Typical cross-section for multi-dimensional confinement system using kerb edging.

The area of 'CellWeb' shall be covered with permeable geotextile fabric and the finished wearing course laid on top. The wearing course shall be permeable to both water and air to comply with 'SUDS' regulations.

Edge supports of an appropriate size and strength will be set above ground level and will be secured with either haunching or steel pins driven into the ground. The outer edge of the supports may be banked up with clean topsoil.

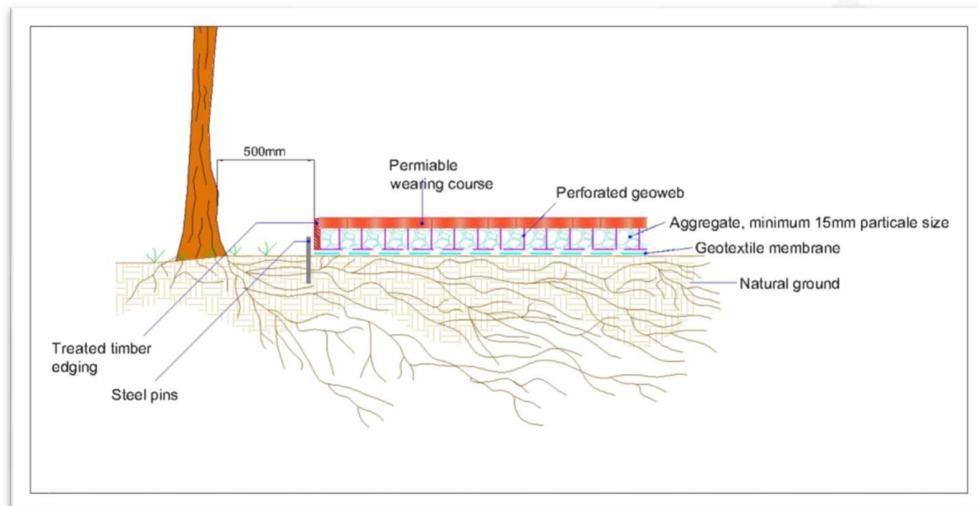
**Figure 5:** Typical cross-section for multi-dimensional confinement system using timber edging.
