Preliminary Ecological Appraisal and Roost Assessment

Premier inn London Uxbridge, Phase, 500 Riverside Way, Uxbridge UB8 2YF

Whitbread Group PLC

The partial demolition and extension of the building.

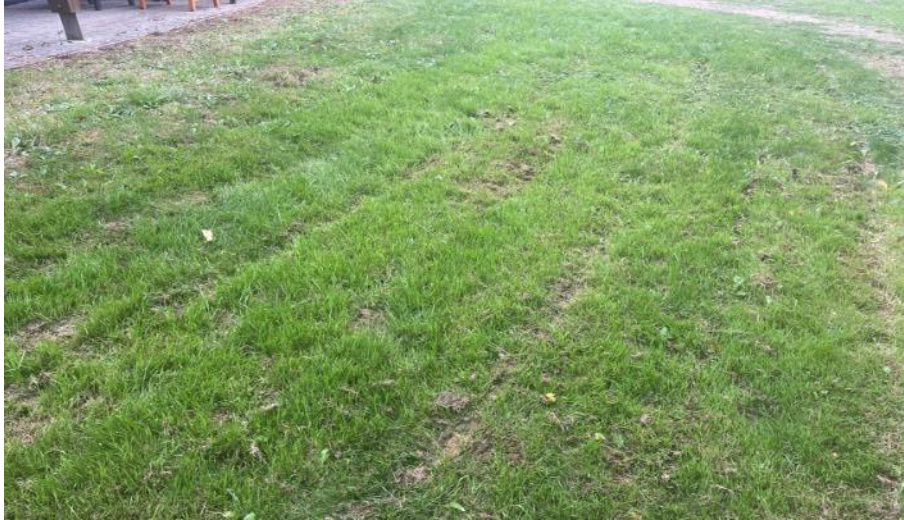
<p>unsealed surface (u1c)</p>	<p>There is one building onsite (B1). B1 is a part three-storey, part single-storey brick-built building with a flat roof clad in lead flashing. The building is in very good condition, with no roosting features in which bats could roost.</p> <p><u>Modified grassland with scattered trees and introduced shrubs (g4 32 847)</u></p> <p>Mainly to the east of the site, are small areas of modified grassland which are subject to intensive management through mowing, resulting in a sward of approximately 2cm in length. Species composition is comprised of perennial ryegrass (D), daisy (A), creeping cinquefoil (F), creeping buttercup (F), dandelion (O), self-heal (O), black meddick (O), plantain (O), hawkbit (R), large-leaved avens (R) and ragwort (R).</p> <p>Modified grassland condition assessment:</p> <ul style="list-style-type: none"> a) There is less than 6-8 vascular plant species per m² present. b) Sward height is not varied. c) No scattered scrub present d) Physical damage is evident in less than 5% of total grassland area. e) Cover of bare ground is between 1% and 10%, including localised areas. f) Cover of bracken <i>Pteridium aquilinum</i> is less than 20%. g) There is an absence of invasive non-native plant species (as listed on Schedule 9 of WCA). <p>Located within the grassland and around B1, are areas of introduced shrubs. These are comprised of Portuguese laurel, evergreen spindle, broadleaved mock orange, rose and Japanese mahonia. These areas have low ecological value.</p> <p>Present onsite are scattered trees throughout the site, which are comprised of pine, tulip poplar, hornbeam, birch and linden. The trees are approximately 3m-6m tall, with a DBH of approximately 5-15cm. The trees are young to semi-mature in age and represent a fair to good structural condition.</p>

<p>Roosting habitat</p> <p>There is one building onsite (B1). B1 is a part three-storey, part single-storey brick-built building with a flat roof clad in lead flashing. The flat roofs are in very good condition with no gaps in which bats could roost. The doors and windows are UPVC and appear in excellent condition with no suitable bat roosting sites. The brickwork around the building appears in excellent condition with no gaps or cracks within which crevice-dwelling bats could roost. Additionally, there is metal cladding on the walls, between the brickwork, which is in very good condition with no raised sections under which bats could roost. There are metal parapet walls around the building which are in good condition. There is no loft space within B1 as the building has a flat roof. Additionally, there are 12 small trees which will be removed as part of the proposed plans. However, these trees are young to semi-mature in age and represent a fair to good structural condition with no roosting features in which bats could utilise.</p>

Buildings	
Photograph	Description
 	<p>Figure 1 and figure 2: Main building (B1) on site.</p>
Modified grassland	Description

<i>Recommendations</i>	<p>Roosting habitat [Buildings and trees]</p> <p>B1 and the trees proposed to be removed have negligible habitat value for roosting bats. In the unlikely event that a bat or evidence of bats is discovered during the development all work must stop and a bat licensed ecologist contacted for further advice.</p> <p>Foraging and commuting habitat</p> <p>No further surveys are required.</p> <p>Artificial lighting</p> <p>A low impact lighting strategy will be adopted for the site during post-development which outlines the areas of the site that will be retained as dark corridors. Parameters can be found on the Bat Conservation Trust website: https://www.bats.org.uk/our-work/buildings-planning-and-development/lighting-2</p> <p>Suggested biodiversity enhancements</p>

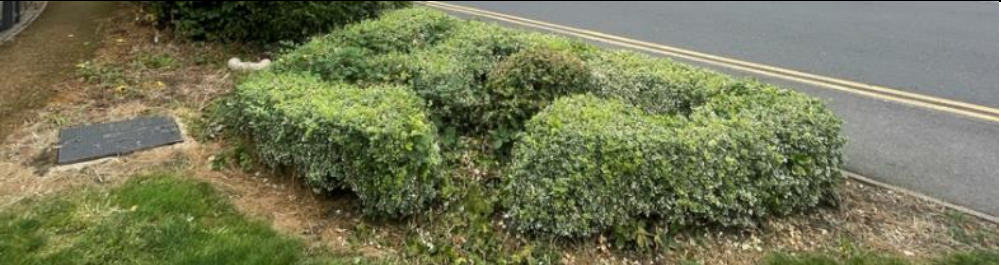
<p>Figure 3: modified grassland on site (to east of B1)</p>
<p>Introduced shrubs</p>		
<p>Photograph</p>	<p>Description</p>

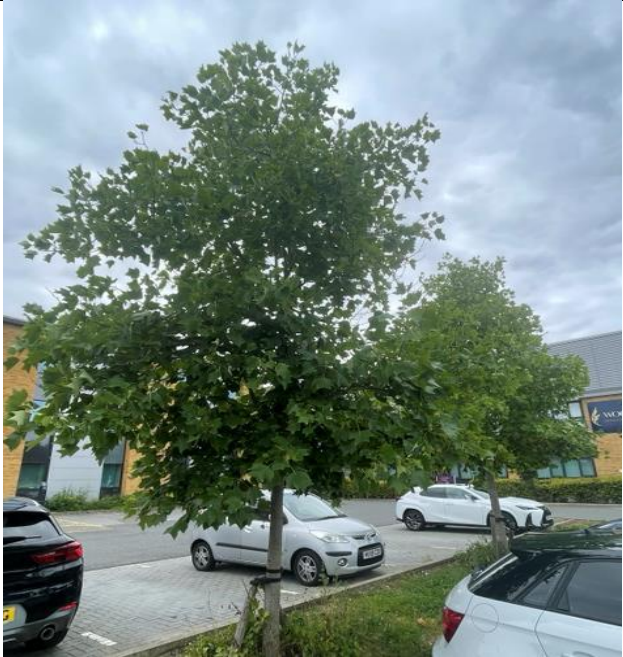
<p>Figure 4: Introduced shrubs on site (along northern side of site)</p>
<p>Scattered trees</p>		
<p>Photograph</p>	<p>Description</p>

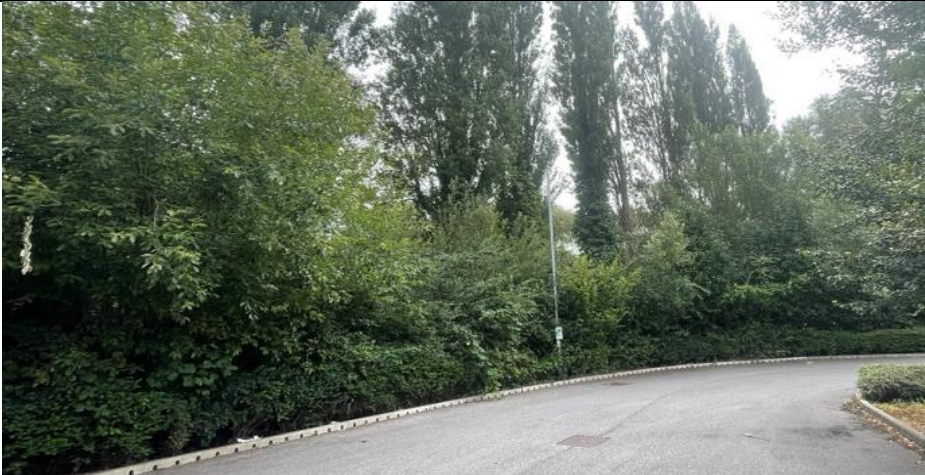
<p>Figure 5: Scattered trees present on site</p>
<p>Tree line</p>			
<p>Photograph</p>		<p>Description</p>

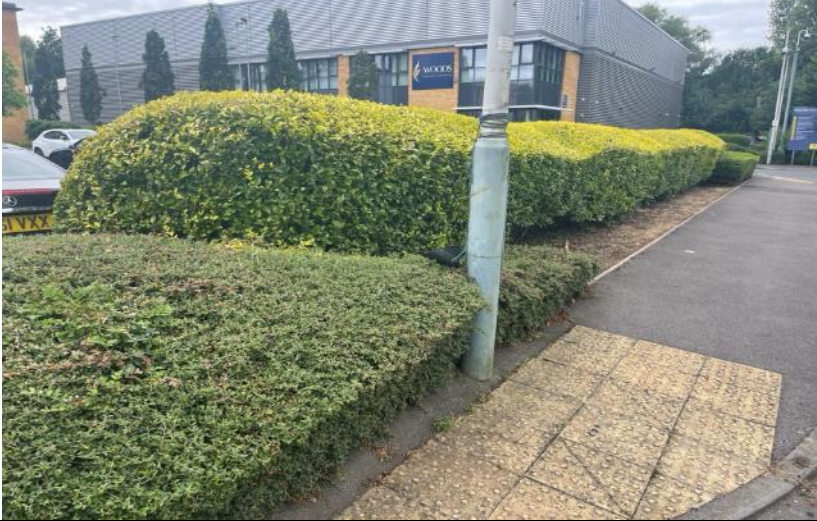
<p>Figure 6: Along the eastern and southern boundaries of the site is a line of trees. The treeline is comprised of maple, willow, holly, hawthorn, grey willow, whitebeam and hazel.</p>
<p>Non-native hedgerow</p>
