HORTON ROAD – INDUSTRIAL
DEVELOPMENT
LE MASURIER LTD

DRAINAGE STRATEGY

23rd May 2025

5027861-RDG-XX-XX-T-C-000550

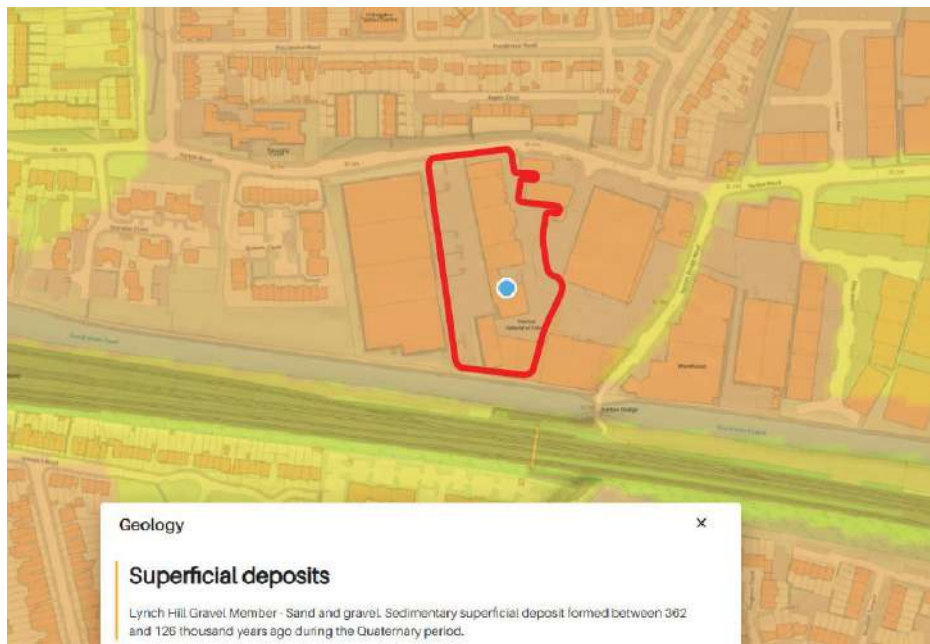
British Geological Survey (BGS) online mapping for the area shows that the site is likely underlain by bedrock of London Clay Formation below superficial geology deposits of formation Lynch Hill Gravel Member. The BGS bedrock and superficial geology records for the surrounding area of the site are shown in *Figure 3* and *Figure 4*.

Figure 3 - Superficial Deposits at the site (British Geological Survey, 2025)

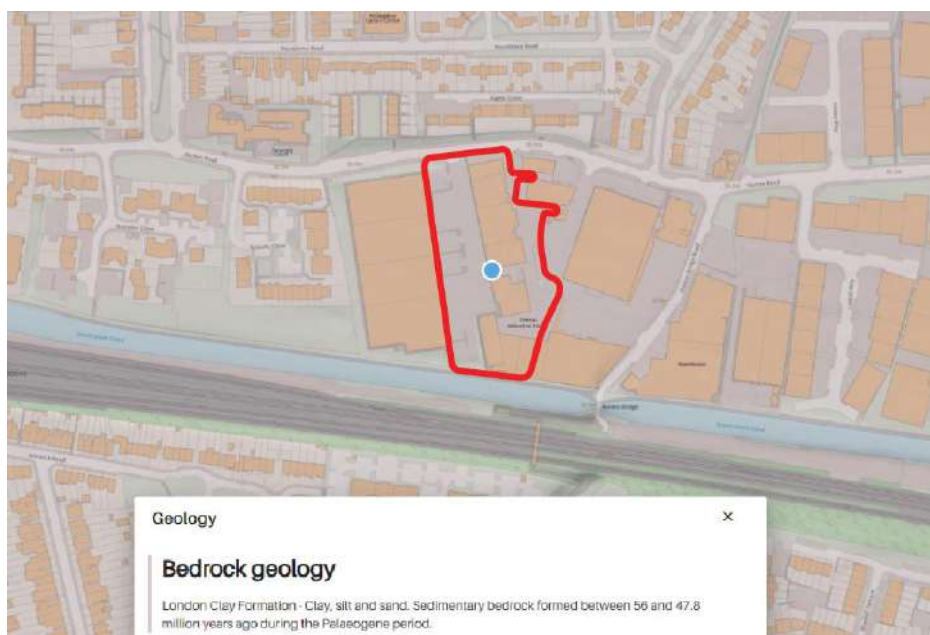
Figure 4 - Bedrock Deposits at the site (British Geological Survey, 2025)

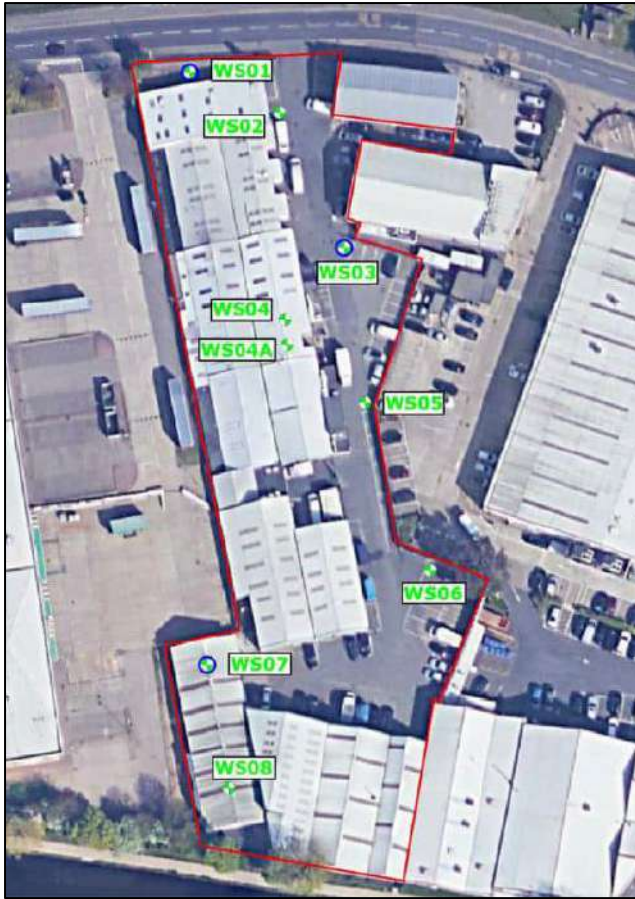
An intrusive ground investigation was undertaken by Ridge and Partners LLP on site between 25th and 27th February 2025. This consisted of 8 windowless sample boreholes WS01 – WS08 (up to a maximum depth of 5.0mbgl). The borehole locations are shown in the below extract (*Figure 5*) from the Exploratory Hole Location Plan within the ground condition assessment found in Appendix F – Ground Condition Assessment.

Figure 5 - Windowless Borehole Location Plan (Ground Condition Assessment, Ridge 2025)

Infiltration testing was completed on the site in accordance with BRE Digest 365. Falling head testing was conducted at locations WS01, WS03 and WS07 (as shown in [Figure 5](#)) targeting the underlying natural soils to provide indicative infiltration rates. The calculated infiltration rates are shown in [Table 4](#) below.

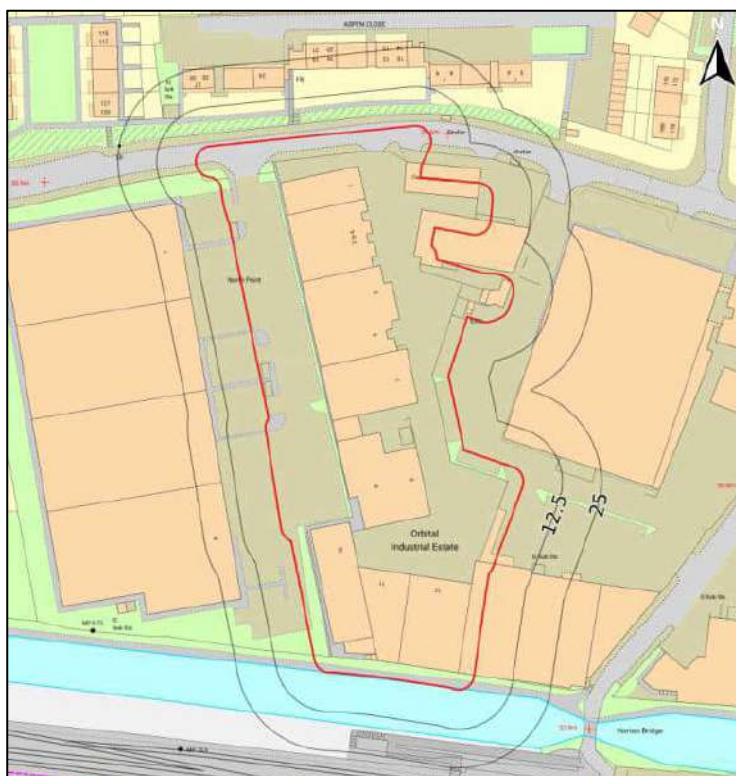
Image 1: Investigation Area

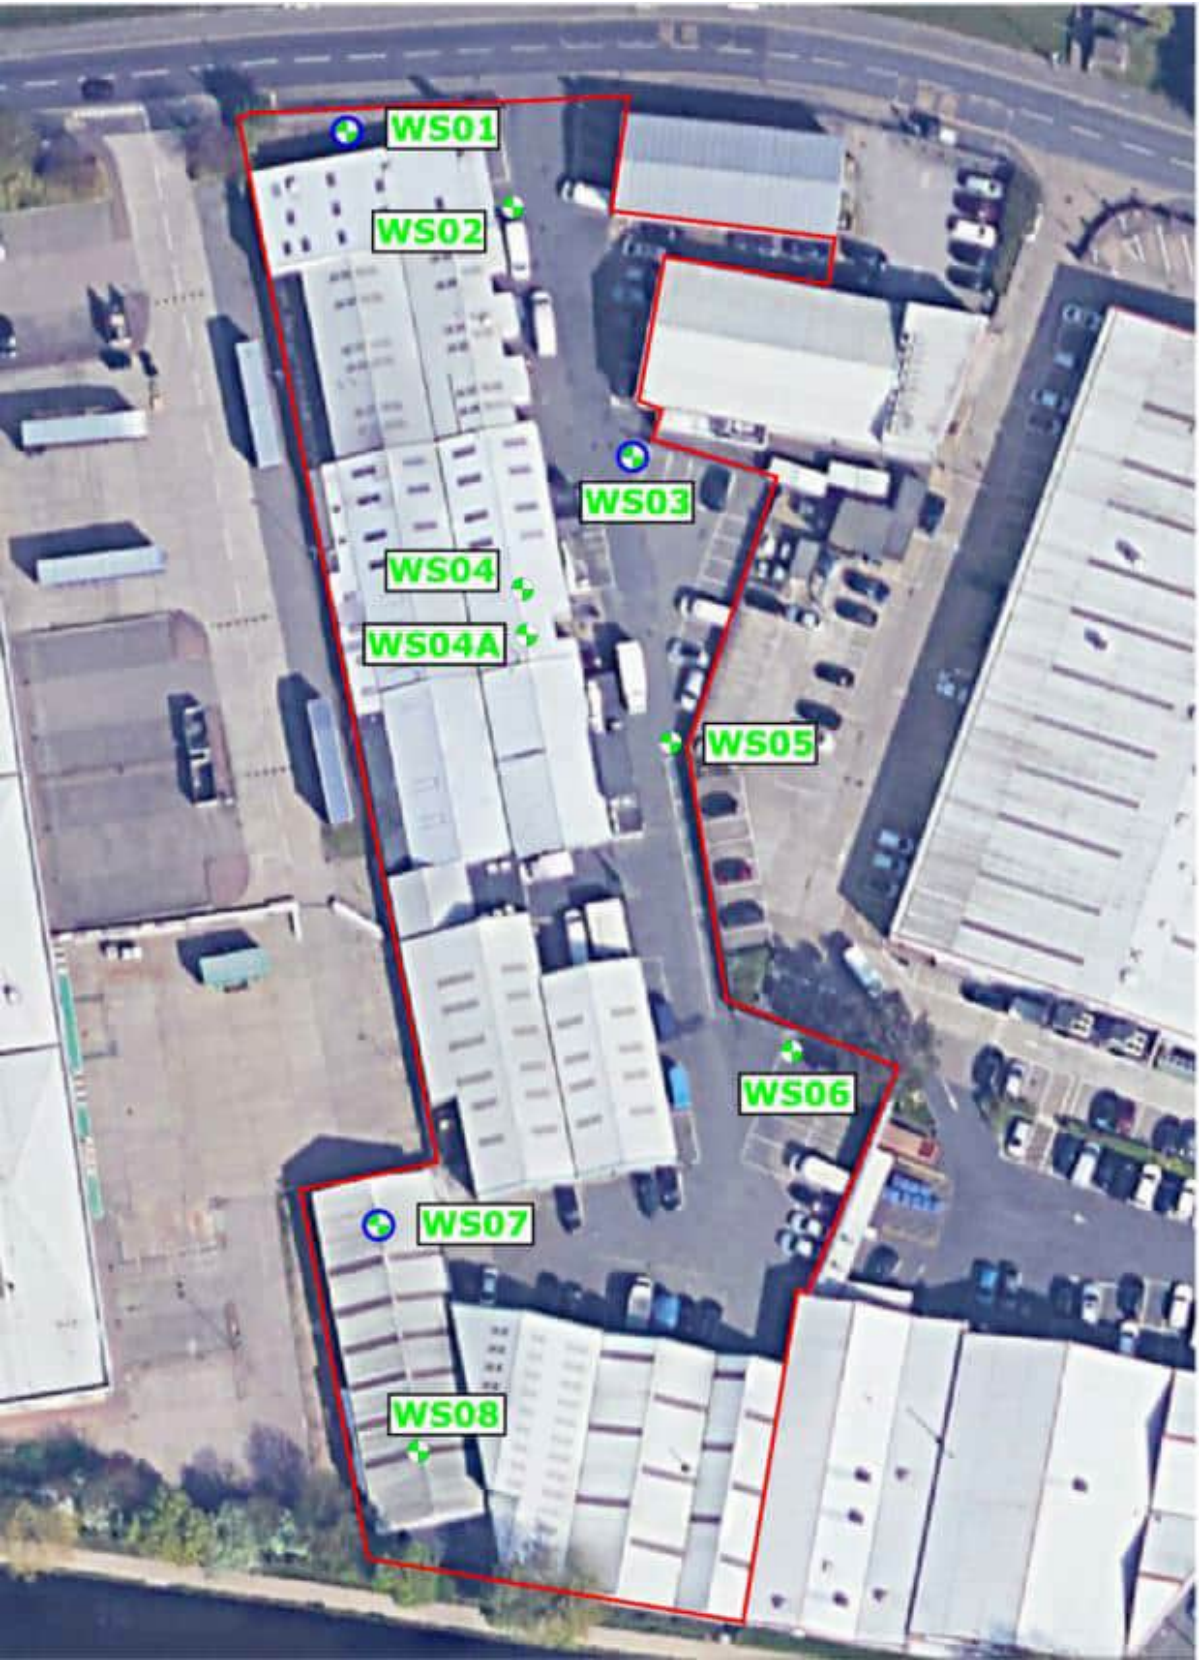
FIGURE 3 - TEST LOCATION PLAN

Project		Horton Road, West Drayton		Title	Exploratory Hole Location Plan
Job Number	5027861	Client	Le Masurier	<div><div>RIDGE</div><div>PROPERTY & CONSTRUCTION CONSULTANTS</div><div>1 Royal Court Kings Worthy Winchester SO23 7TW</div></div> <div>Ridge and Partners LLP www.ridge.co.uk</div> <div>TEL: 01962 834400</div>	
Drawing	5027861-Fig3	Revision	-		
Drawn	TL	Date	March 2025		
Checked by	ME	Scale	NTS

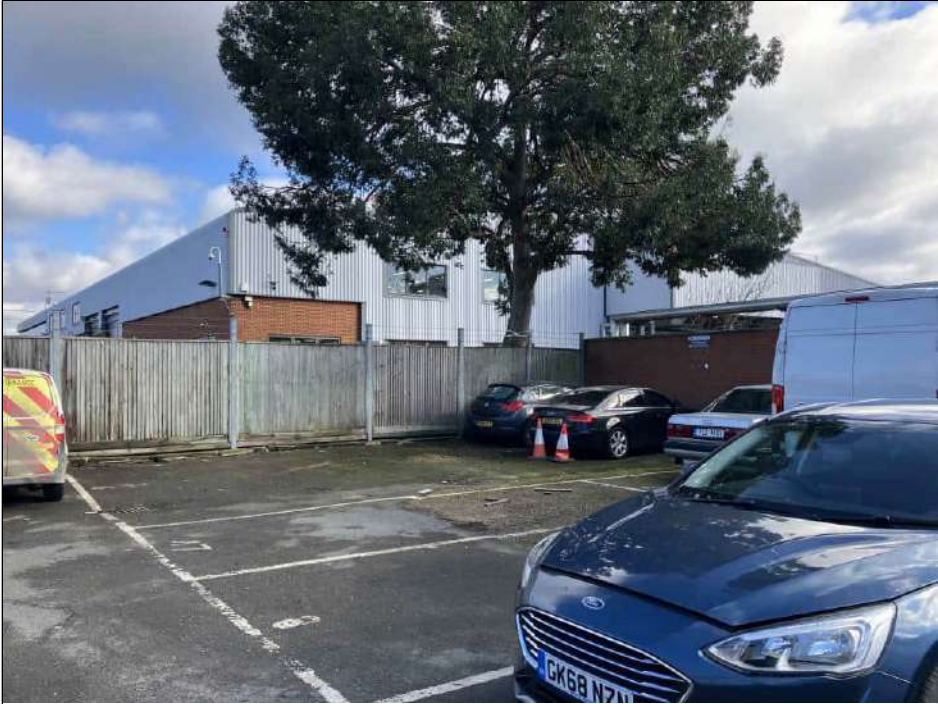
Photo No.	Date	
04	25/02/25	
Photo Title View of the eastern section in the south of the site, where WS06 was located.

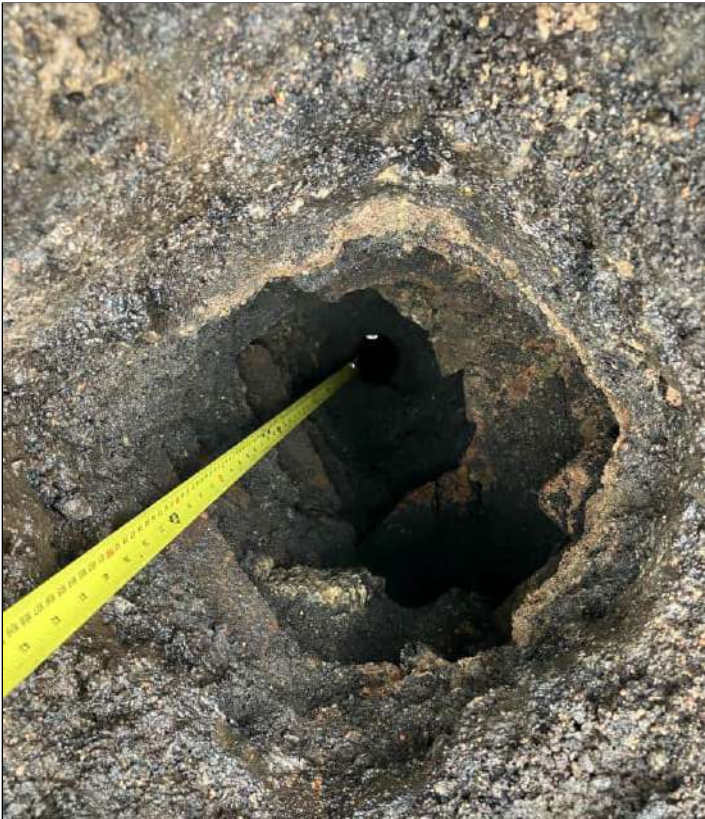
Photo No.	Date
07	25/02/25
In-situ view of shallow Made Ground, including brick fill.

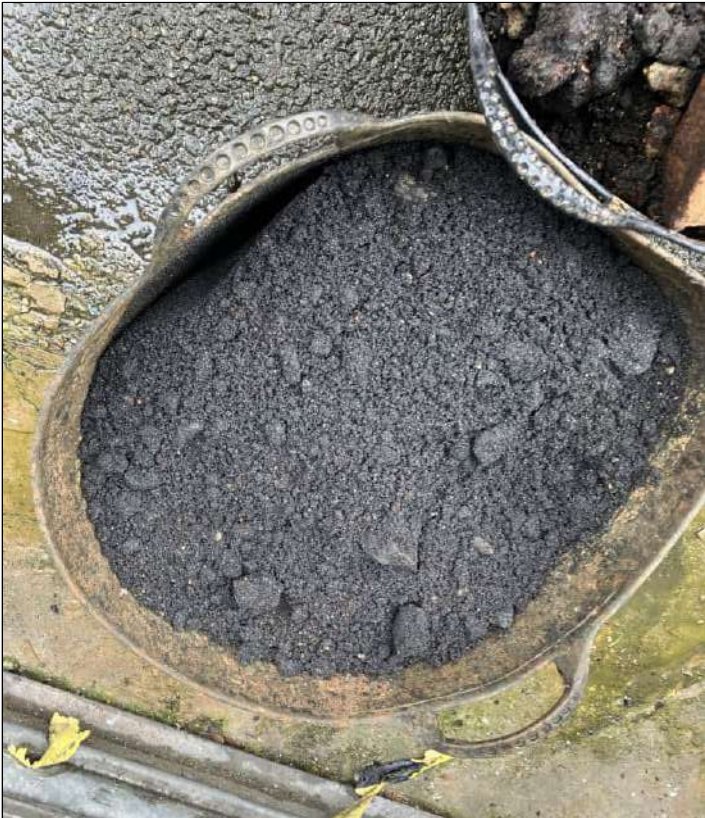
Photo No.	Date
08	25/02/25
Typical ash and clinker fill encountered across site.

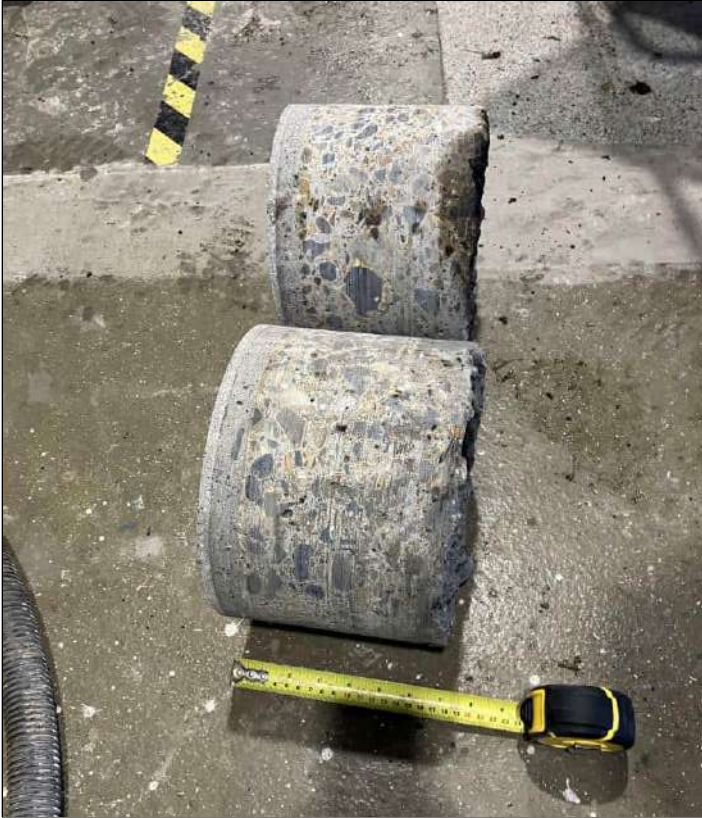
Photo No.	Date	
10	25/02/25	
Concrete cores from Unit 6.
