Chase New Homes Limited

**The Barn Hotel, West End
Road, Ruislip, HA4 6JB**
*Desk Study, Geotechnical and
Geoenvironmental Interpretative
Report*

January, 2023

Reference	CG/39435	Revision	Draft	Issue Date	January 2023
			0	Issue Date	February 2023

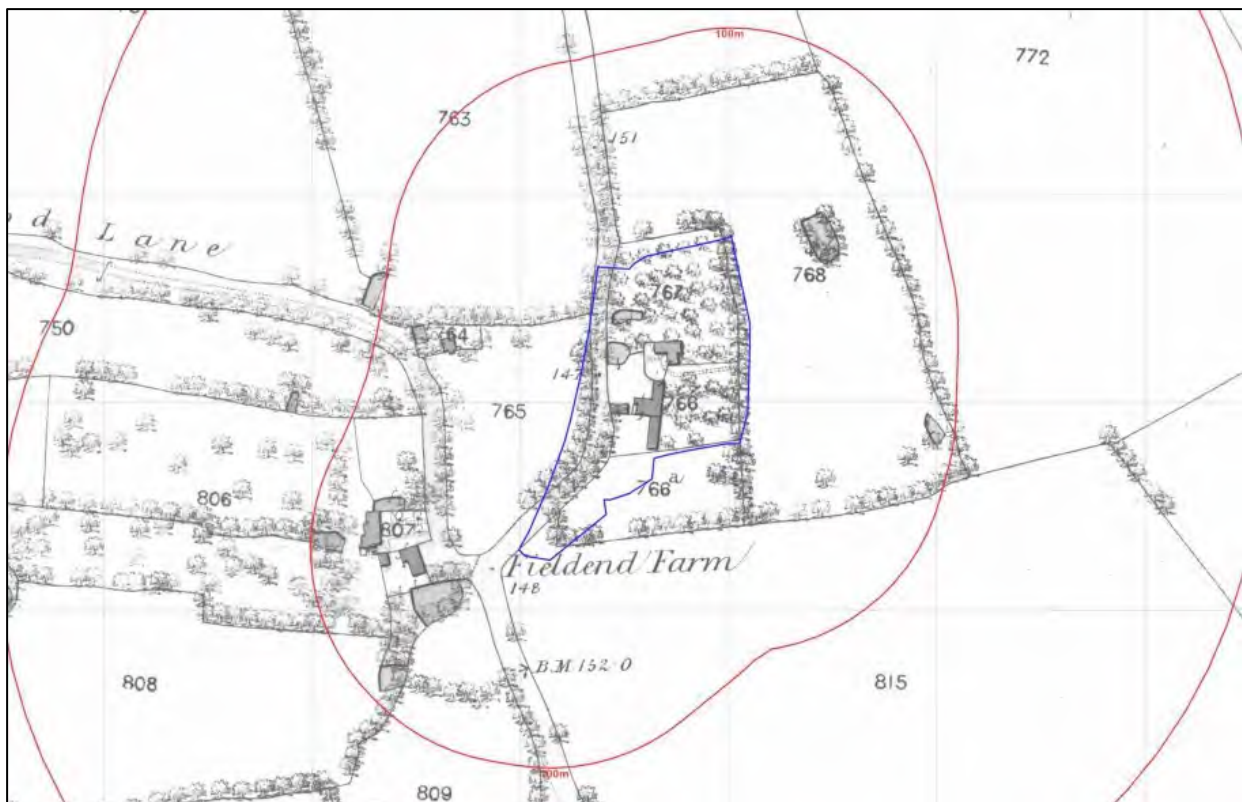
Plate 5: An excerpt from a 1:2,500 map from 1864-1865

With reference to the earliest Ordnance Survey map dated 1864-1865, the site was occupied by a farm which comprised of two farm buildings (corresponding to the existing listed buildings) towards the middle of the site and two ponds in the northwest corner of the site. Off-site were a number of ponds, including those 100m west of the site and 90m east of the site, as well as *Fieldend Farm* 75m southwest of the site. The site as it appeared in 1864-1865 is shown in an extract of an historical map in Plate 5.

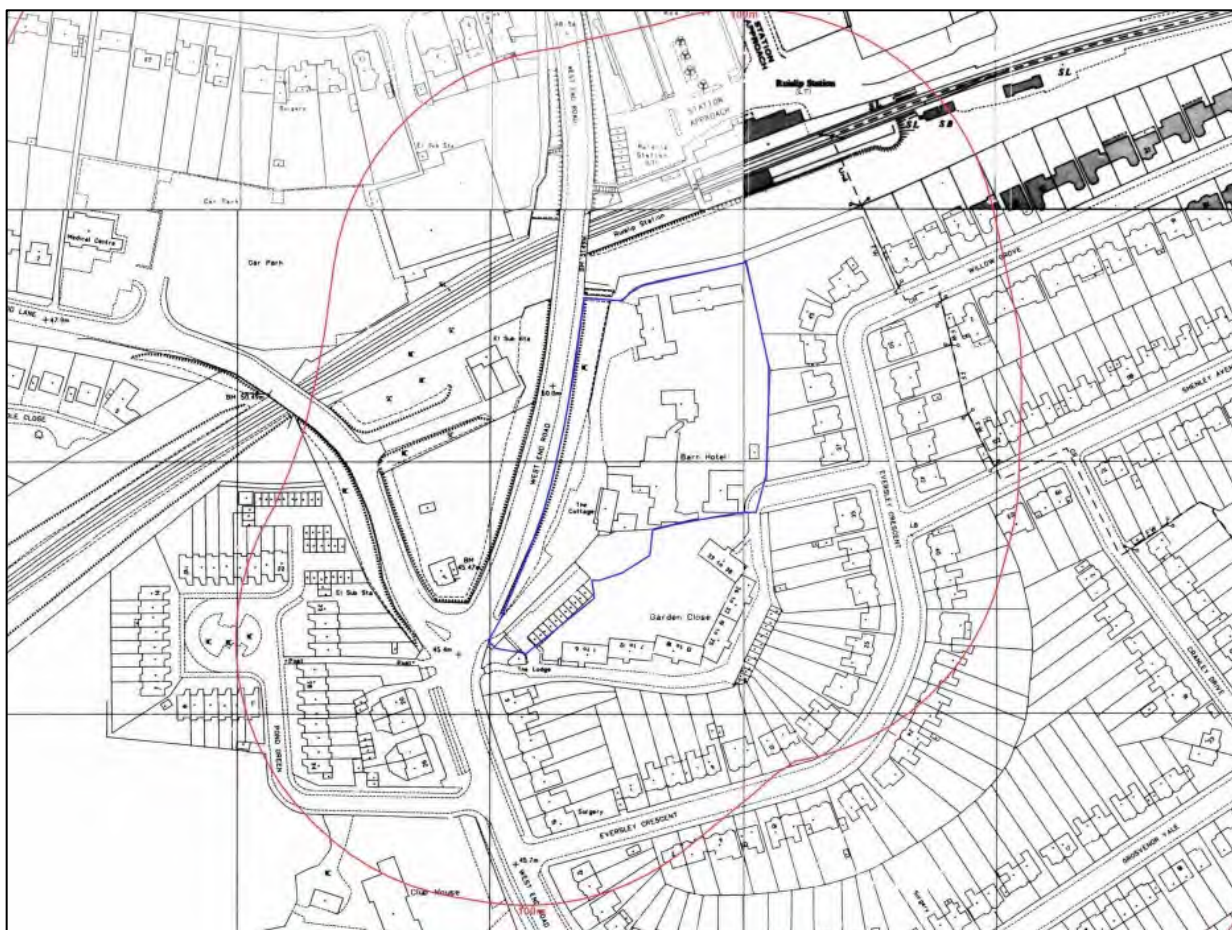
Plate 9: Excerpt from a 1:1,250 map from 1988-1992

Fieldend Farm was also developed further from c. 1972-1974 in the form of the Pond Green housing development. These developments are shown in an extract of a 1988-1992 historical map in Plate 9.

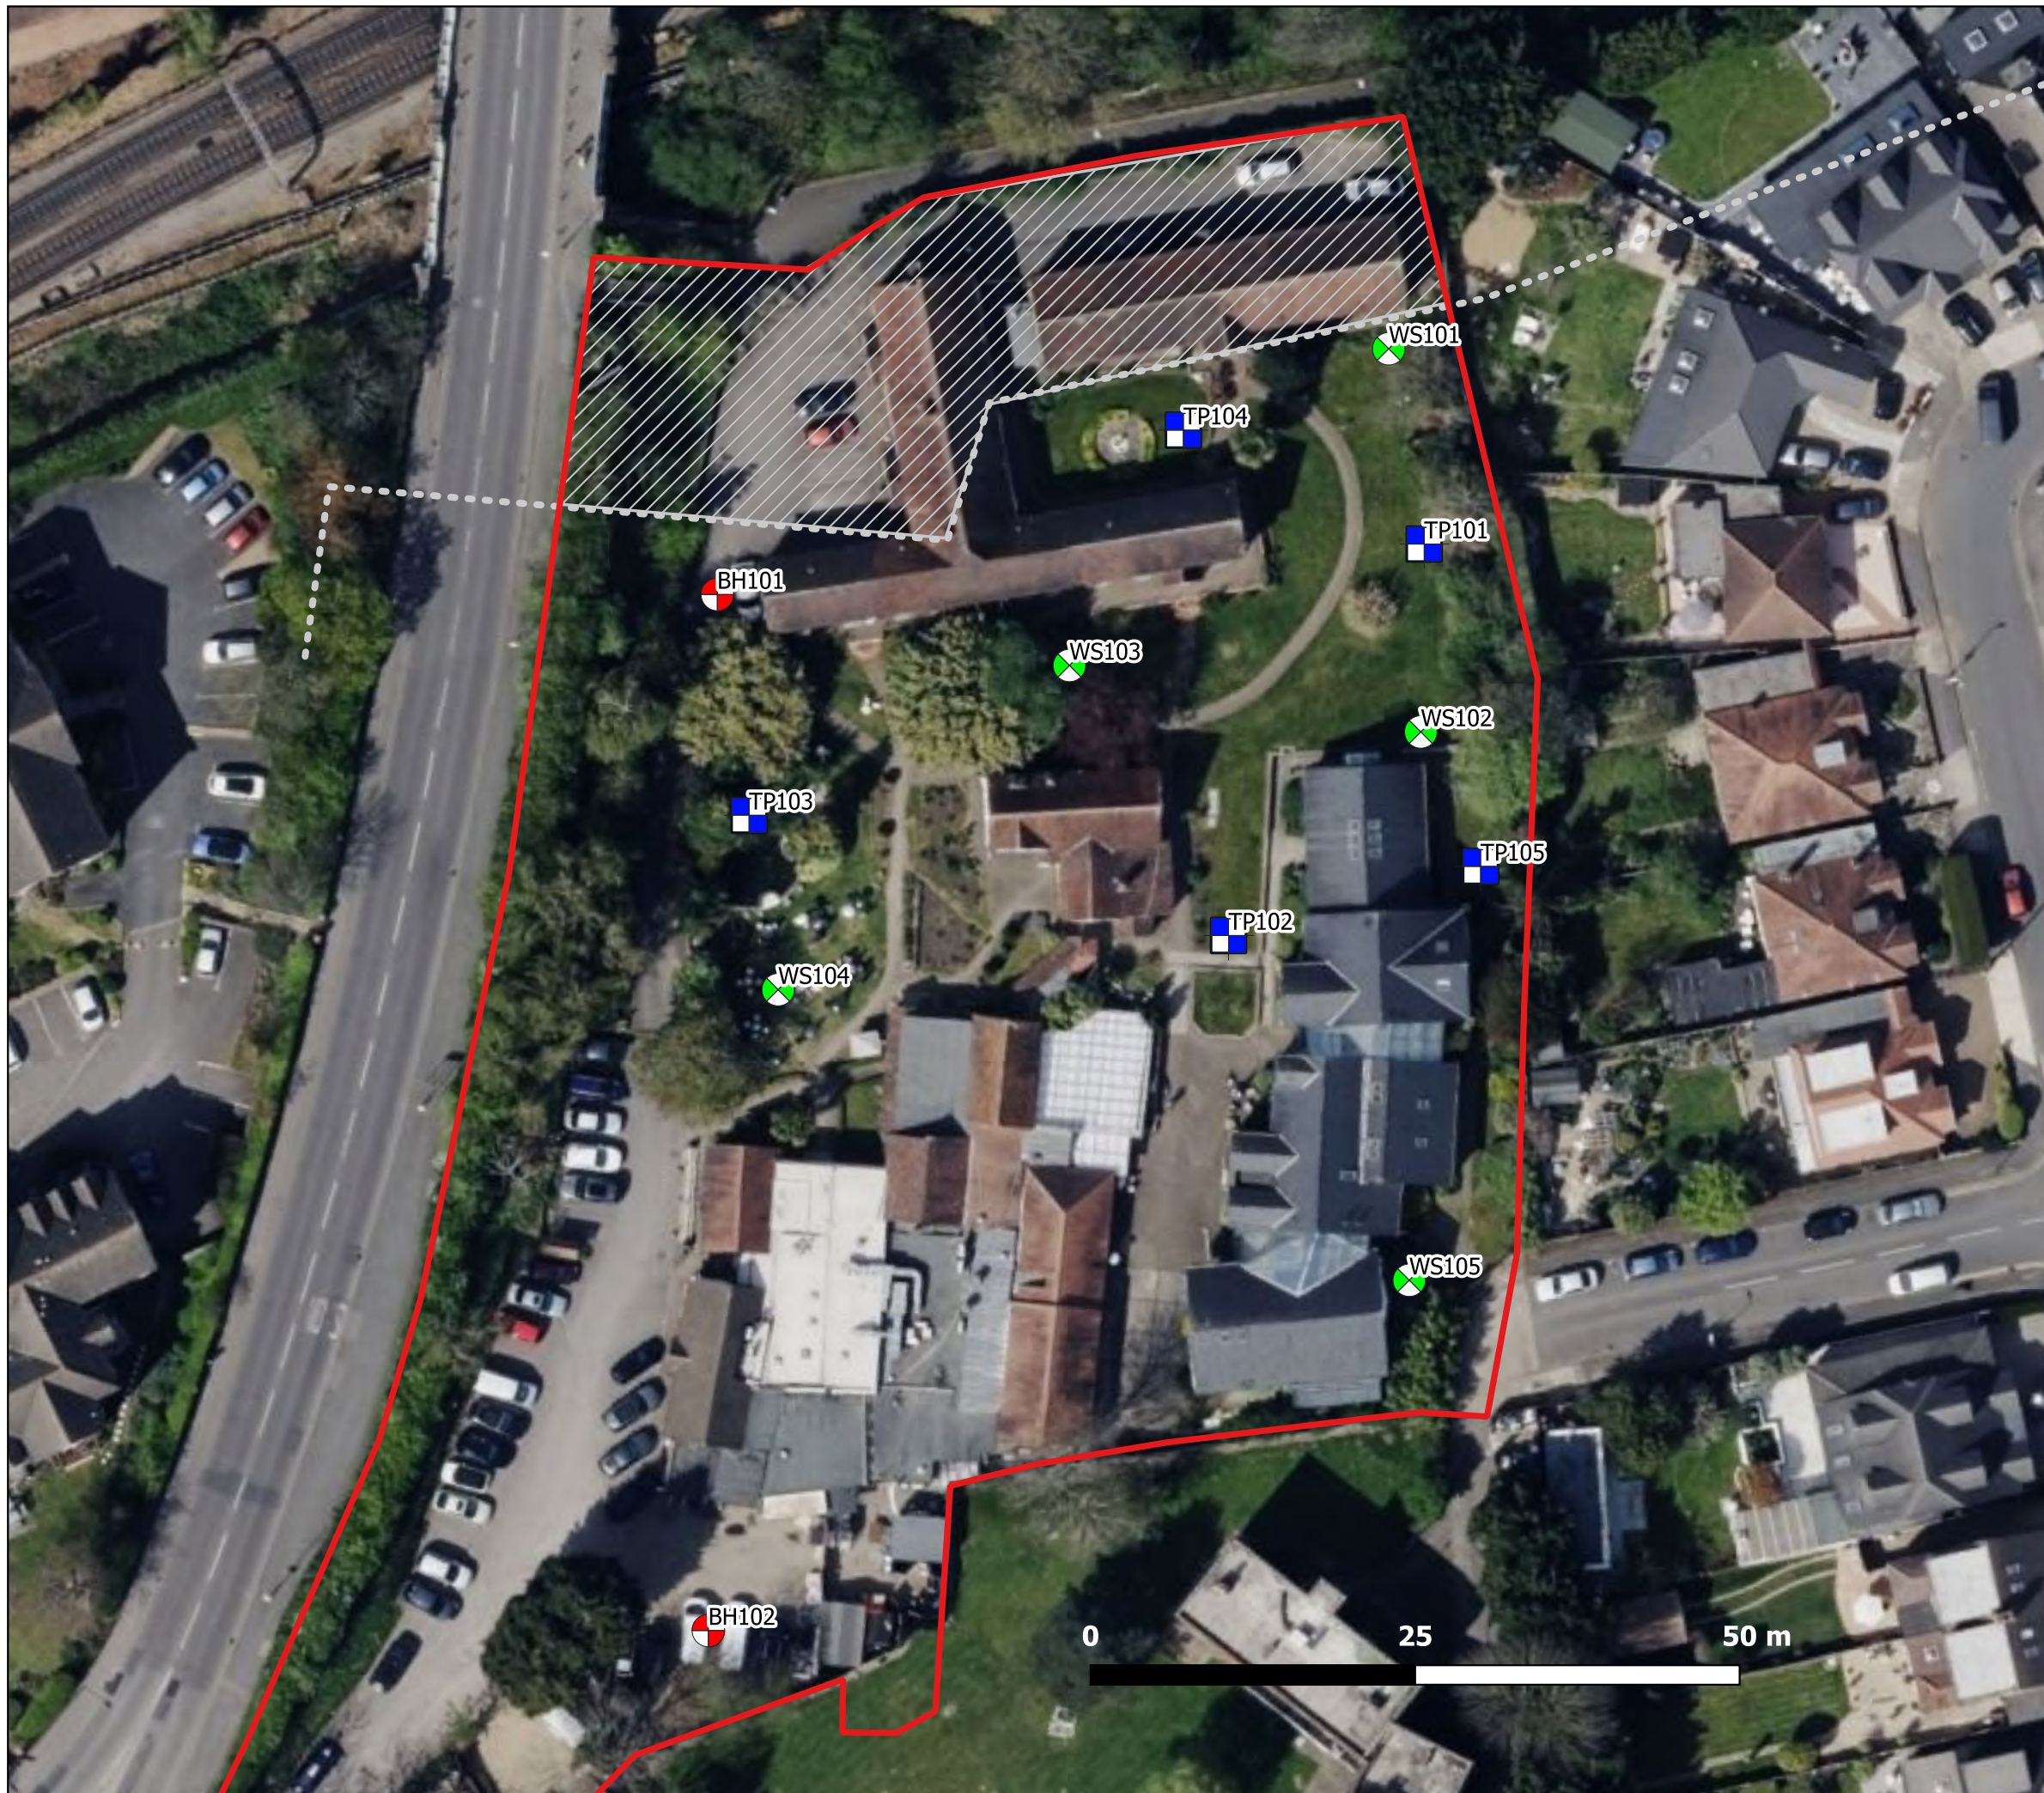
Rev	Date	Comments
 		Card Geotechnics Ltd 4 Godalming Business Centre Wolsack way Godalming Surrey GU7 1XW T: 01483310600
Project	The Barn Hotel, West End Road, Ruislip HA4 6JB	
Client	Chase New Homes Limited	
Drawing title	Proposed Exploratory Hole Location Plan	
Scale(s)	Job no. CG/39435	
Drawn	DTM 09/11/2022	Dwg No. SR-01
Checked	draft	Rev. 0
Approved	draft	
© This drawing is the copyright of Card Geotechnocs limited. It may not be reproduced or amended without the written approval of Card Geotechnic

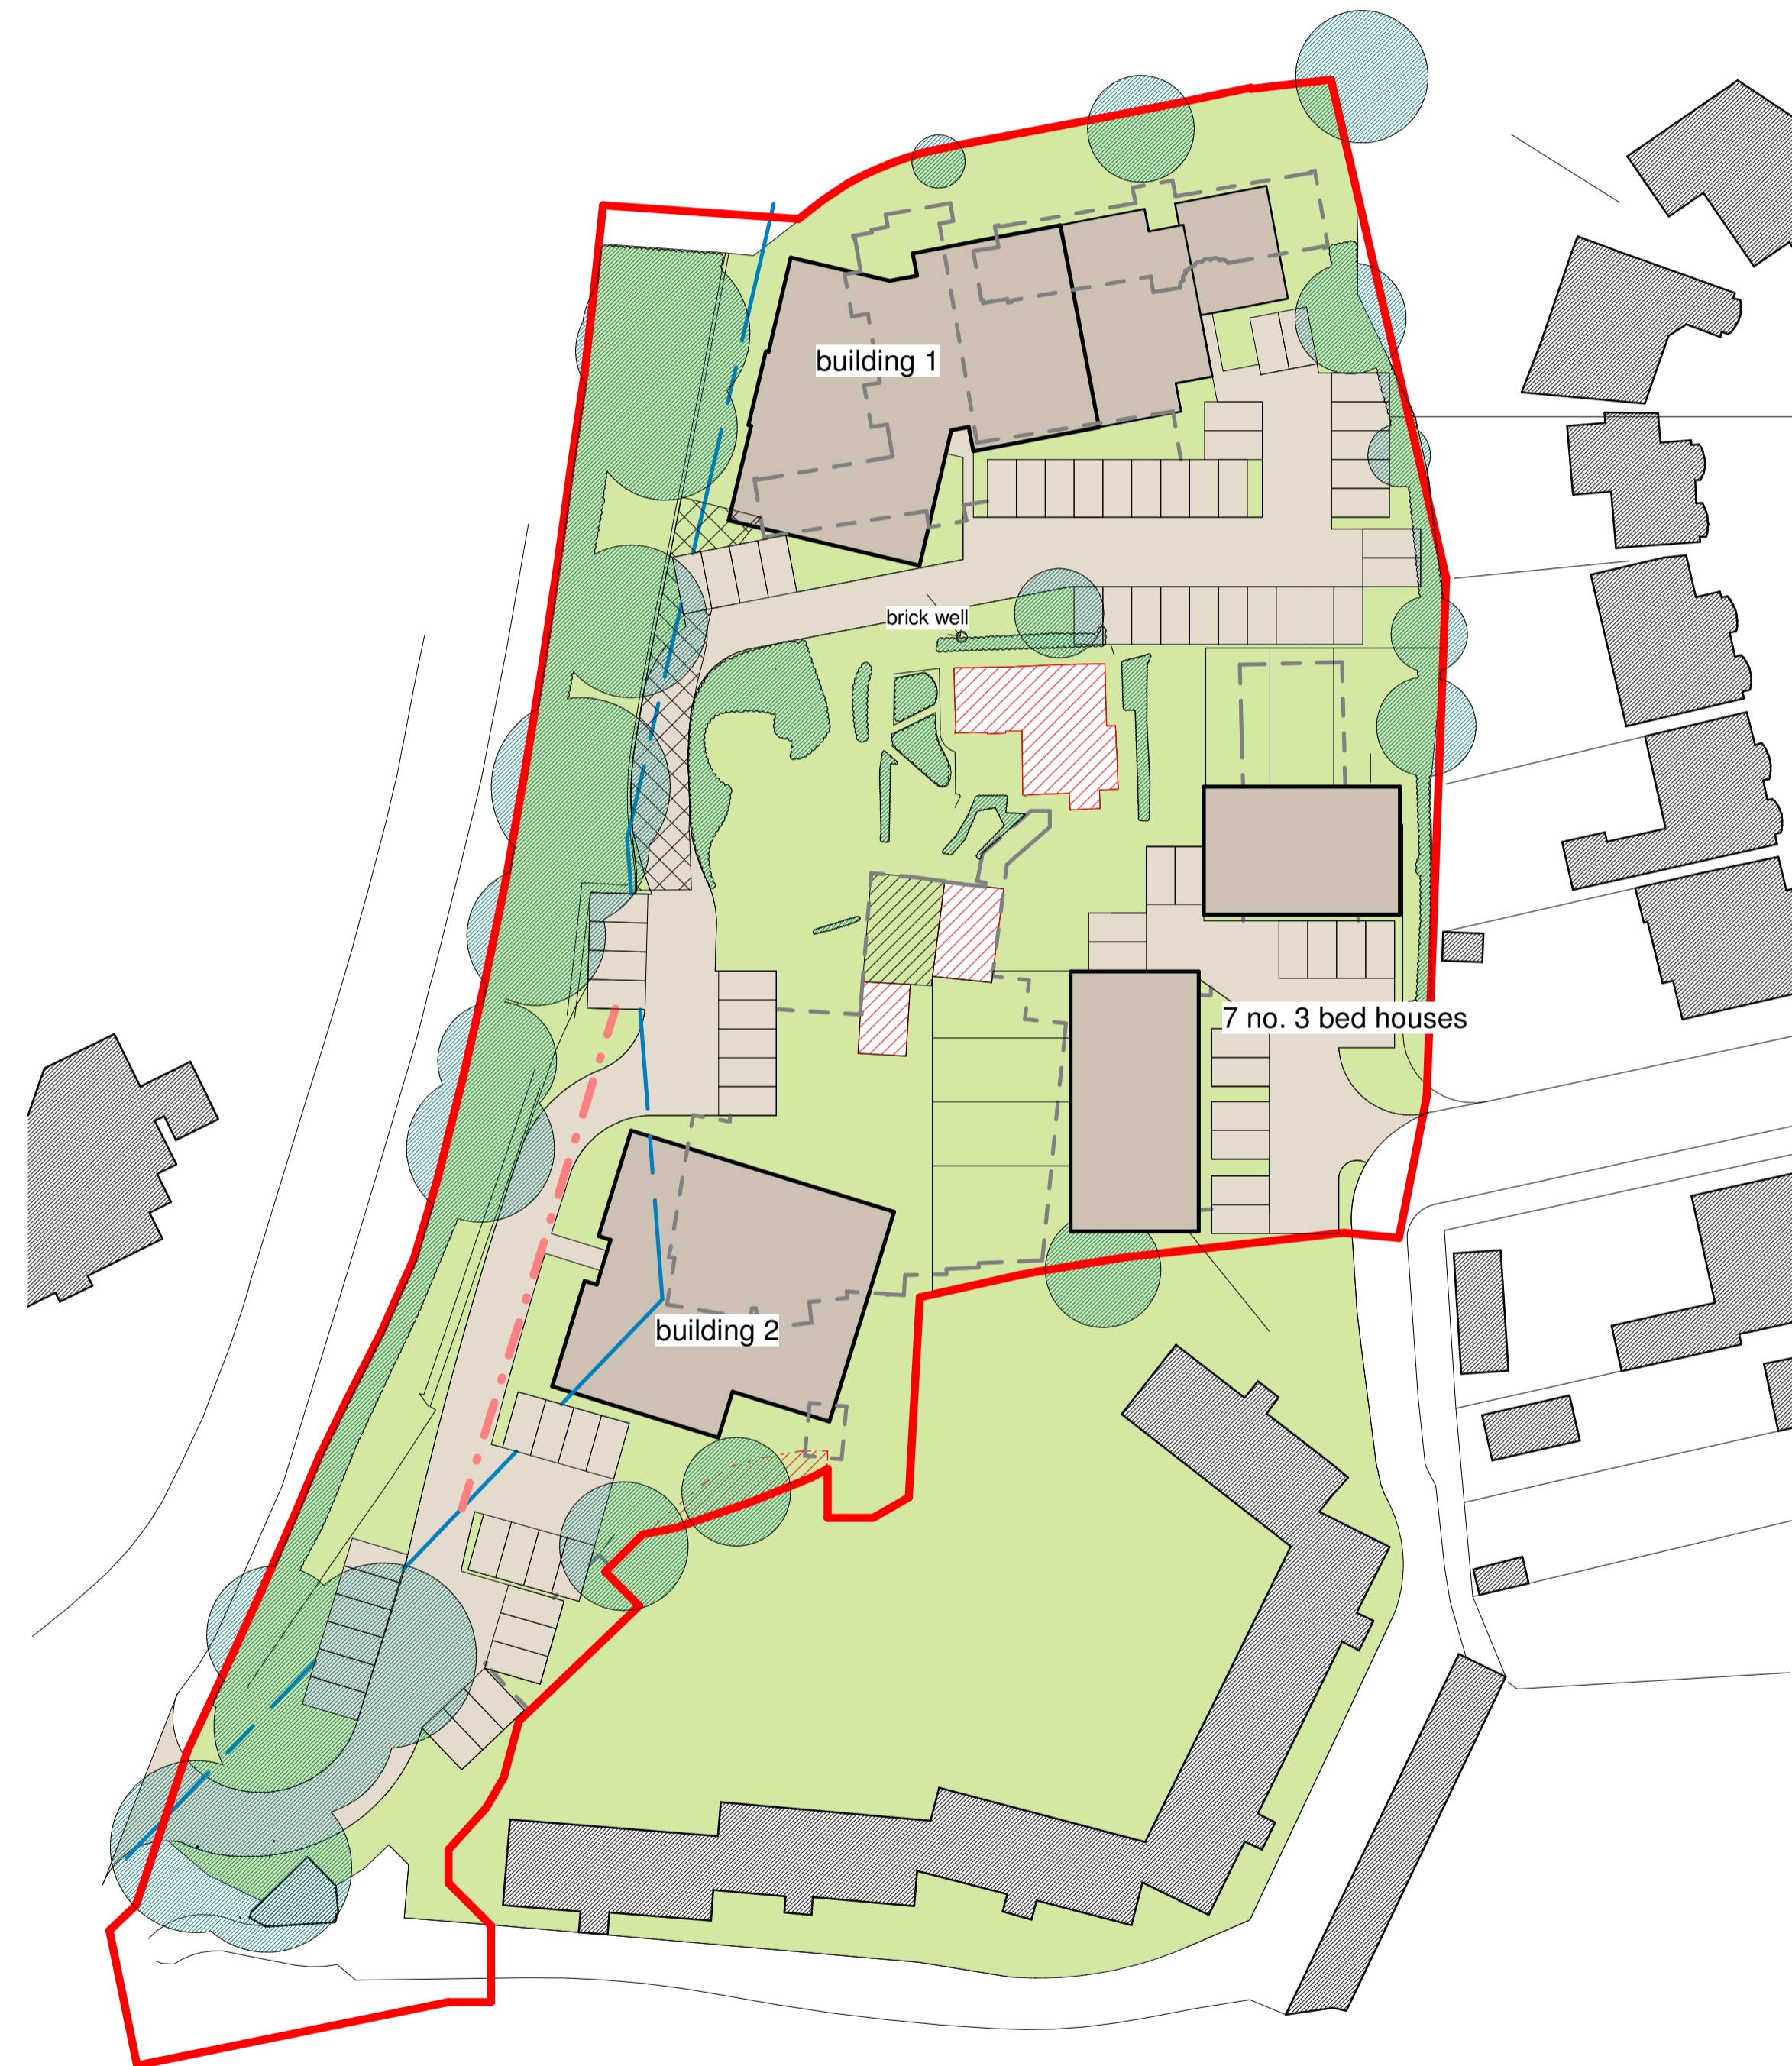
- 25 no. 1 bed flats approx 50 sq.m.
- 25 no. 2 bed flats approx 61 sq.m.
- 17 no. 2 bed flats approx 70 sq.m.
- 7 no. 3 bed houses approx 106.9 sq.m.

77 parking spaces

C	scheme including houses	20/04/22
B	revised access and parking	19/04/22
A	revised red line	08/04/22
REV	AMENDMENTS	DATE
DRAWN BY		DATE
Author		02/04/22
SCALE (@ A1)		PROJECT NUMBER
1:500		Project Number
CHECKED BY		APPROVED
Checker		
TITLE		
Proposed site layout plan		
PROJECT		
THE BARN HOTEL, WEST END ROAD, RUISLIP, HA4 6JB		
DRAWING NUMBER		
22 0063-1C
